Operator: 8 North

Location Name: WELD-611N61W 28NESW

Loc ID: 310706

Inspection: 696301300

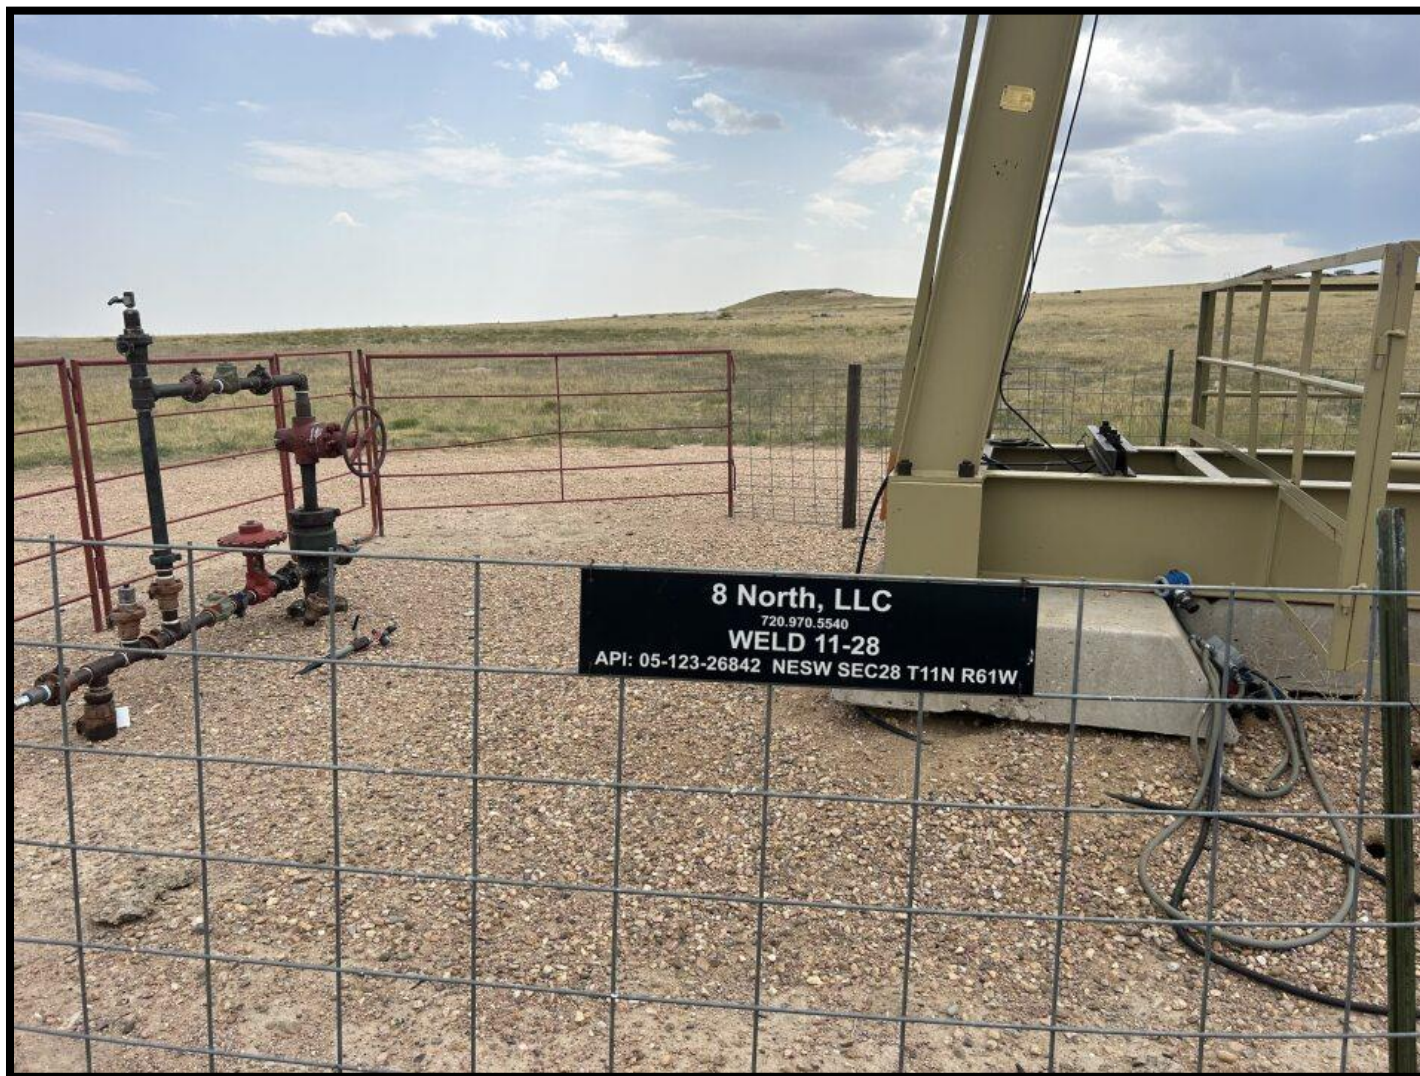
Exhibit A

CA: Wellhead Sign is missing. Comply with 210.b.

CA Resolution: Operator has provided photo evidence that a wellhead sign has been installed in compliance with Rule 210.b

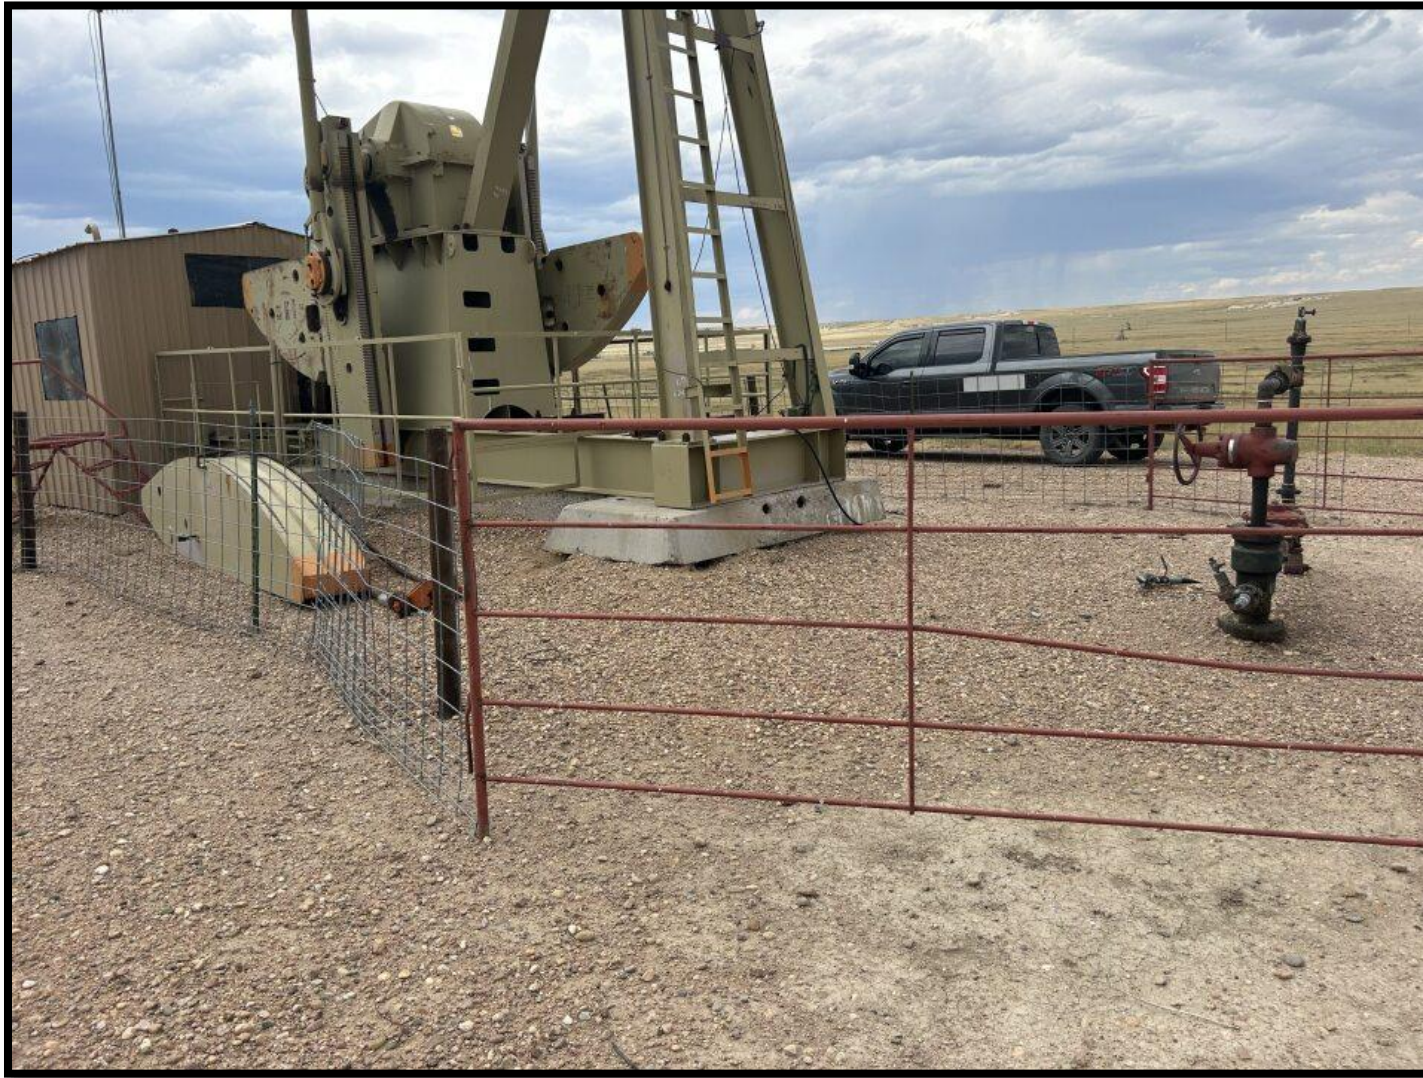
Exhibit B

CA: Unused Wellhead parts- Comply with Rule 603.f.

CA Resolution: Operator has provided photo evidence that unused wellhead parts have been properly removed or secured in compliance with the 600 series.
