Interim Reclamation and Stormwater Inspection

Operator: CRESTONE PEAK RESOURCES OPERATING
LLC - 10633

Inspection Document #: 708201513

Location Name: Chavez 61N65W HZ Pad

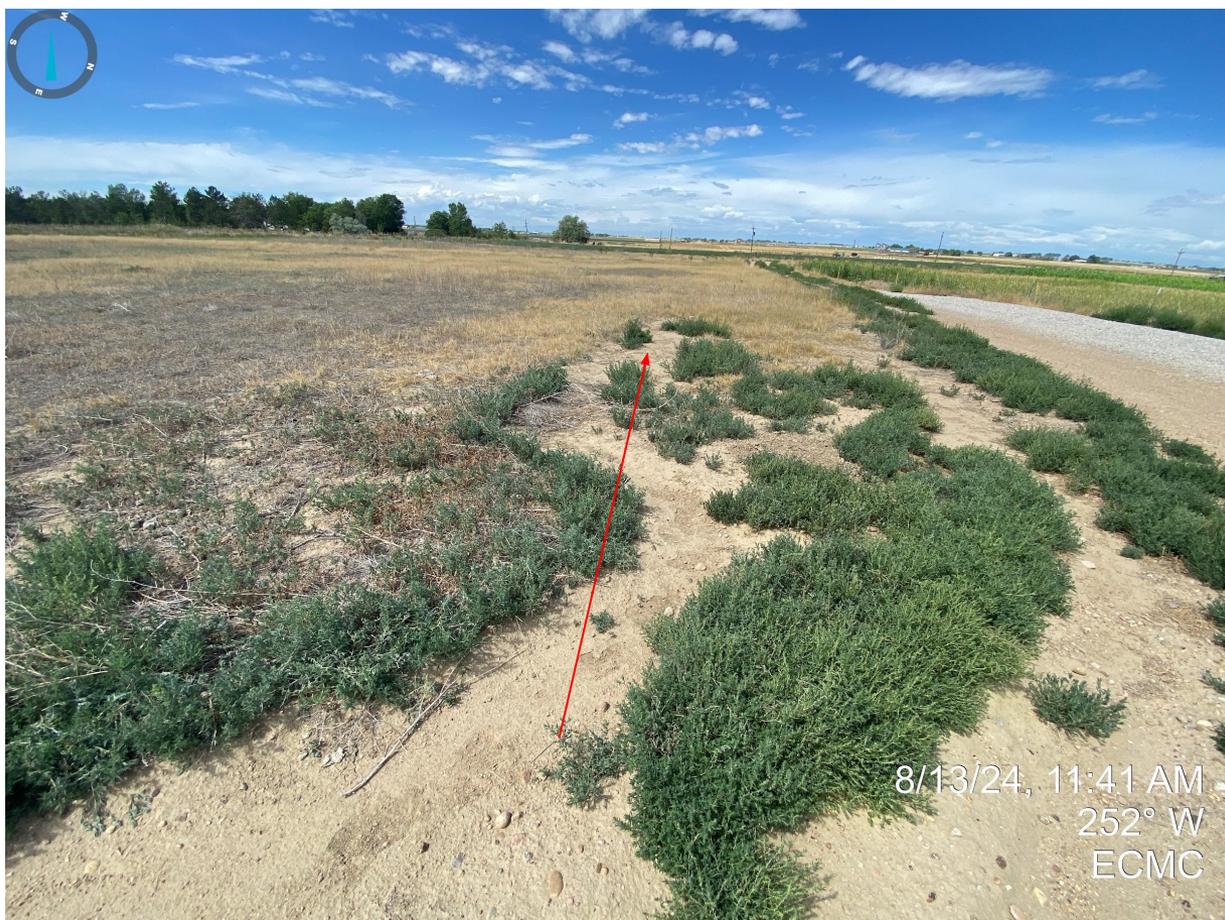
Photo 1. Erosion degradation observed on the southern production areas with sediment discharge into the interim areas. Also pictured, undesirable vegetation (kochia and russian thistle) observed to be growing. Pictured in background, the southern interim areas do not appear to be progressing towards reclamation standards and regulations with little evidence of desirable perennial vegetation observed.

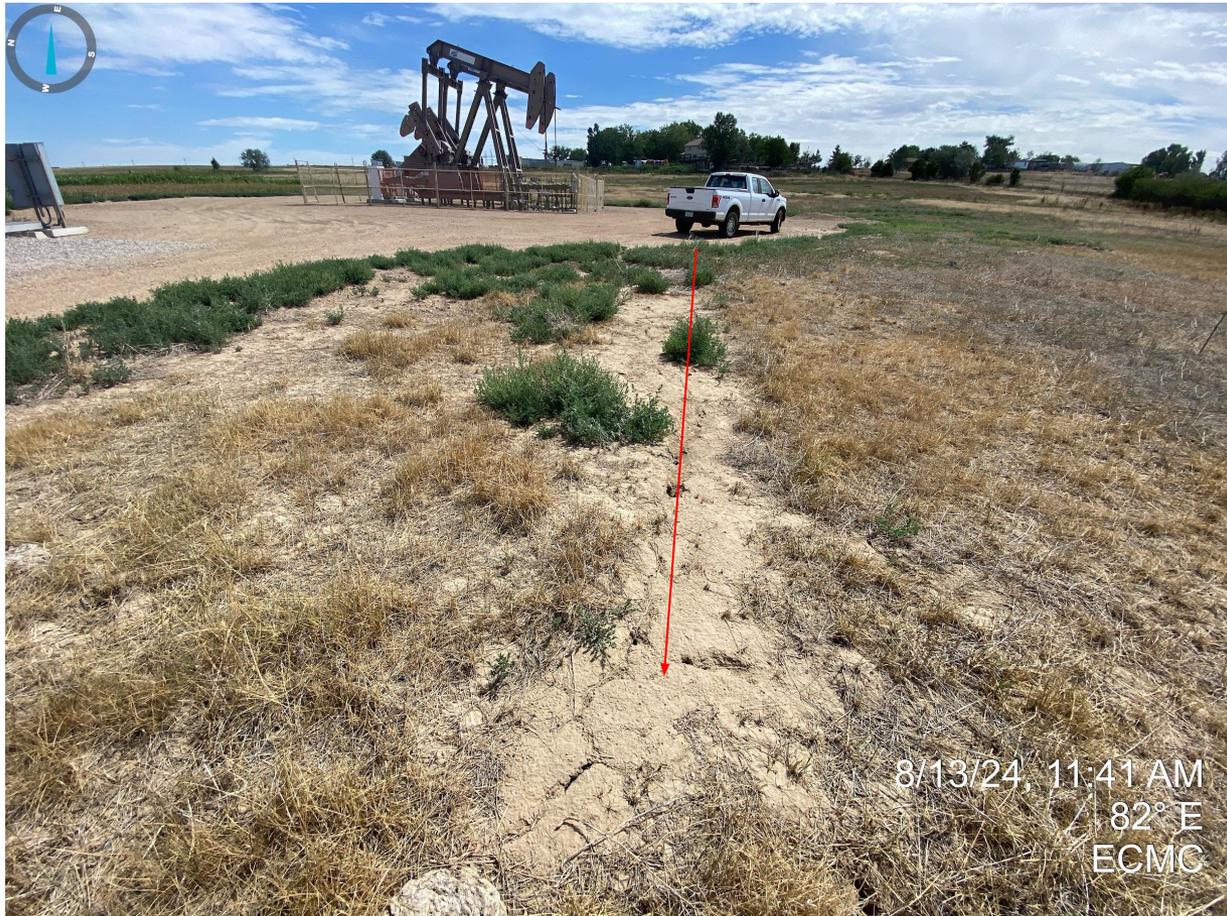
Photo 2. Continued from Photo 2, facing east.

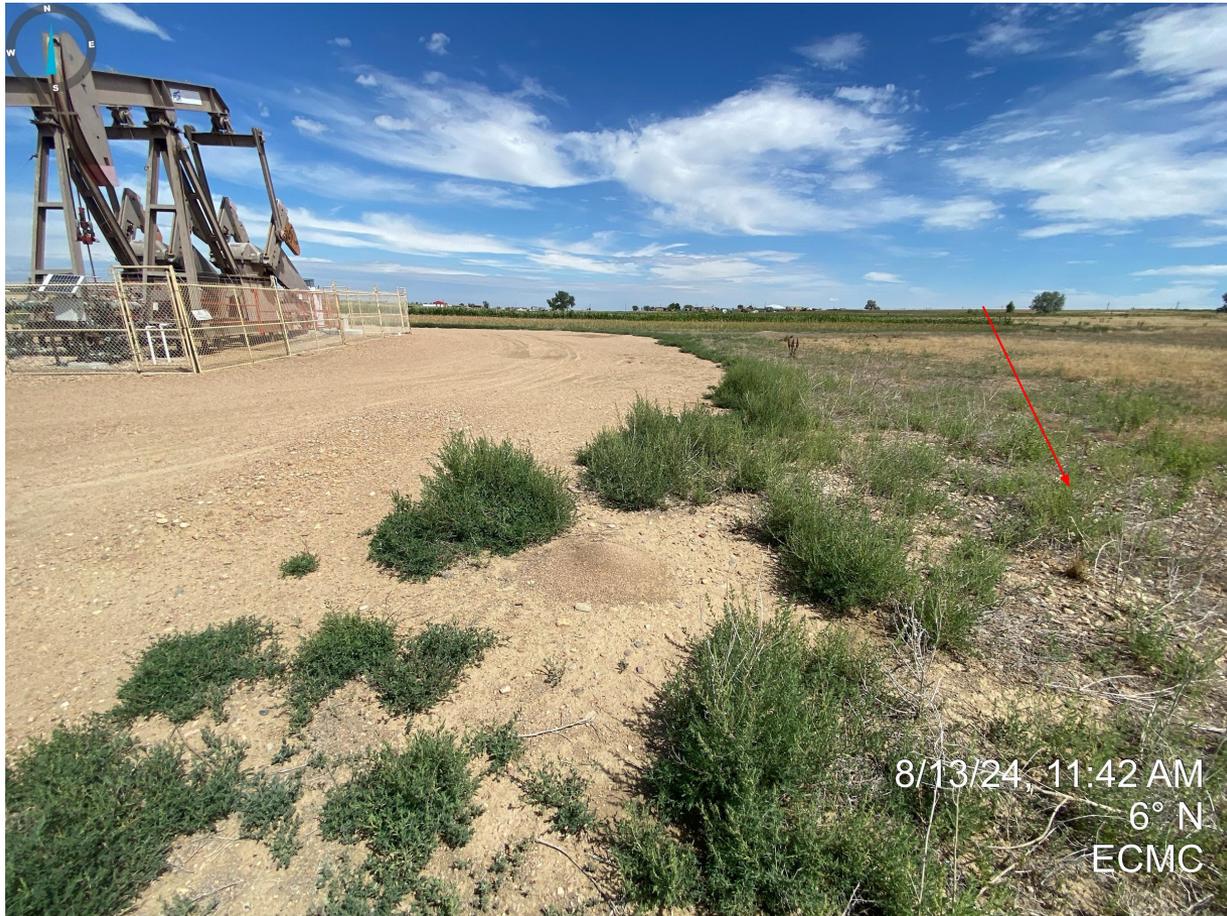
Photo 3. Undesirable vegetation observed throughout the production areas. Evidence of road base material/cobble observed in the eastern interim areas, illustrated by red arrow.

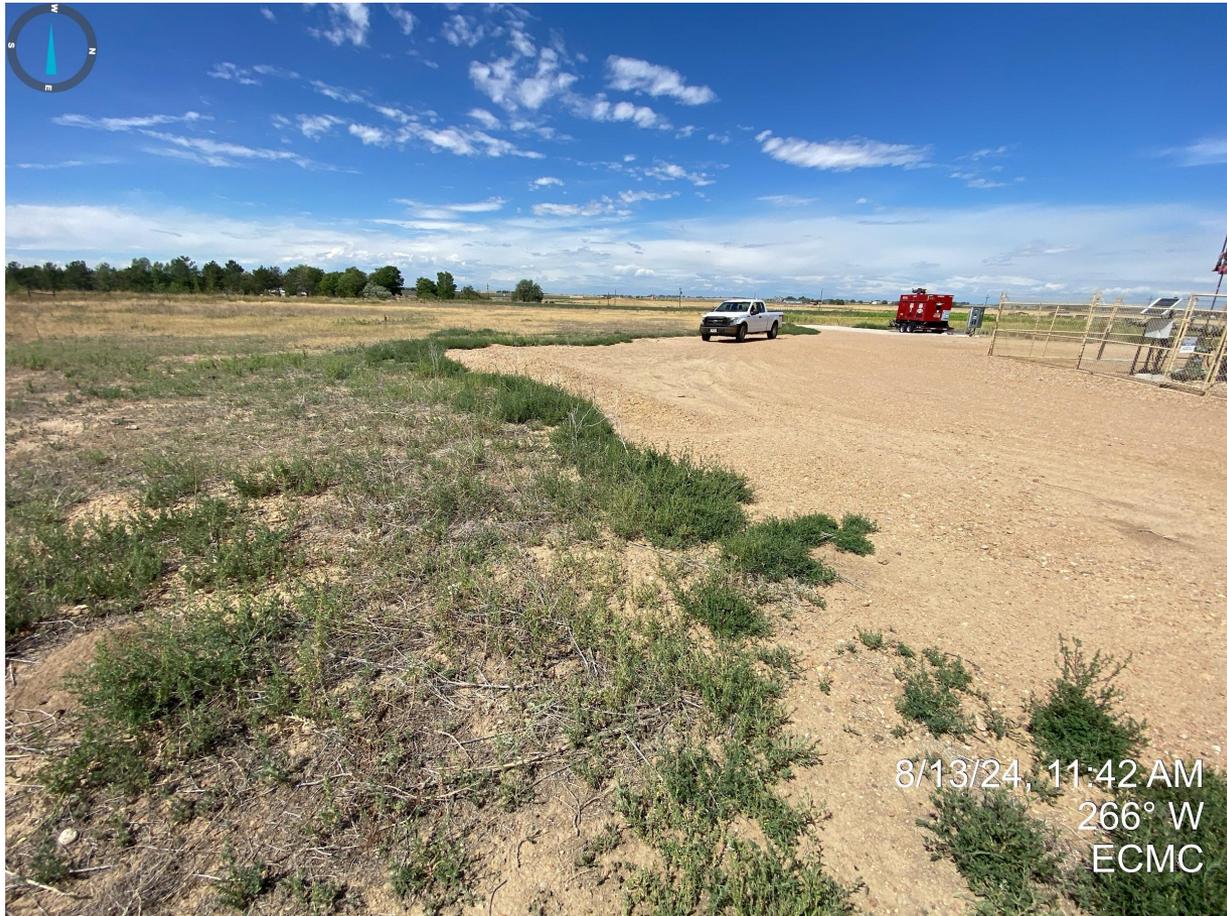
Photo 4. Continued from Photo 3; facing west.

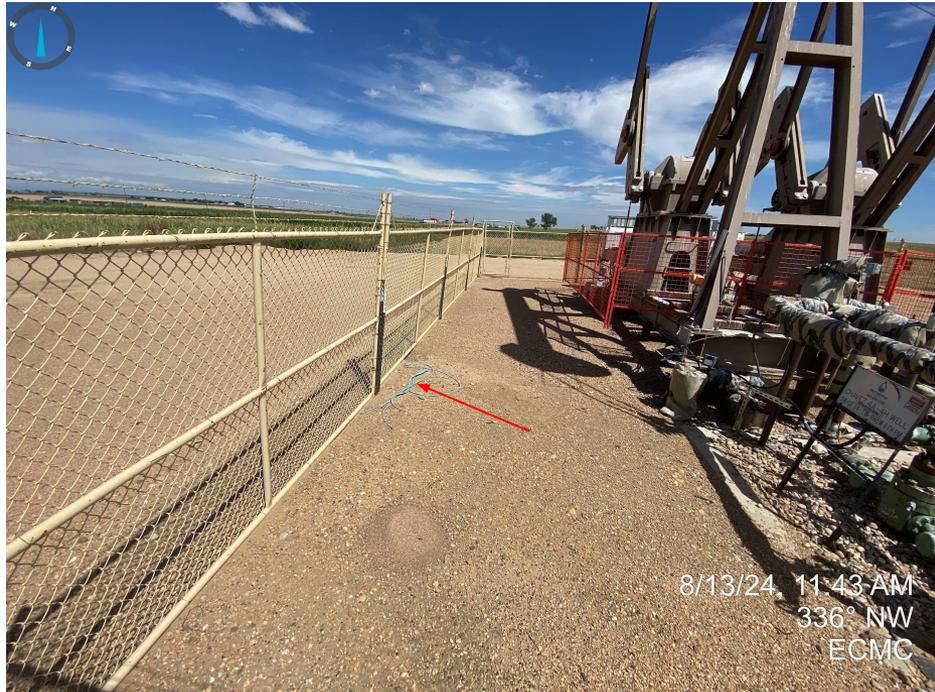
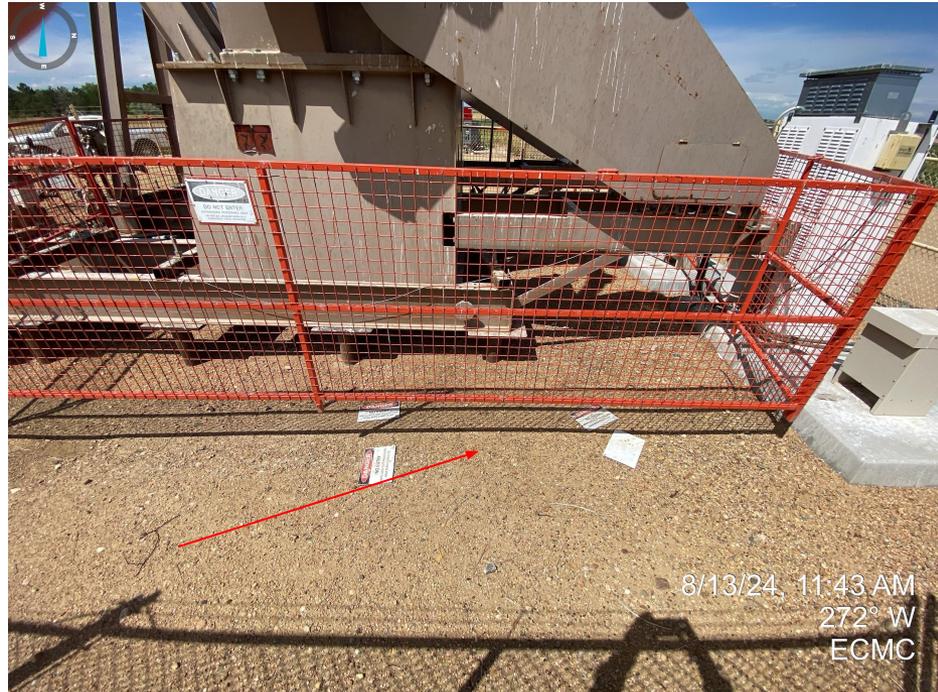
Photos 5 & 6. Debris observed around wells should be removed from the location

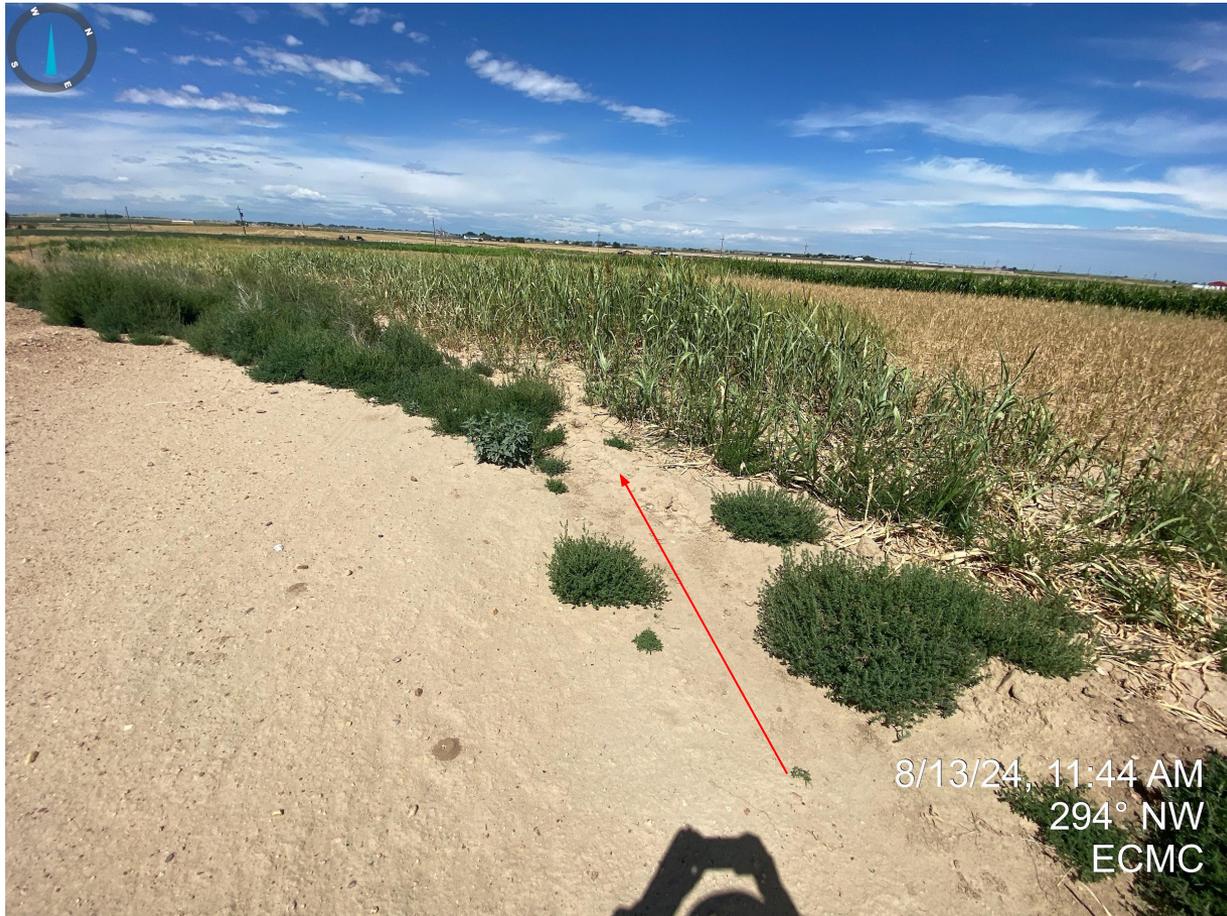
Photo 7. Erosion degradation observed on the northern production areas with sediment discharge into the interim areas. Also pictured, undesirable vegetation (kochia and russian thistle) observed to be growing.

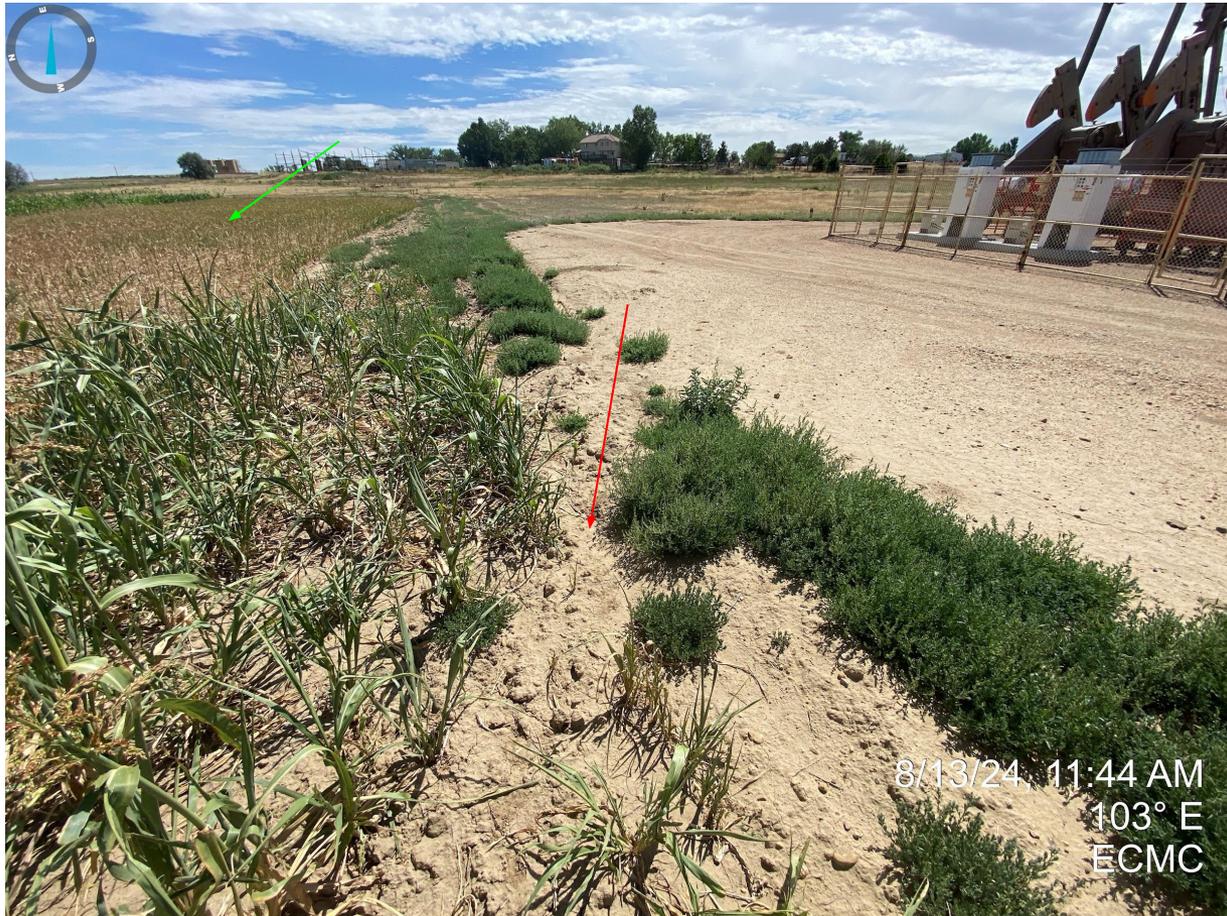
Photo 8. Continued from Photo 7; facing east. Pictured in background, the northern interim areas appear to be converted into cropland with poor crop growth observed, indicated by green arrow.

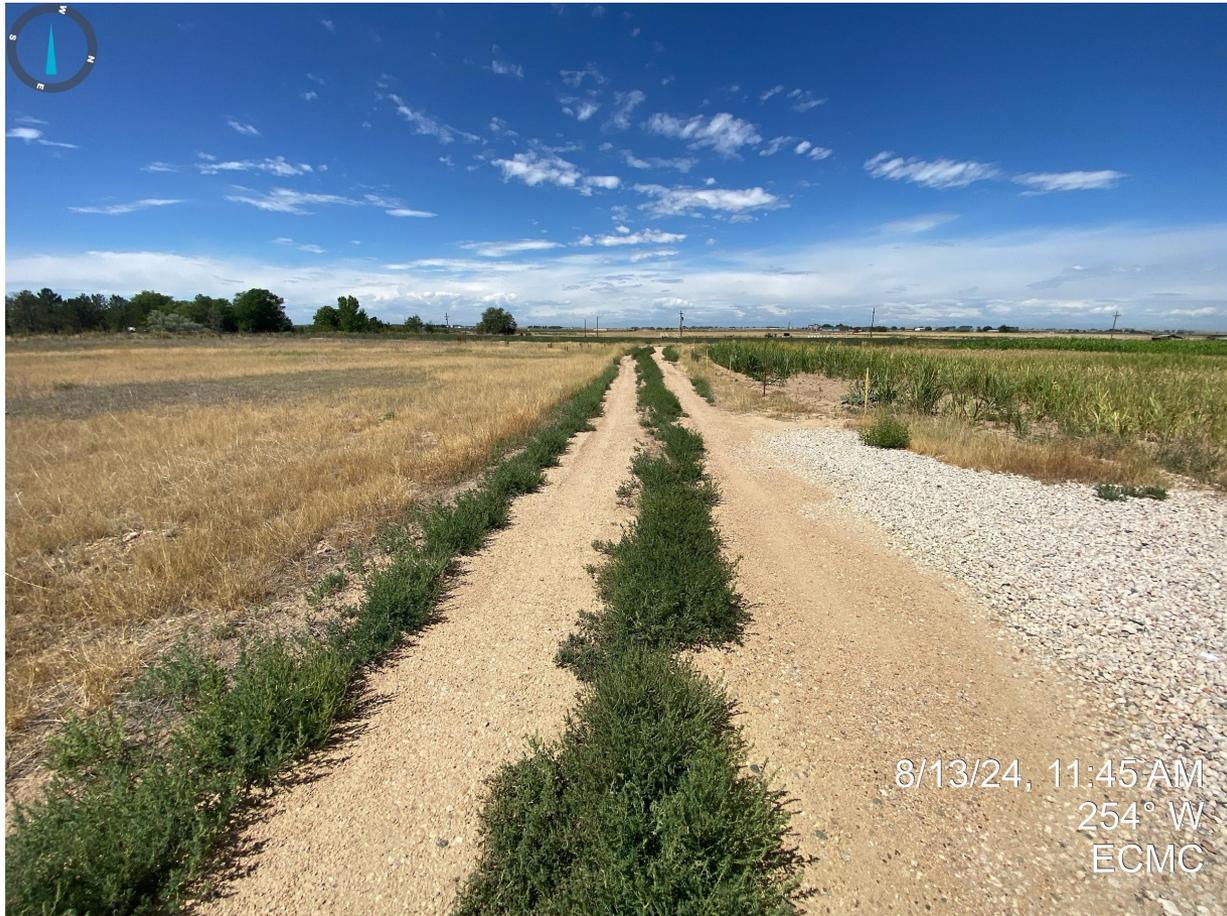
Photo 9. Undesirable vegetation growing throughout the access road.
