Inspection Photos

Operator: TEP ROCKY MOUNTAIN LLC #96850

Location ID: 335742

Inspection Doc: 696206140

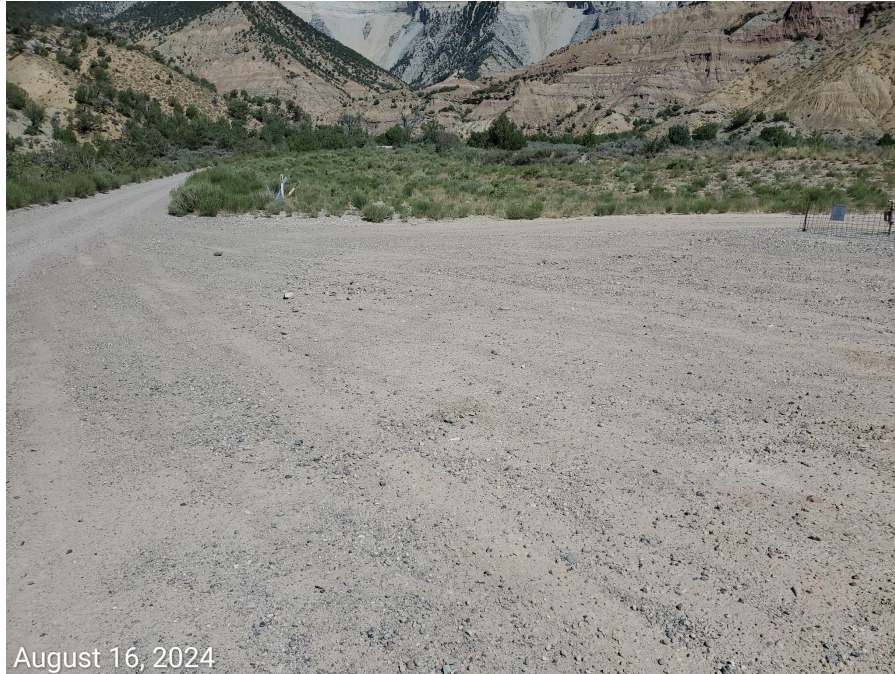
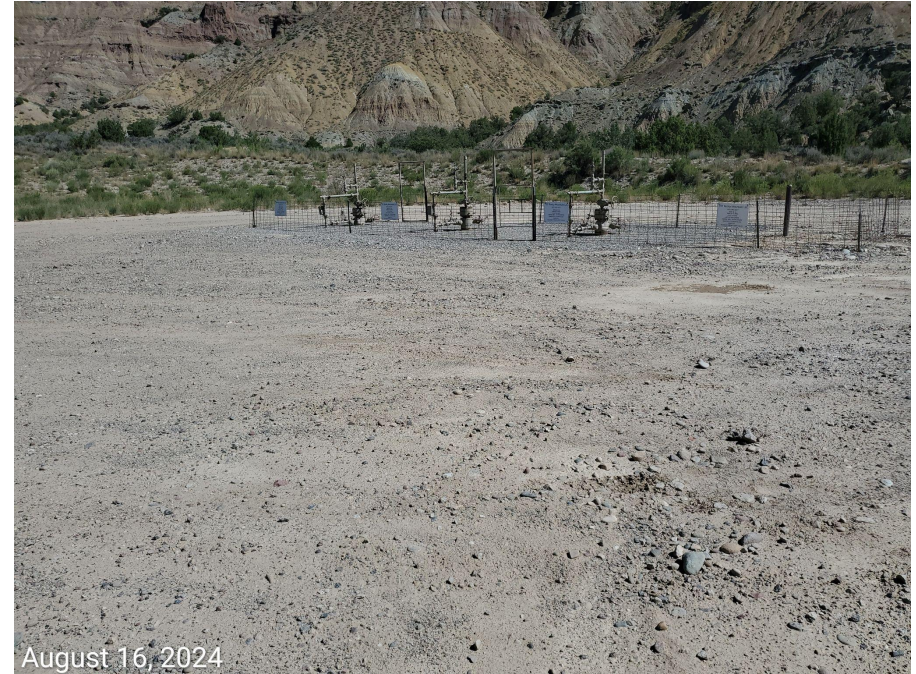
Photo 1: Photos 1-2 taken from the west end of the Location. Photos provide an overview from north, northeast, southeast to south. Photos also shows areas on the south end of the well pad not reasonably needed for production have not been reclaimed in accordance with 1003 Rules.

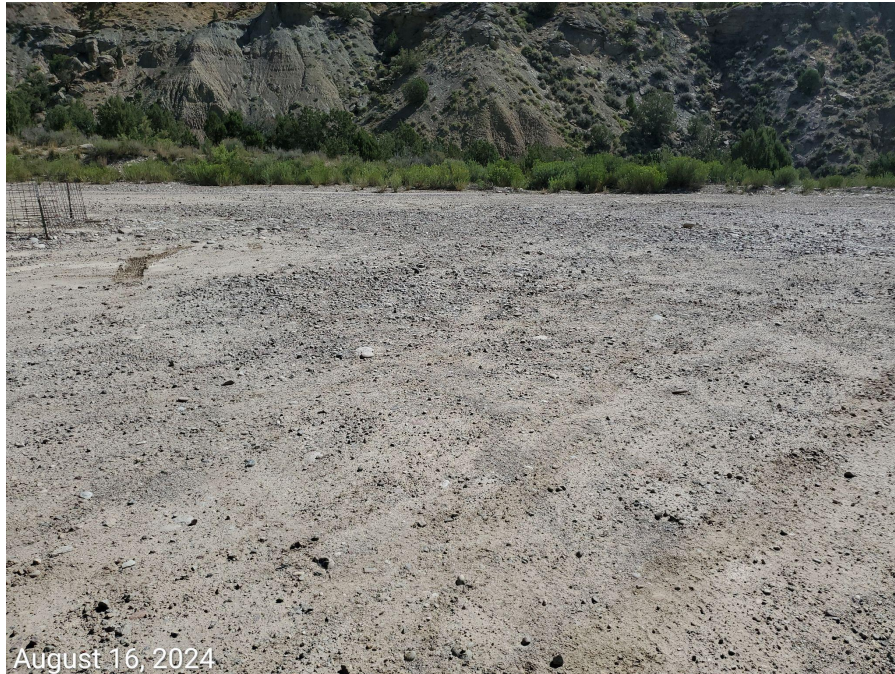
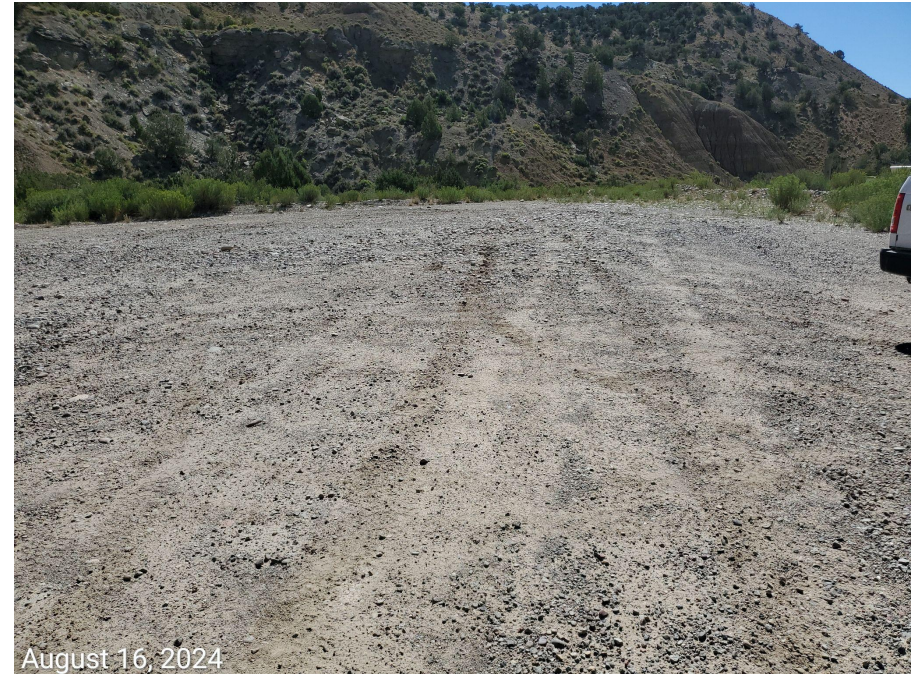
Photo 2: See comments under photo 1.

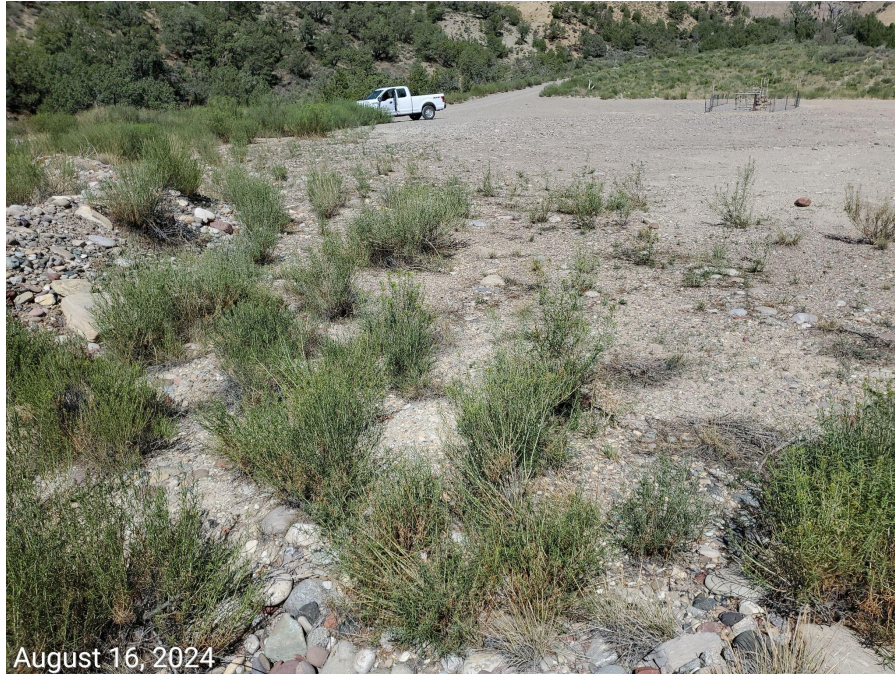
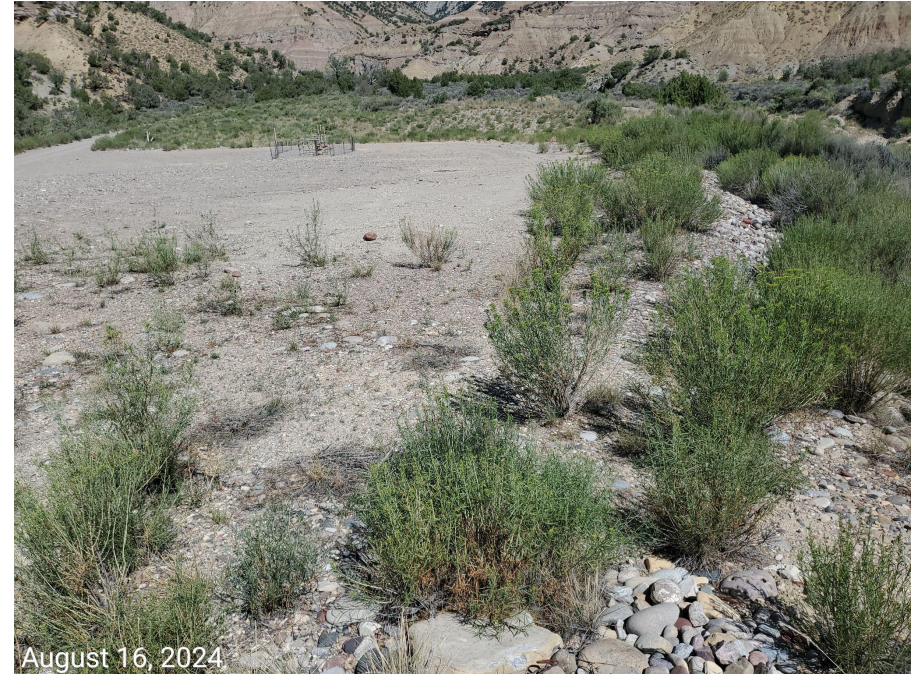
Photo 3: Photos taken from the south end of the well pad, facing northwest and north. Photos show areas on the south end of the well pad are not reasonably needed for production, and have not been reclaimed in accordance with 1003 Rules.

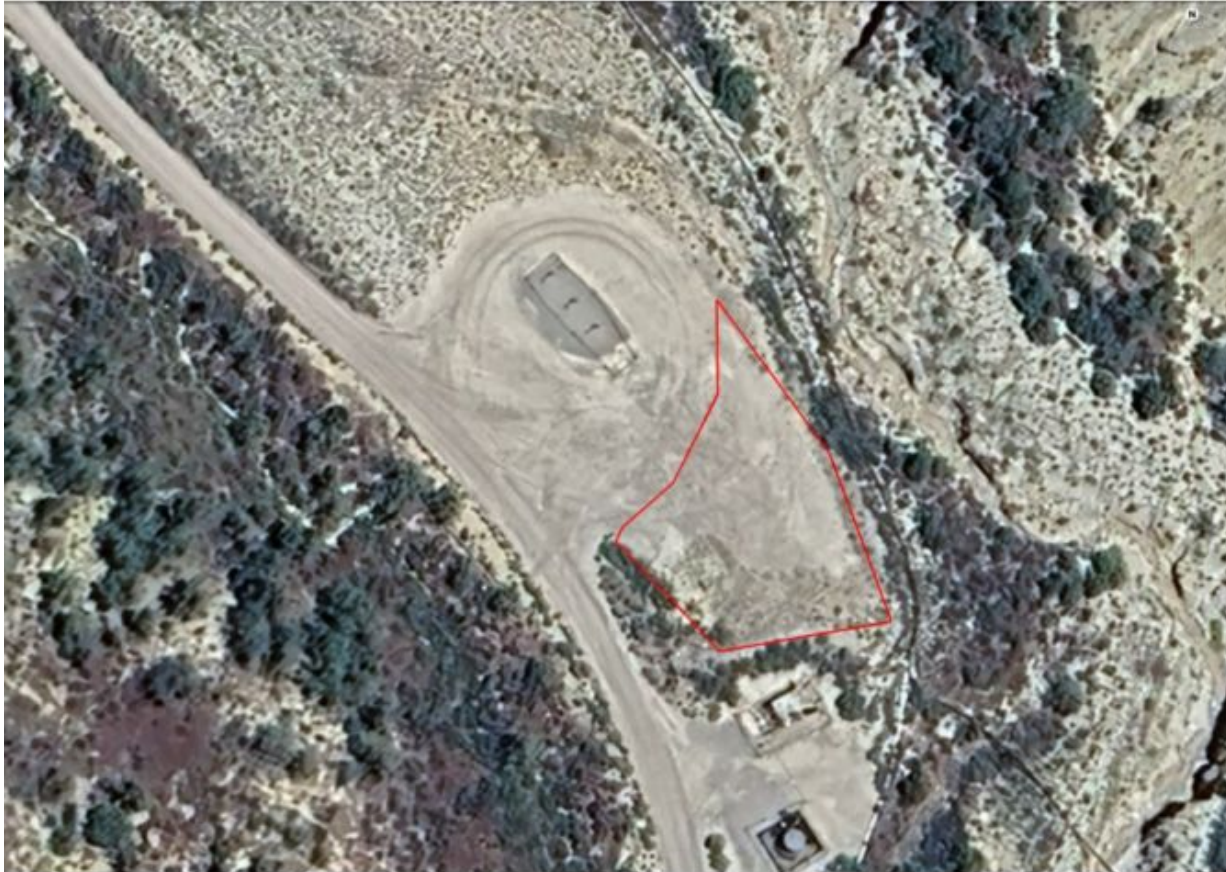
Photo 4: Google Earth aerial image. Red polygon represent approximate areas of the well pad not reasonable necessary for production activities.

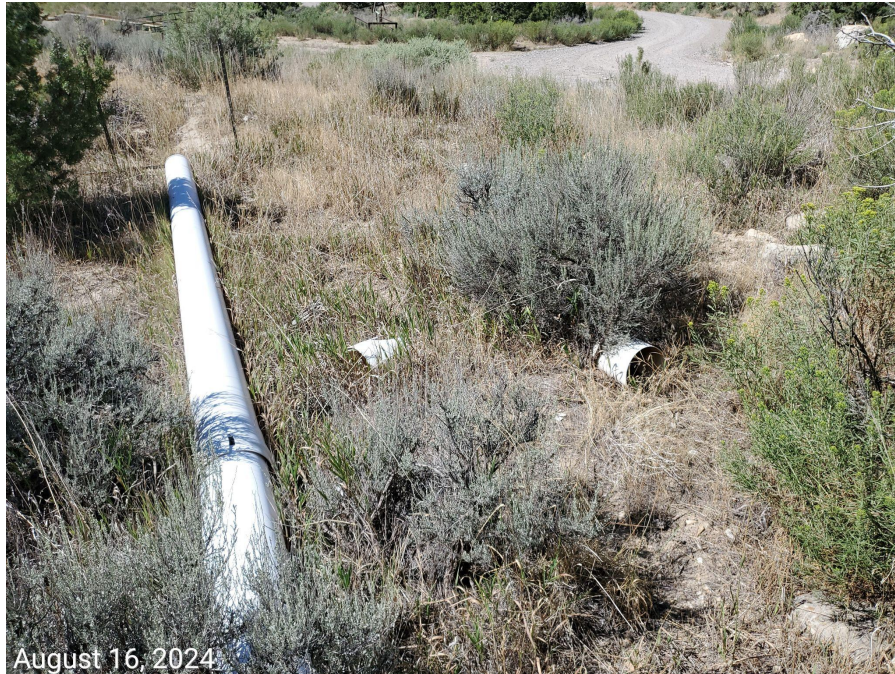
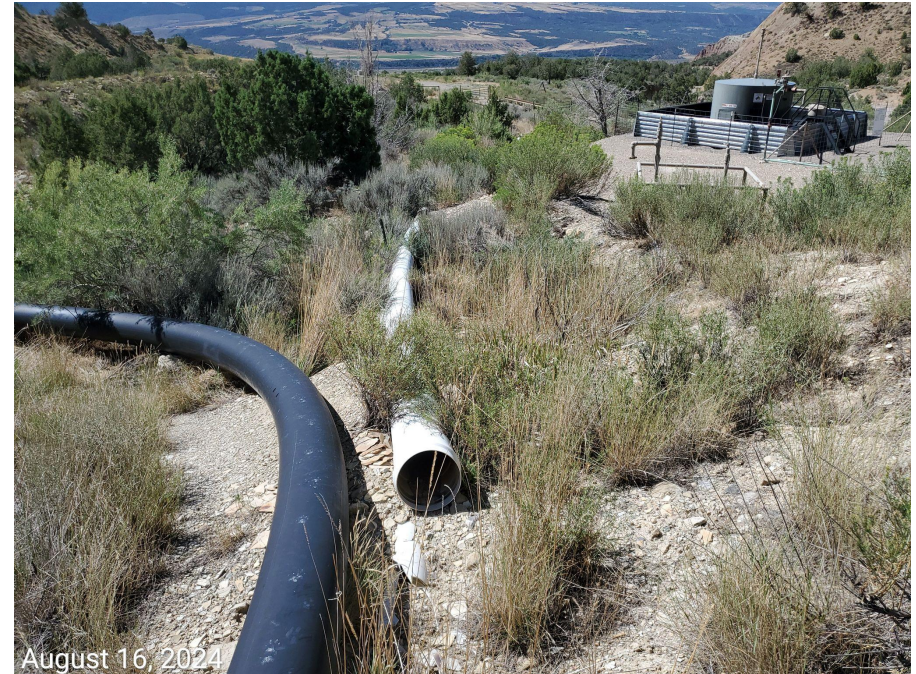
Photo 5: Photo shows unused pipe, trash and debris remain stored on the east end of the Location.

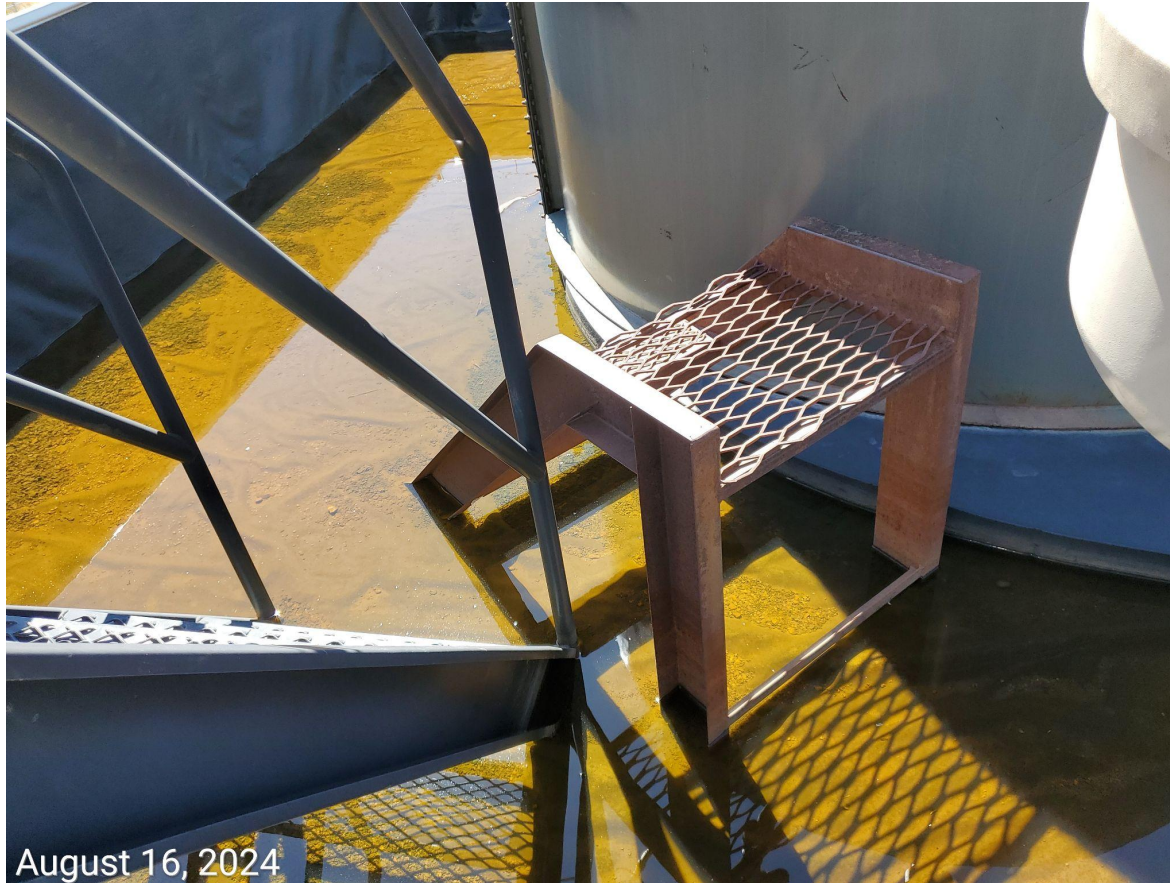
Photo 6: Unused equipment stored within containment at the battery facility.
