Inspection Photos

Operator: TEP ROCKY MOUNTAIN LLC #96850

Location ID: 335788

Inspection Doc: 696206142

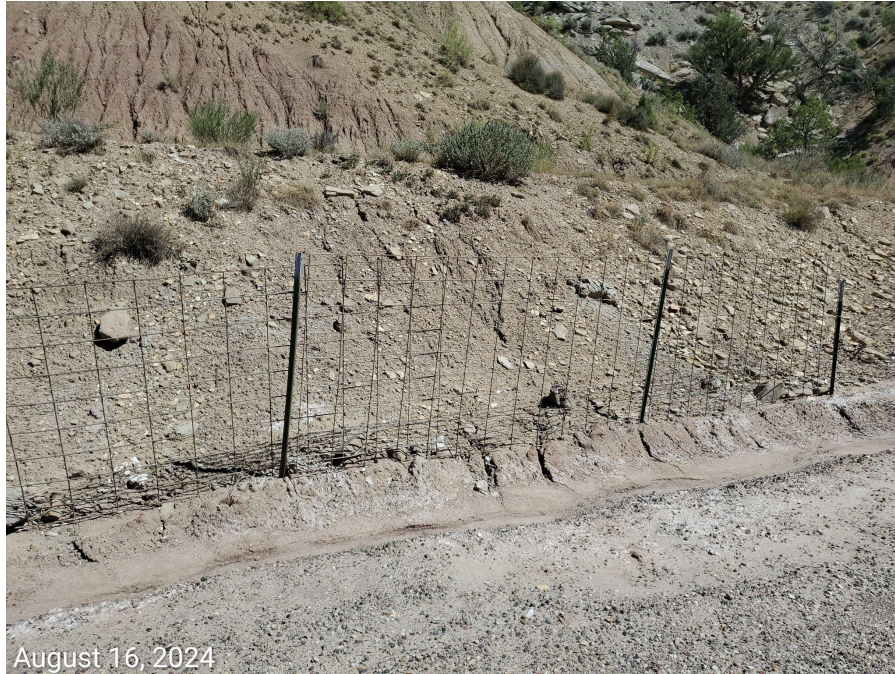
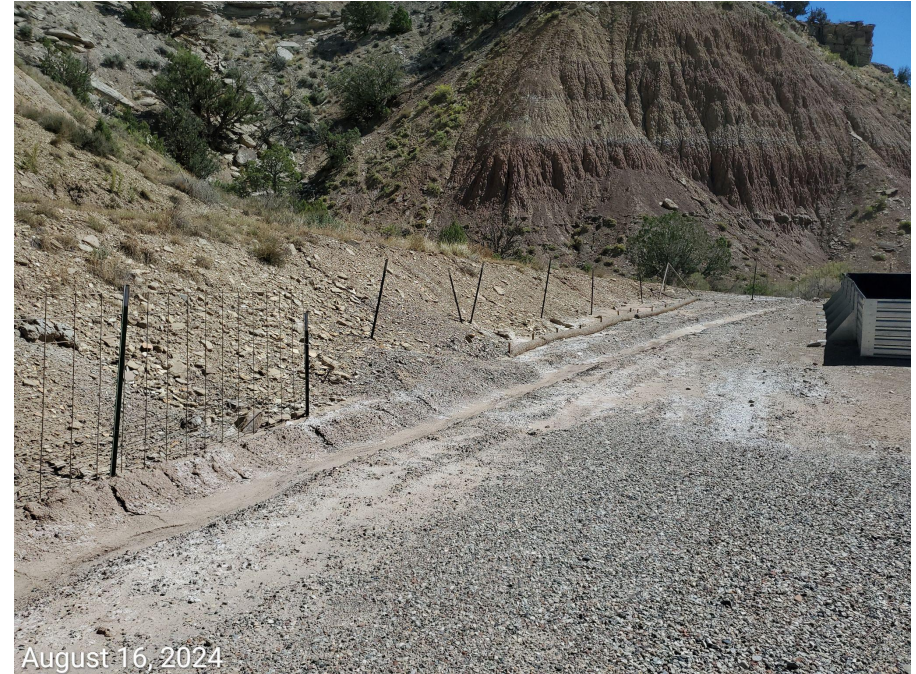
Photo 1: BMPs to stabilize, as well as to minimize erosion and degradation remain missing or insufficient at the slopes on Location.

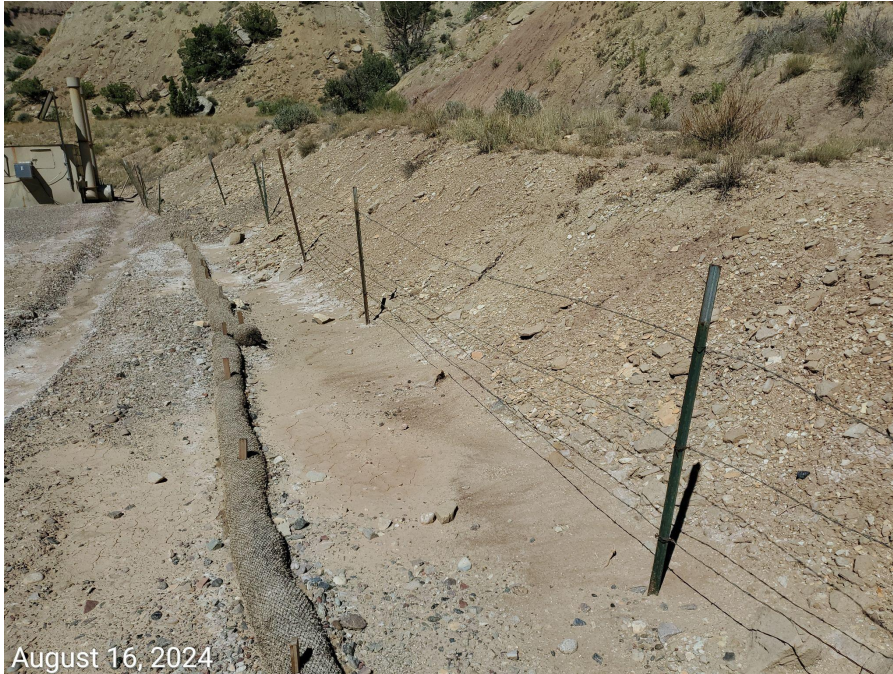
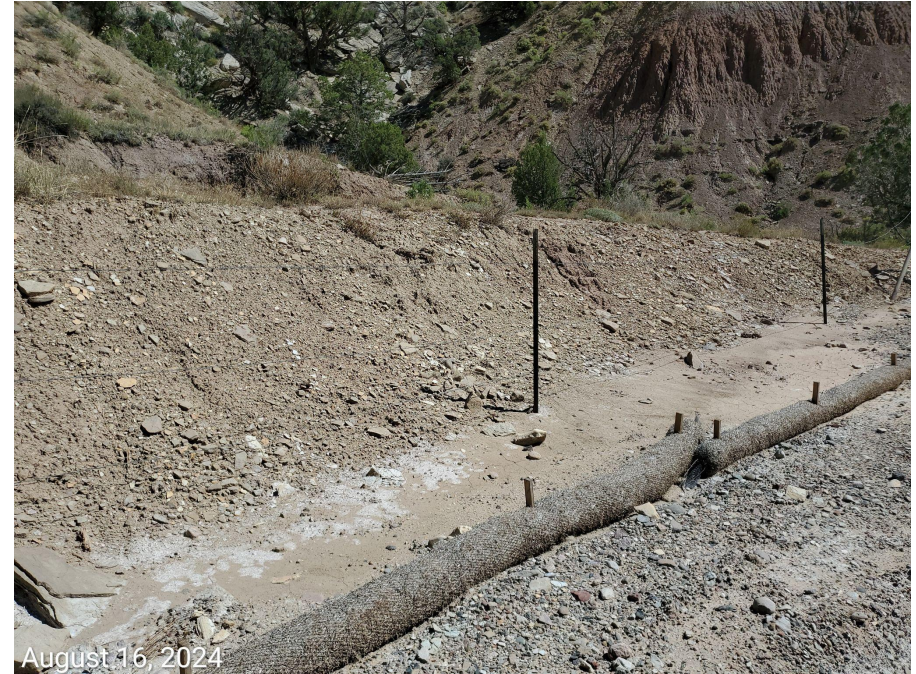
Photo 2: BMPs to stabilize, as well as to minimize erosion and degradation remain missing or insufficient at the slopes on Location. Lighter soils at toe of slopes sediment deposition due to unstablized slopes.
