Inspection Photos

Operator: TEP ROCKY MOUNTAIN LLC #96850

Location ID: 335777

Inspection Doc: 696206144

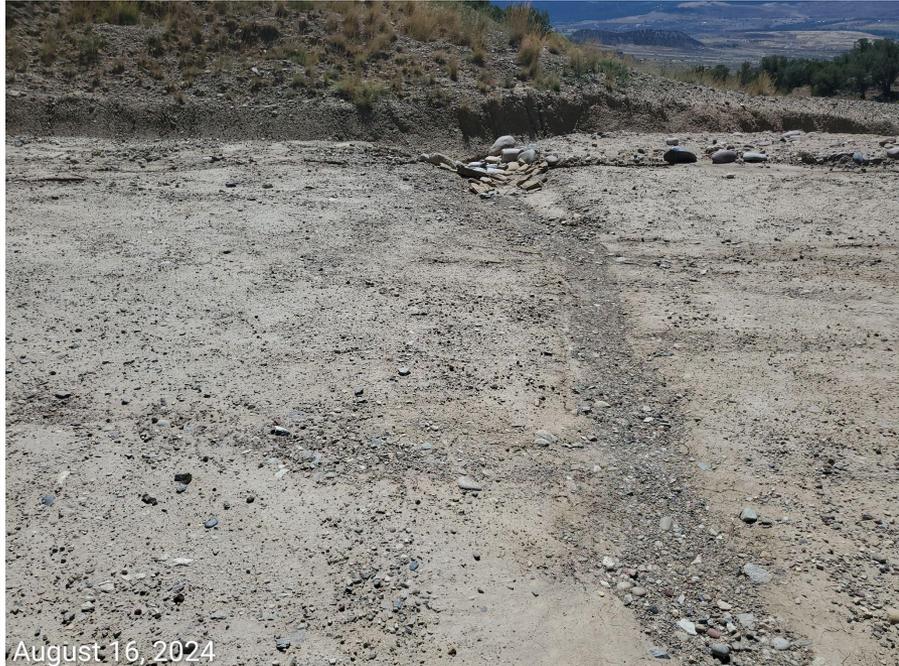
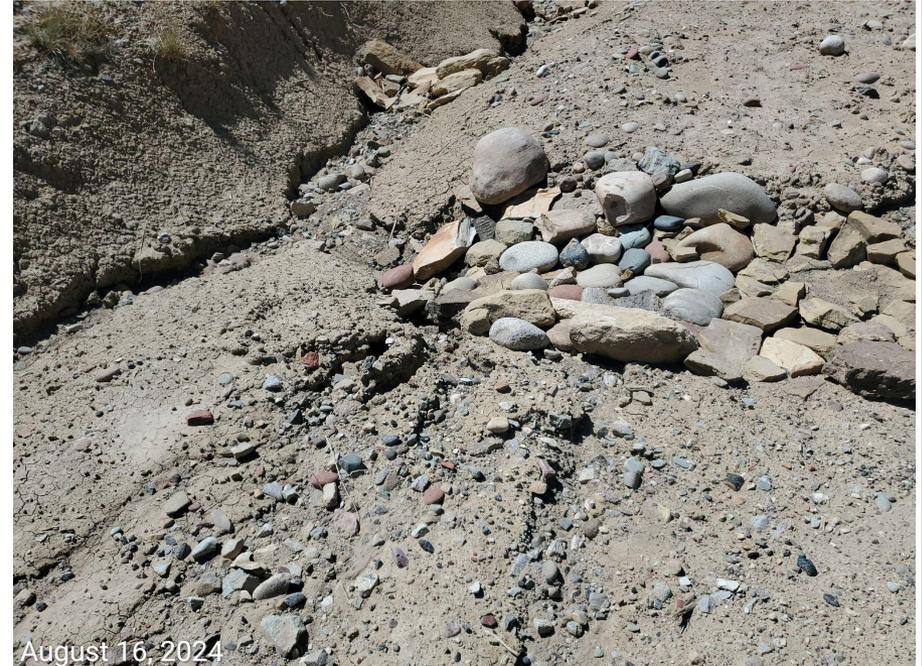
Photo 1: An armored outlet has been implemented on the east end of the Location. Controls to properly divert stormwater to the outlet do not appear to have been implemented in conjunction with the outlet. Stormwater scouring/degradation is becoming evident at sides of the BMP.

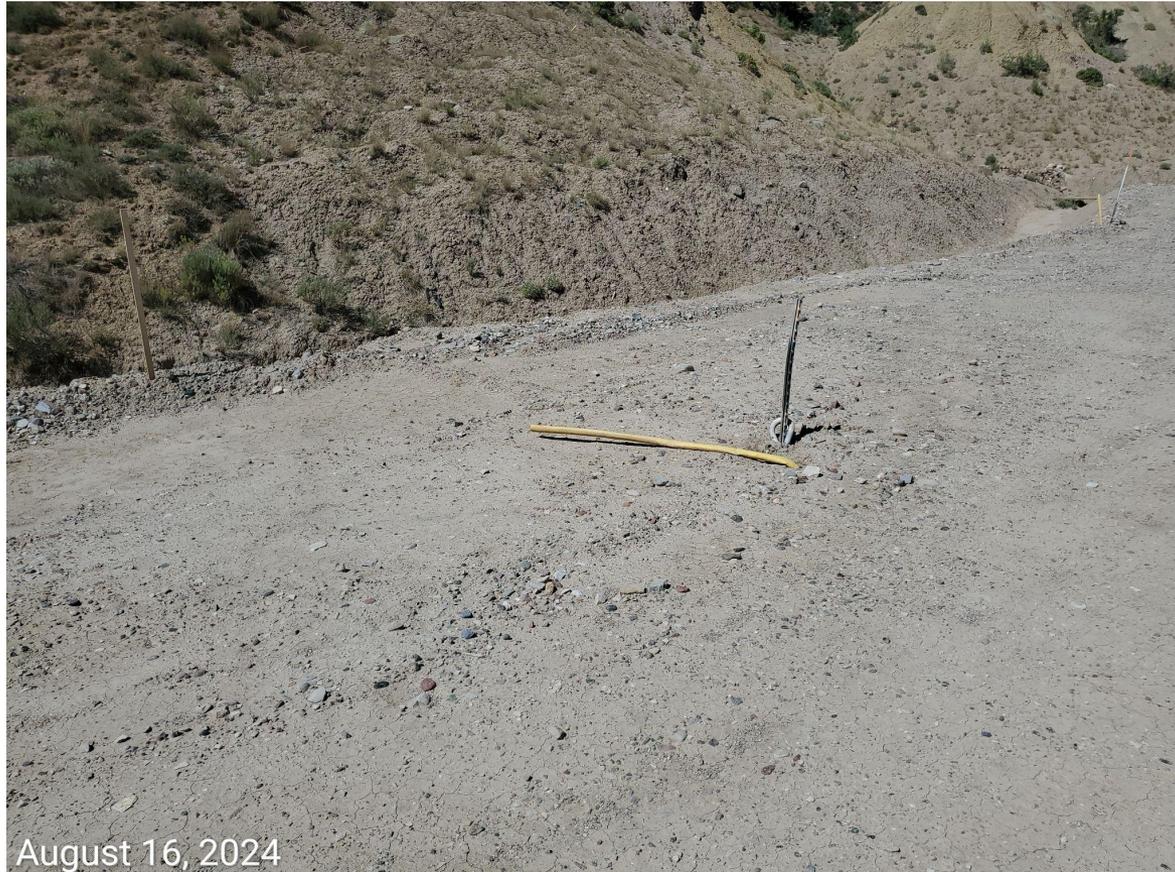
Photo 2: Marker at anchor has not been maintained and/or does not comport with 603.j requirements.
