# Inspection Photos

**Operator:** SWN PRODUCTION COMPANY LLC  
#10396

**Location ID:** 335174

**Inspection Doc:** 696206152

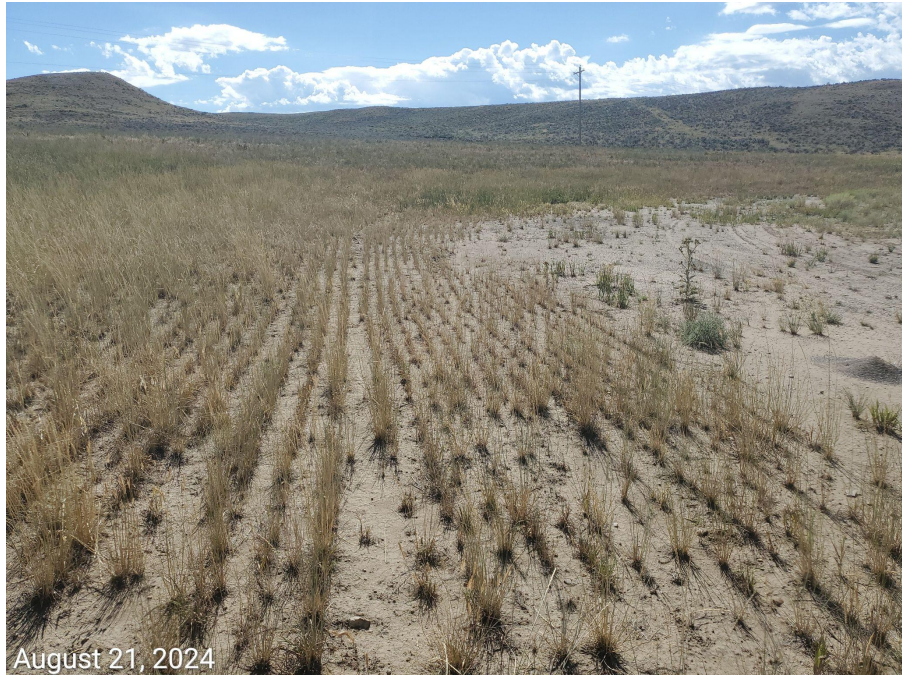
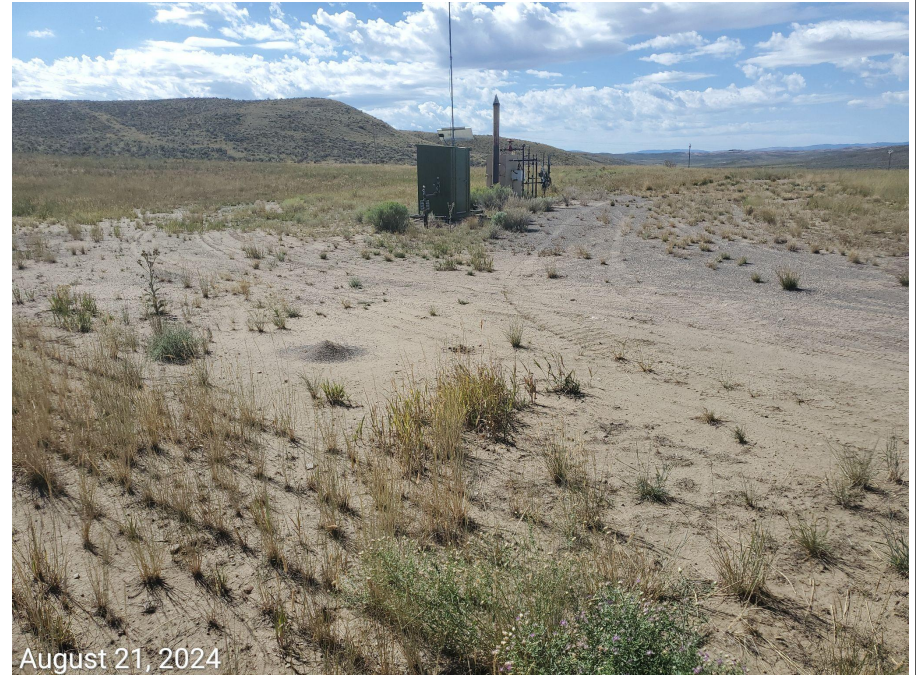
**Photo 1:** Photos 1-2 taken from the north end of the Location. Photos provide an overview of the Location from east, southeast, southwest to west. Location has not been reclaimed in accordance with 1004 requirements. Photo right also shows production equipment remaining on the Location.

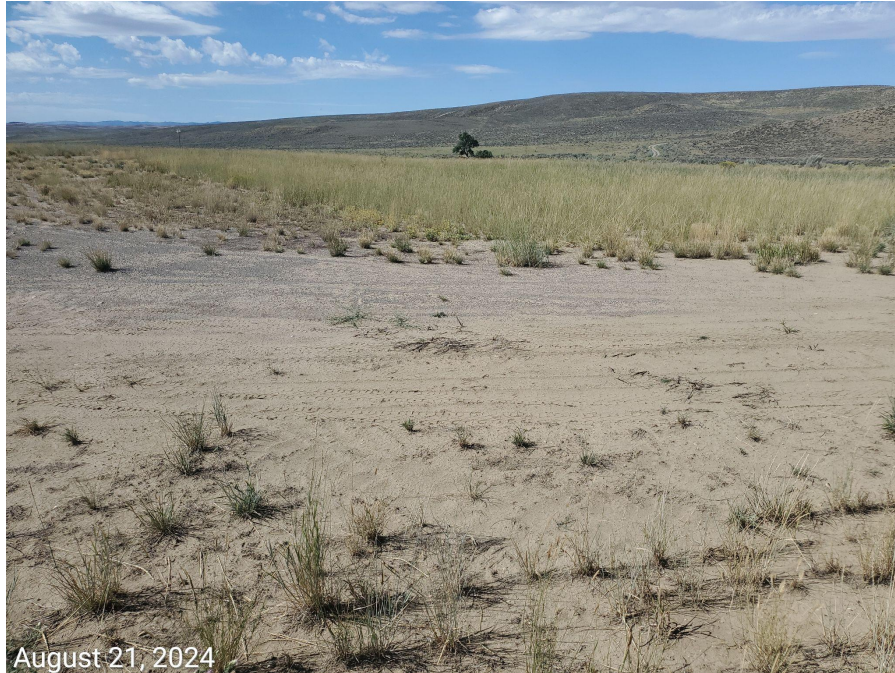
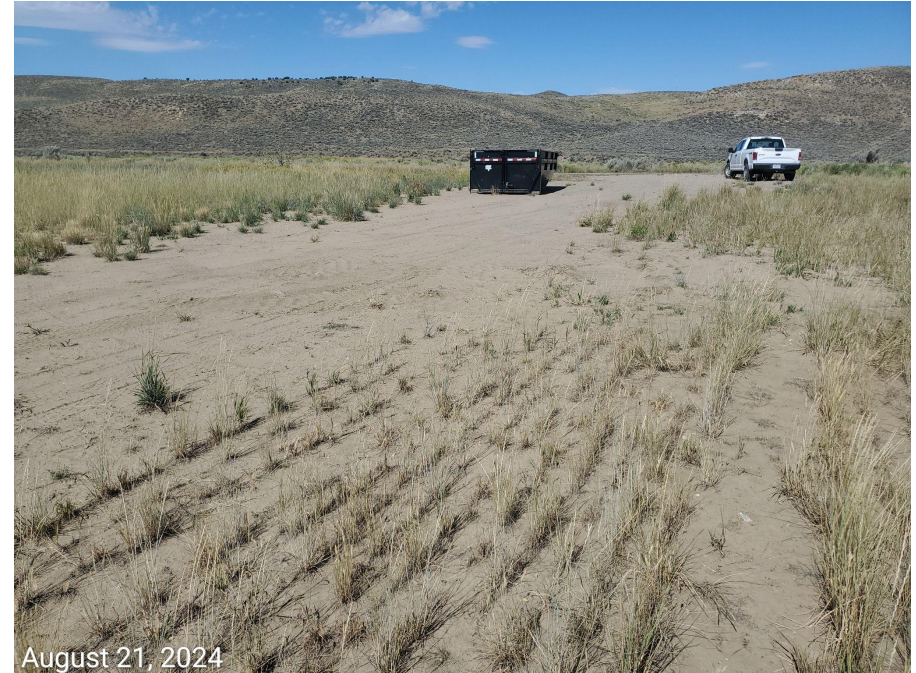
**Photo 2:** See comments under photo 1.

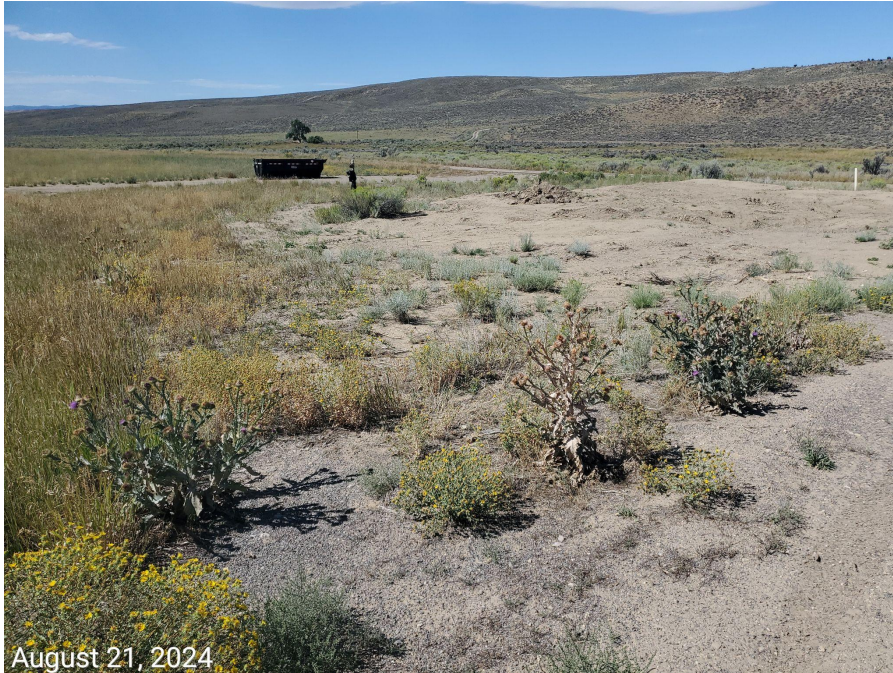
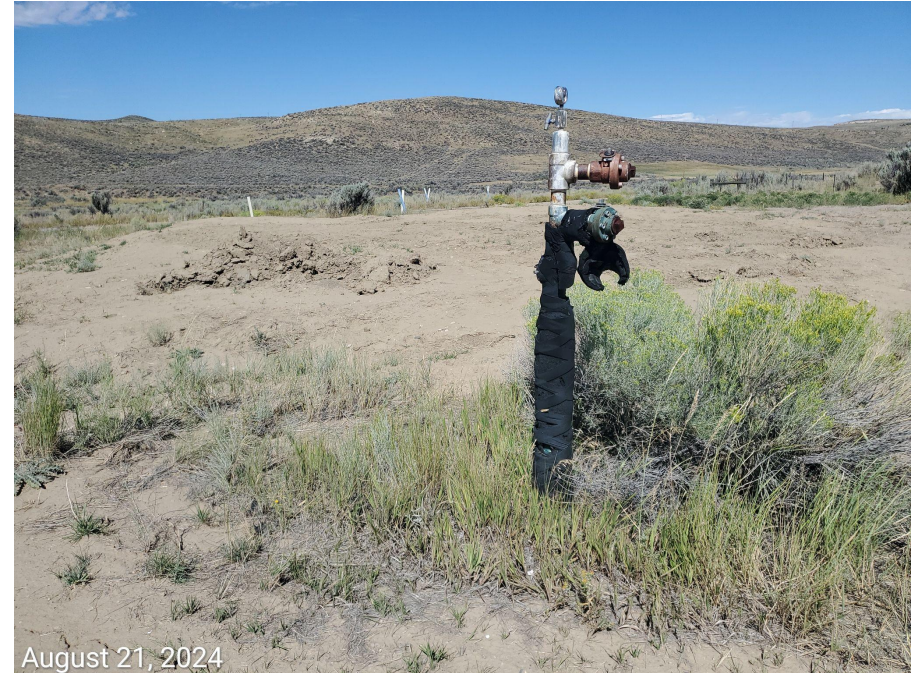
**Photo 3:** Photo taken from the northwest end of the Location, facing southwest. Photo shows weeds (Scotch thistle), bare/unvegetated areas and a riser remaining on the Location.

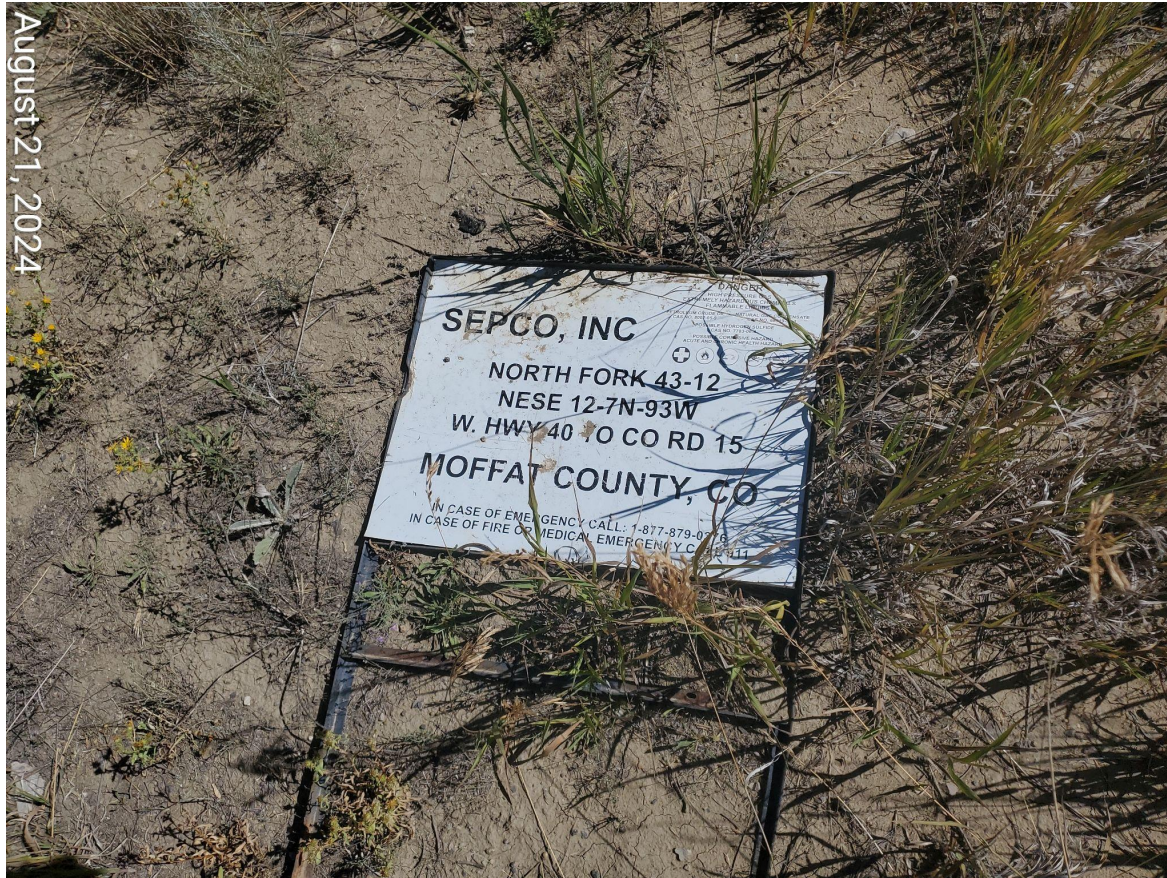
**Photo 4:** Photo taken from the north end of the Location. Photo shows signage/debris remaining.

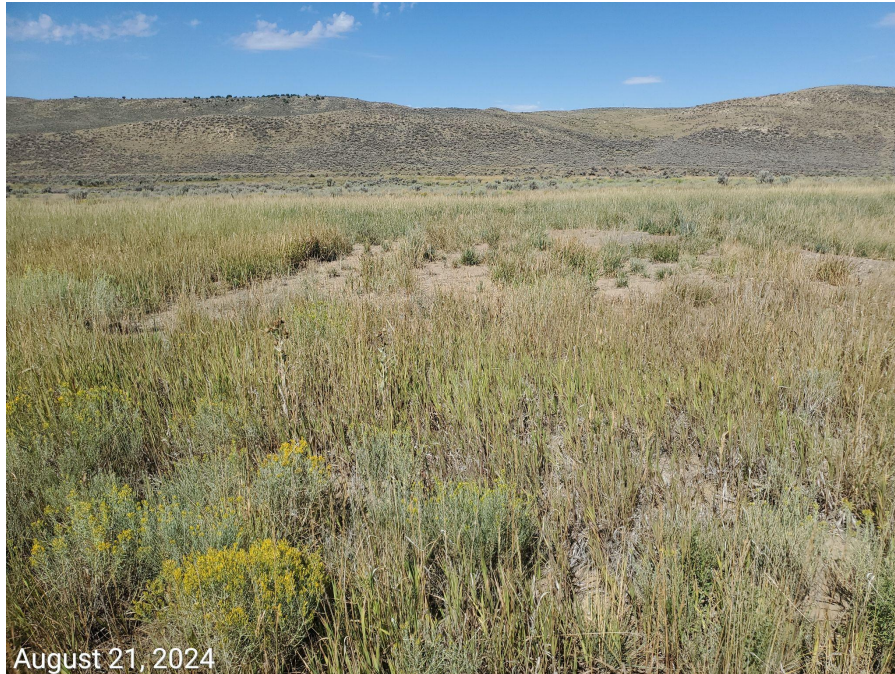
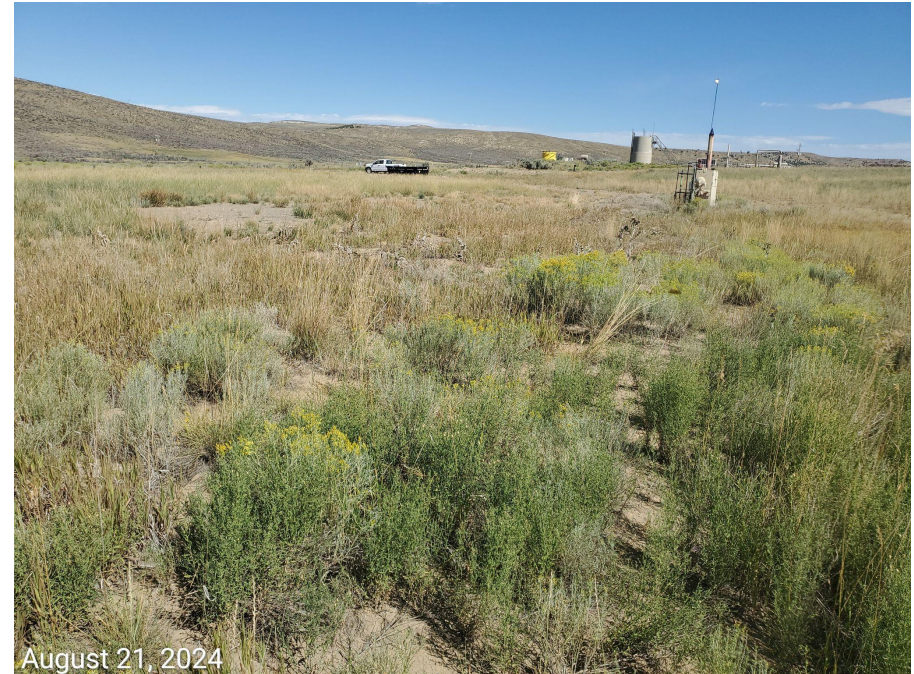
**Photo 5:** Photo taken from the southern area of the Location, facing west and north. Location has not been reclaimed in accordance with 1004 Requirements. Areas where production equipment have been removed are not progressing towards 1004 uniform perennial vegetative establishment requirements.

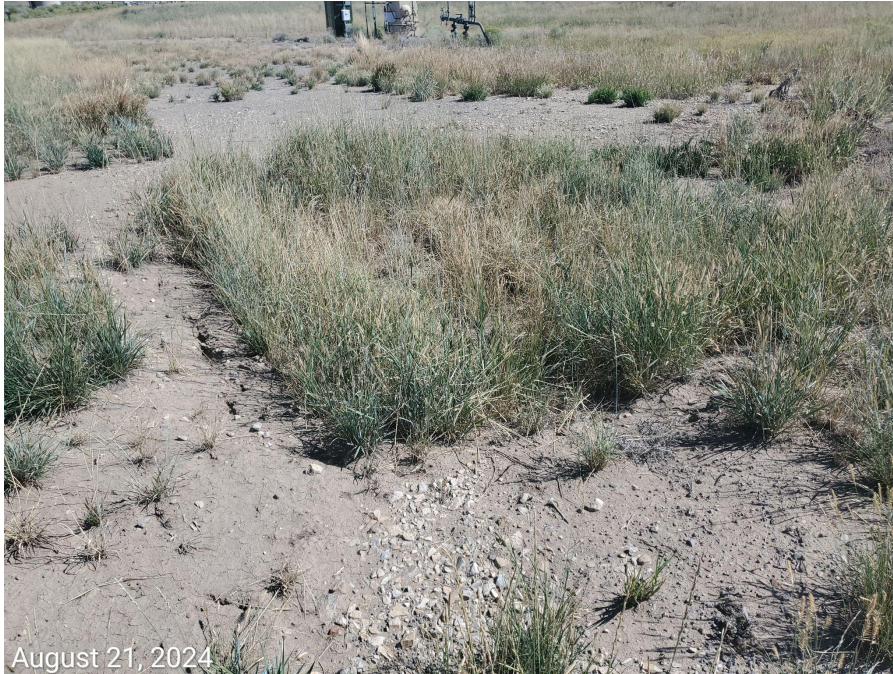
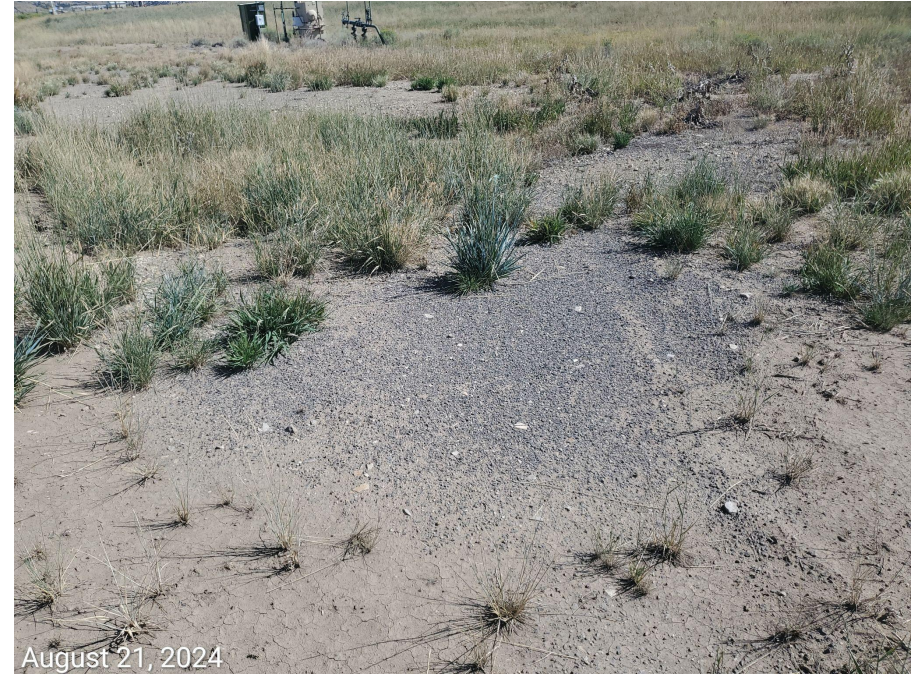
**Photo 6:** Photo taken from the area of the well. Gravel remains. Vegetative establishment is not uniform. Subsidence issues also observed at well site.

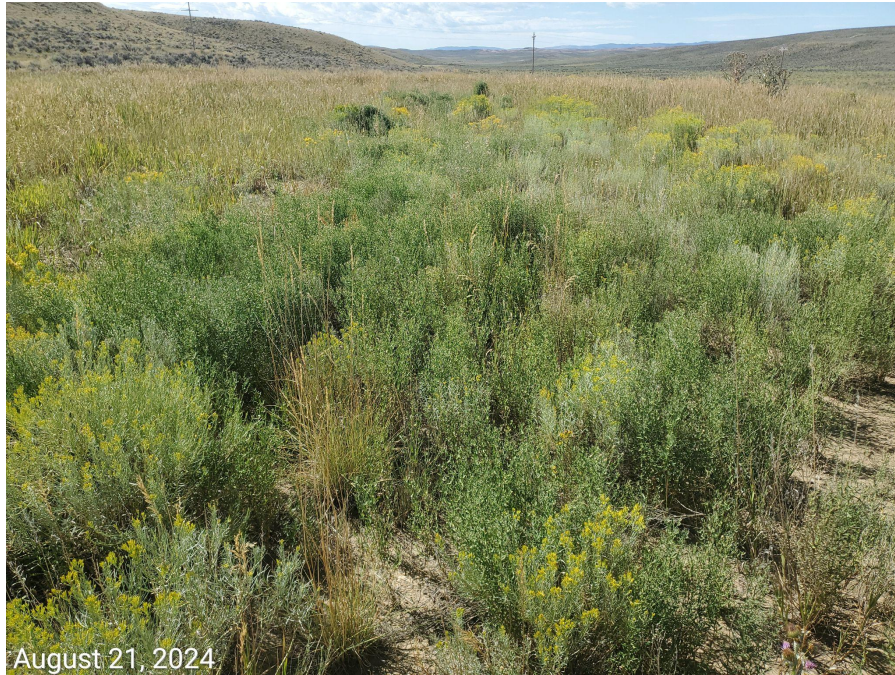
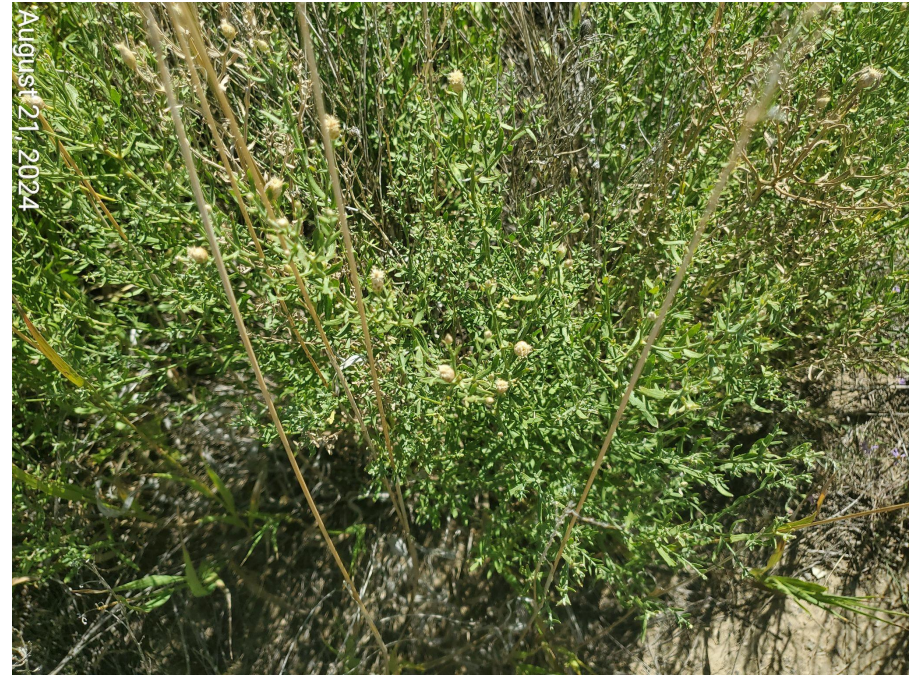
**Photo 7:** Photo taken from the southern area of the Location. Photos examples showing Knapweed (Green vegetation sans yellow flowers) establishment on the Location. Noxious weed establishment observed throughout the Location.

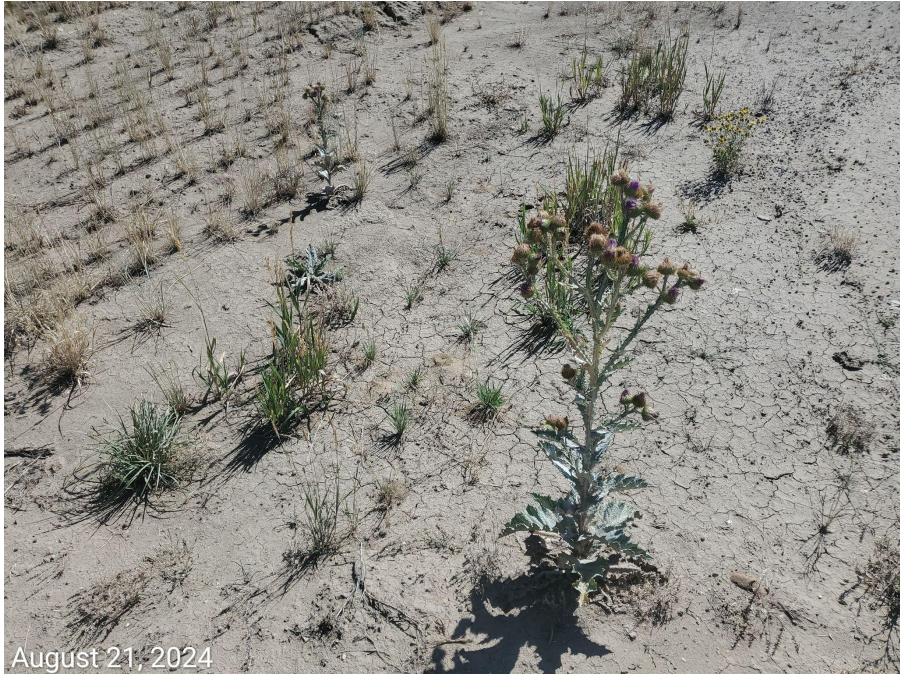
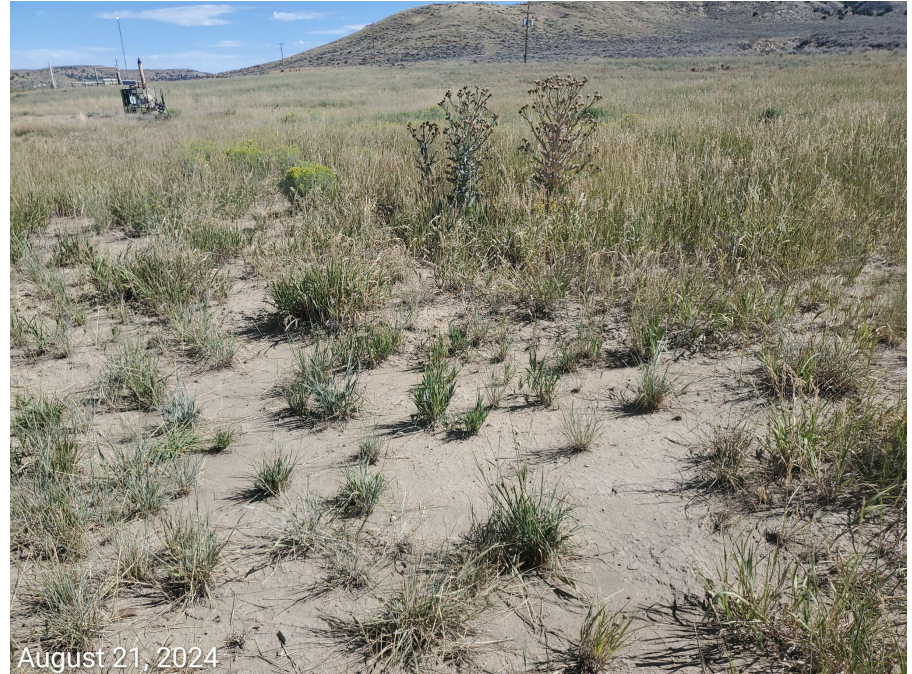
**Photo 8:** Photos taken from the northern and southern areas of the Location. Photos examples showing Scotch thistle establishment on the Location. Noxious weed establishment observed throughout the Location.
