# Interim Reclamation and Stormwater Inspection

Operator: Crestone Peak Resources Operating LLC -  
10633

Location ID: 443722

Location Name: Prosper Farms/4-65 2-1-6

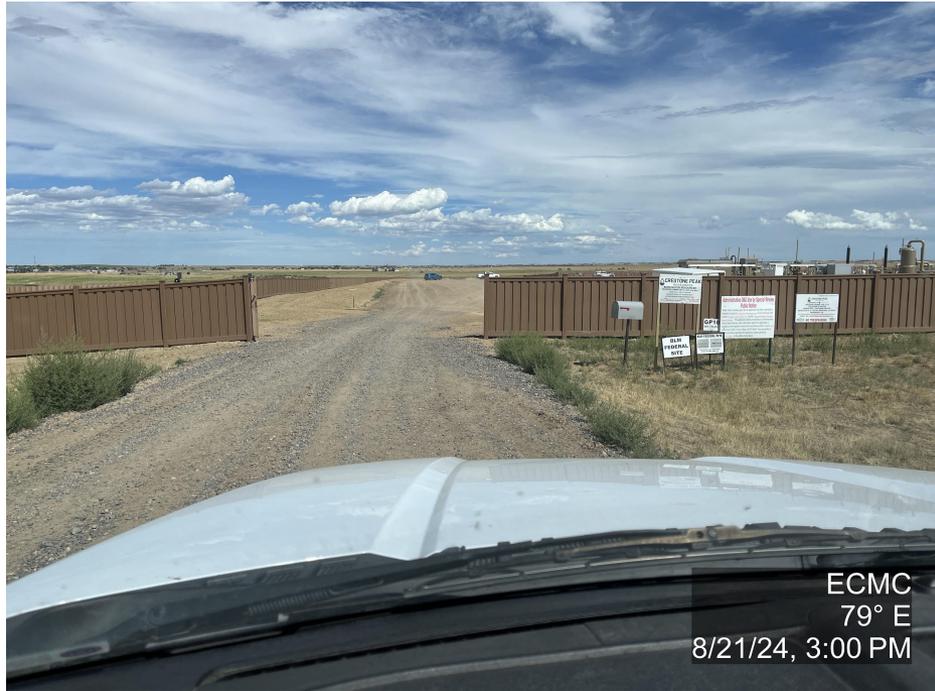
**Photo 1.** The photo was taken at the entrance to the well location facing East. The photo illustrates the entrance to the location and Operator signs.

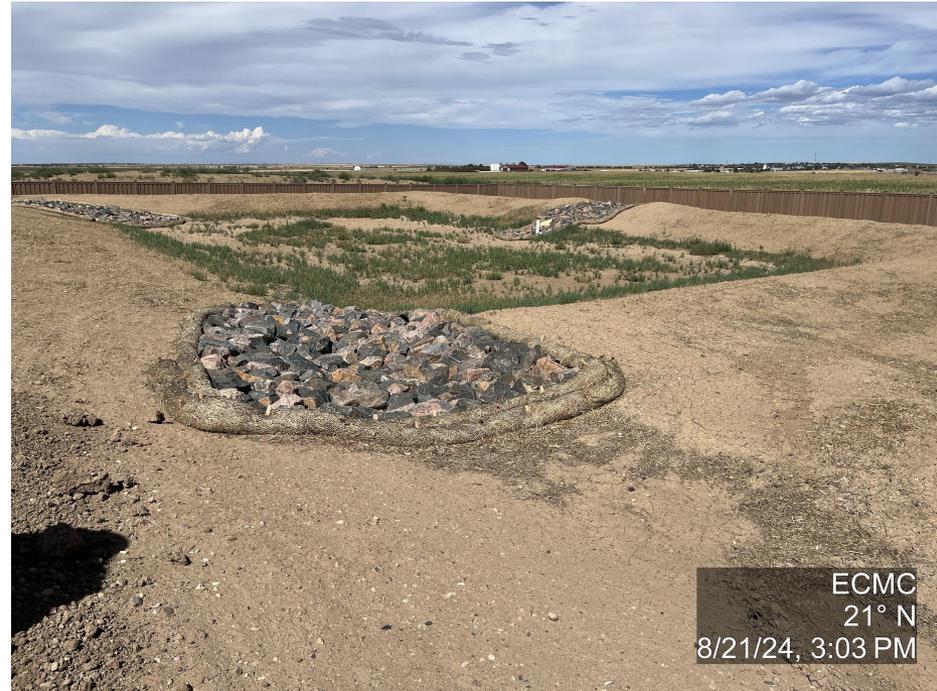
**Photo 2.** The photo was taken at the well location facing North. The photo illustrates the northeastern sediment trap with ditch inlets and overflow outlet.

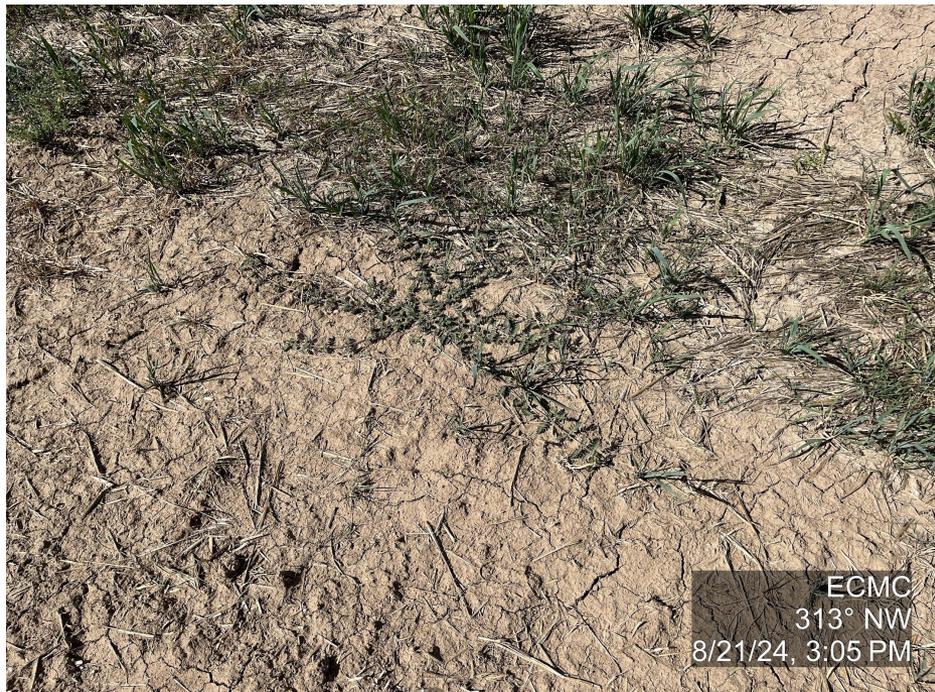
**Photo 3.** The photo was taken at the well location facing Northwest. The photo illustrates puncturvine growing on the production pad.

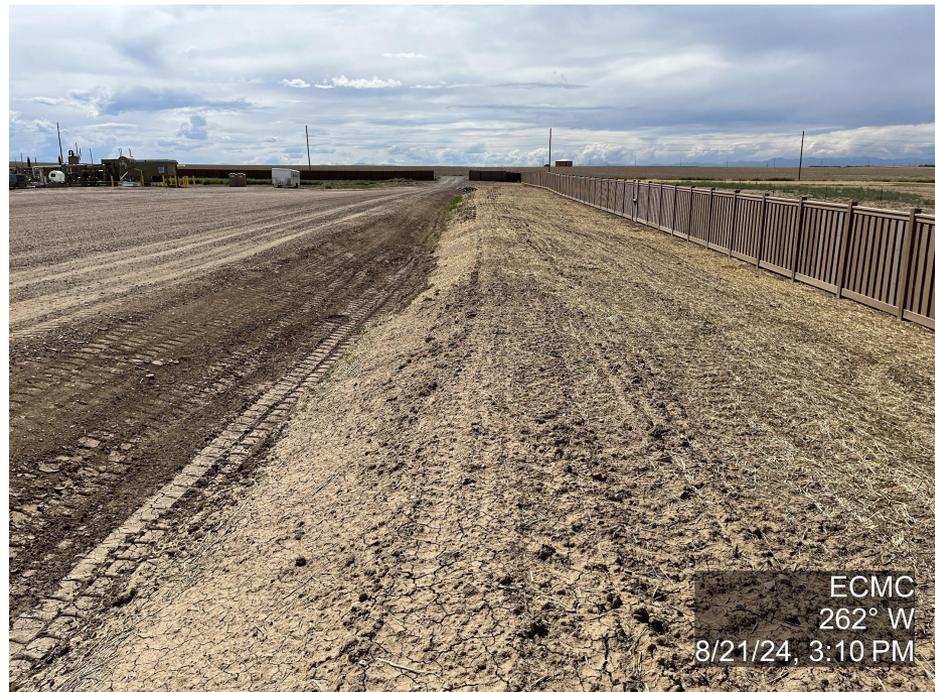
**Photo 4.** The photo was taken at the well location facing West. The photo illustrates the ditch and berm around the exterior of the production pad and perimeter fence.

Note - Interim areas appear to have been mulch crimped and seeded.

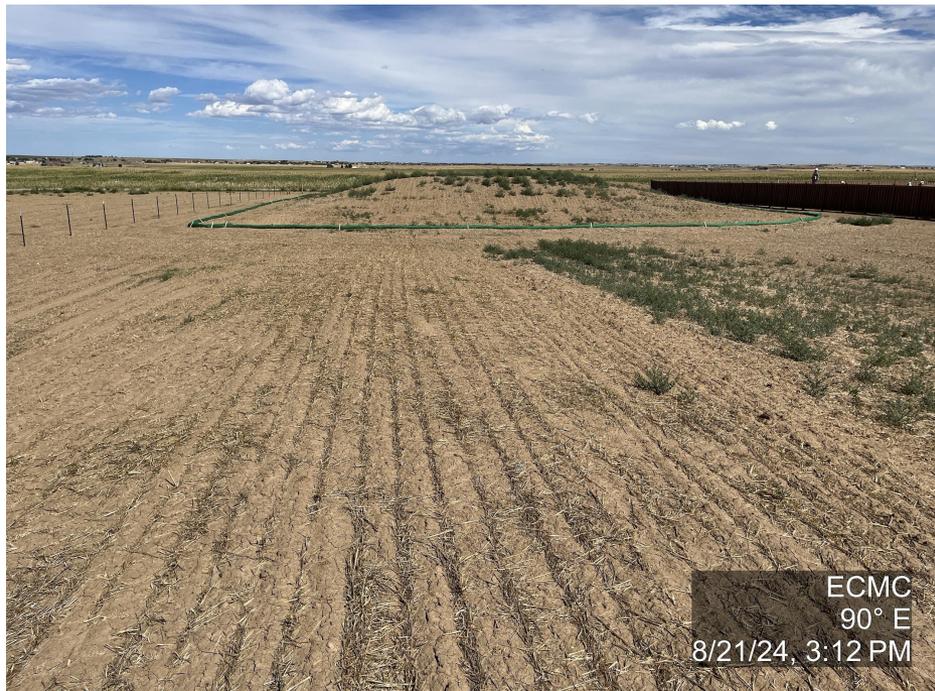
**Photo 5.** The photo was taken at the well location facing East. The photo illustrates filtrex wattle surrounding the topsoil stockpile. The area has also been seeded and crimped but at the moment is bare soil, kochia and russian thistle.

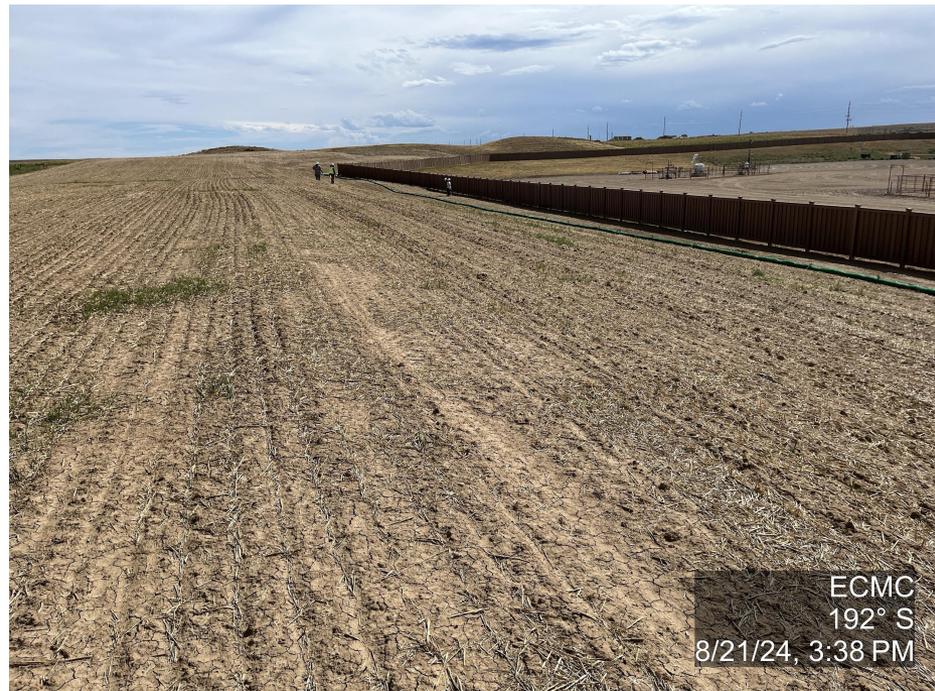
**Photo 6.** The photo was taken at the well location facing South. The photo illustrates the topsoil stockpile has been seeded and crimped and has a filtrex wattle surrounding the base.

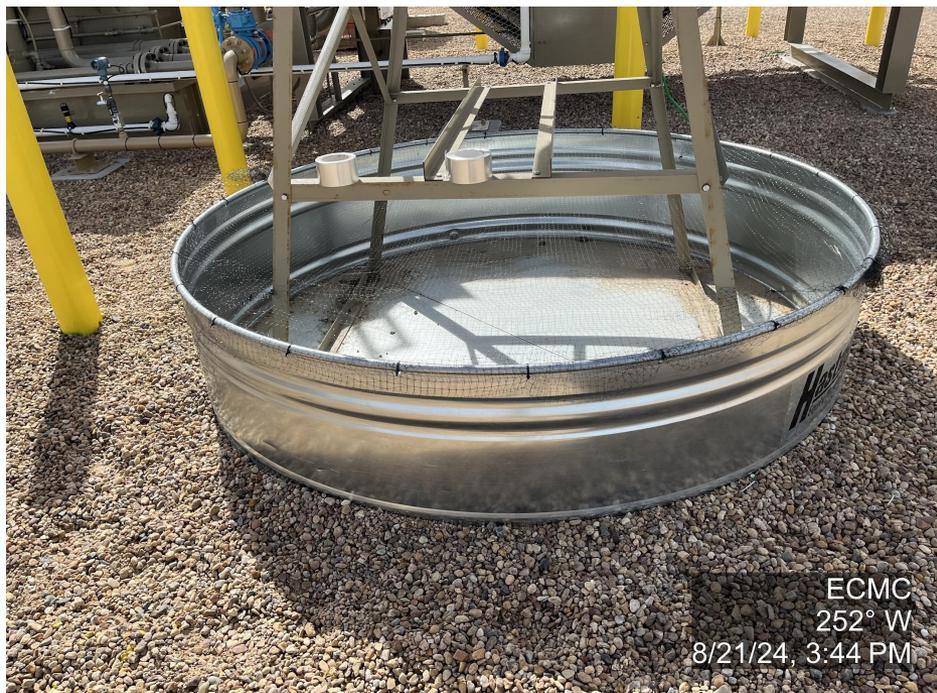
**Photo 7.** The photo was taken at the well location facing West. The photo illustrates a representative secondary containment of a tank is being maintained with wildlife protections.

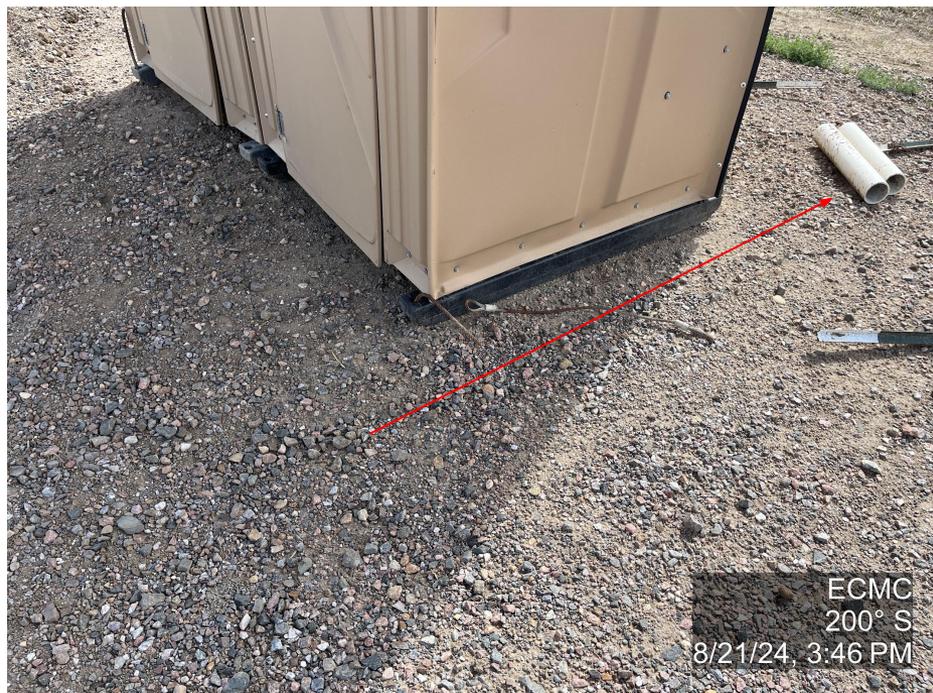
**Photo 8.** The photo was taken at the well location facing South. The photo illustrates portajohns have been staked down with rebar at the corners.

Note - There was also debris behind them on the pad.

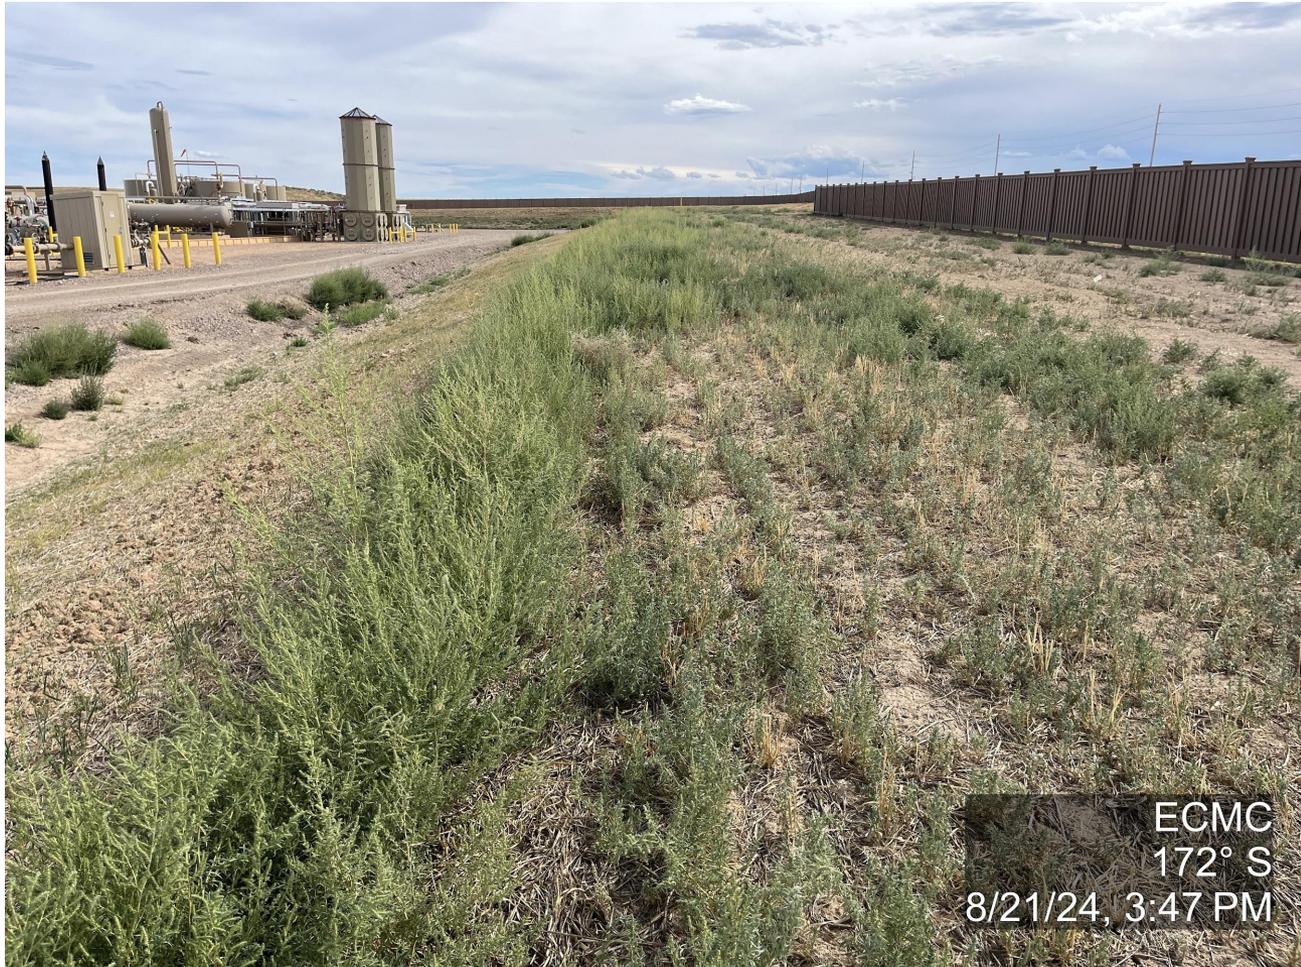
**Photo 9.** The photo was taken at the well location facing South. The photo illustrates kochia growing along the interim areas within the location fencing.

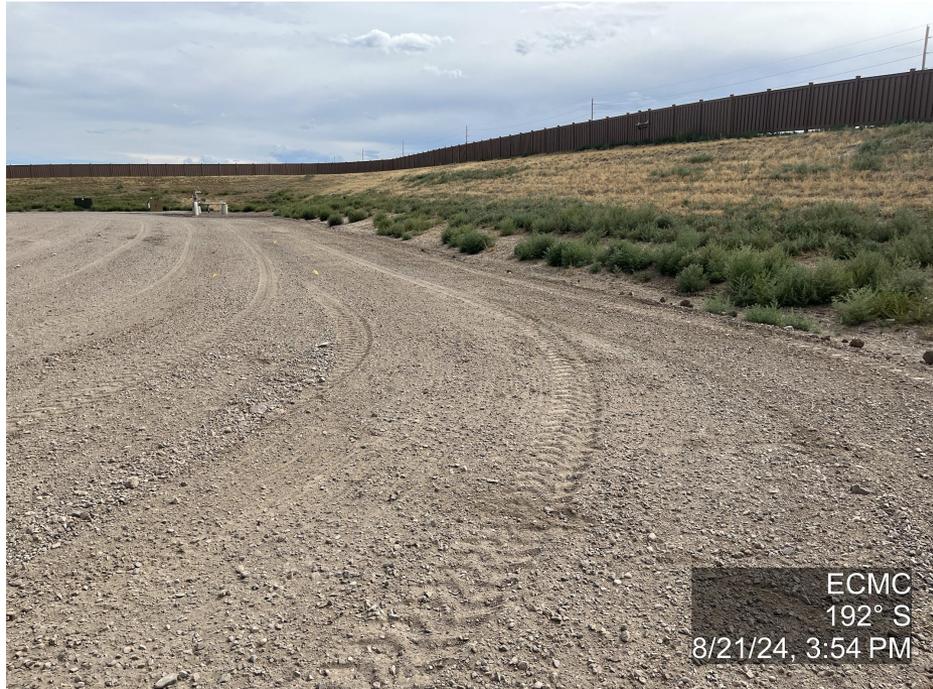
**Photo 10.** The photo was taken at the well location facing South. Refer to the comment for photo 9.

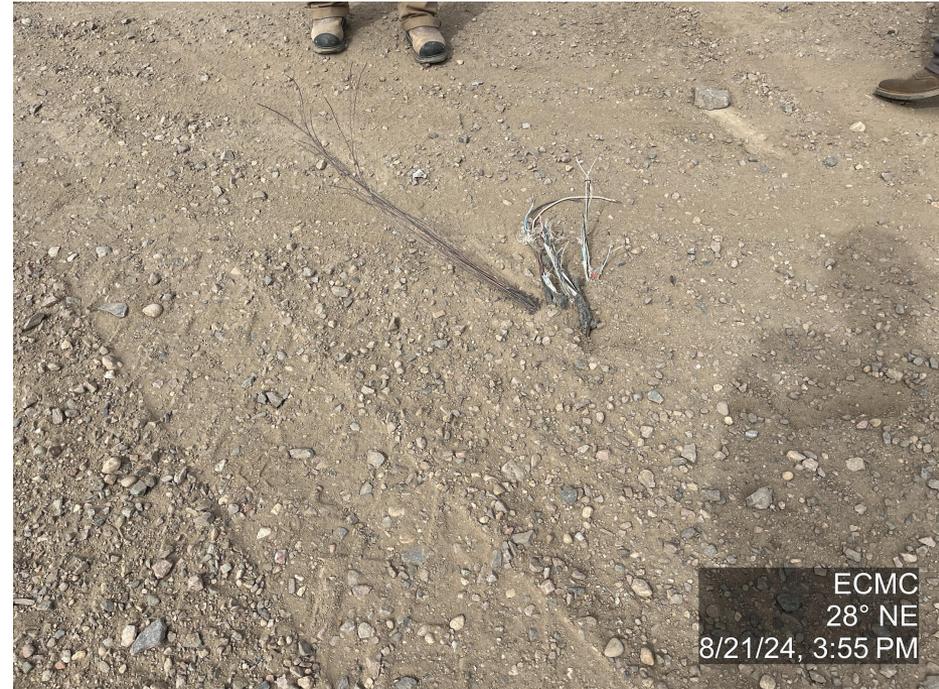
**Photo 11.** The photo was taken at the well location facing Northeast. The photo illustrates loose wires daylighting out of the production pad in the Southwest corner.
