Interim Reclamation and Stormwater Inspection

Operator: Crestone Peak Resources Operating LLC -
10633

Location ID: 449486

Inspection Photos
Location Name: Lone Tree/North
Location ID: 449486

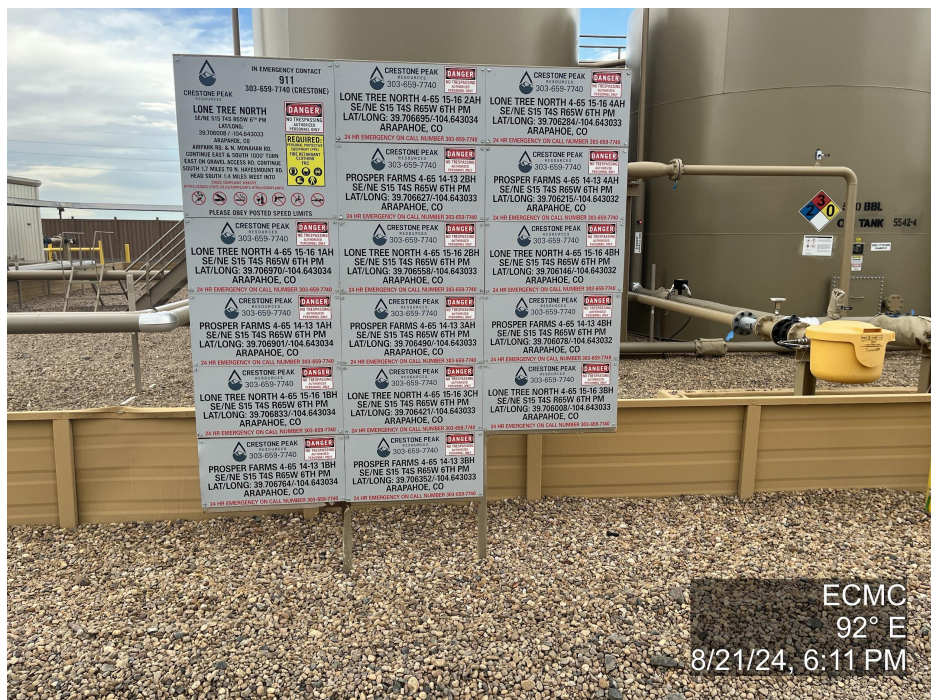
Photo 1. The photo was taken at the well location facing East. The photo illustrates location signage at the tank batteries.

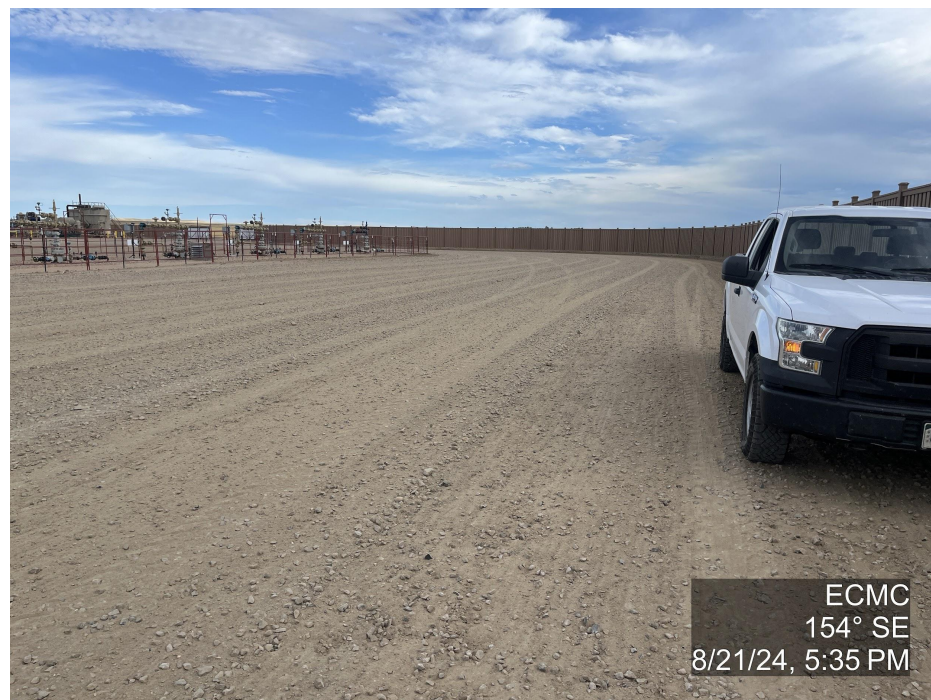
Photo 2. The photo was taken at the well location facing Southeast. The photo illustrates the production pad.

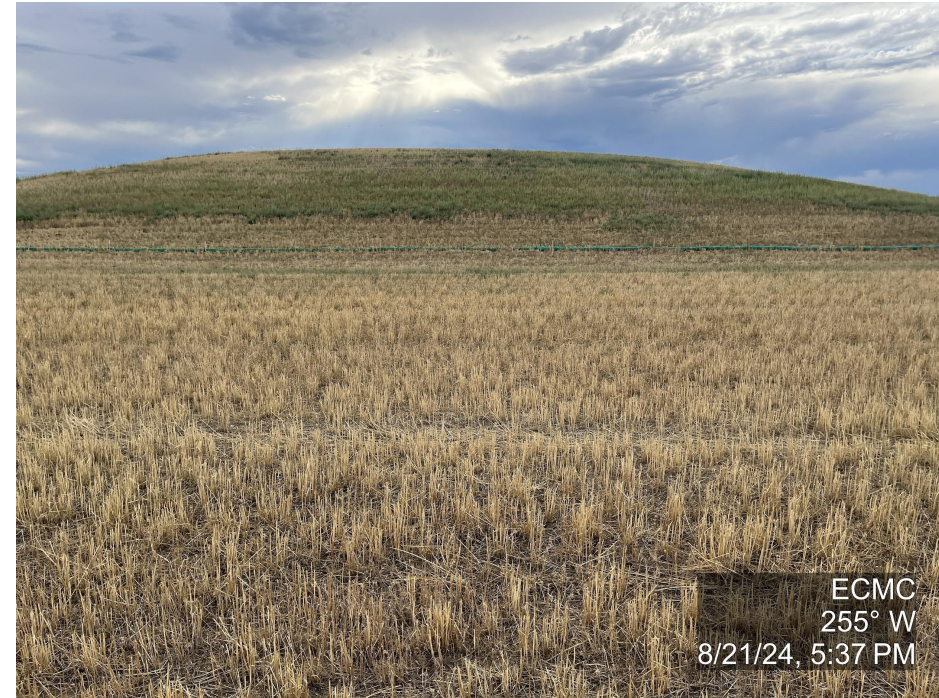
Photo 3. The photo was taken at the well location facing South. The photo illustrates interim areas outside the permanent location fence are dominated by triticale and have been mowed.

Photo 4. The photo was taken at the well location facing West. The photo illustrates the topsoil stockpile is being managed by evidence of mowing however it's dominated by kochia and triticale.

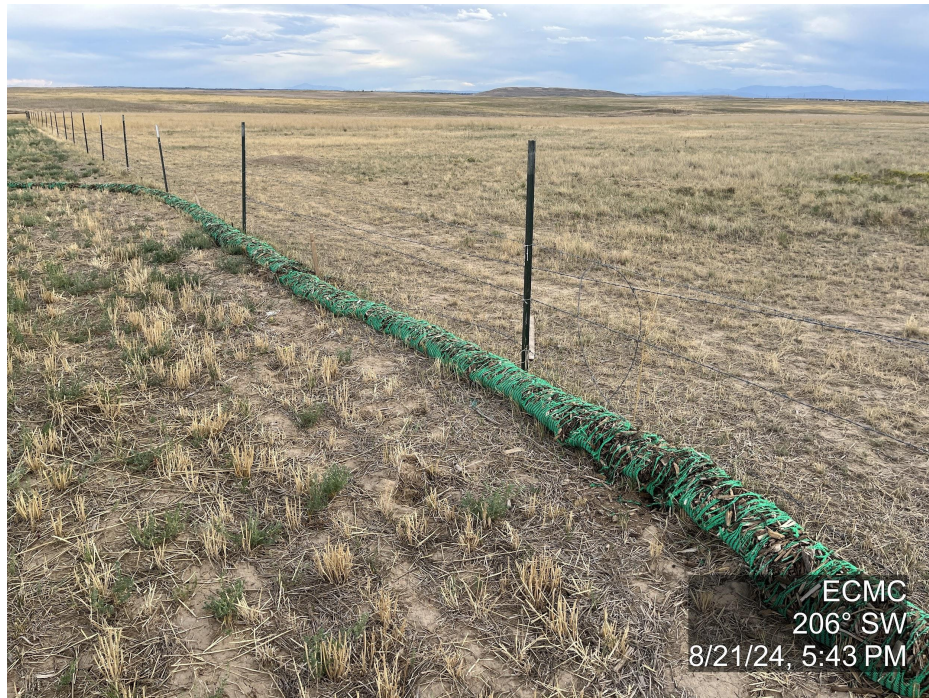
Photo 5. The photo was taken at the well location facing Southwest. The photo illustrates a representative photo of filterxx wattle across the location and demonstrates that the majority is filled with holes on the top side.

Note - The fence top wire was damage and in need of repair.

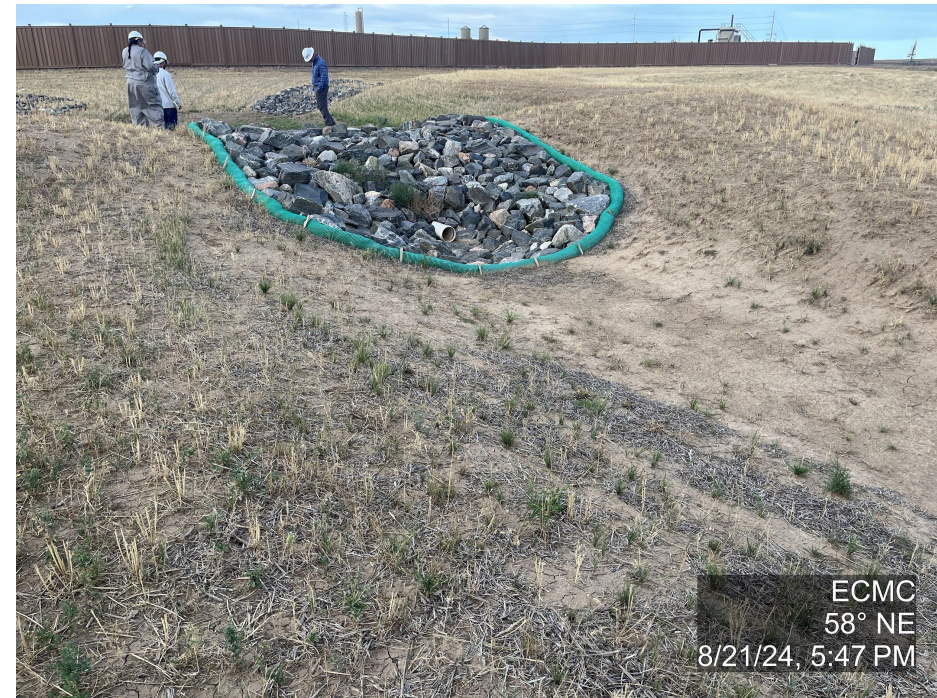
Photo 6. The photo was taken at the well location facing Northeast. The photo illustrates the sediment trap in the Southwest corner of the location.

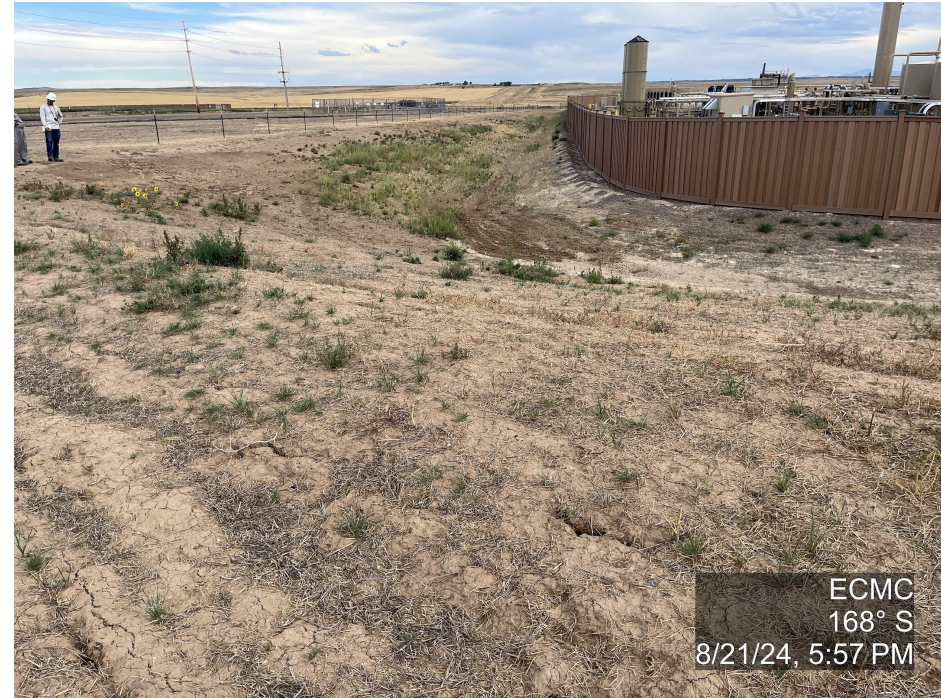
Photo 7. The photo was taken at the well location facing Southeast. The photo illustrates interim areas North of the location are vegetated with some bare spots.

Photo 8. The photo was taken at the well location facing South. Refer to the comment for photo 7.

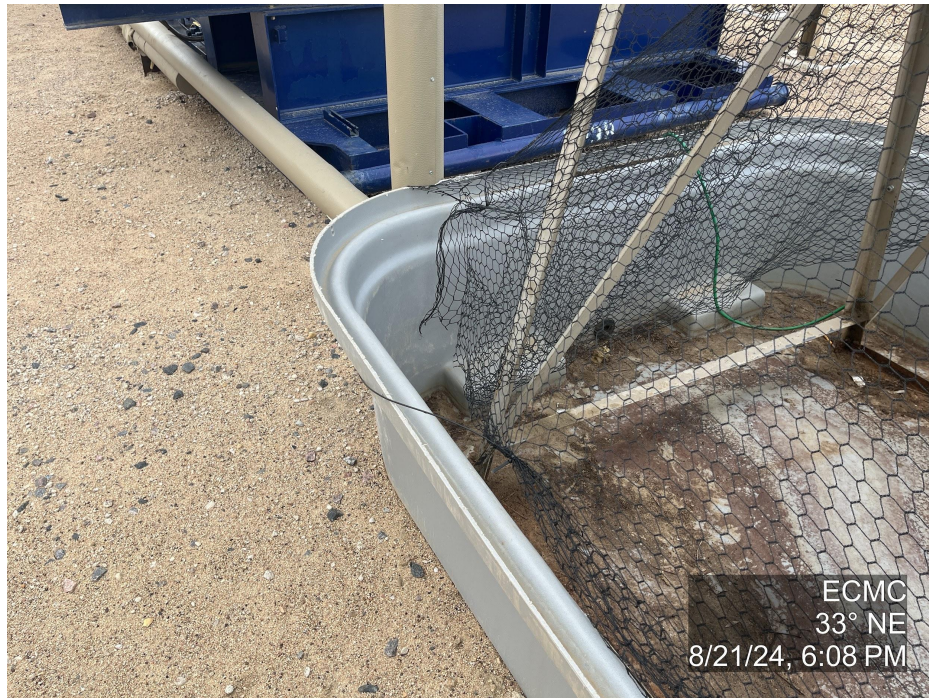
Photo 9. The photo was taken at the well location facing Northeast. The photo illustrates wildlife netting on secondary containment has not been secured correctly creating gaps where wildlife can enter.

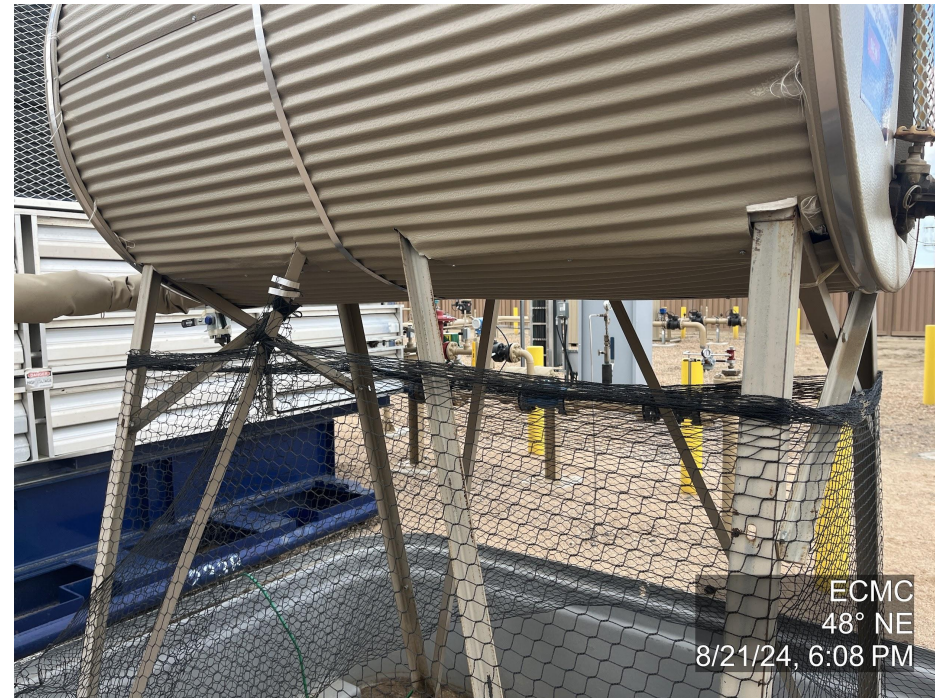
Photo 10. The photo was taken at the well location facing Northeast. Refer to the comment for photo 9 .
