Interim Reclamation and Stormwater Inspection

Operator: CARBON STORAGE SOLUTIONS LLC -
10786

Location ID: 483256

Weld County, CO

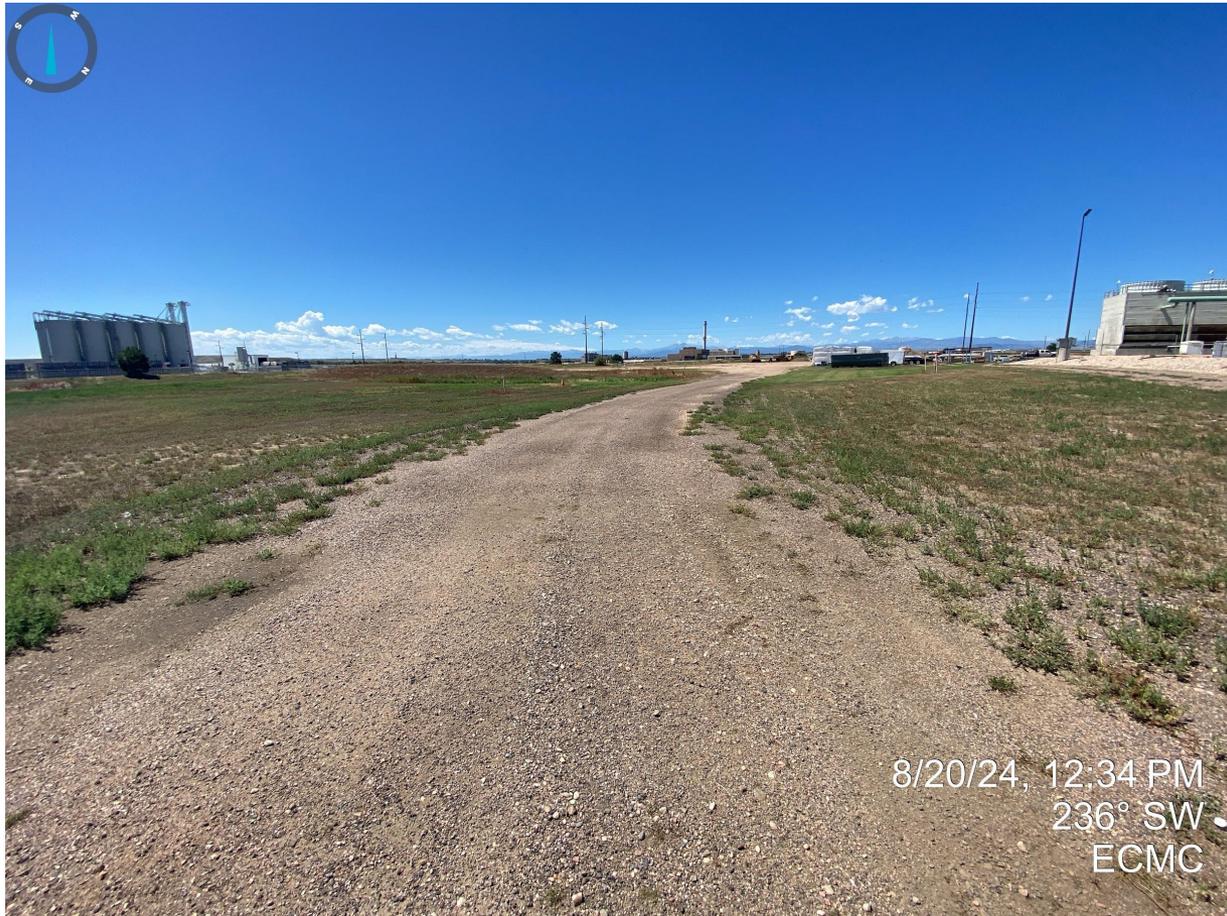
Photo 1. Facing southwest along the access road. No stormwater erosion issues observed at the time of this inspection.

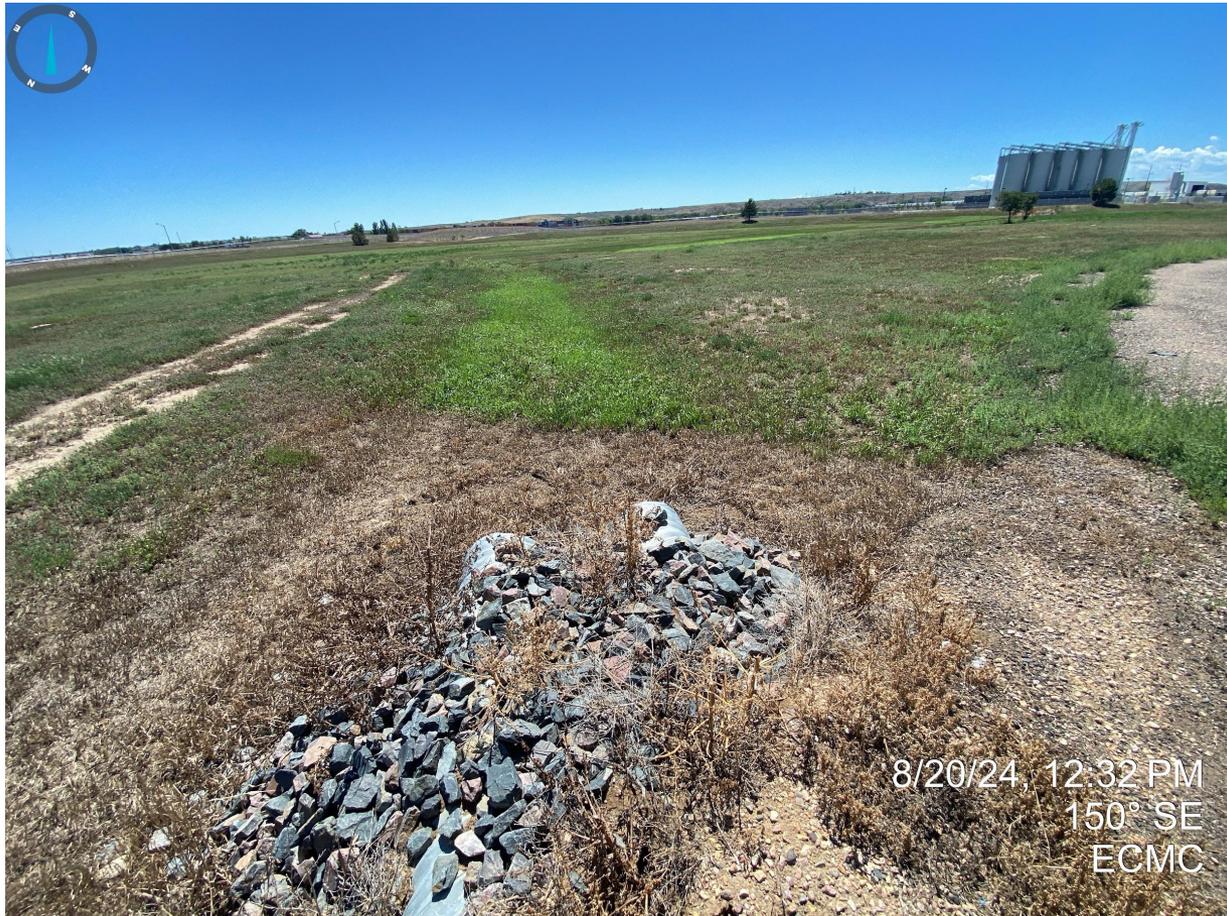
Photo 2. Facing southeast towards the stormwater detention area. No stormwater erosion issues observed at the time of this inspection.

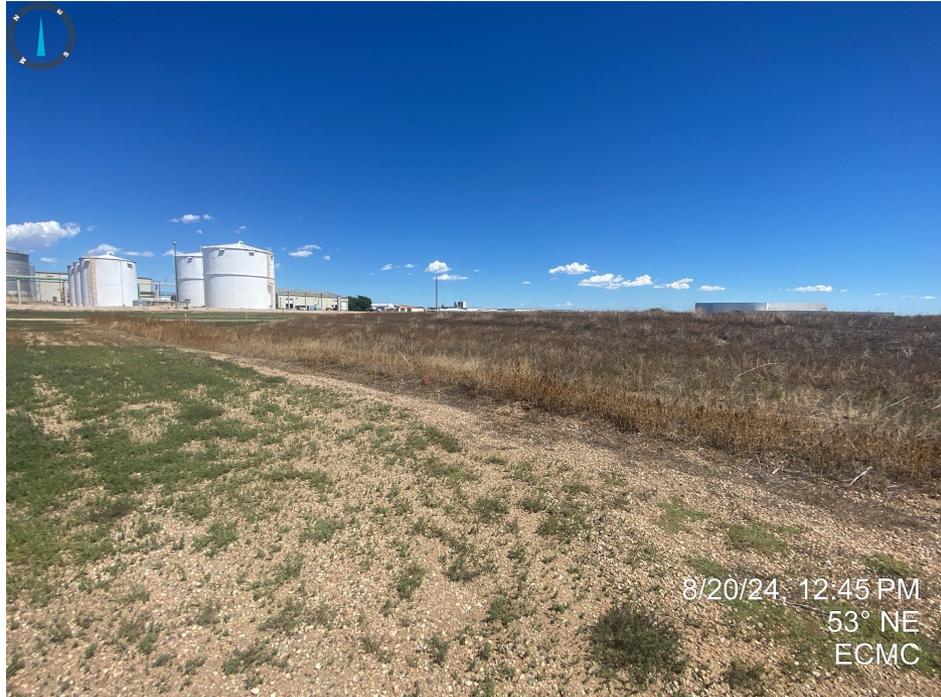
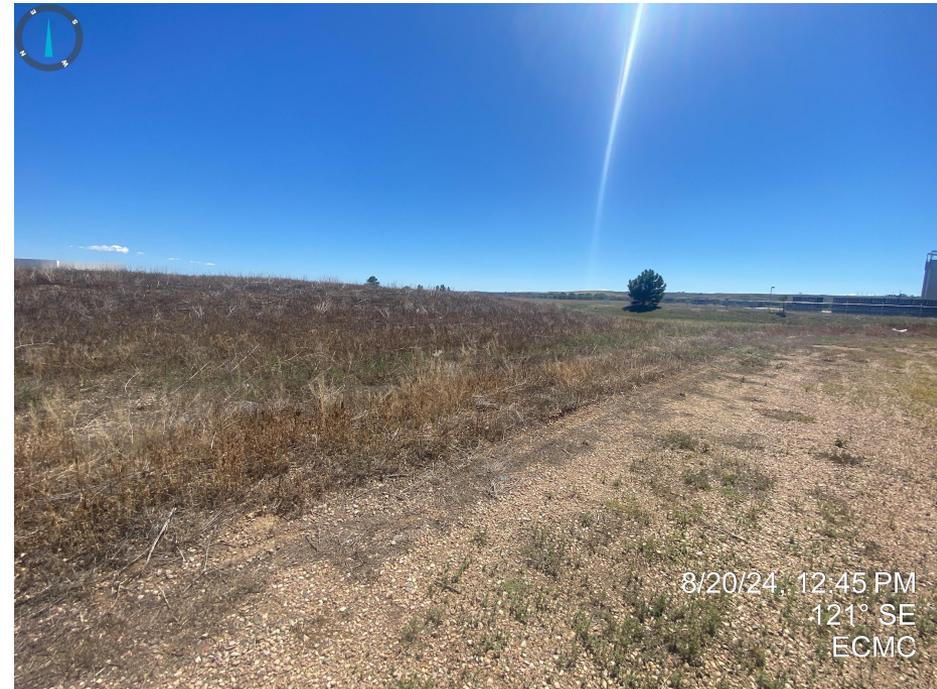
Photos 3 & 4. Facing northeast and southeast at the topsoil stockpile area. Topsoil stockpile has significant weed cover consisting primarily of kochia and russian thistle; this is not in compliance with Rule 1002.c. It does appear that undesirable vegetation is being either mechanically or chemically managed throughout the location.

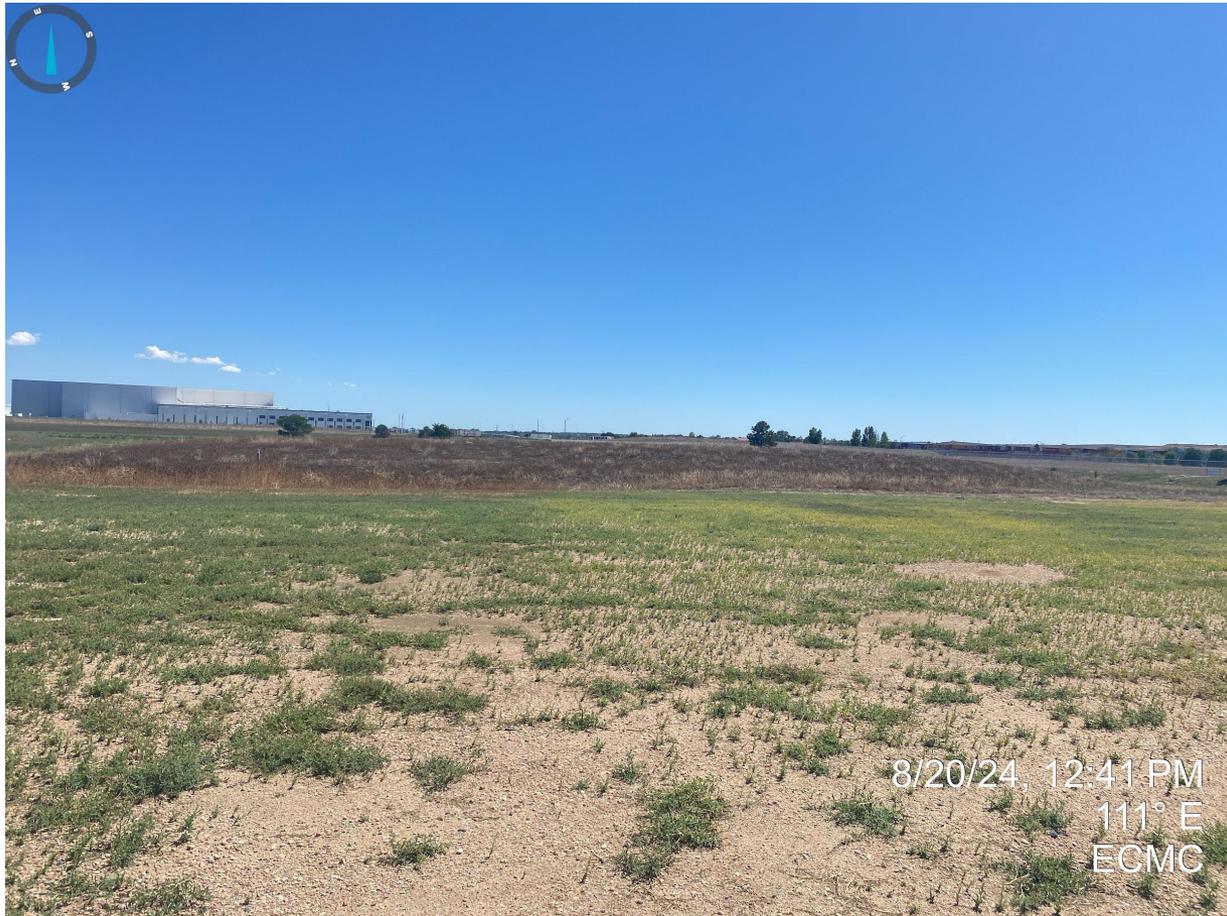
Photo 5. Facing east towards the topsoil stockpile from the well location. It does not appear that interim reclamation activities have been performed at the time of this inspection.

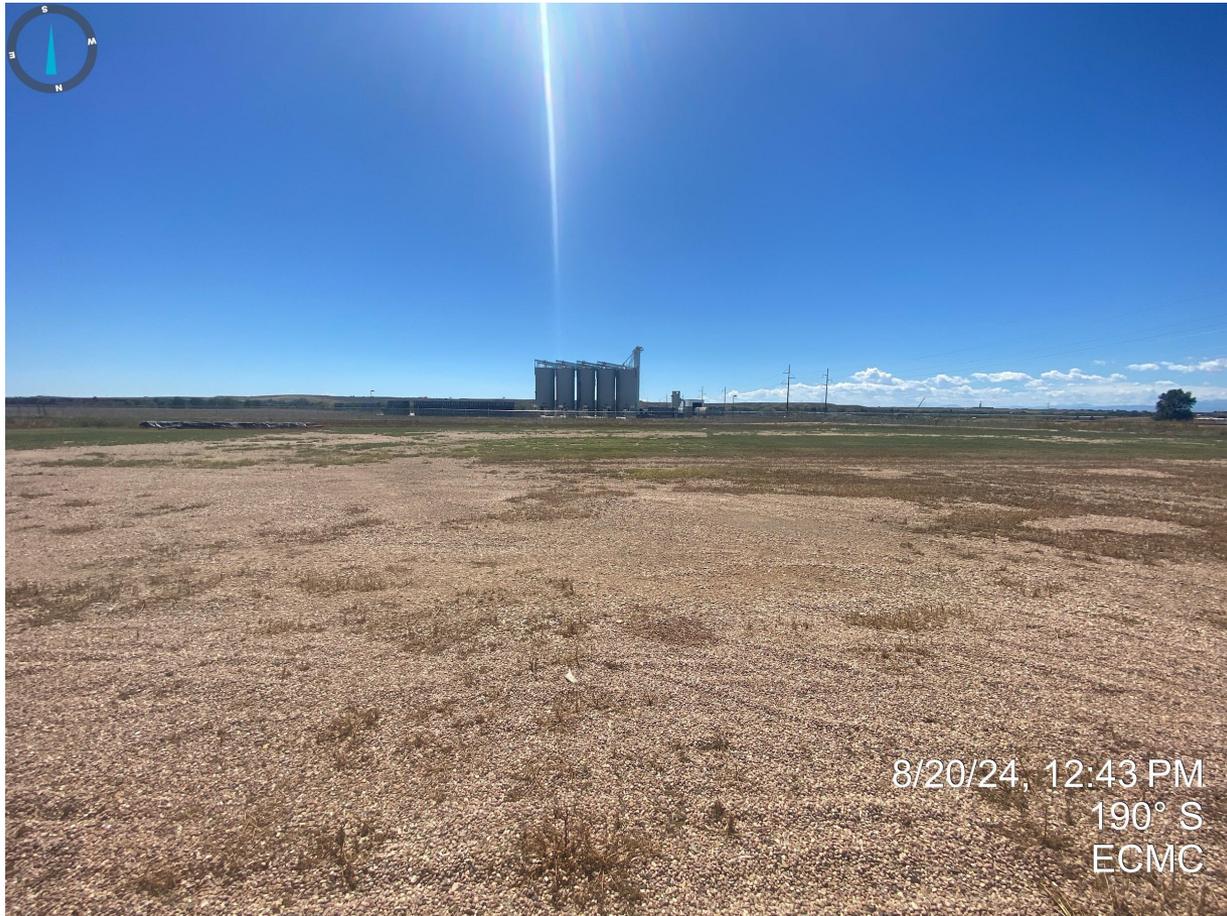
Photo 6. Facing south from the well location; see comments in Photo 5.

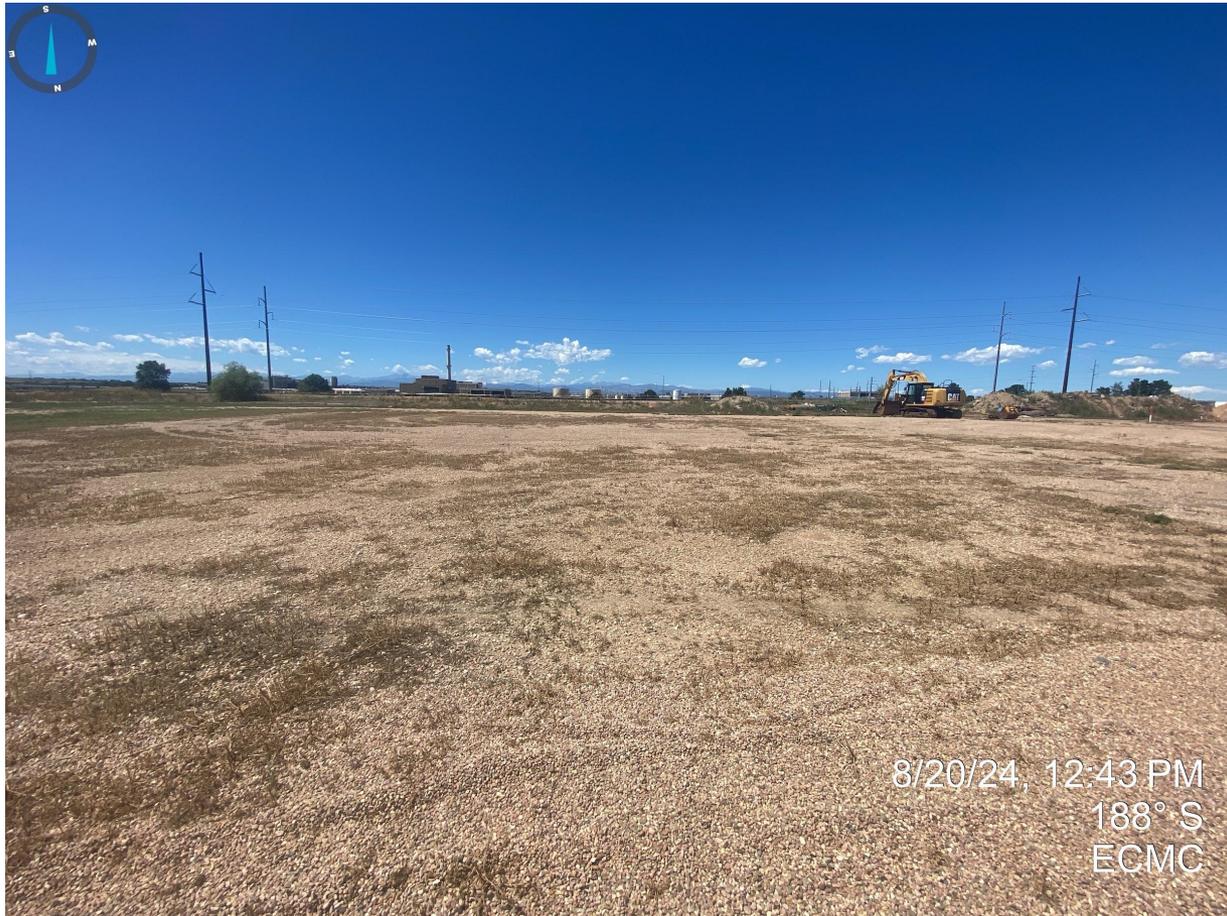
Photo 7. Facing west from the well location; see comments in Photo 5. Note: Photo coordinates erroneously state “188 degrees S”, however, this photo was oriented towards the west based on field observations.

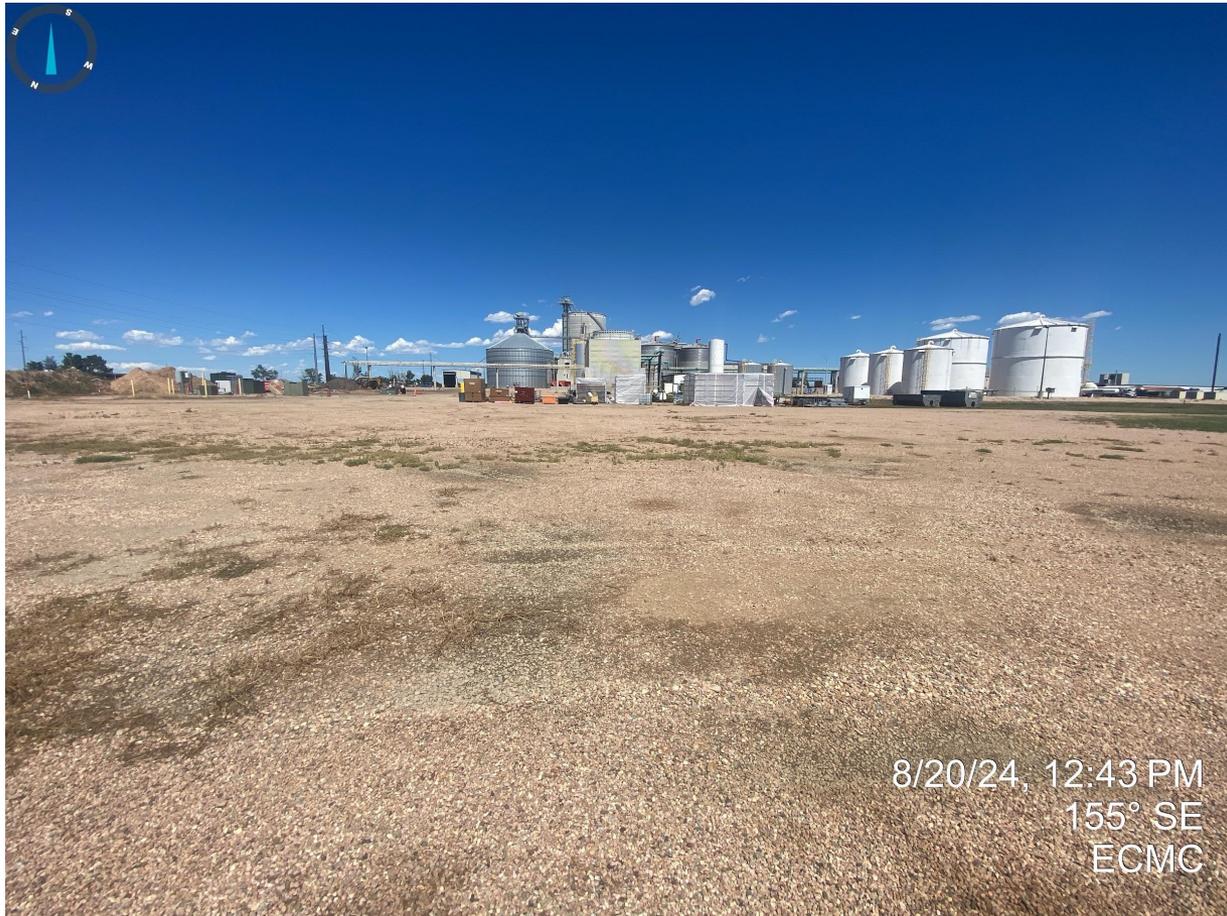
Photo 8. Facing north from the well location; see comments in Photo 5. Note: Photo coordinates erroneously state “155 degrees SE”, however, this photo was oriented towards the north based on field observations.

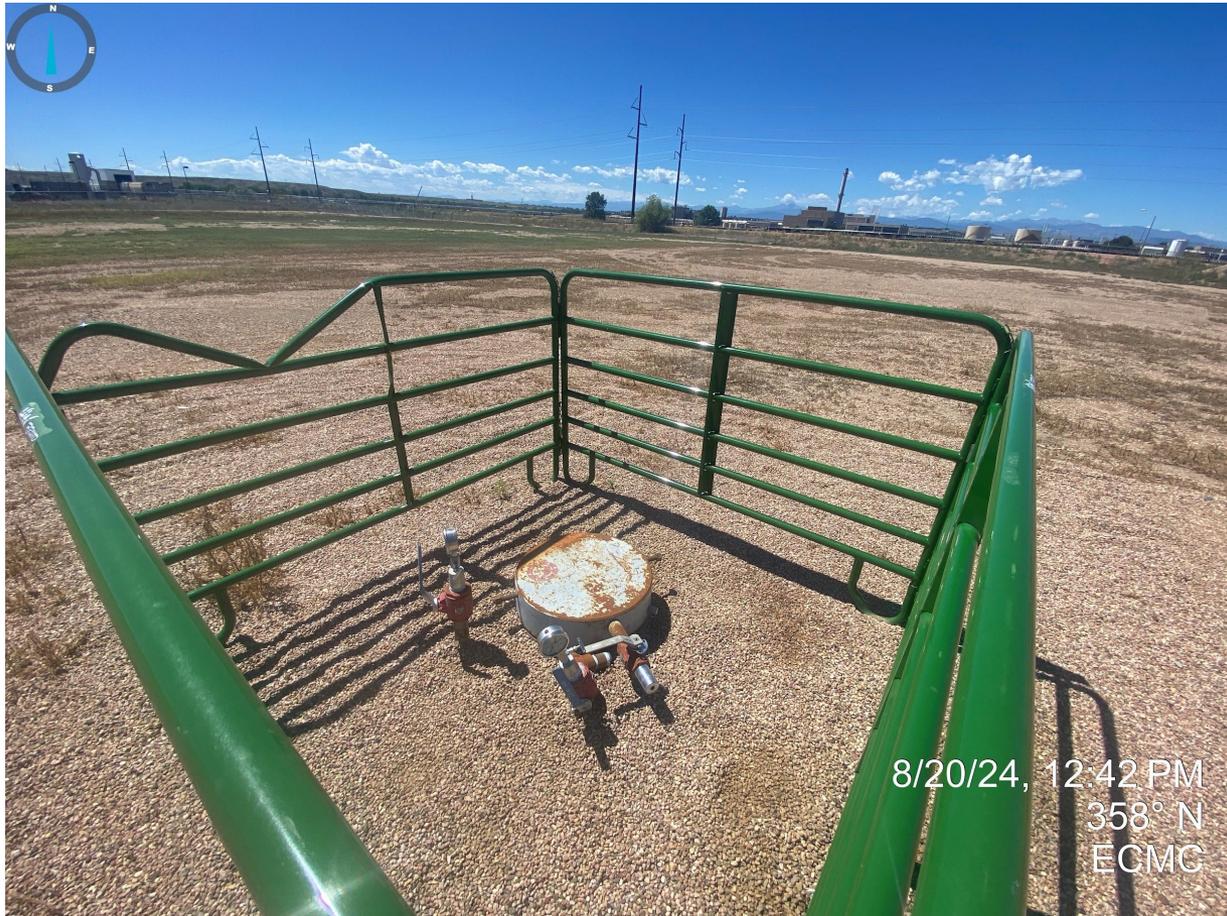
Photo 9. Front Range 1-1 (Well API 123-51898). Note: Photo coordinates erroneously state “358 degrees N”, however, this photo was oriented towards the southwest based on field observations.
