Inspection Photos

Operator: Simcoe LLC - 10749

Location ID: 326612

Inspection Photos
Location Name: Montgomery Federal 2
Location ID: 326612

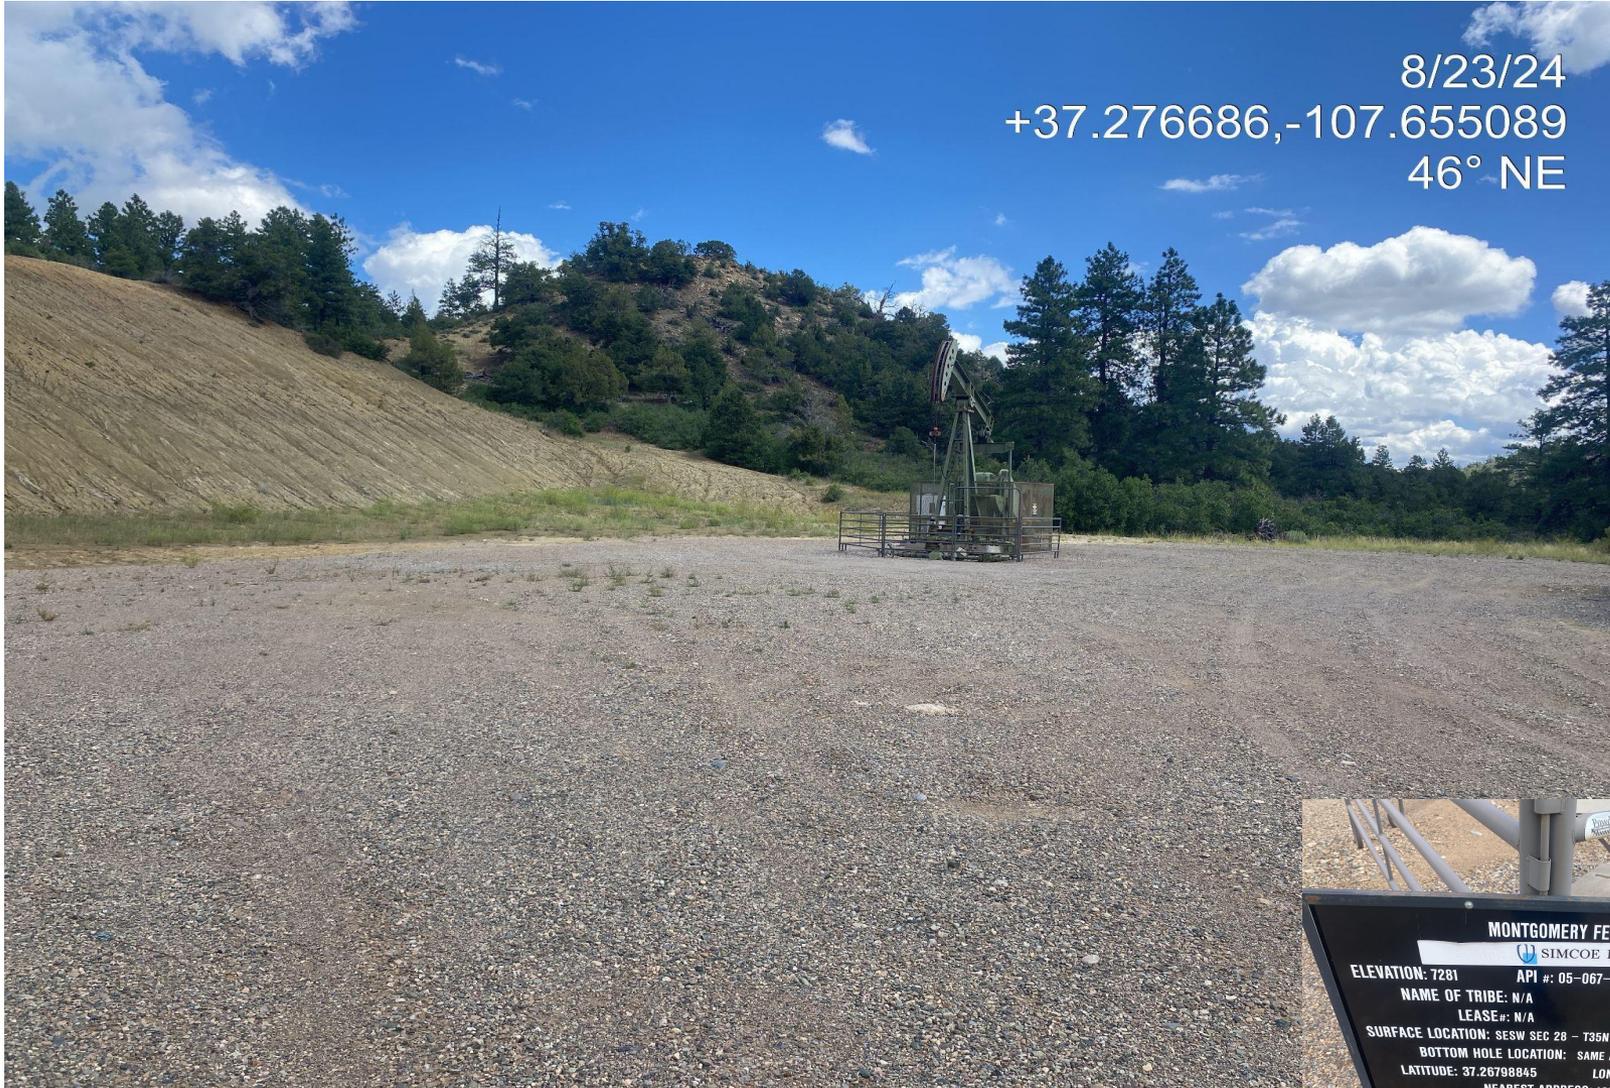
Photo 1. View of well pad taken from the access point facing center.

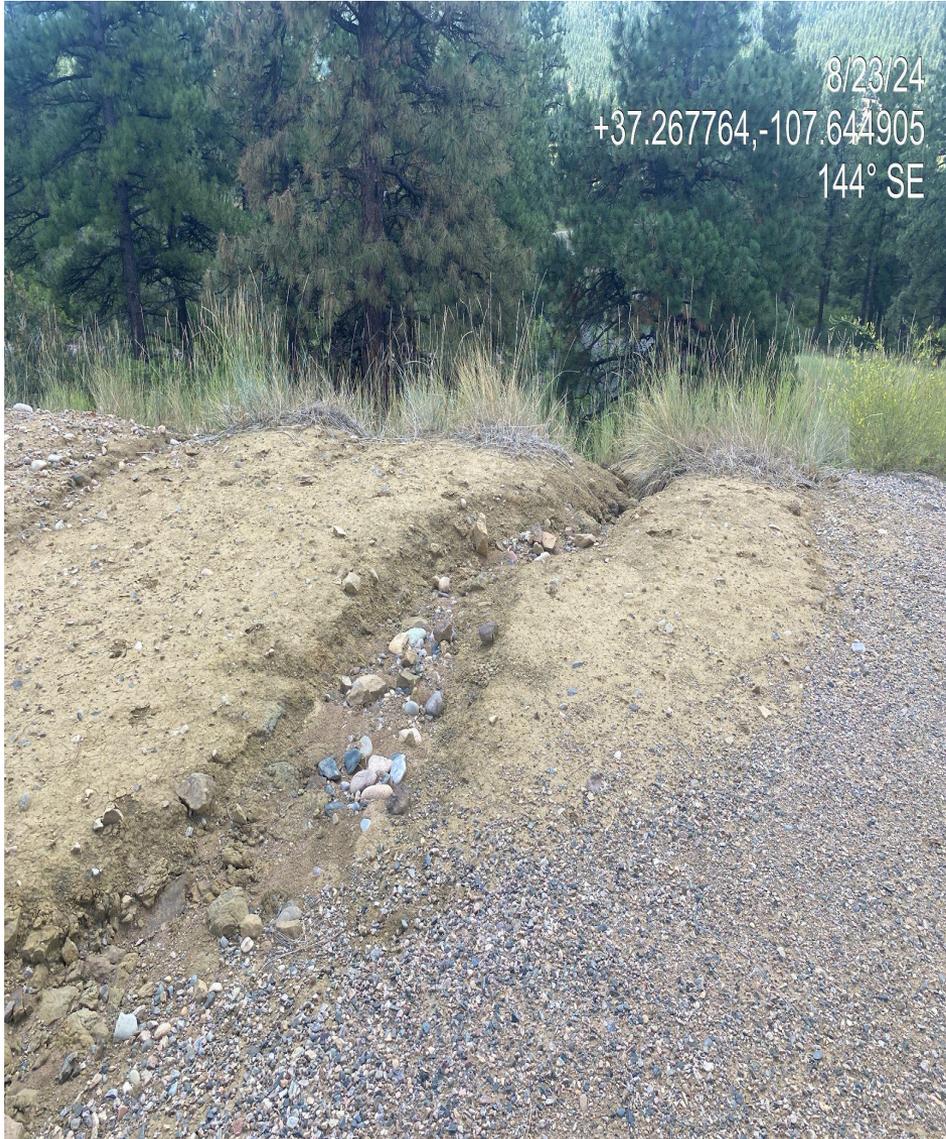
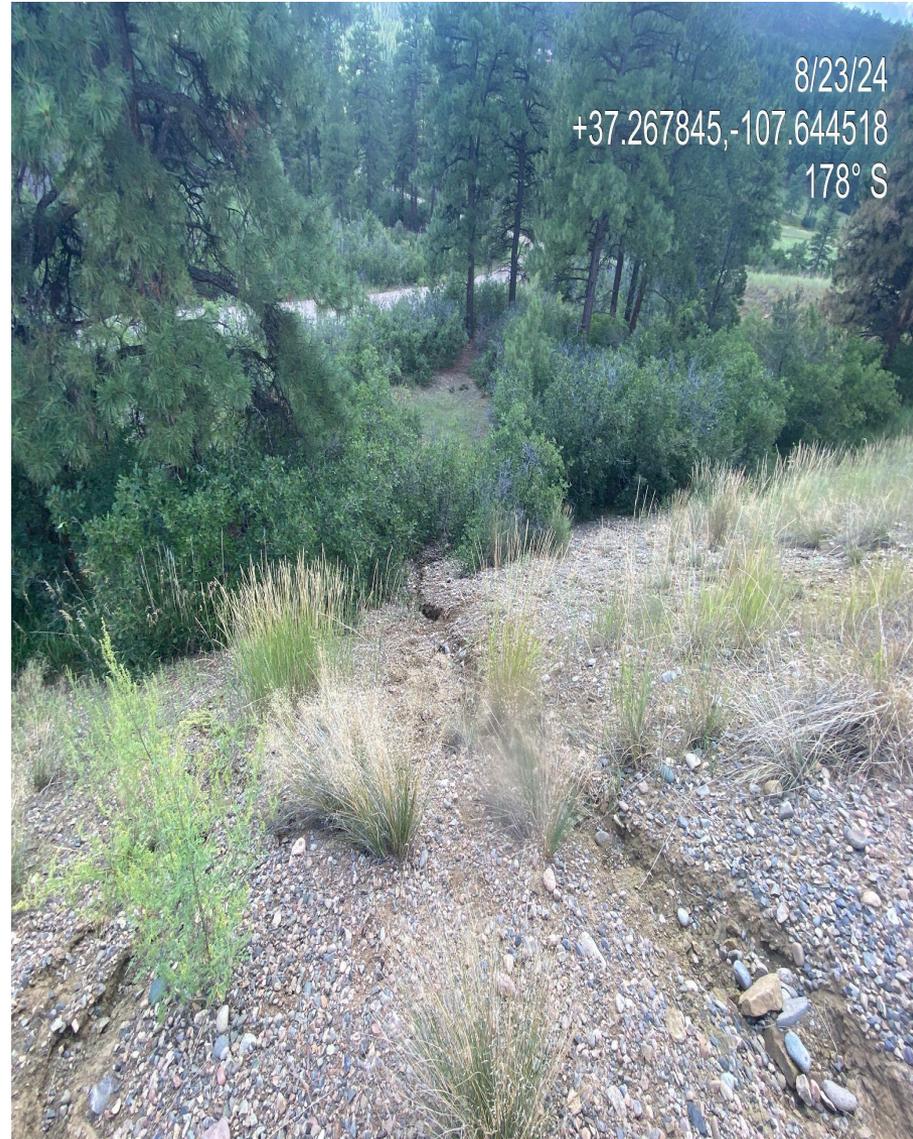
Photo 2. Gully erosion observed forming in the southern interim reclamation area, stabilization/control measures needed in this area.

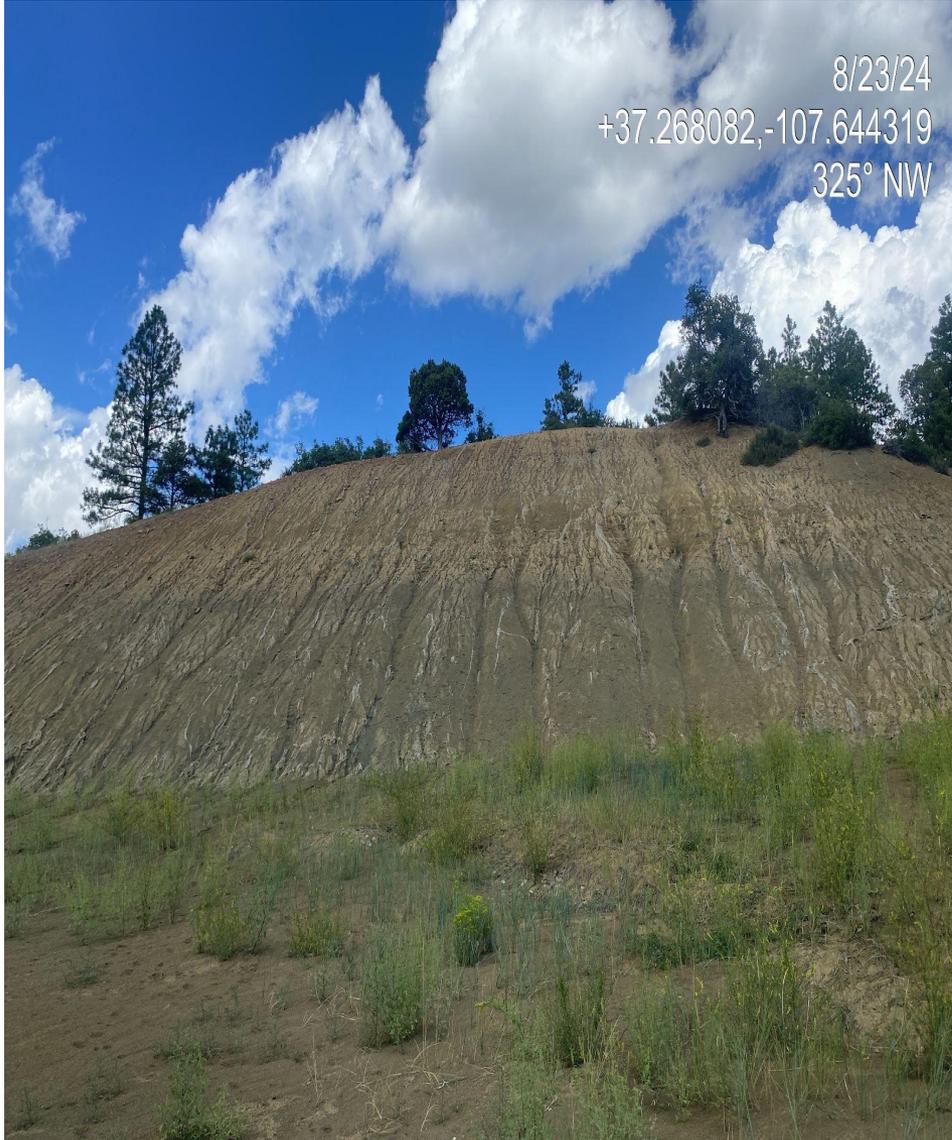
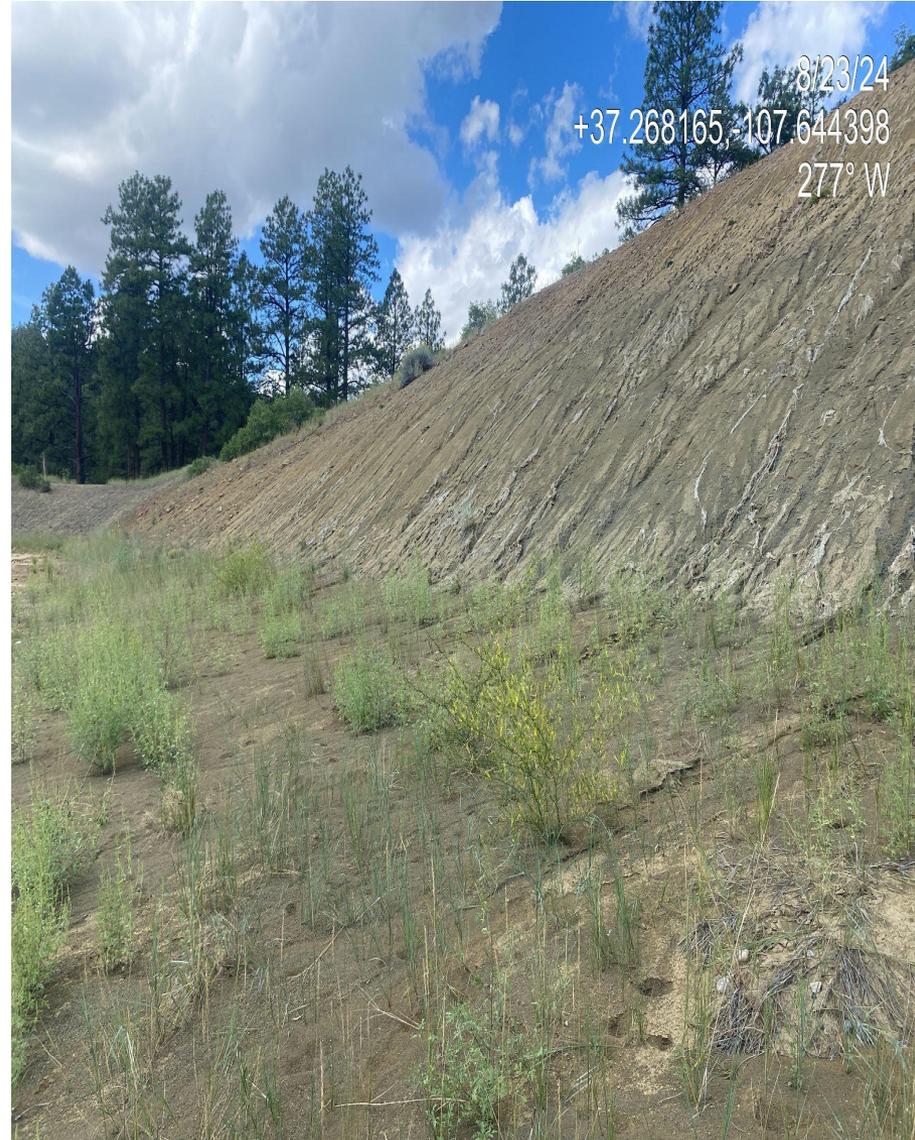
Photo 3. View of western cut slope with active erosion, bare soils and sediment deposition occurring. ECB installed in 2020 has degraded, maintenance is needed.

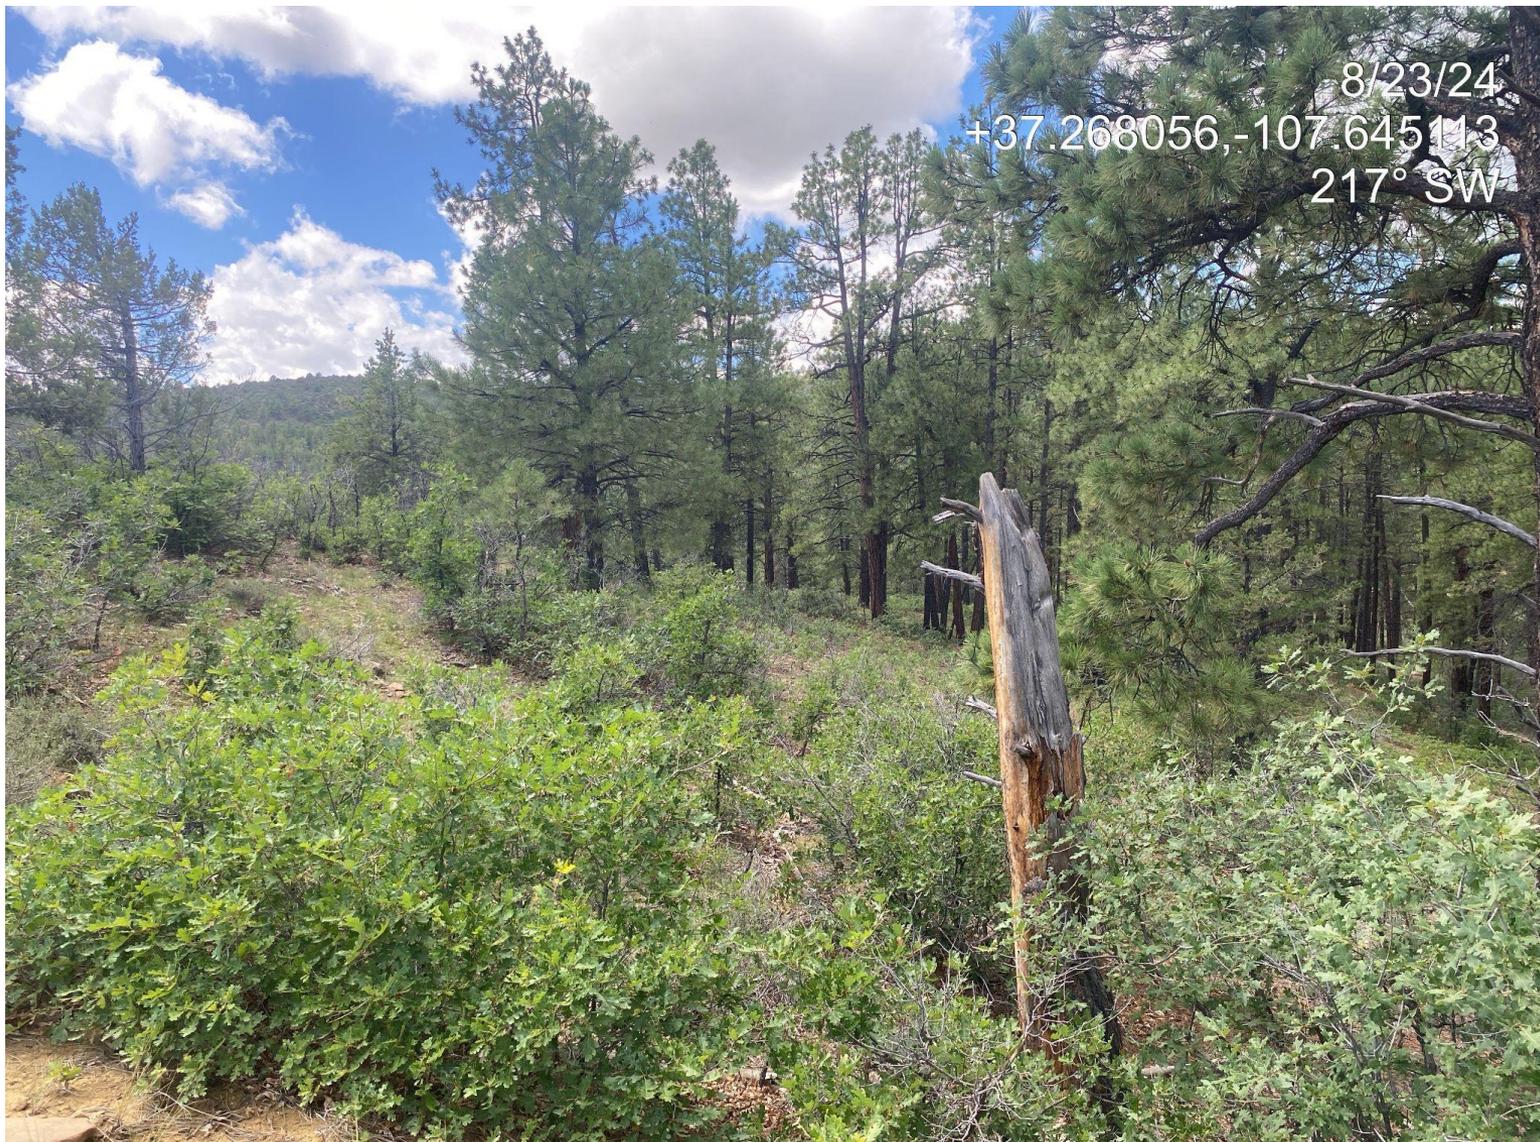
Photo 5. Reference area comprised of Squirrel tail, Pine and Gambel oak.
