Inspection Photos

Operator: SWN PRODUCTION COMPANY LLC -
10396

Location ID: 313134

Inspection Doc: 696206184

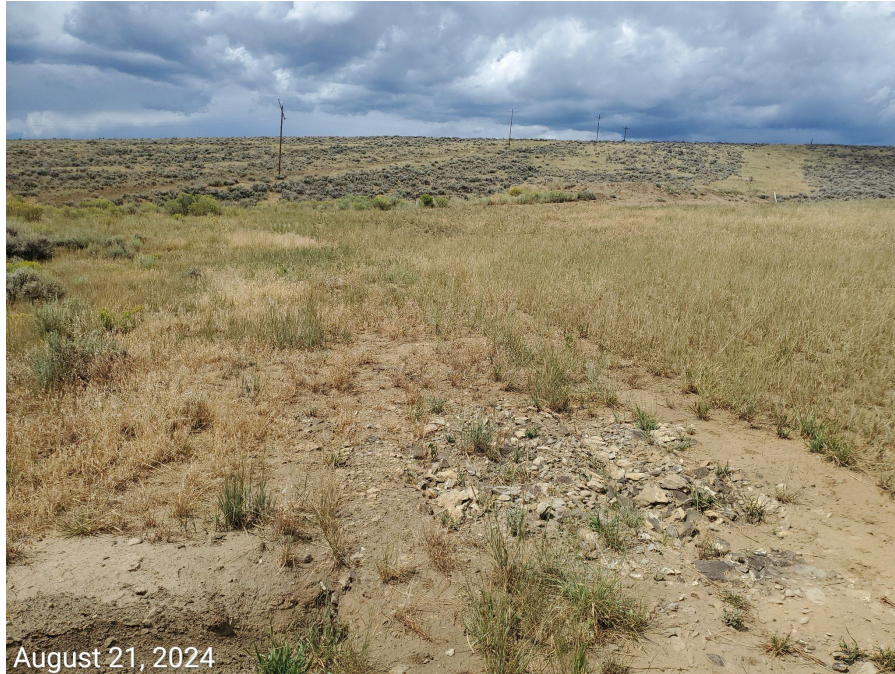
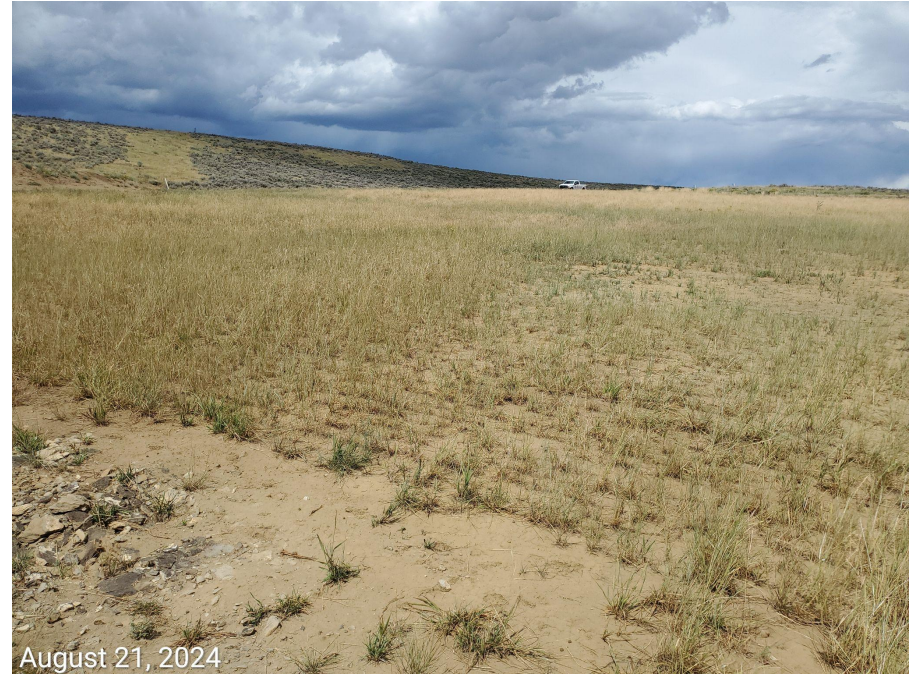
Photo 1: Photos 1-2 taken from the south end of the Location. Photos provide an overview from west, northwest, northeast to east.

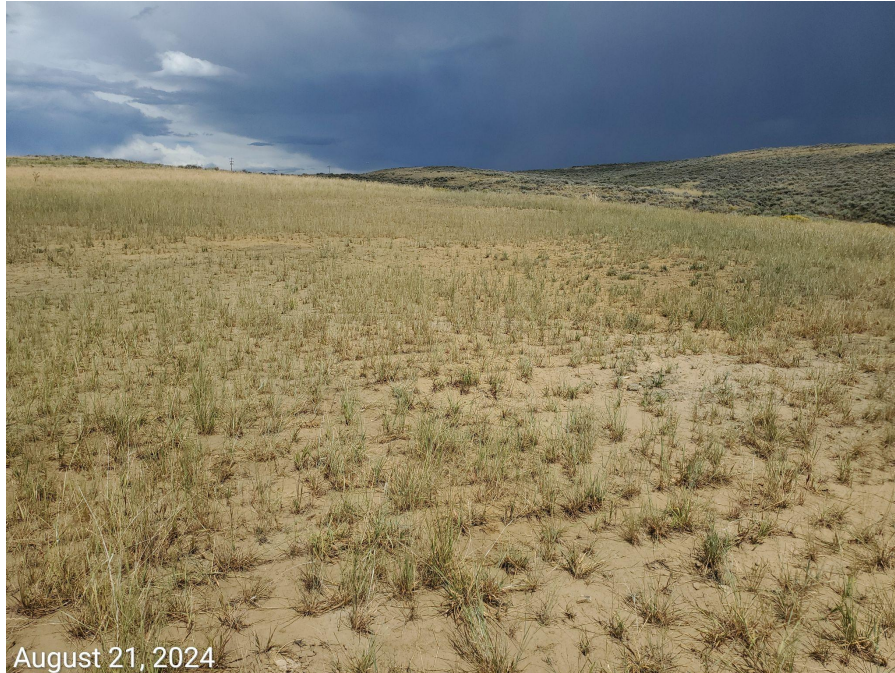
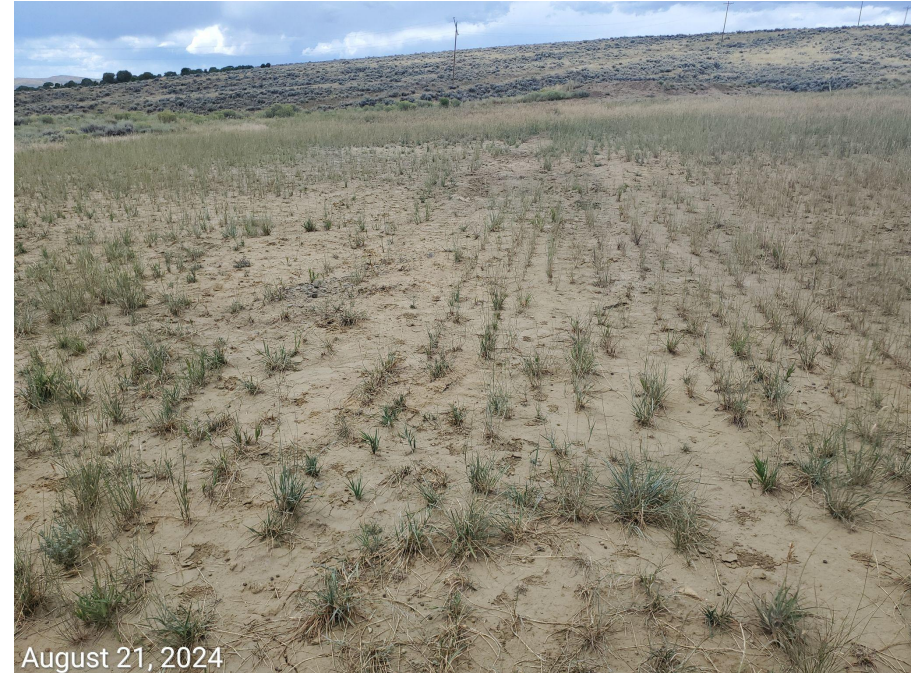
Photo 2: See comments under photo 1.

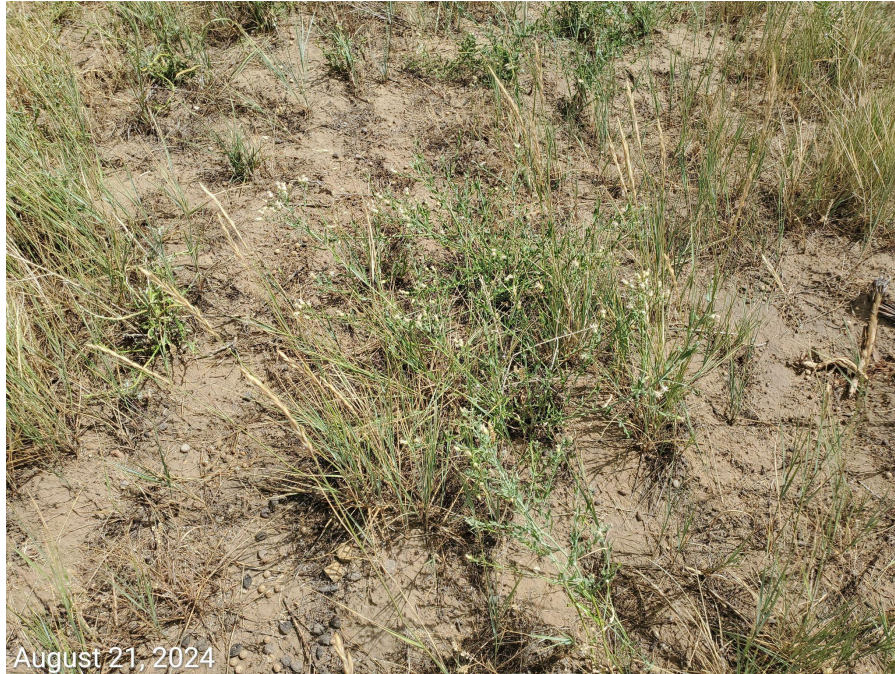
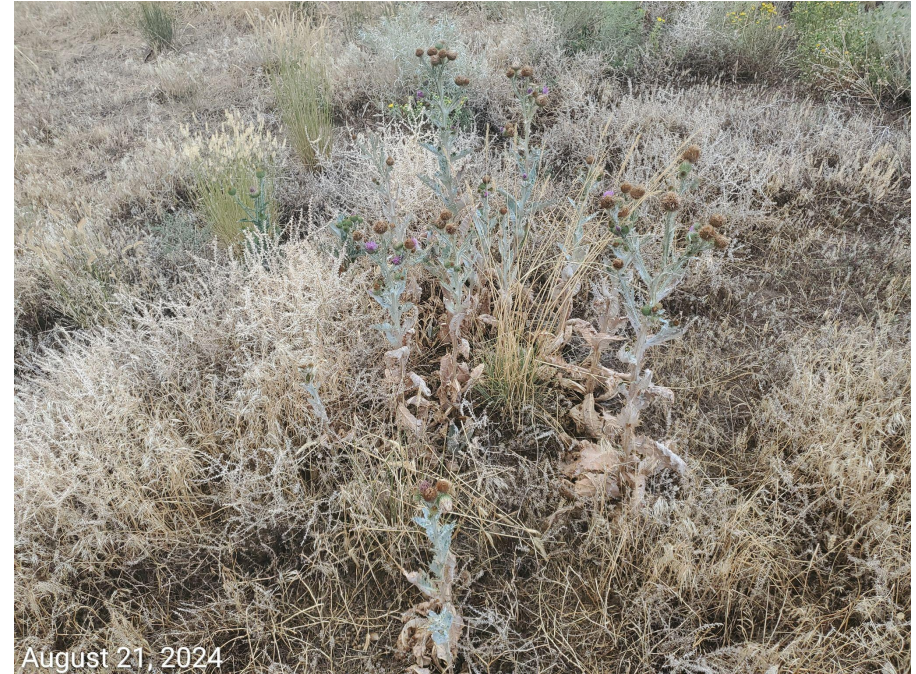
Photo 3: Photos examples of Noxious weeds (Knapweed, Scotch thistle) observed established on the Location.

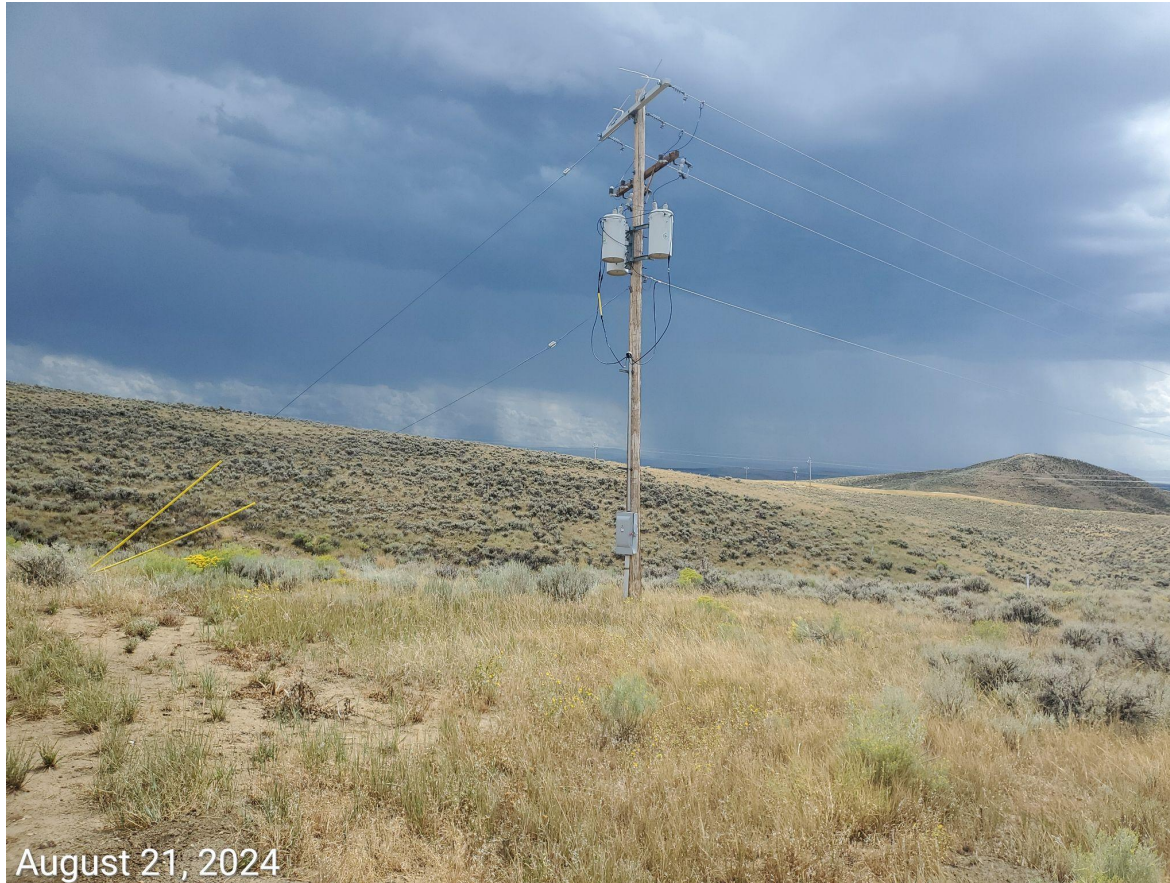
Photo 4: Photo taken from the south end of the Location. Photo shows Utility equipment on, and leading to, the Location has not been removed.

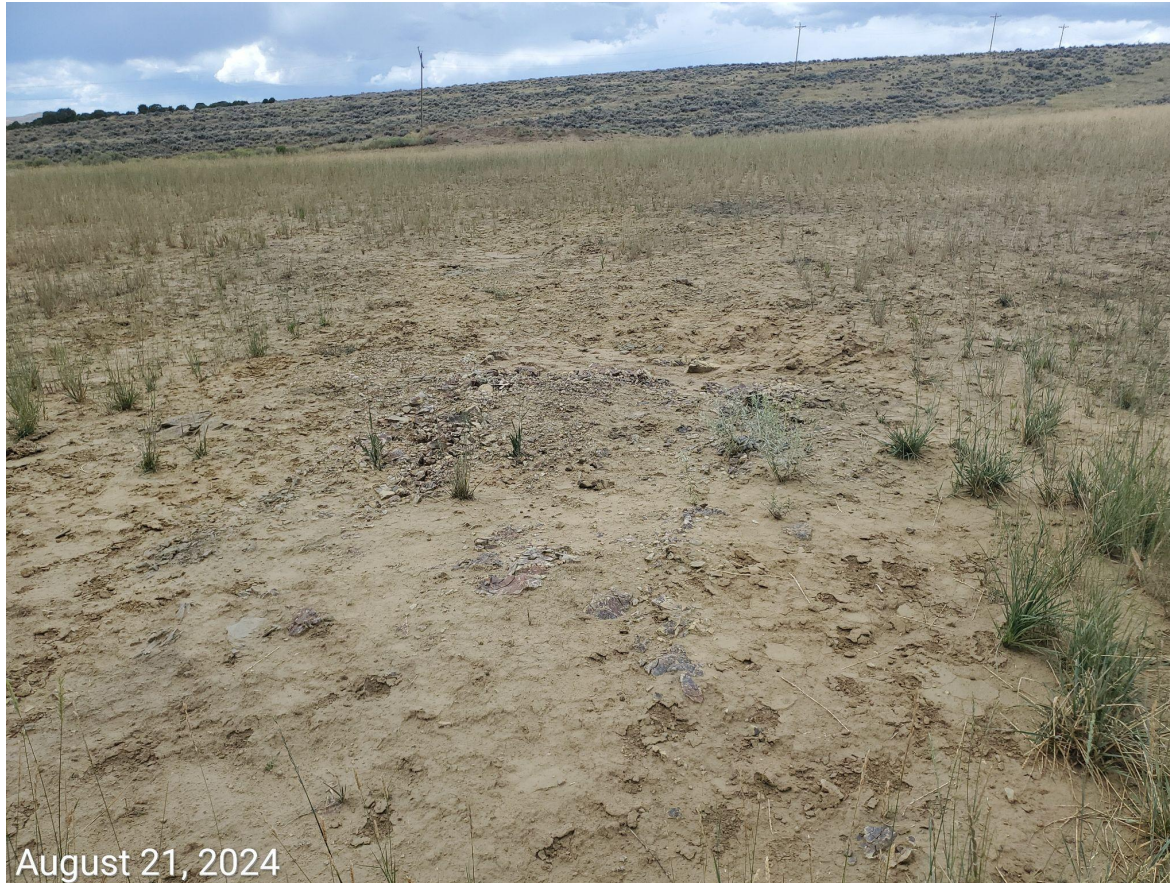
Photo 5: Photo taken from the south end of the Location, facing west. Photo shows areas of the Location that have not achieved uniform vegetative cover.

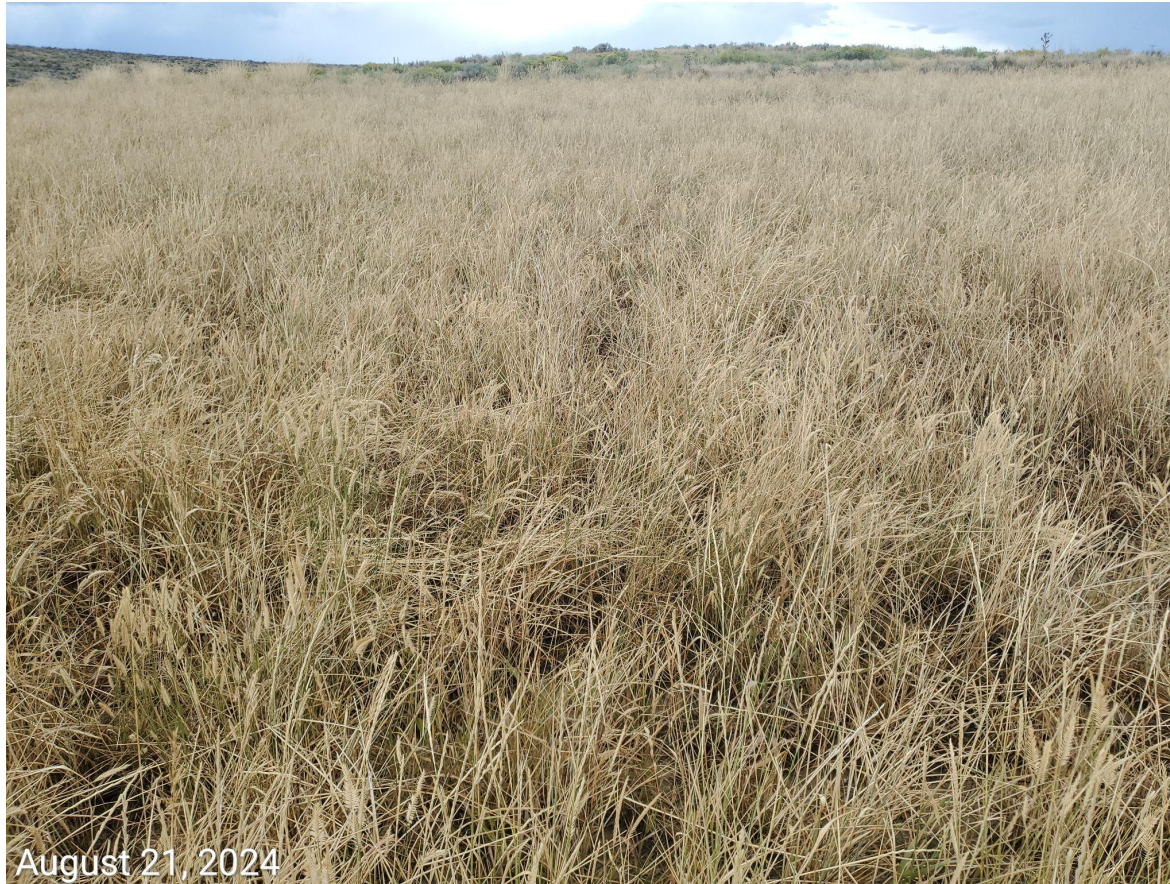
Photo 6: Photo taken from north-central areas of the Location, facing north. Photo shows areas of the Location where vegetative establishment is uniform.

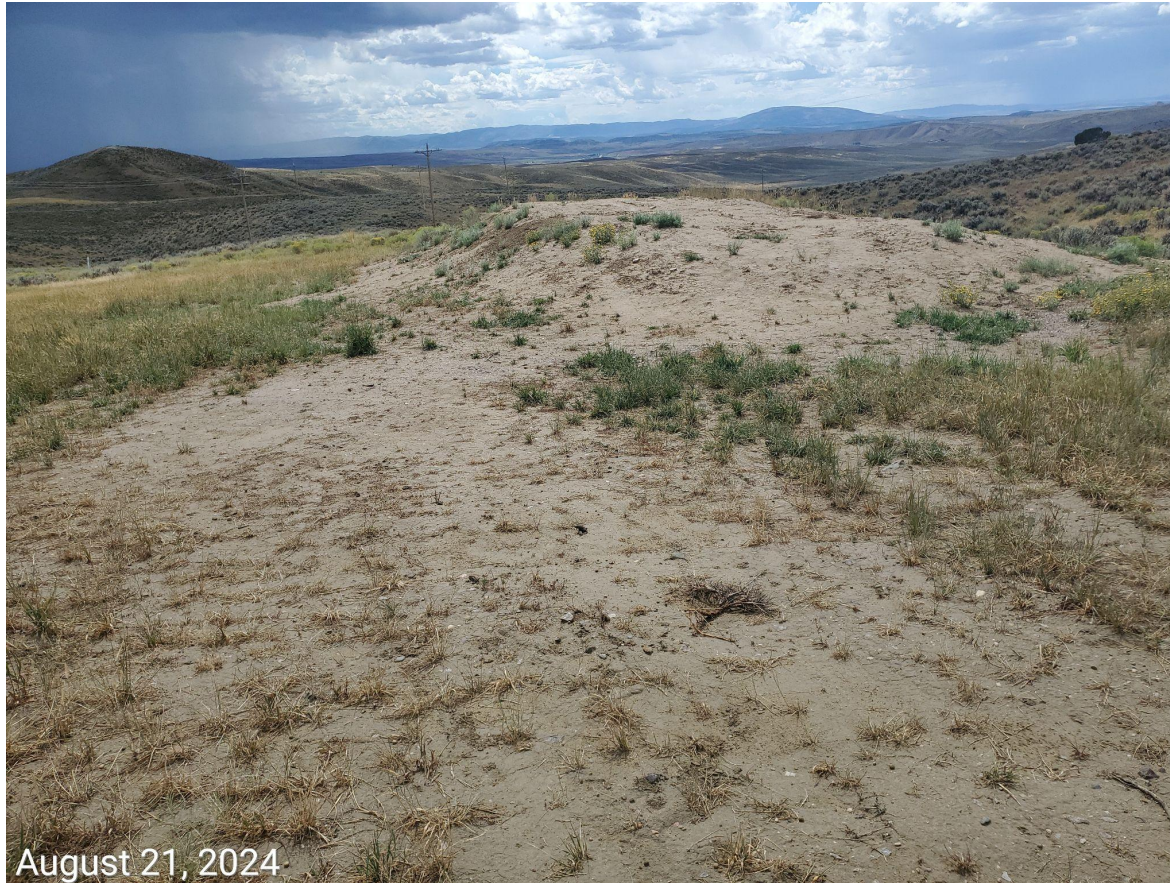
Photo 7: Photo taken from the west end of the Location, facing south. Photo shows a stockpile/berm remaining on the Location. Location has not been properly contoured, and soils replaced. Soils are barep; BMPs to protect the stockpiled soils from erosion, degradation, weed establishment, as well as BMPs to minimize sediment transport are missing or insufficient.

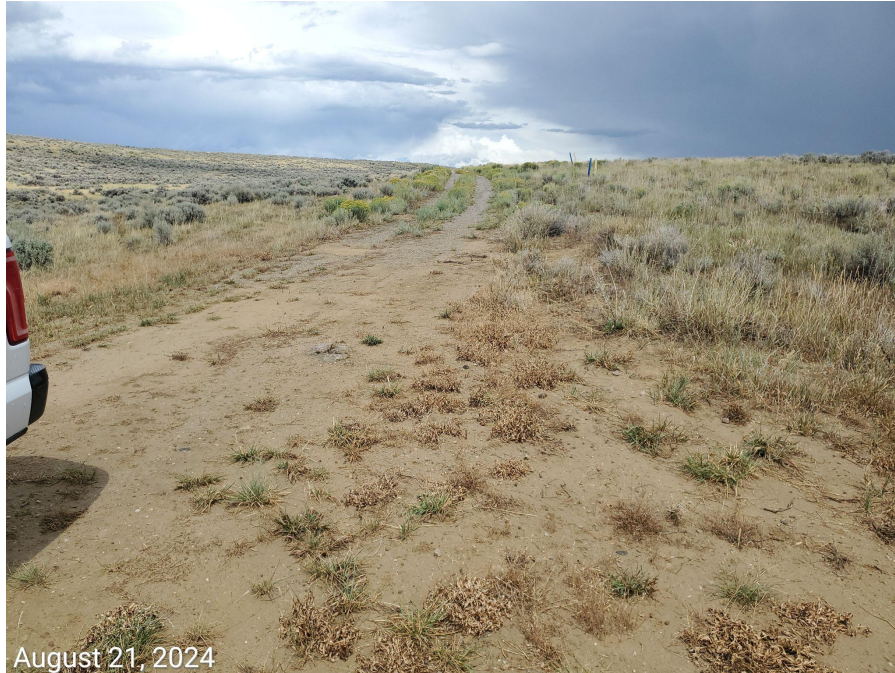
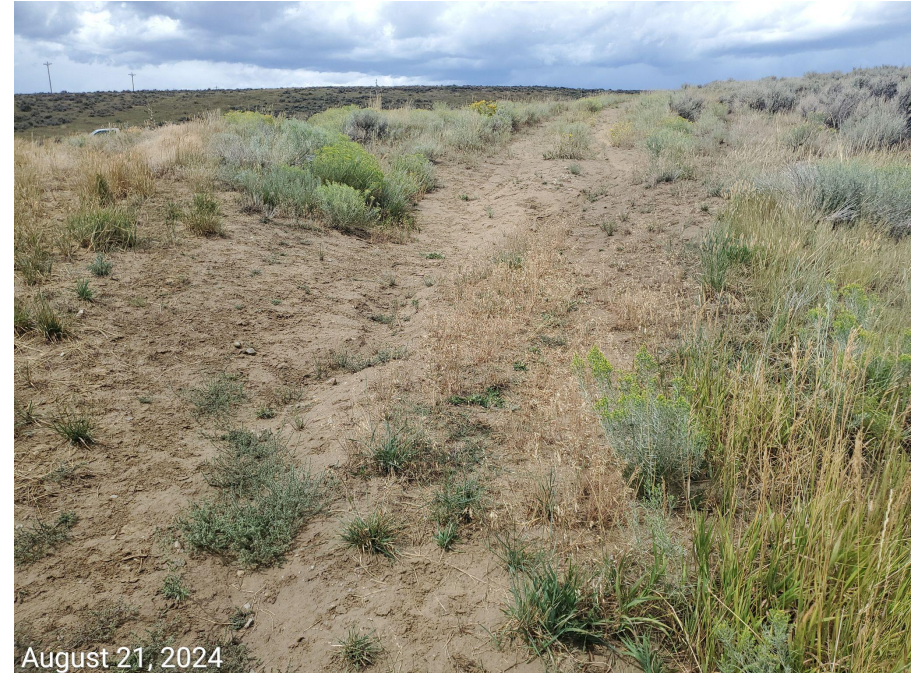
Photo 8: Photos taken from the northwest and northeast ends of the Location, facing north. Photos examples showing the access road to the Location has not been reclaimed.
