Inspection Photos

Operator: SWN PRODUCTION COMPANY LLC -
10396

Location ID: 313327

Inspection Doc: 696206198

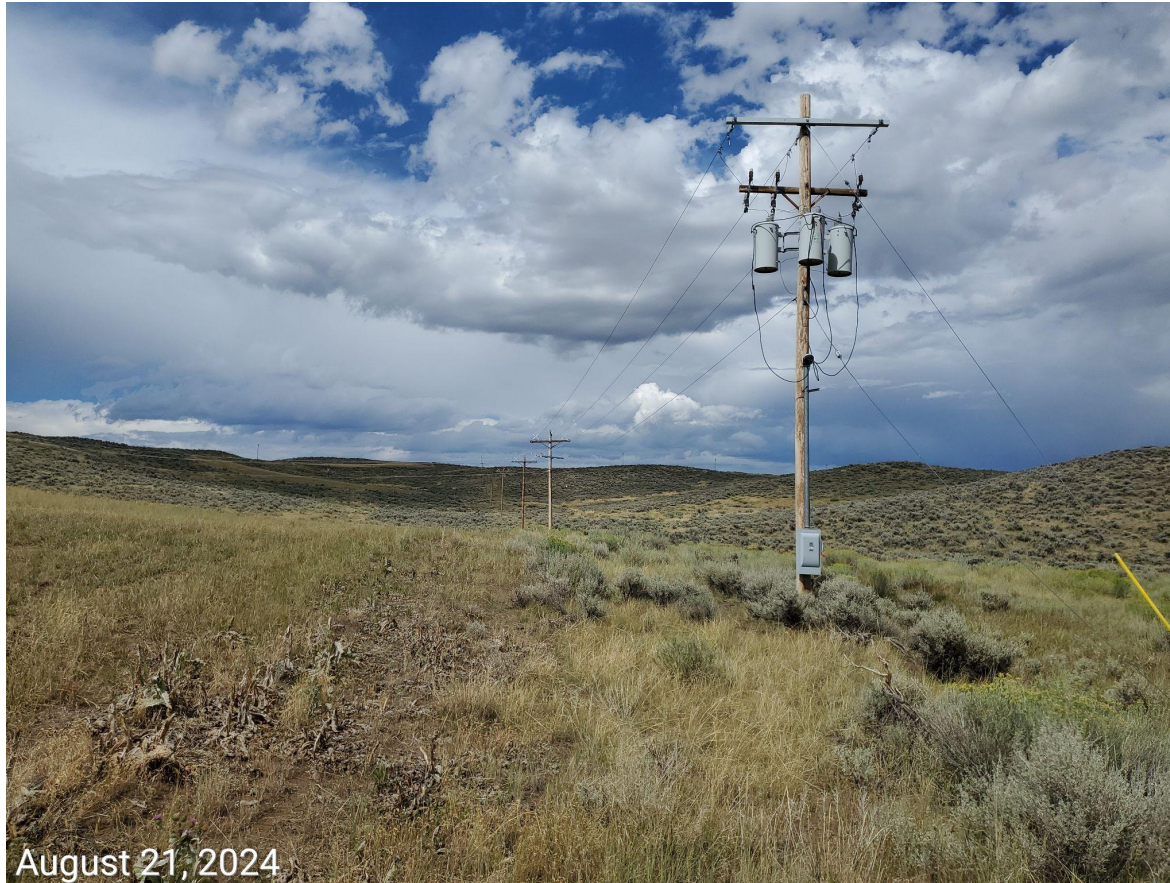
Photo 1: Photo taken from the east end of the Location, facing north. Photo shows utility equipment on, and leading to, the Location has not been removed.

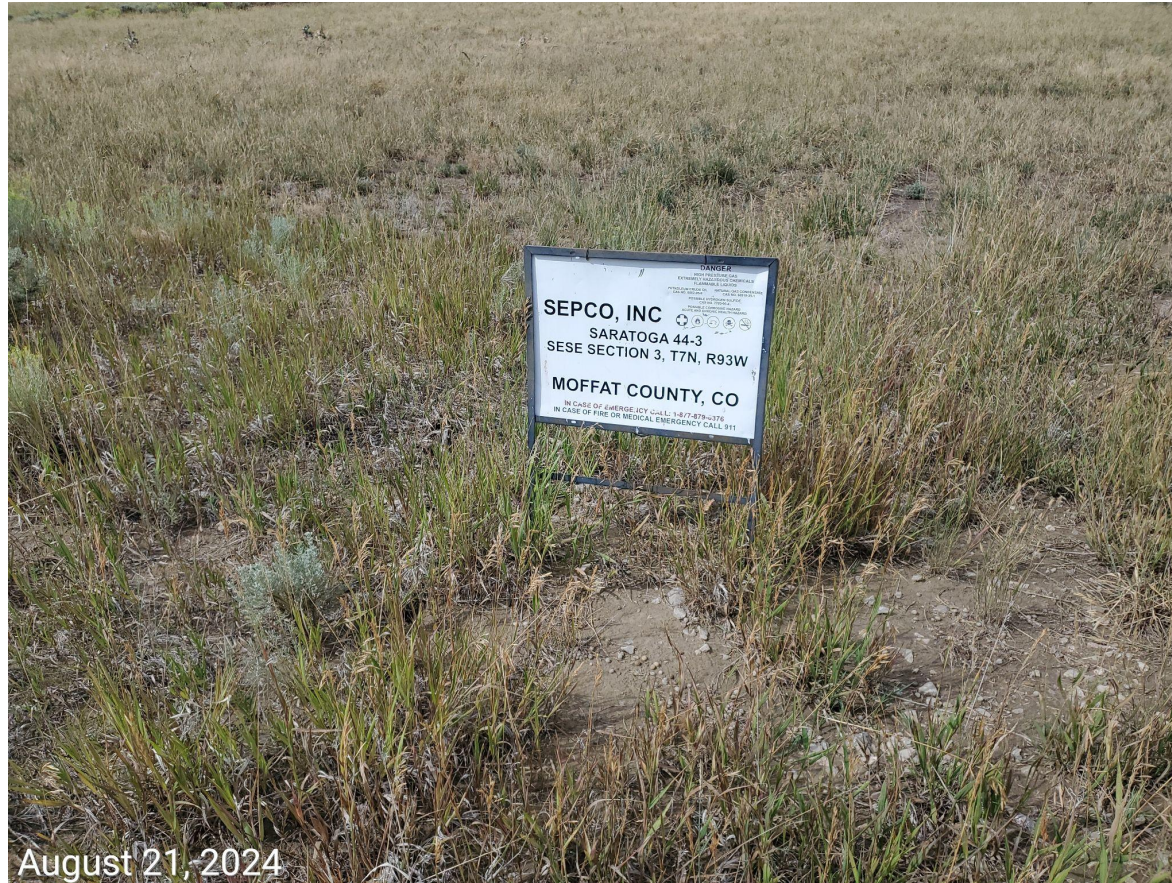
Photo 2: Photo taken from the Location entrance on the south end of the Location. Signage remaining on Location posted with incorrect Operator information.

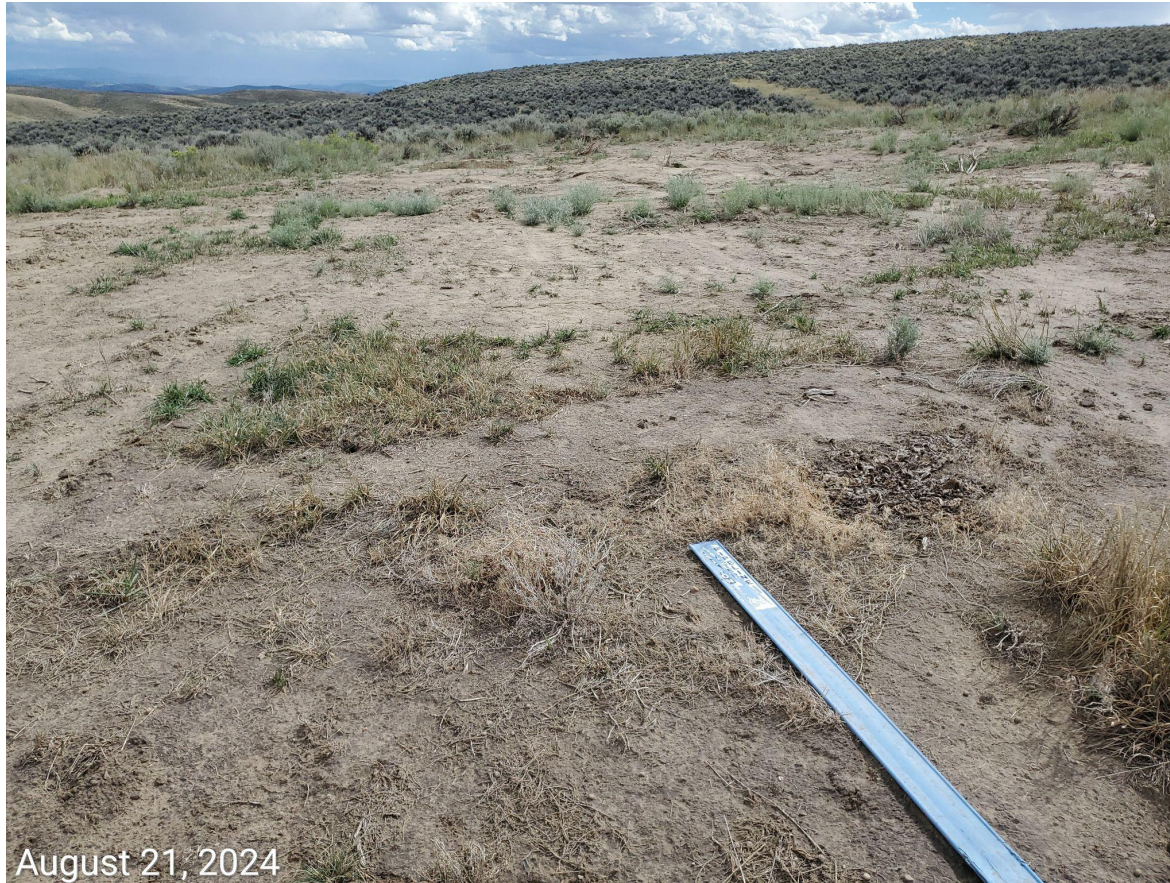
Photo 3: Photo taken from the east end of the Location, facing east. Photo shows areas of the Location that remain predominantly bare; areas are not progressing towards 1004.c.(2) standards.

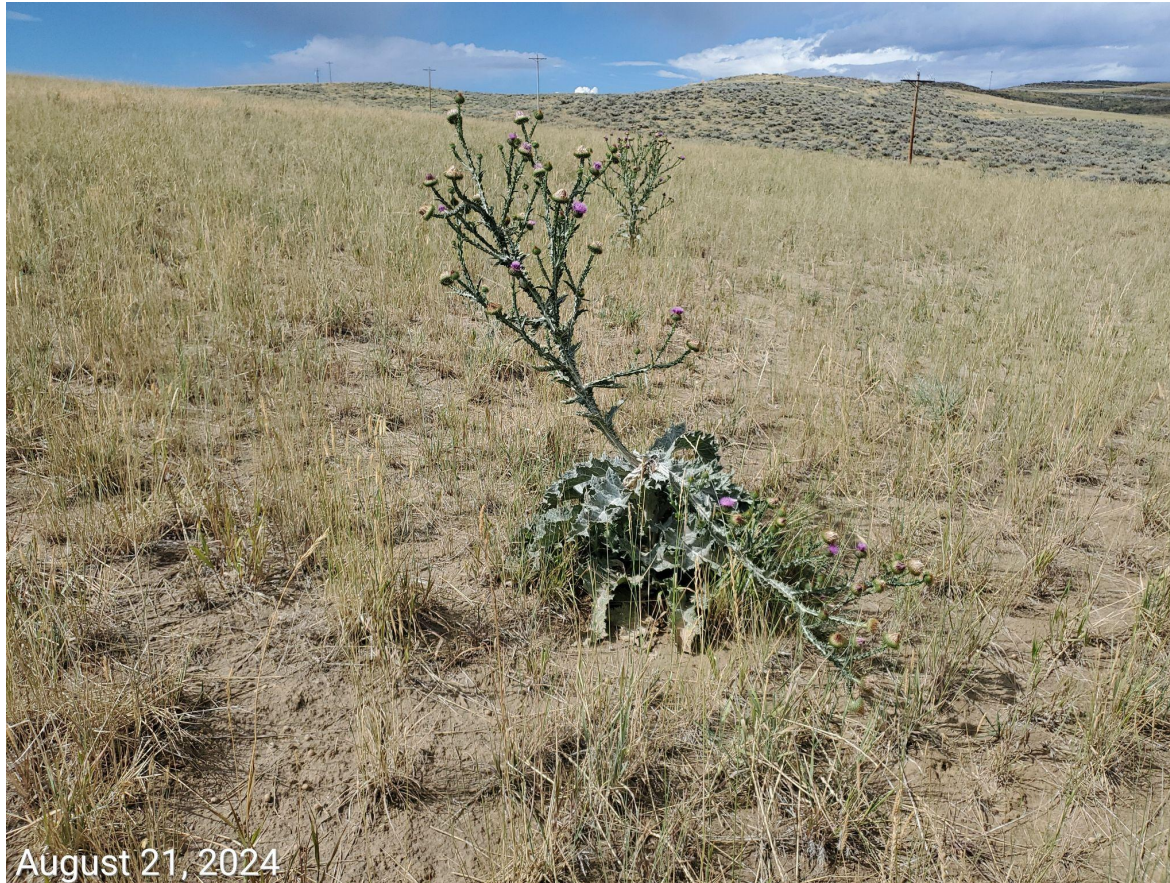
Photo 4: Photo examples of Noxious weeds (Scotch thistle) observed on the Location.

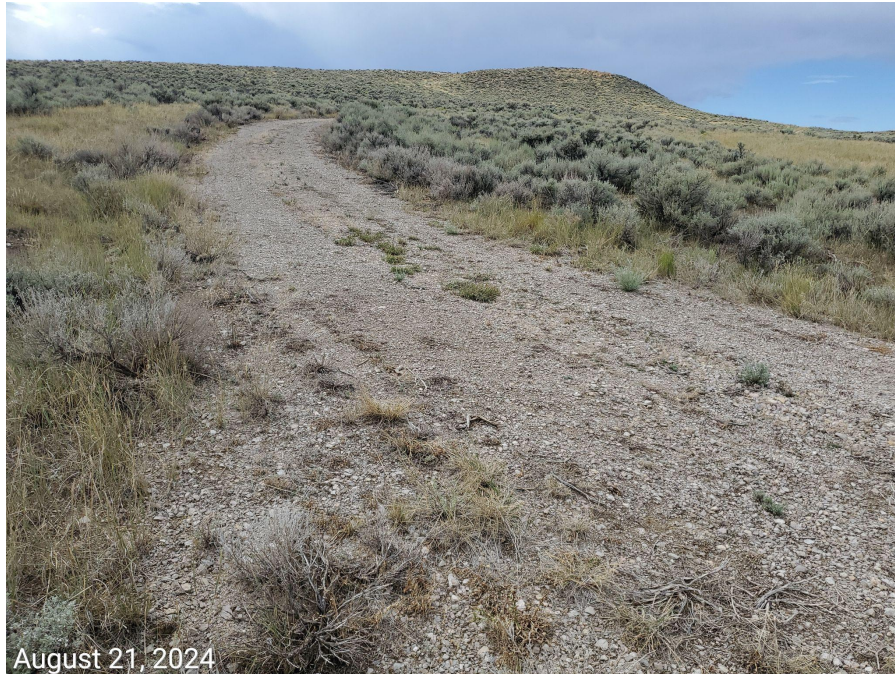
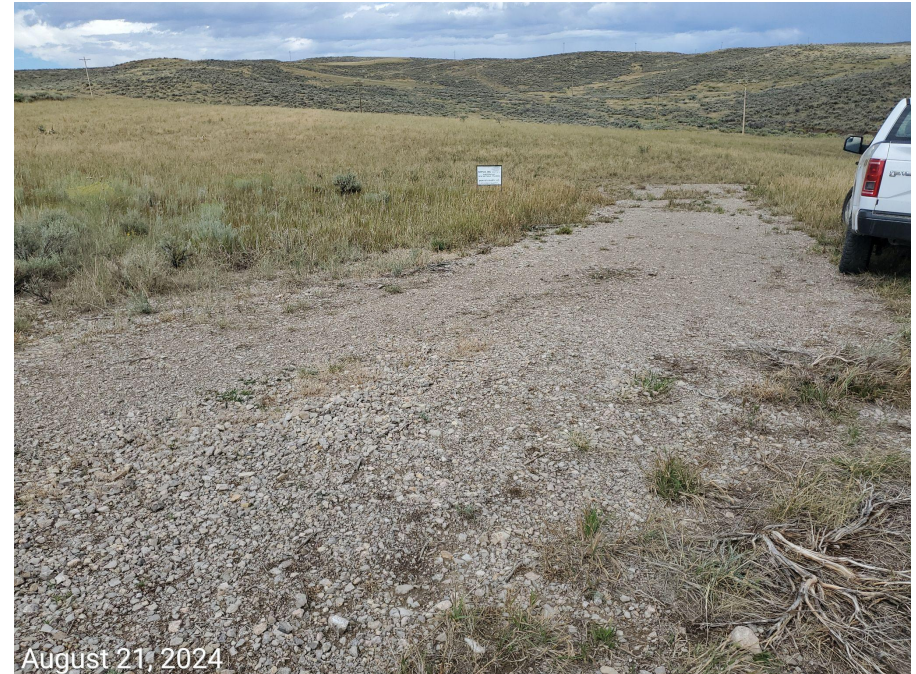
Photo 5: Photos 5-6 show access road to the Location has not been reclaimed in accordance with 1004 Requirements.

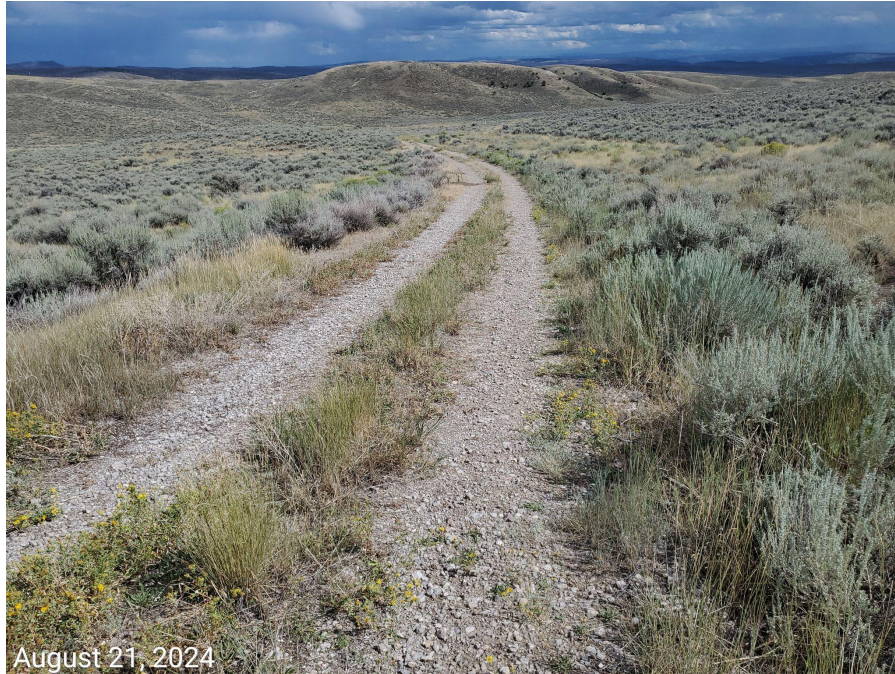
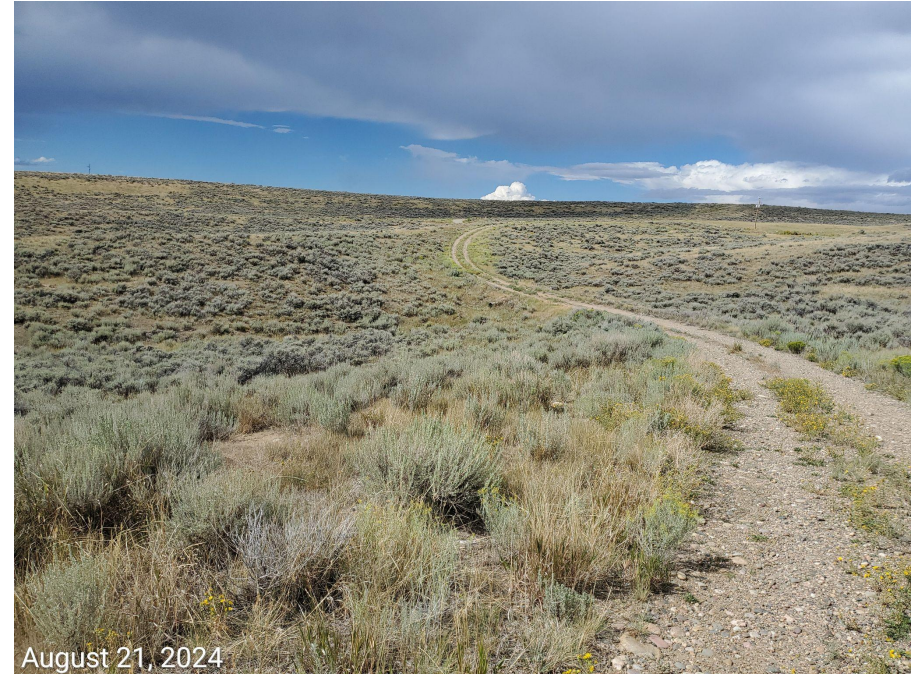
Photo 6: See comments under photo 5.

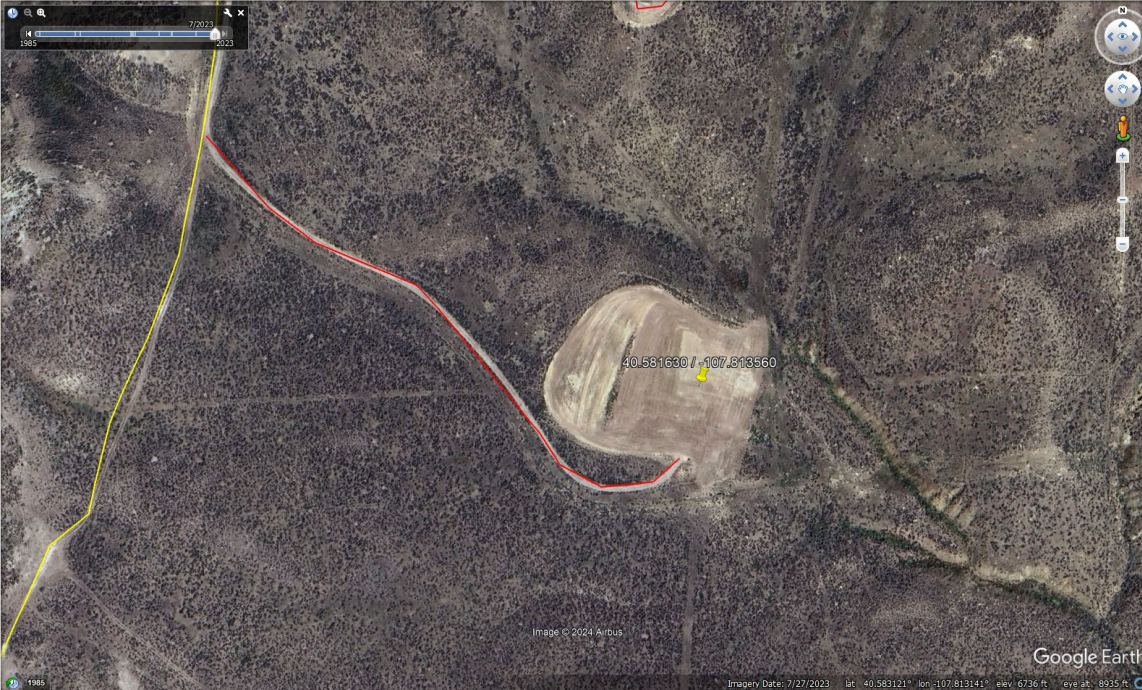
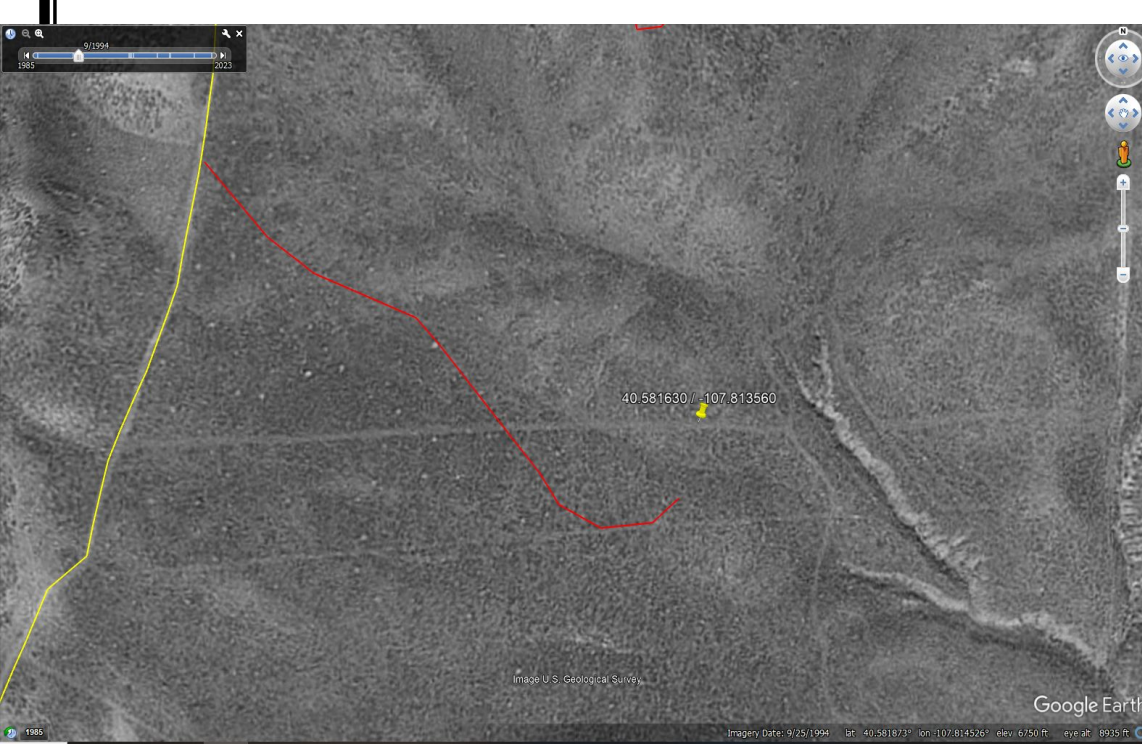
Photo 7: Google earth aerial imagery. Top photo dated 2023; bottom 1994. Yellow lines represent access roads that existed prior to Oil and Gas disturbances. Red lines represent access roads constructed to Oil and Gas Locations subject to 1004 final reclamation requirements. Access road to the SARATOGA #44-3 did not pre-exist the Location.
