Inspection Photos

Operator: SWN PRODUCTION COMPANY LLC -
10396

Location ID: 313257

Inspection Doc: 696206219

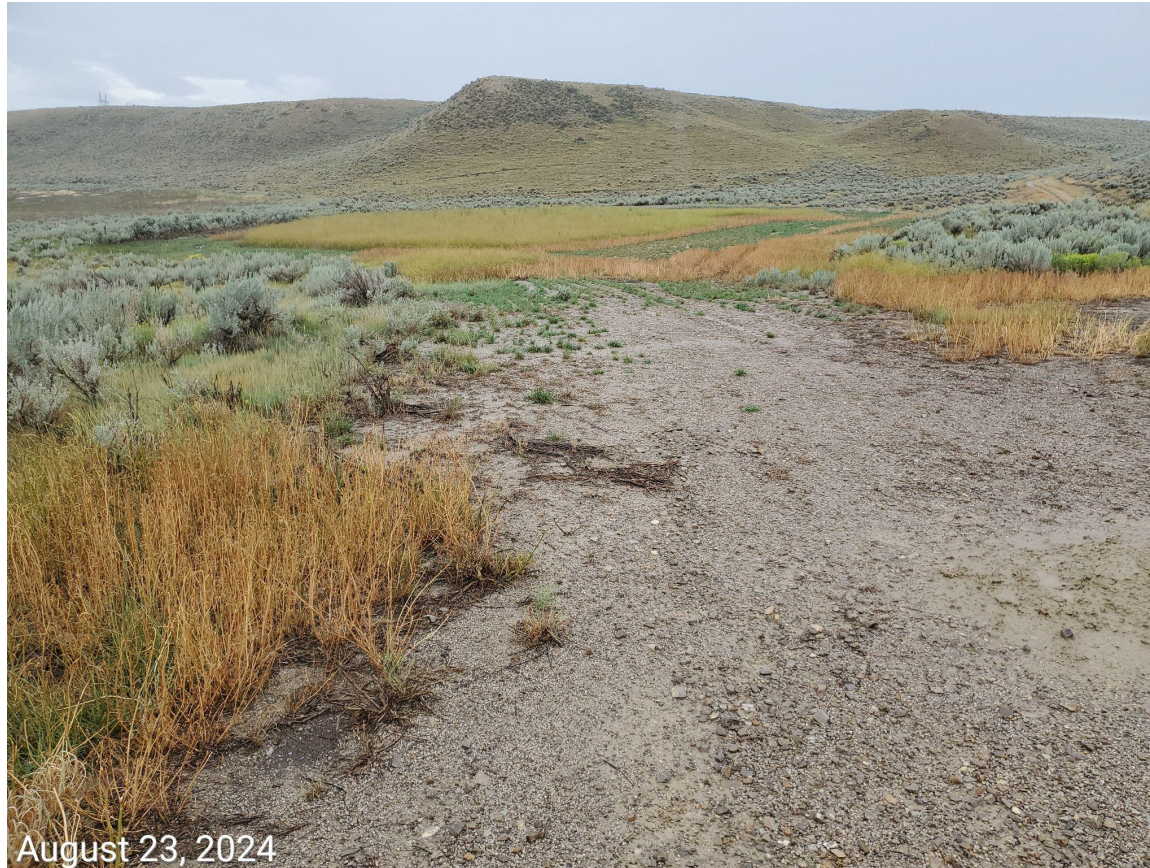
Photo 1: Photo taken from the intersection of the O&G access road, and the Surface Owner's road. Photo shows access road to the Location has not been reclaimed; gravel remains, road areas have not been decompacted and reclaimed.

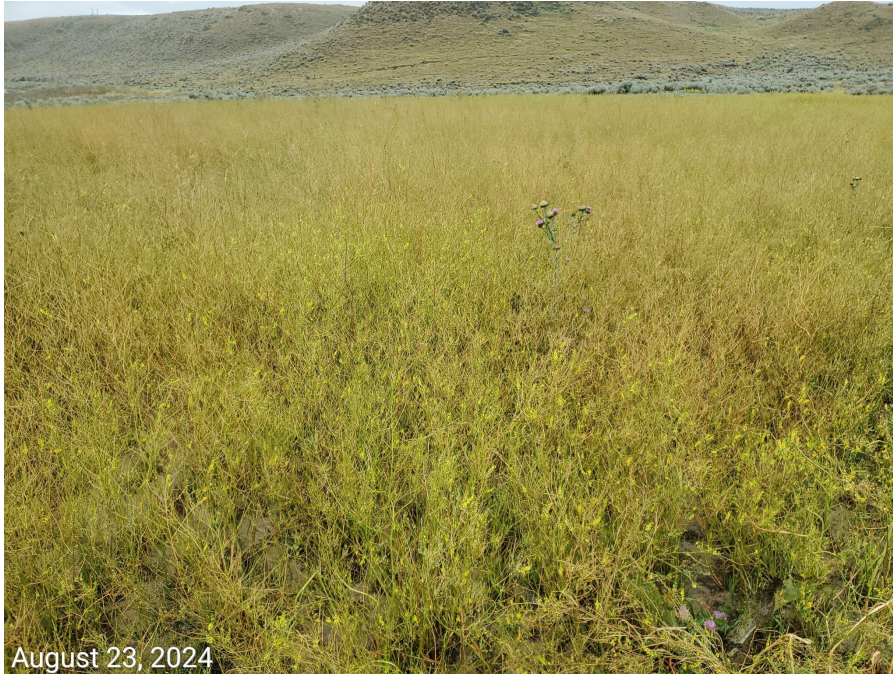
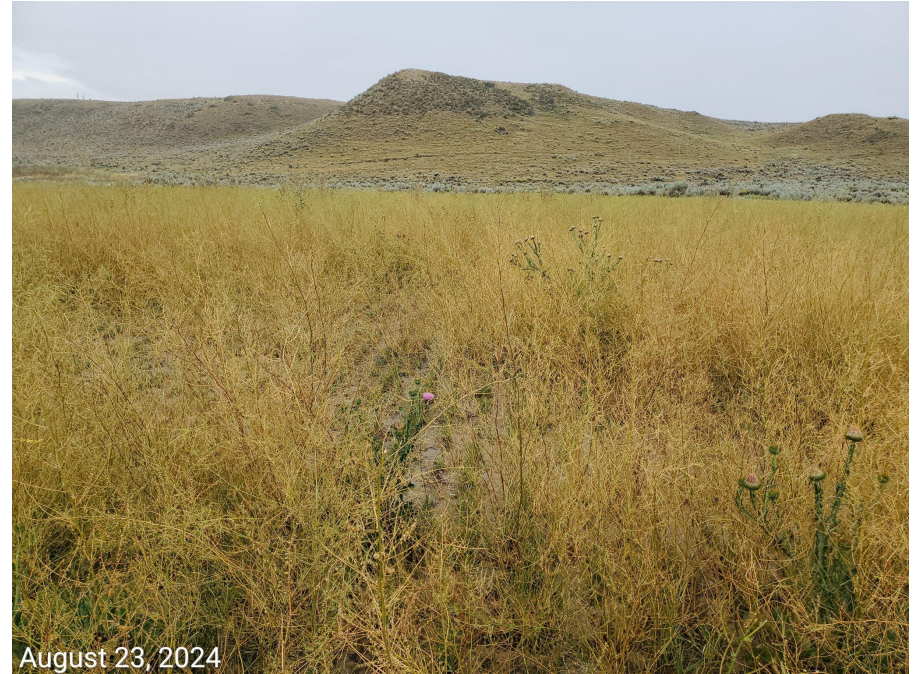
Photo 2: Photos taken from the central areas of the Location. Vegetation within Location is predominantly Yellow Sweet clover, a biennial plant species. Noxious weeds (Scotch thistle) observed throughout the Location. It is noted that species planted do not reflect species within the adjacent undisturbed reference areas, or vegetation that existed pre-disturbance.

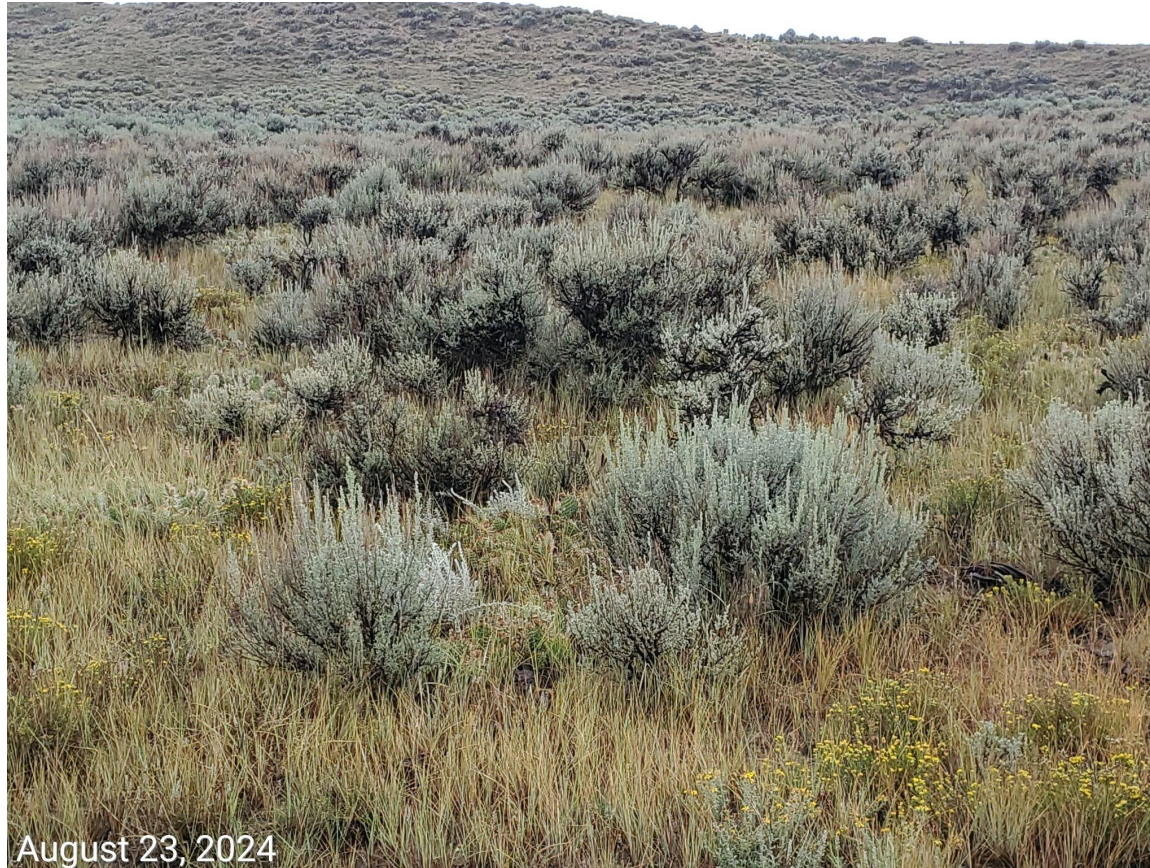
Photo 3: Photo taken from the reference areas west of the Location.
Photo to compare vegetation between reference and disturbance areas
