Inspection Photos

Operator: Alamosa Drilling Inc. - 900

Location ID: 320916

Inspection Photos
Location Name: Martinez A2
Location ID: 320916

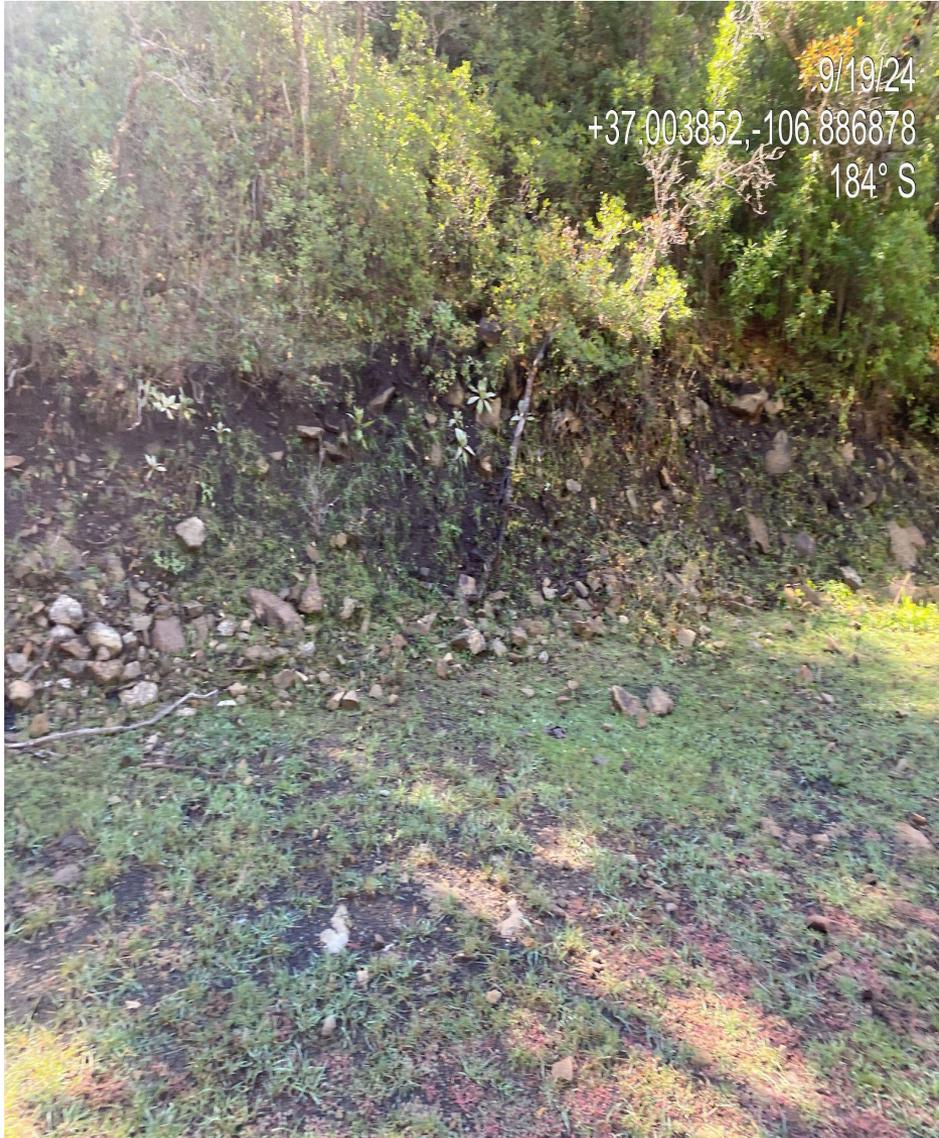
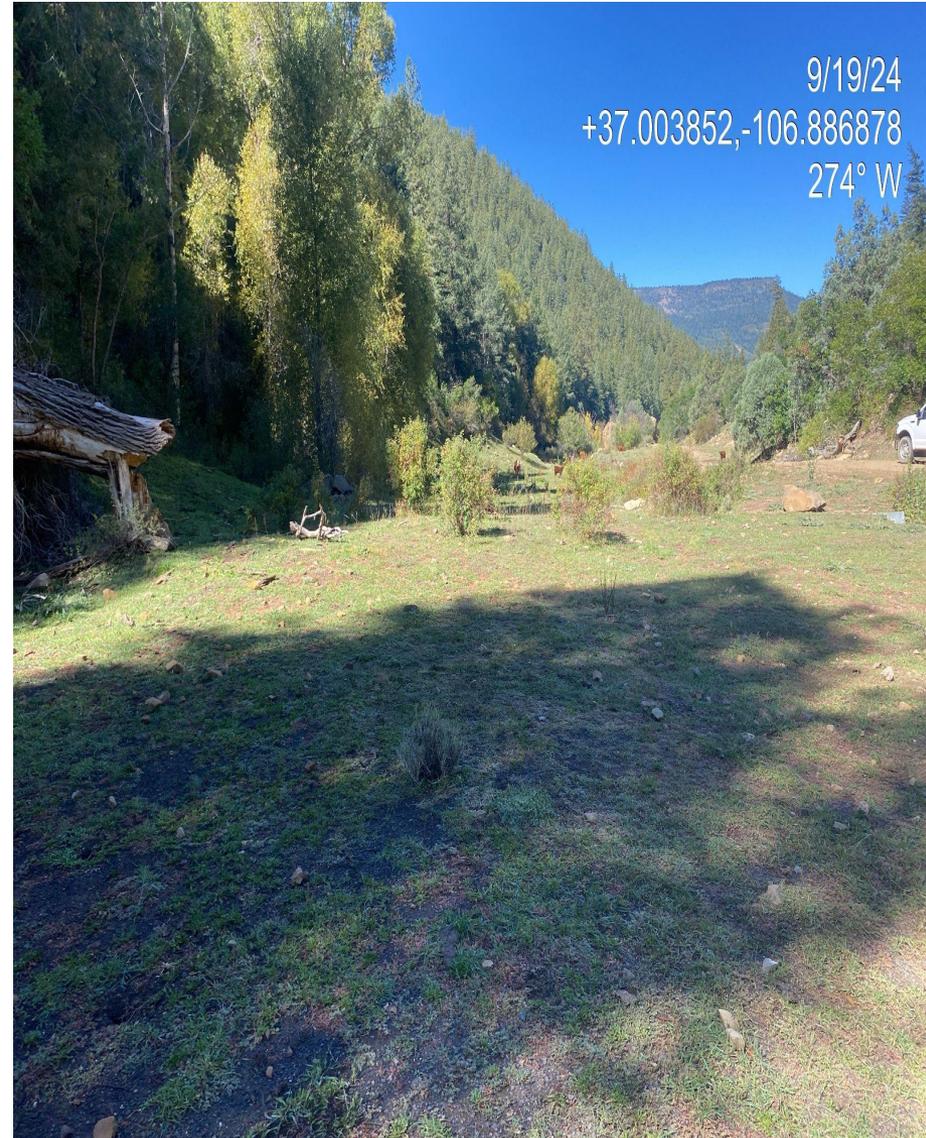
Photo 3. Cardinal photos taken from the center of the disturbance, left photo facing south, right photo facing west. Note: grazed vegetation appears to be dominated by desirable species including Grama sp. and Smooth brome and Rose.

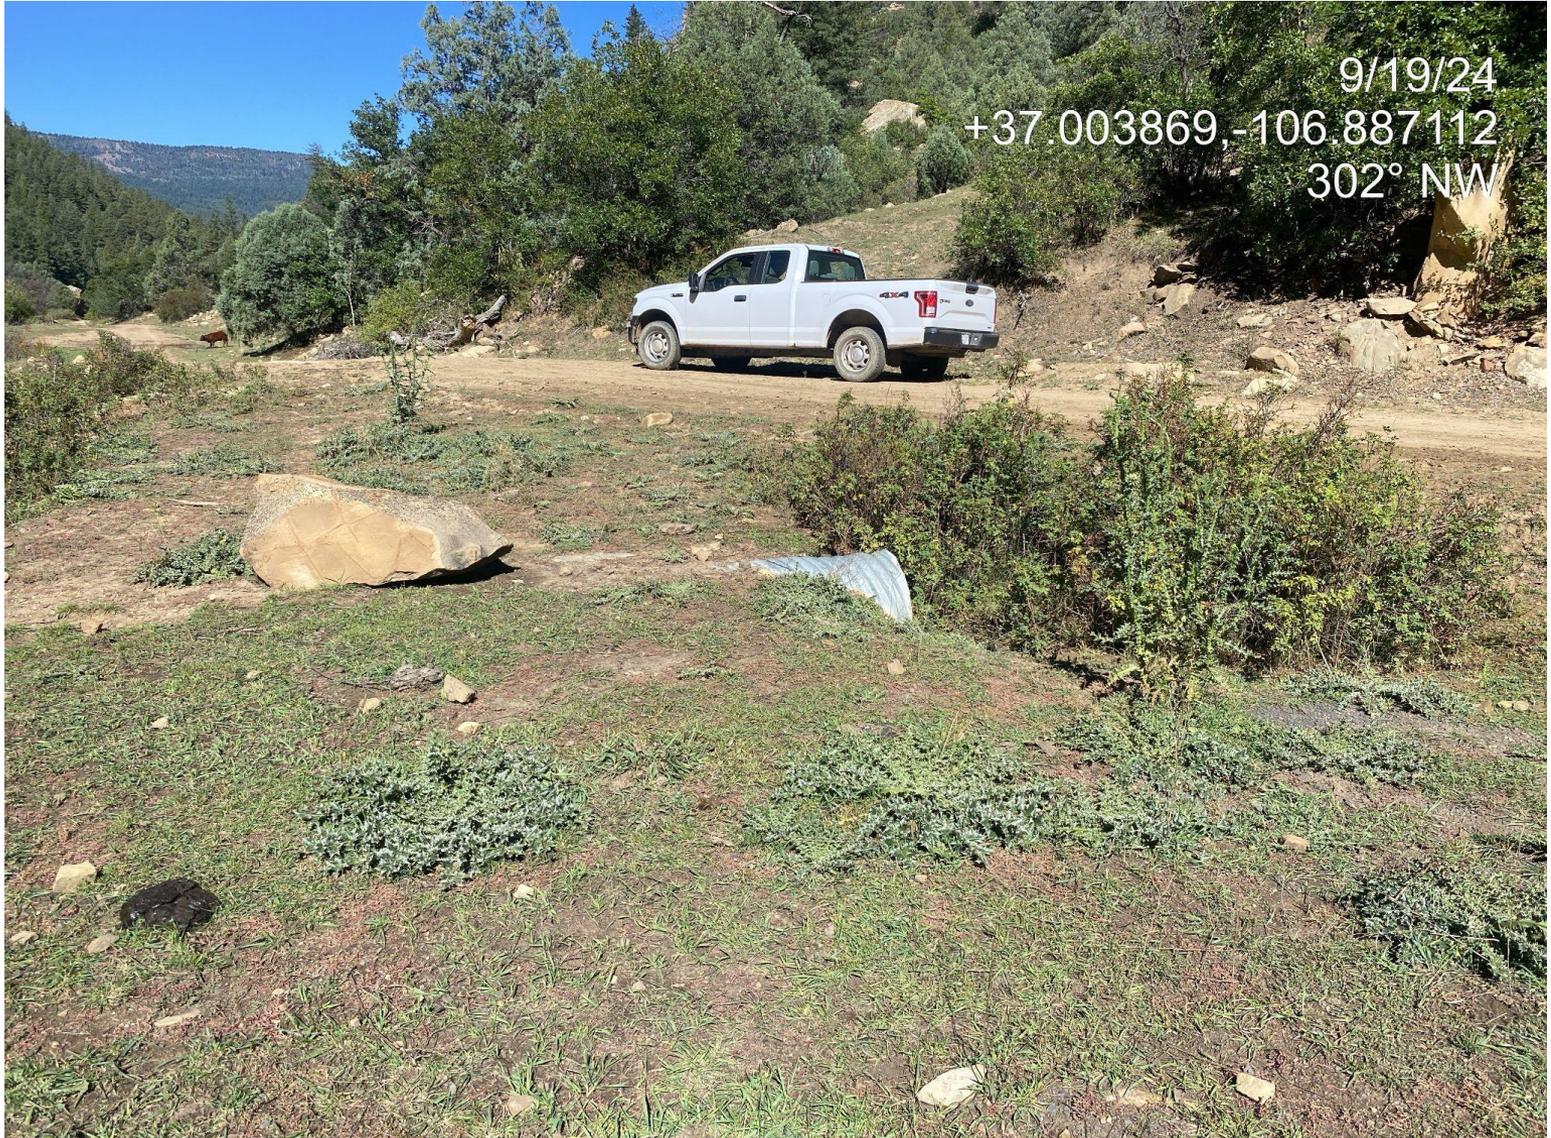
Photo 4. Large patch of Musk thistle observed at the access point of the disturbance, approximately 30 individuals observed.

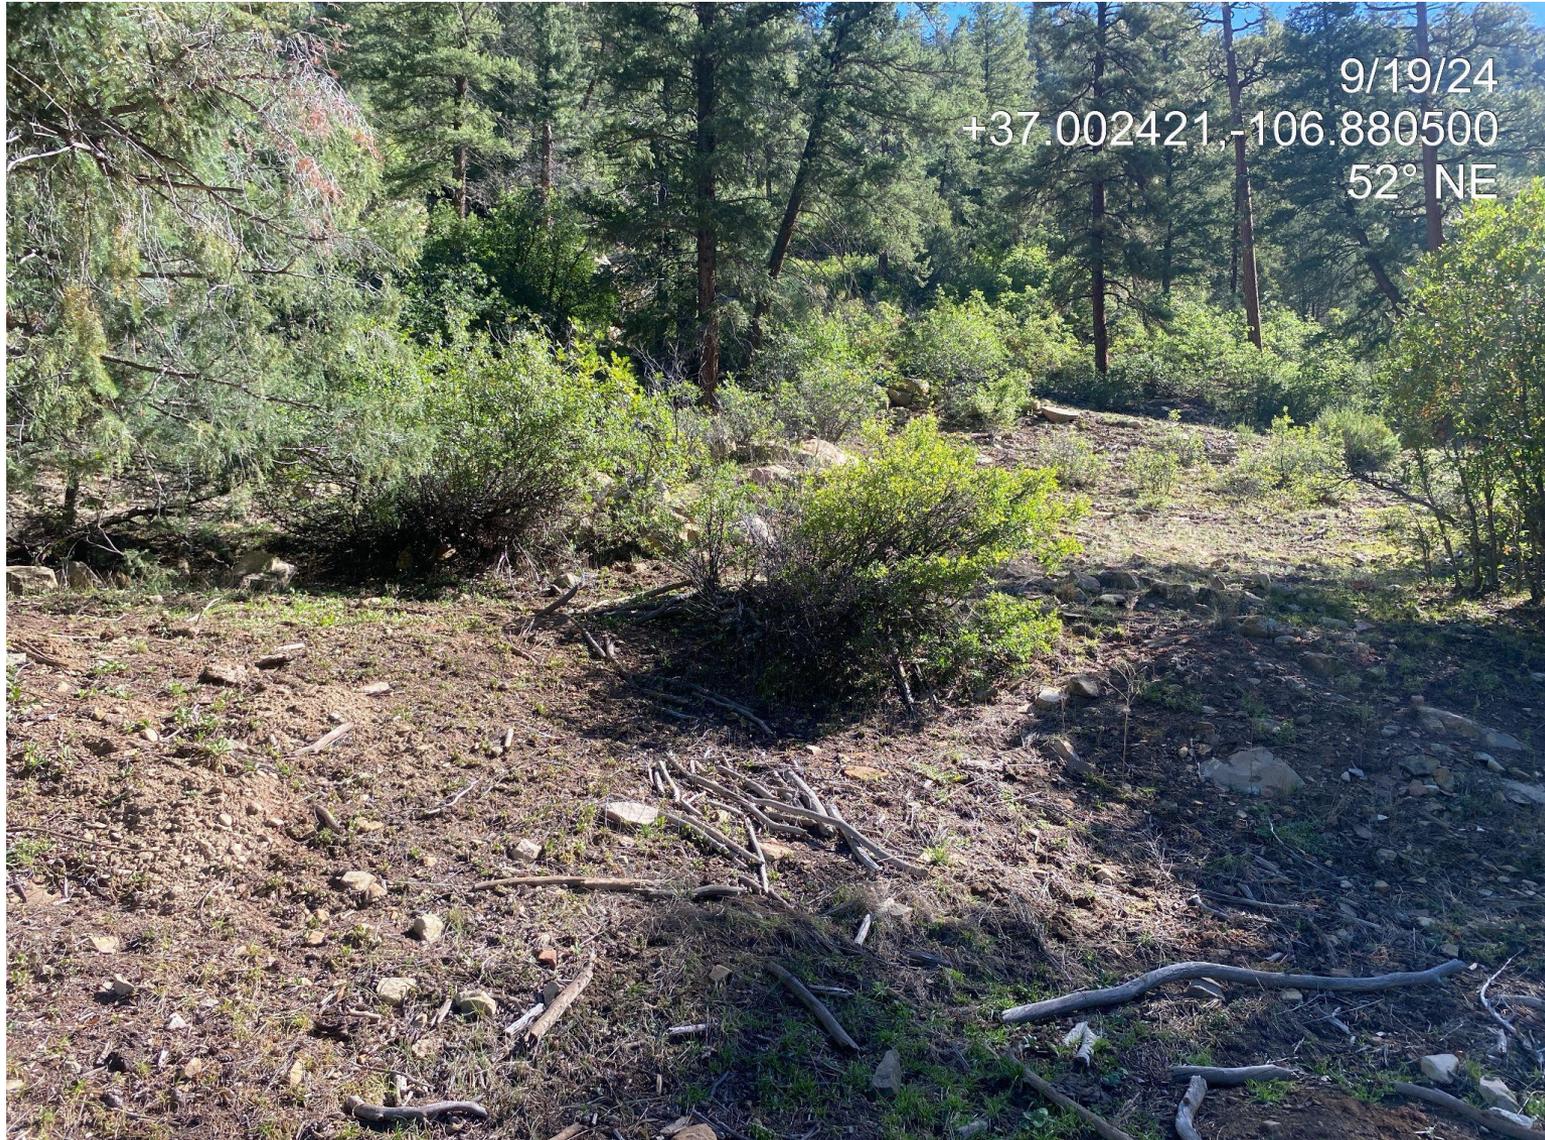
Photo 5. Reference area comprised of Pine and Gambel oak with an understory of Smooth brome and Grama sp.
