Construction and Stormwater Inspection

Operator: St Croix Operating Inc - 81490

Location ID: 487085

Inspection Photos
Location Name: Prairie Ridge #1
Location ID: 487085

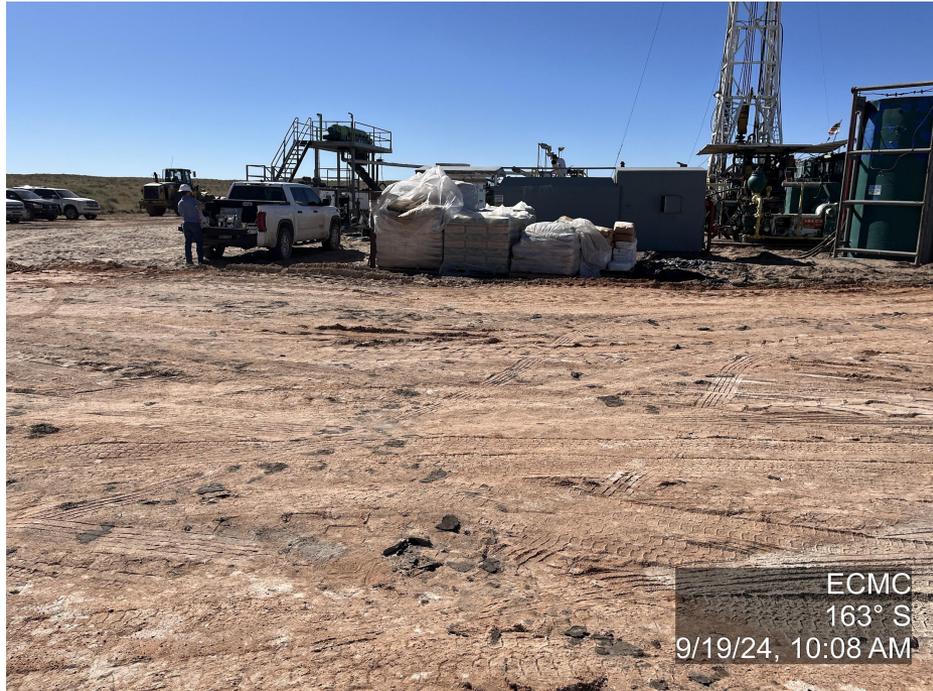
Photo 1. The photo was taken at the well location facing South. The photo illustrates the active drilling operation and equipment.

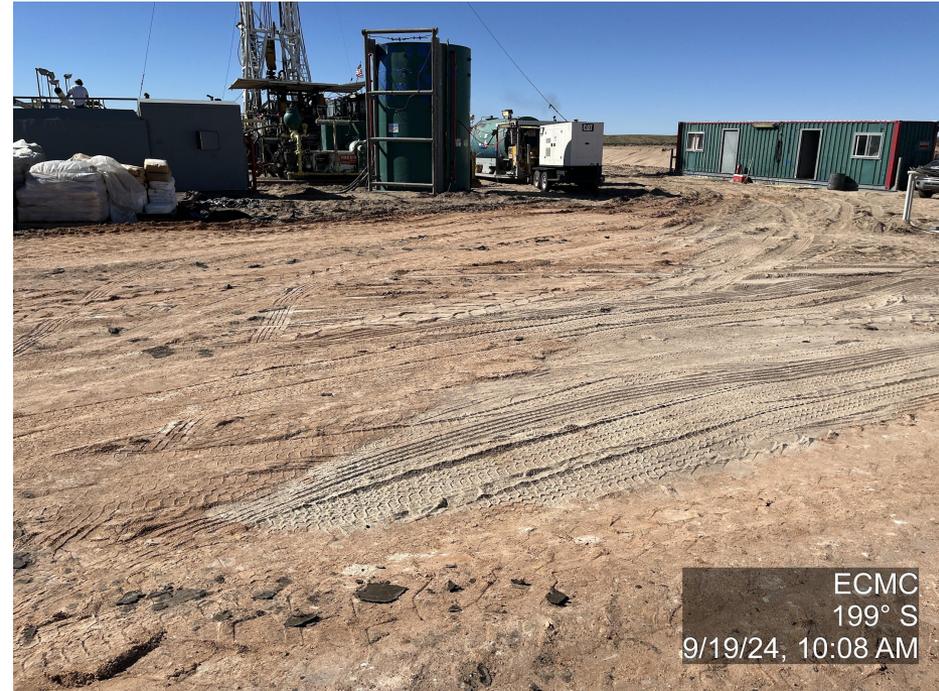
Photo 2. The photo was taken at the well location facing South. Refer to the comment for photo 1.

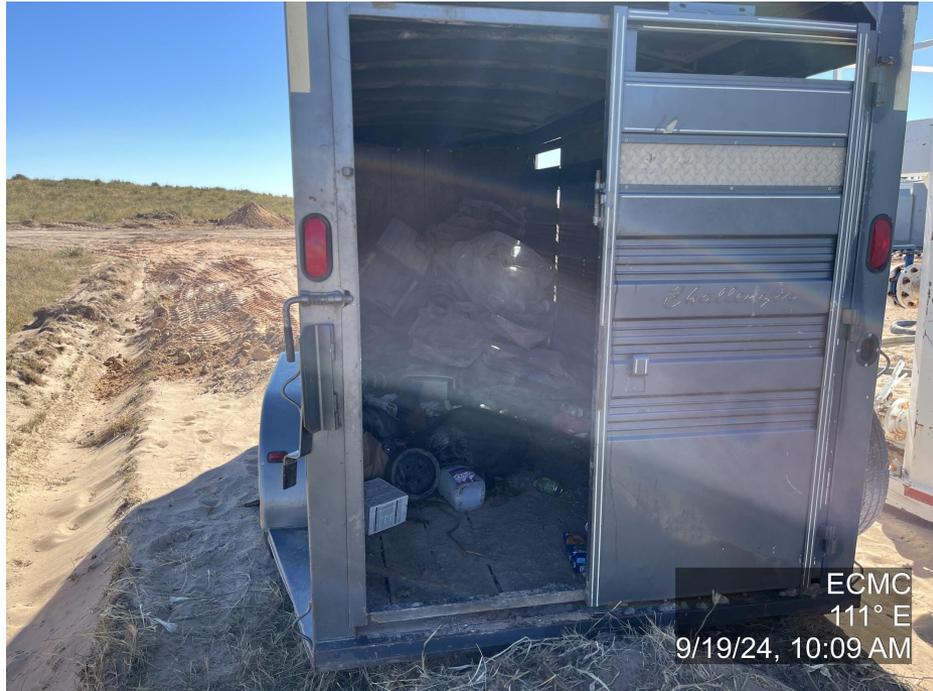
Photo 3. The photo was taken at the well location facing East. The photo illustrates a trailer being used as a dumpster.

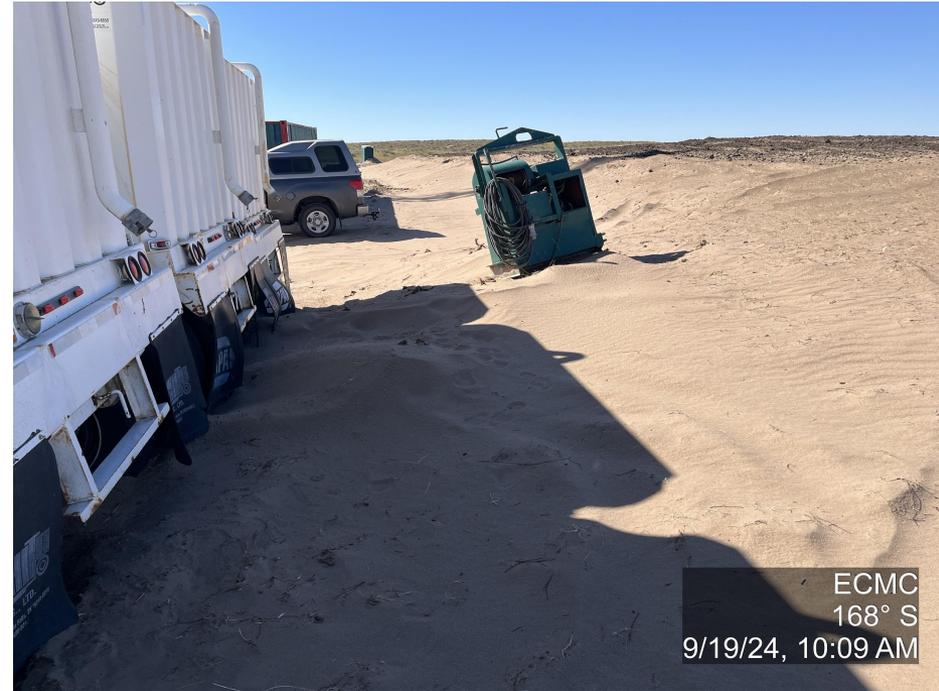
Photo 4. The photo was taken at the well location facing South. The photo illustrates evidence of sedimentation from wind erosion on the West side of the production pad.

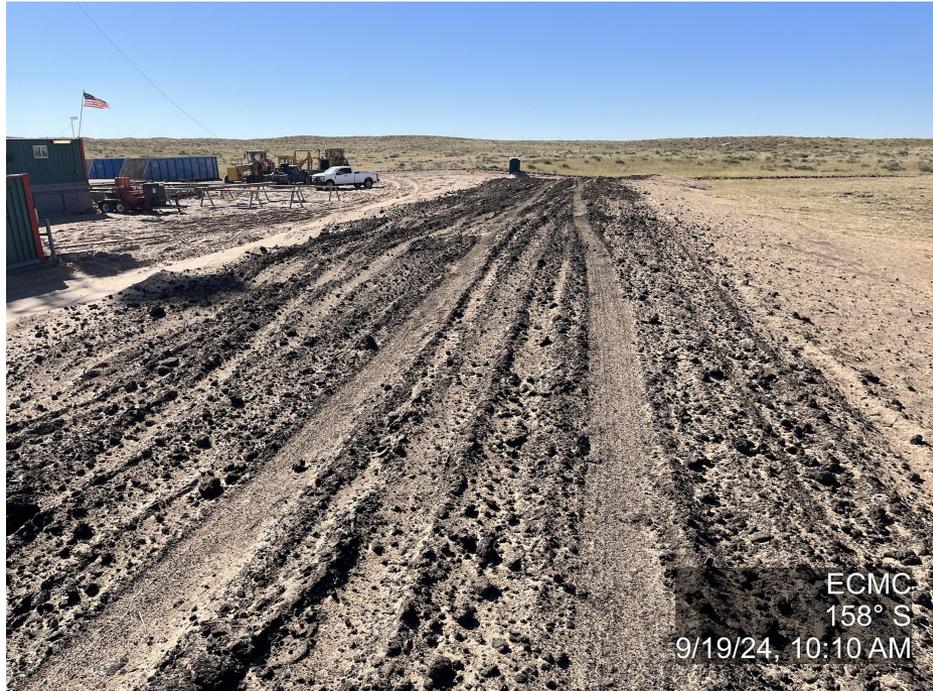
Photo 5. The photo was taken at the well location facing South. The photo illustrates manure has begun being spread along the crown of the topsoil stockpile but has yet to be spread along the slopes.

Note - Bare areas of soil across the well location are being affected by wind erosion.

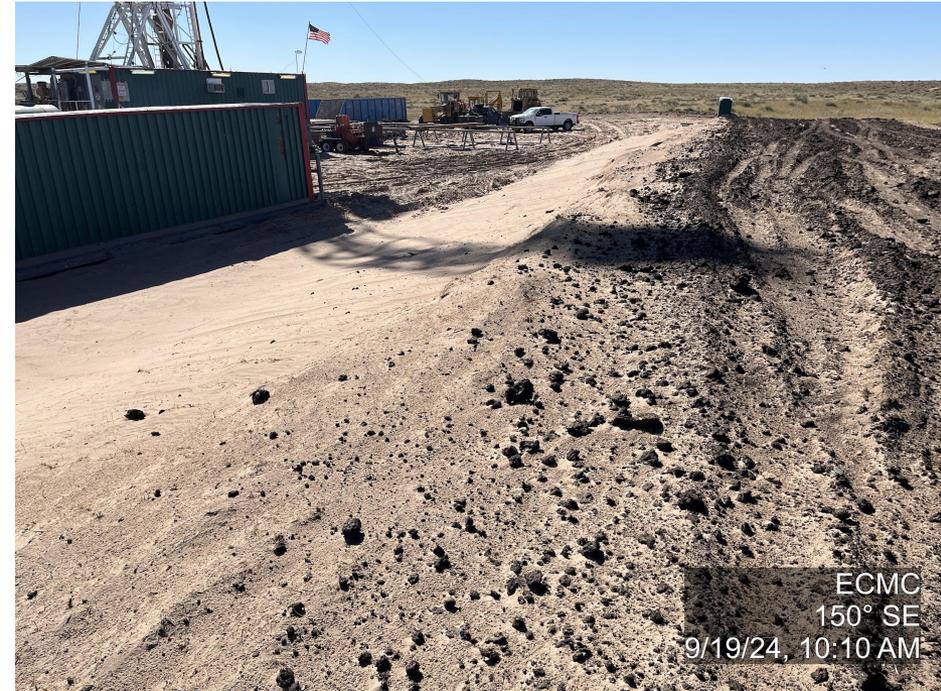
Photo 6. The photo was taken at the well location facing Southeast. Refer to the comment for photo 5.

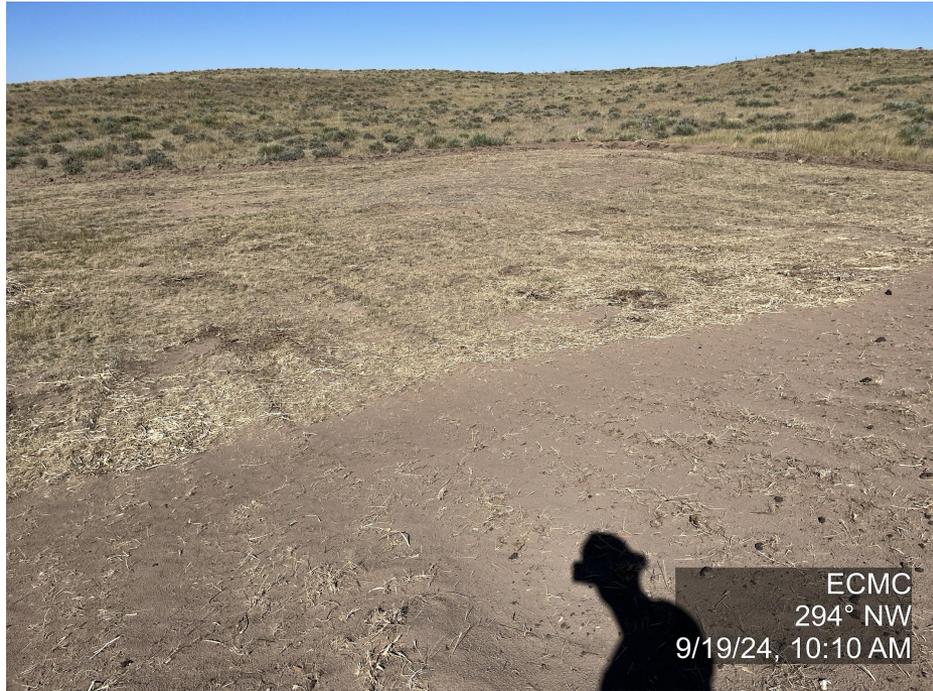
Photo 7. The photo was taken at the well location facing Northwest. The photo illustrates the Western side of the location has been mowed but is not being disturbed with topsoil segregation. Operator shall refrain from driving equipment and using these areas.

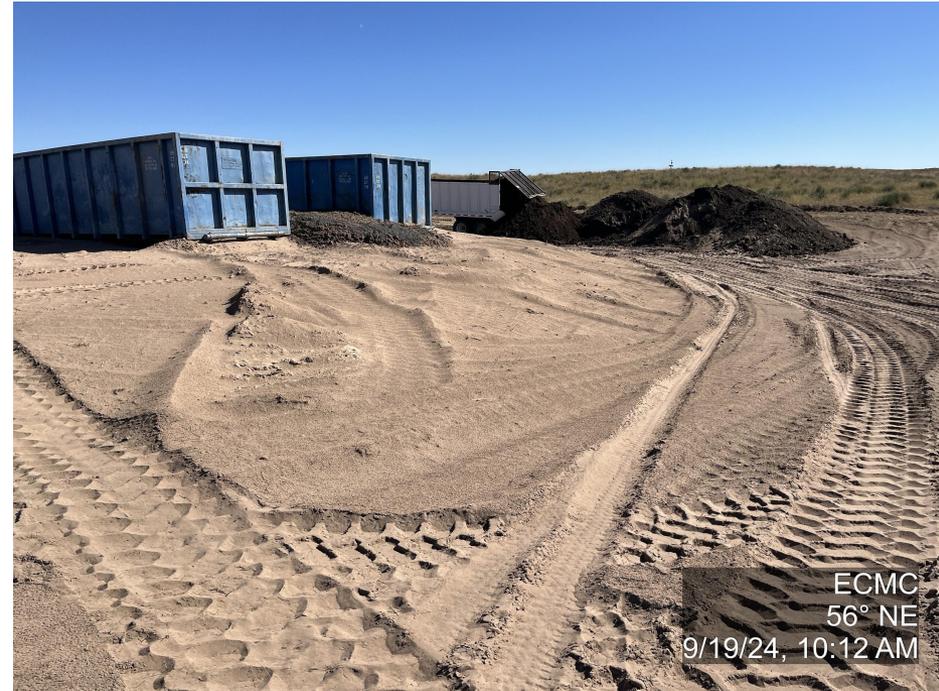
Photo 8. The photo was taken from the well location facing Northeast. The photo illustrates drilling mud containment indicated by the red arrow and manure stockpiling, indicated by the blue arrow.

Note - Operator shall install containment devices around drilling mud outside of blue highwall bins as talked about with representative during the inspection.

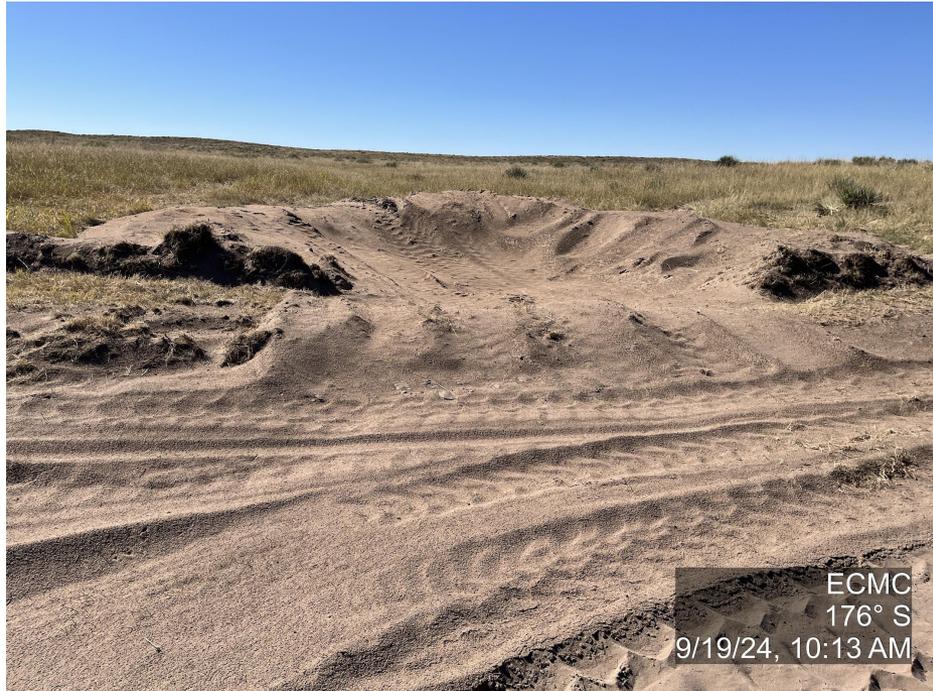
Photo 9. The photo was taken at the well location facing South. The photo illustrates the sediment trap in the Southeast corner of the location. The sediment trap should be stabilized with stormwater BMP's.

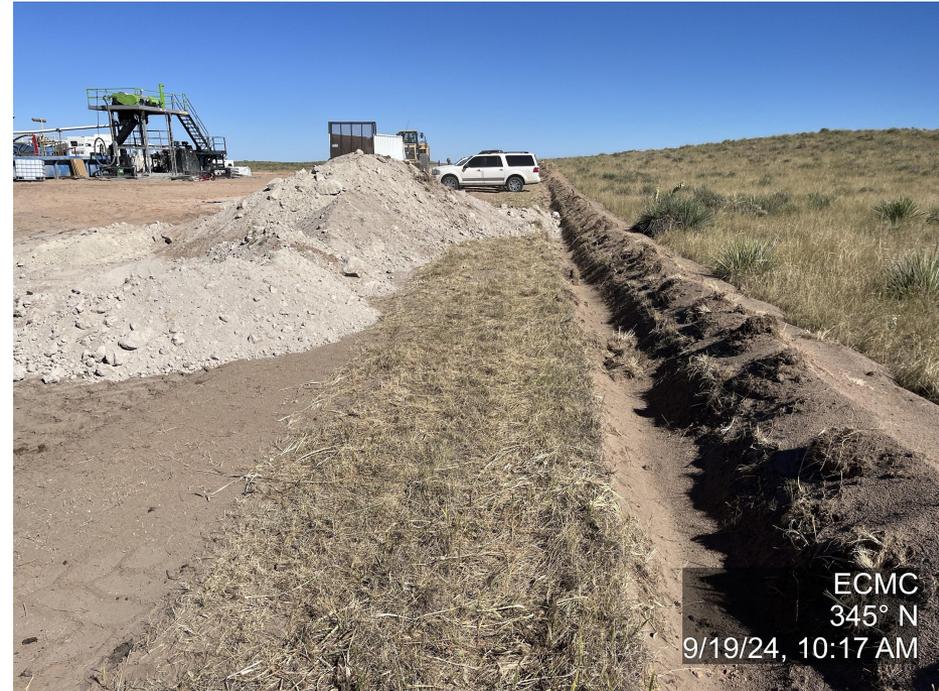
Photo 10. The photo was taken at the well location facing North. The photo illustrates the perimeter ditch and berm have deteriorated and need additional stabilization and continued cleaning out maintenance.

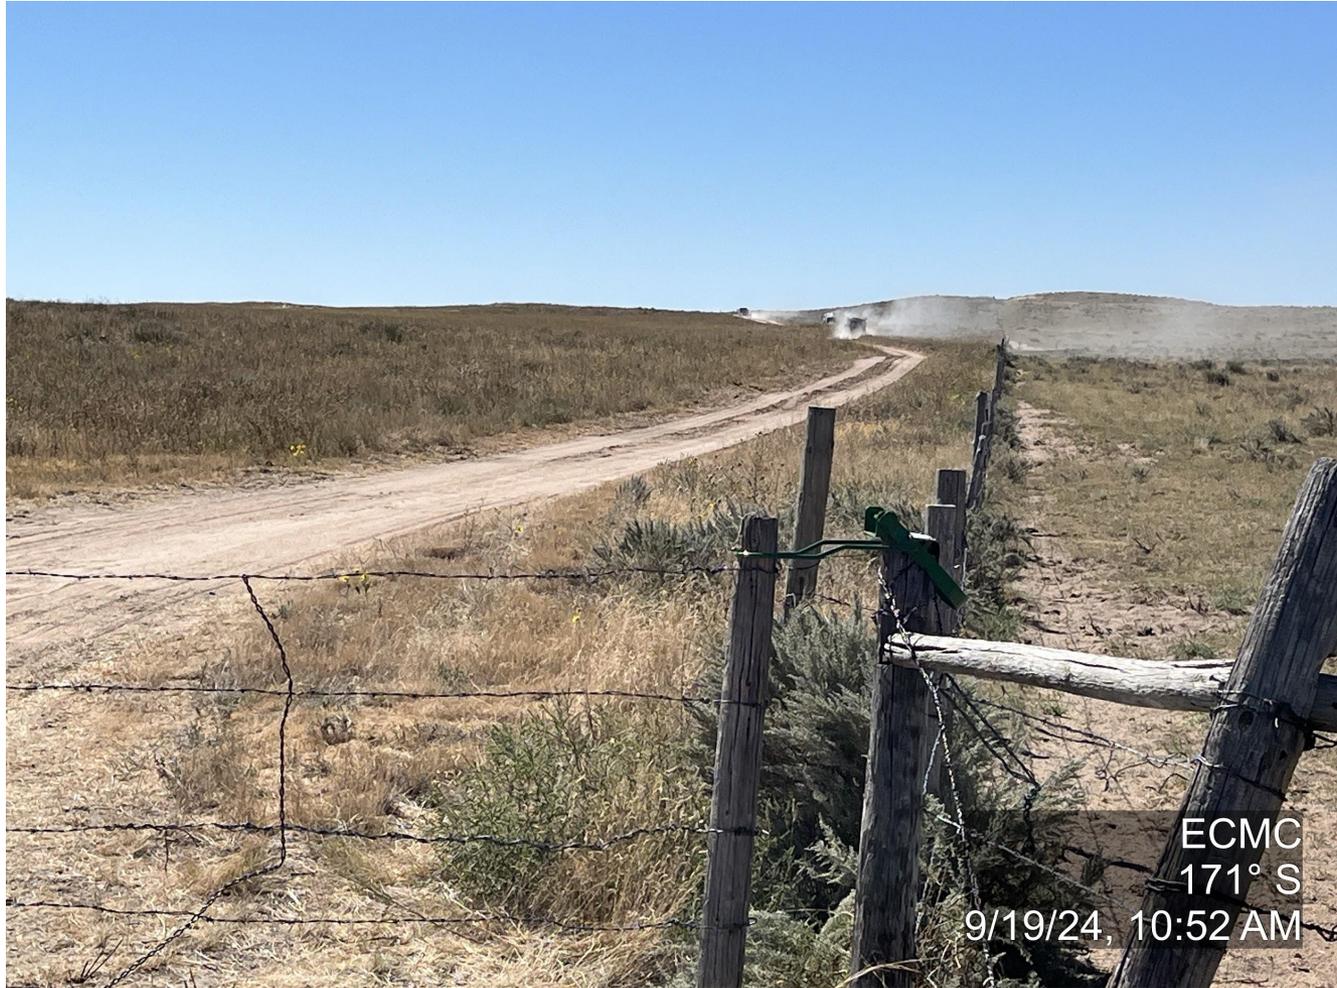
Photo 11. The photo was taken along the access road to the well location facing South. The photo illustrates wind erosion in the form of dust along the access road caused by truck traffic.
