# Interim Reclamation and Stormwater Inspection

Operator: PDC Energy Inc - 69175

Location ID: 447046

Location Name: Werning 01-02B, 08-03B,  
41-03B

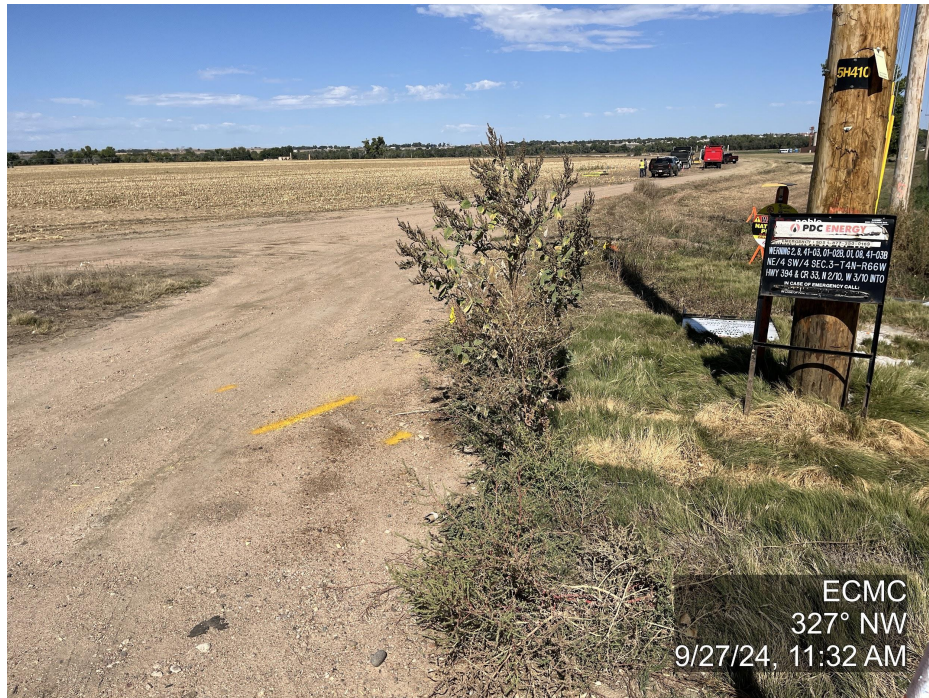
**Photo 1.** The photo was taken at the entrance to the tank battery location facing Northwest. The photo illustrates the Operator location sign.

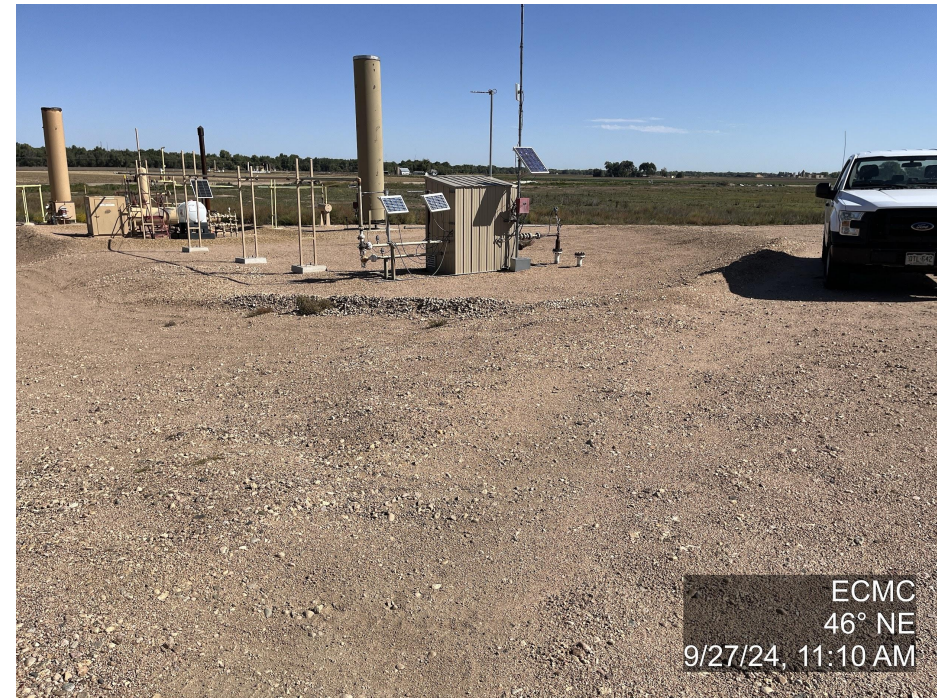
**Photo 2.** The photo was taken at the tank battery location facing Northeast. The photo illustrates the South side of the tank battery facility.

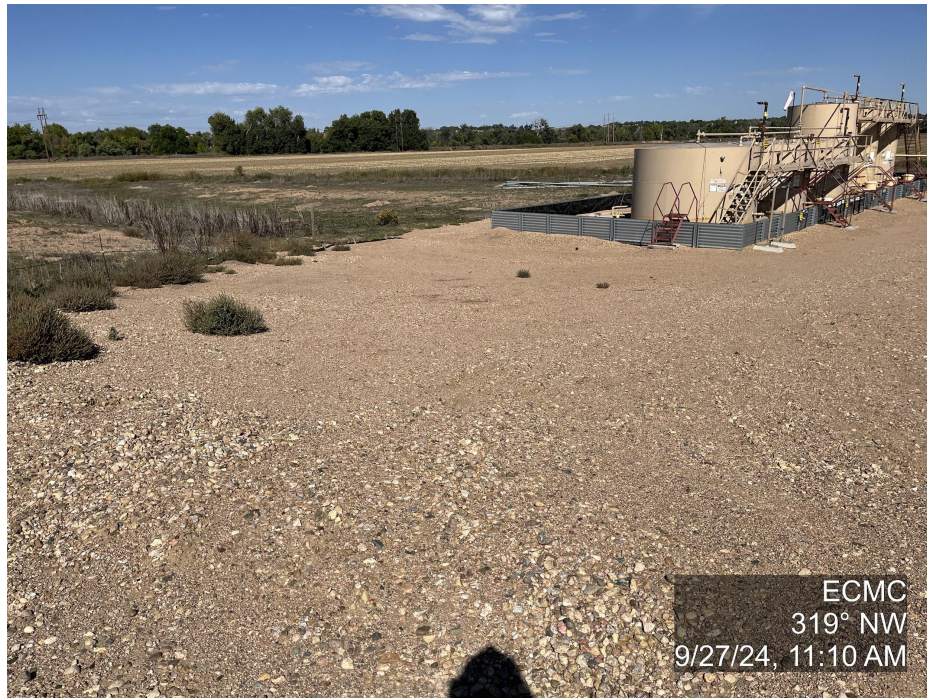
**Photo 3.** The photo was taken at the tank battery location facing Northwest. The photo illustrates the West side of the tank battery facility with tumbleweed growth along the fenceline.

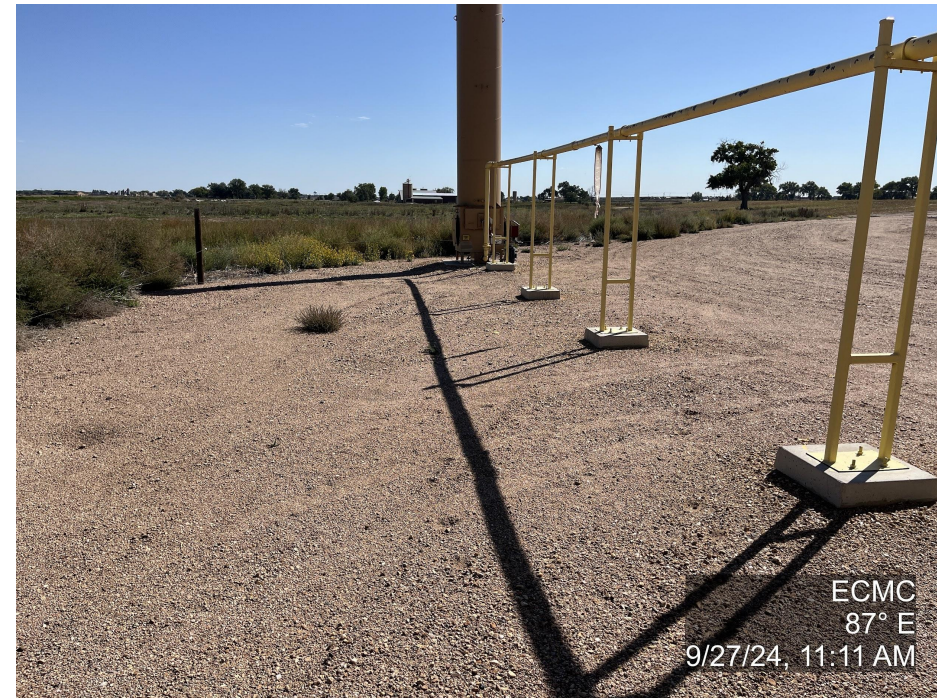
**Photo 4.** The photo was taken at the tank battery location facing East. The photo illustrates the North side of the tank battery facility with tumbleweed growth along the fenceline.

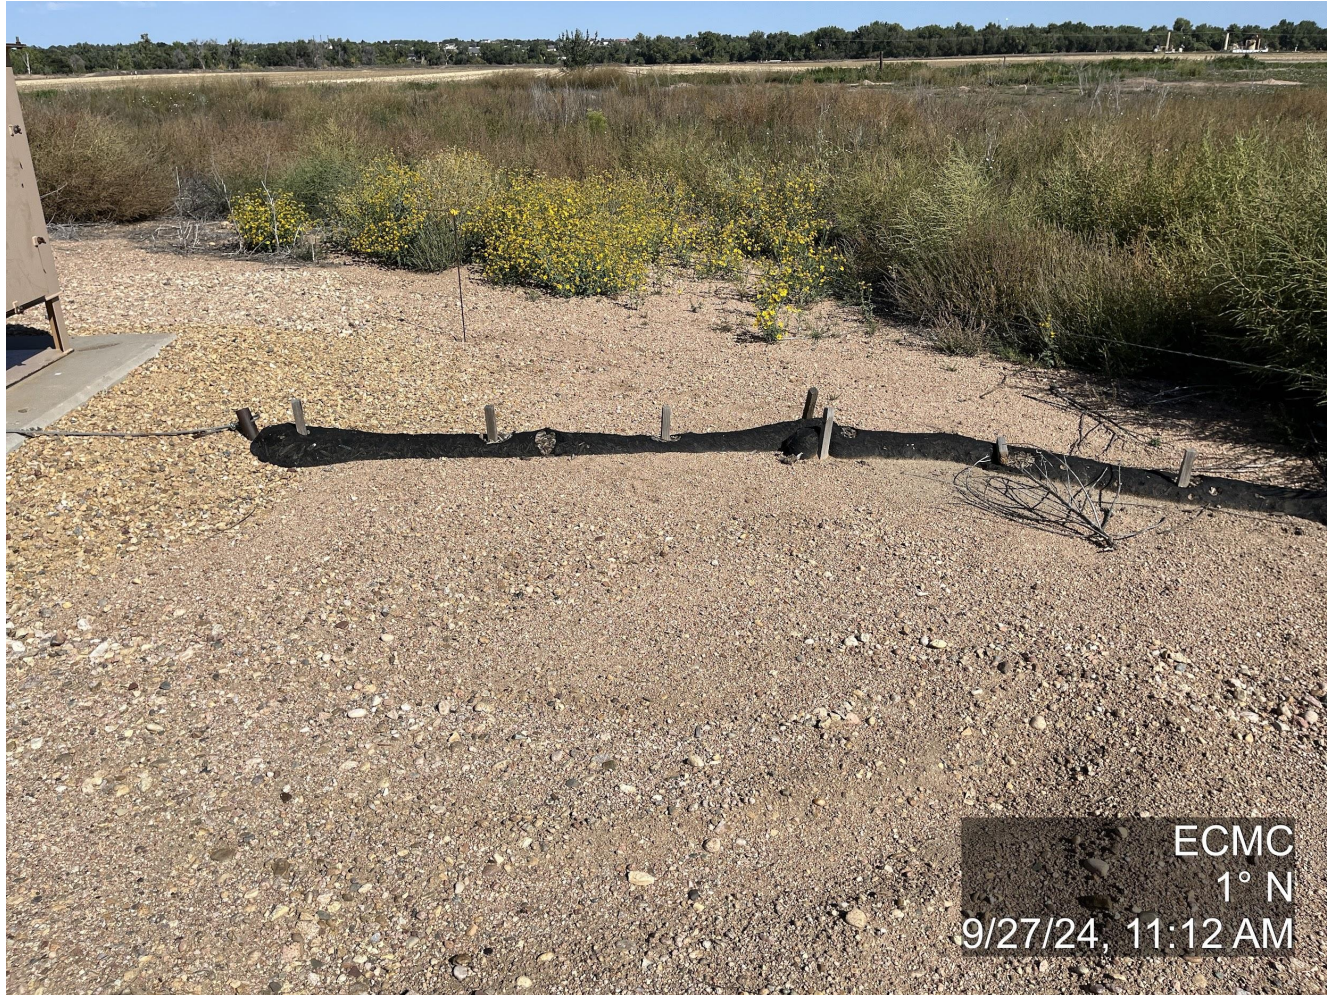
**Photo 5.** The photo was taken at the tank battery facility facing North. The photo illustrates wattle on the North side of the pad that needs repaired or replaced.

Note - The photo is representative for wattle on the West side that needs maintenance.

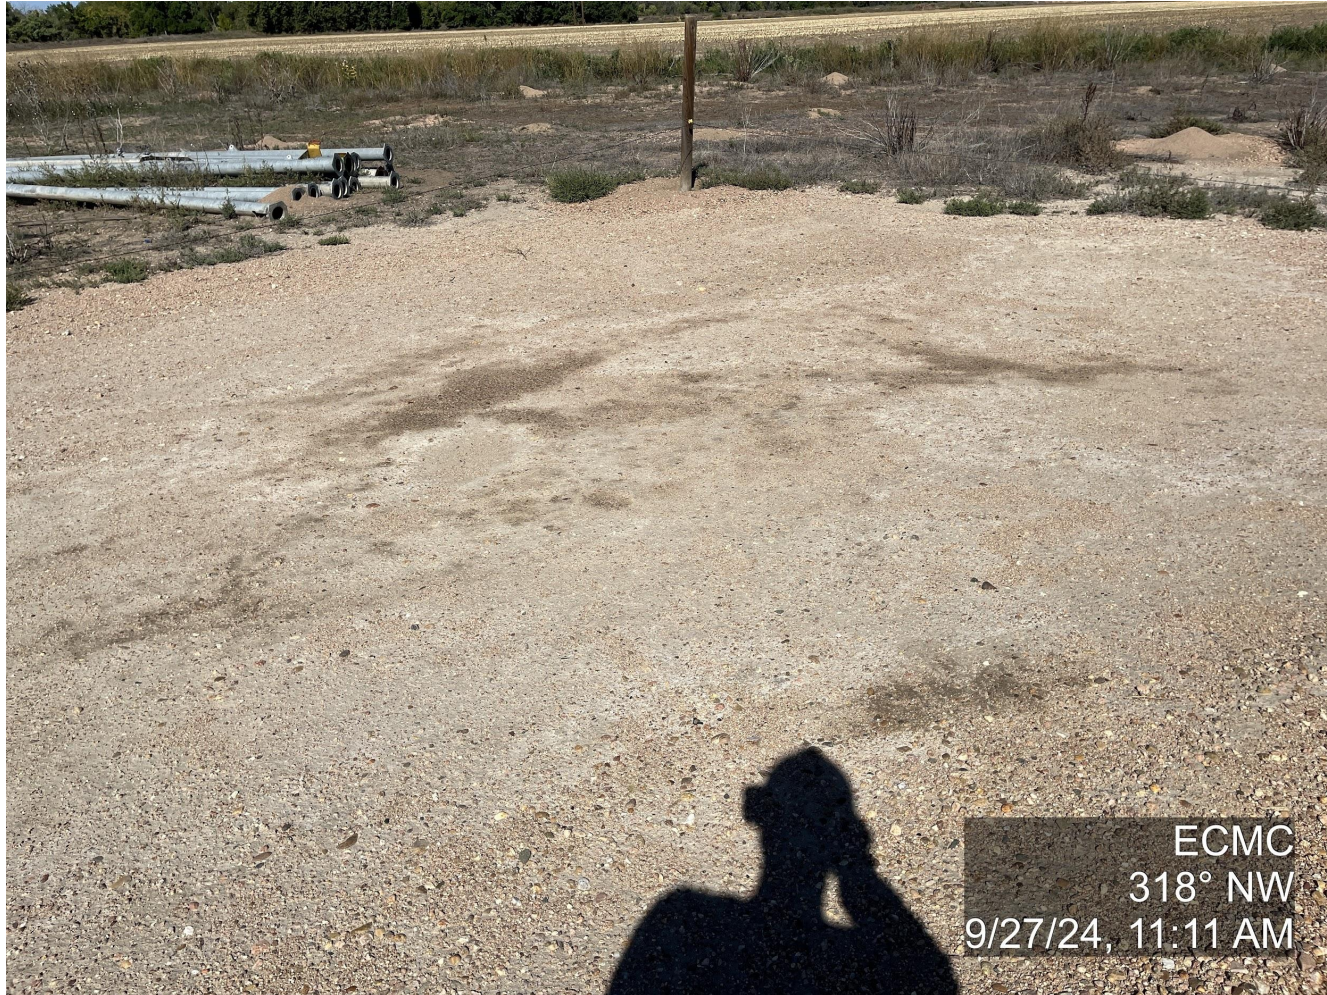
**Photo 6.** The photo was taken at the tank battery facility facing Northwest. The photo illustrates stained soil on the production pad.
