Inspection Photos

Operator: LARAMIE ENERGY LLC #10433

Location ID: 334427

Inspection Doc: 696206341

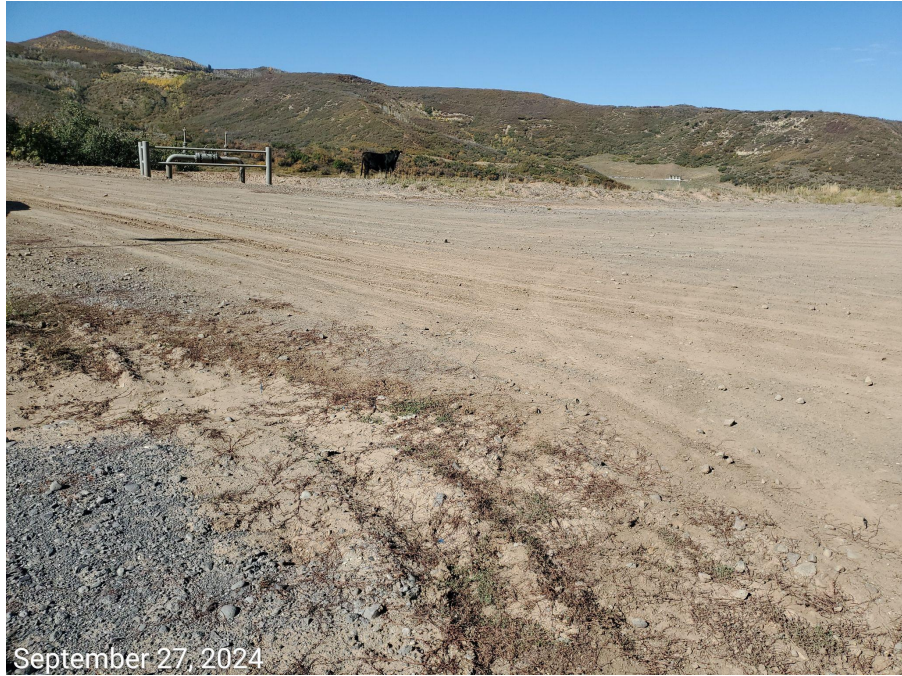
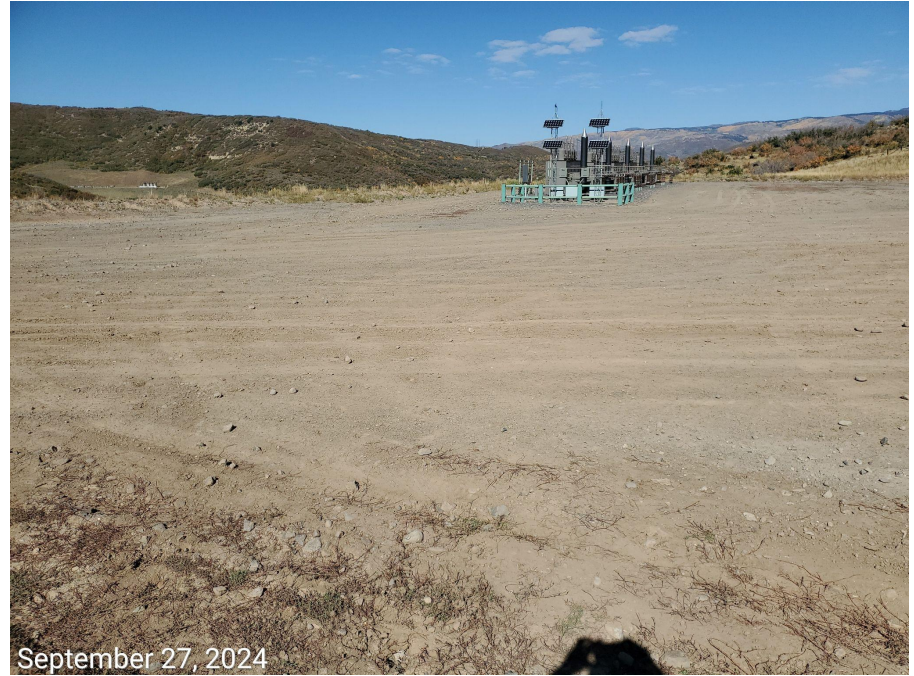
Photo 1: Photo 1-2 taken from the south end of the Location. Photos provide an overview of the Location from west, northwest, northeast to east.

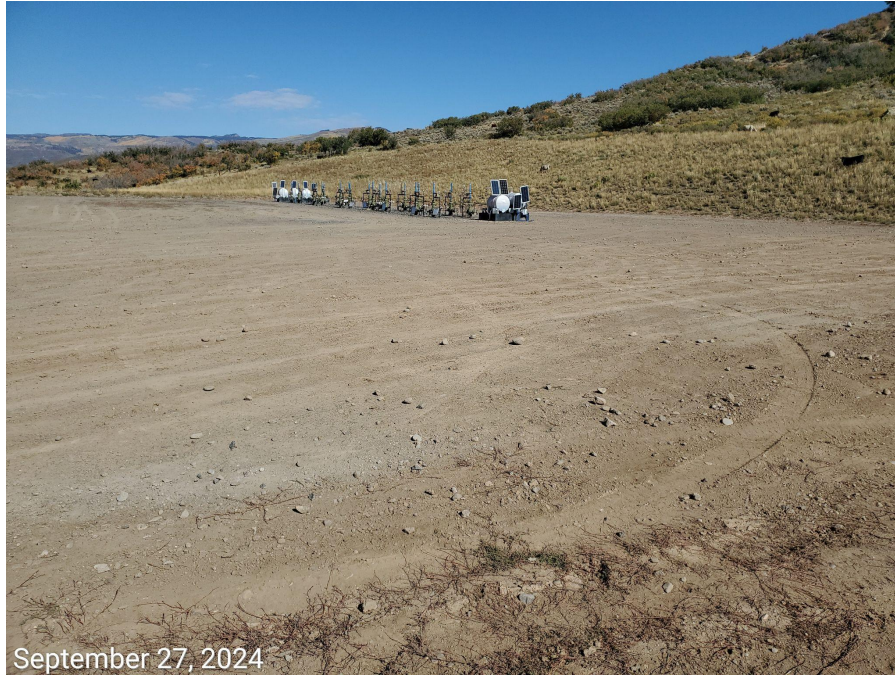
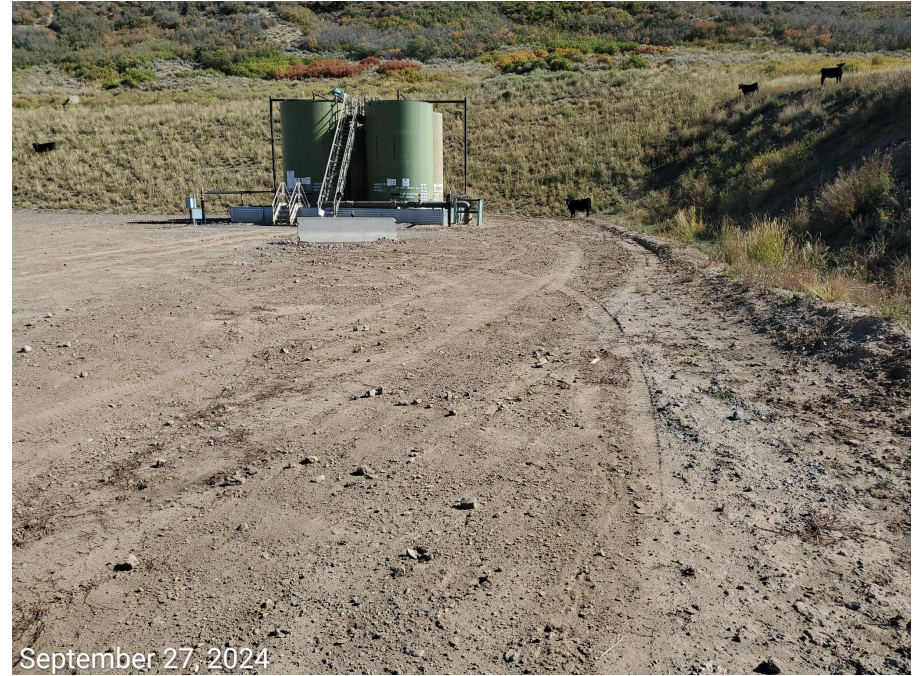
Photo 2: See comments under photo 1.

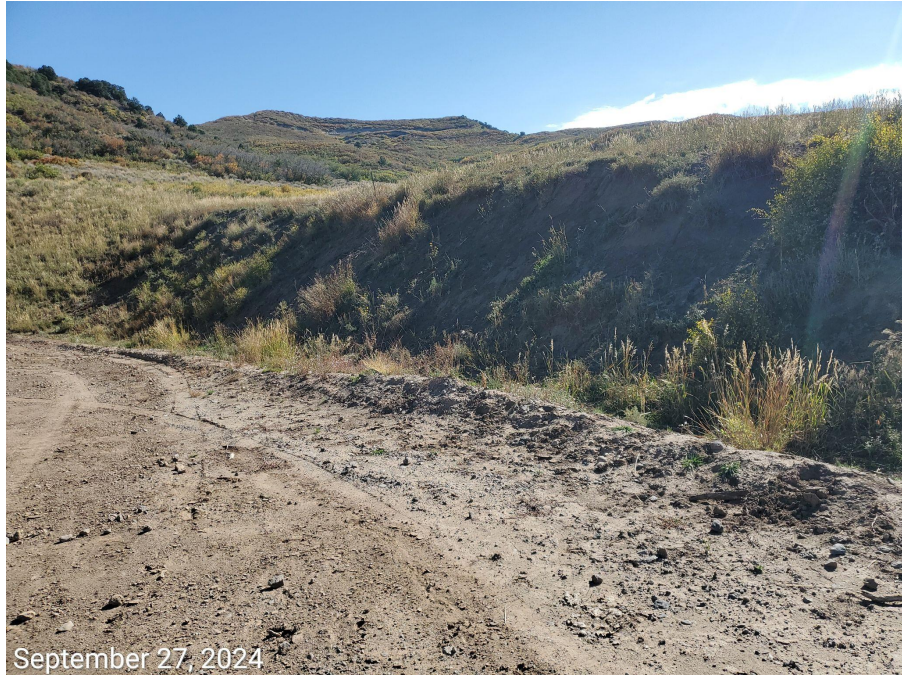
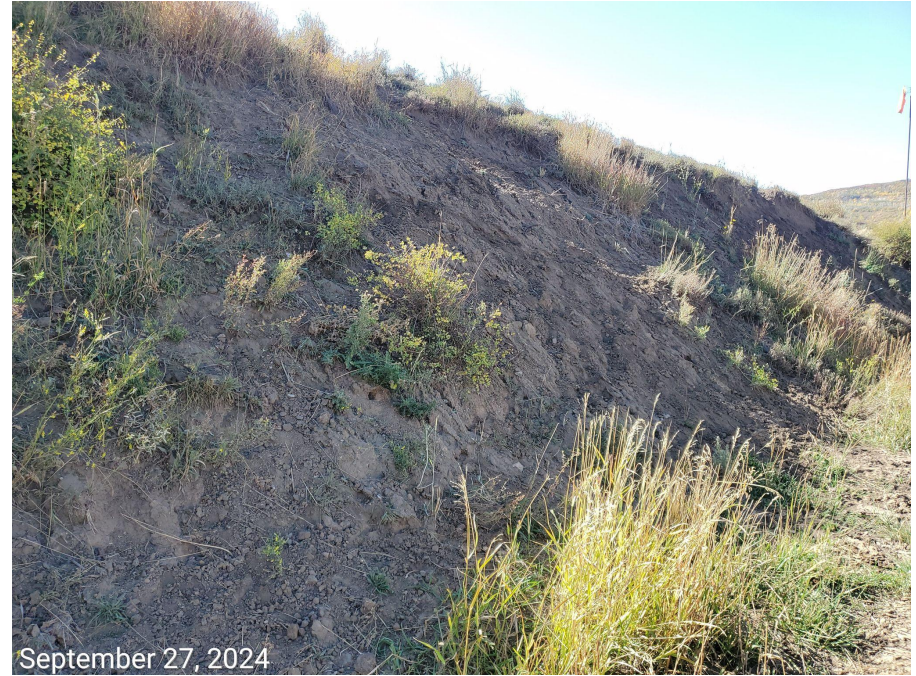
Photo 3: Photos taken from the southeast/east ends of the Location. Photo shows interim areas/slopes that are not progressing towards 1003 revegetation requirements; slopes remain predominantly bare; erosion degradation also observed.

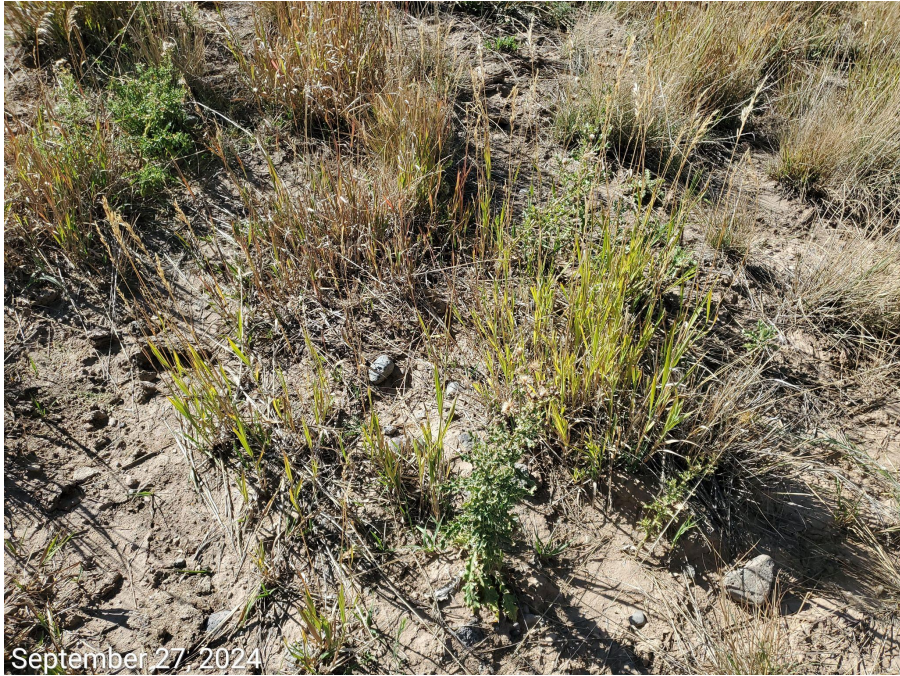
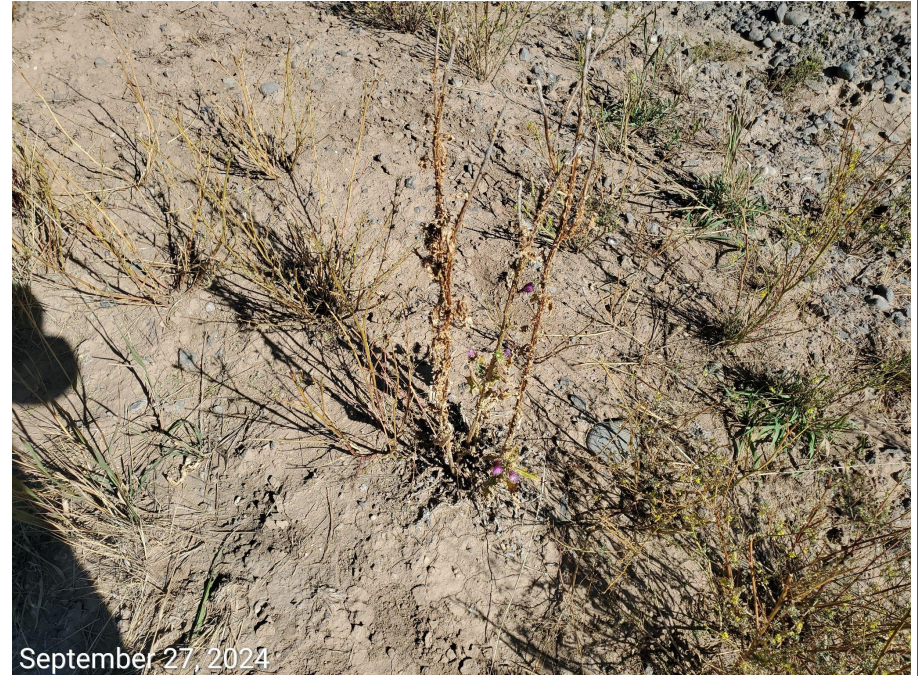
Photo 4: Photos examples showing Noxious weeds (Canada Thistle, photo left; Musk thistle, photo right) observed within the interim areas of the Location, and along access road. Weed management efforts are apparent, however plants observed are still alive.

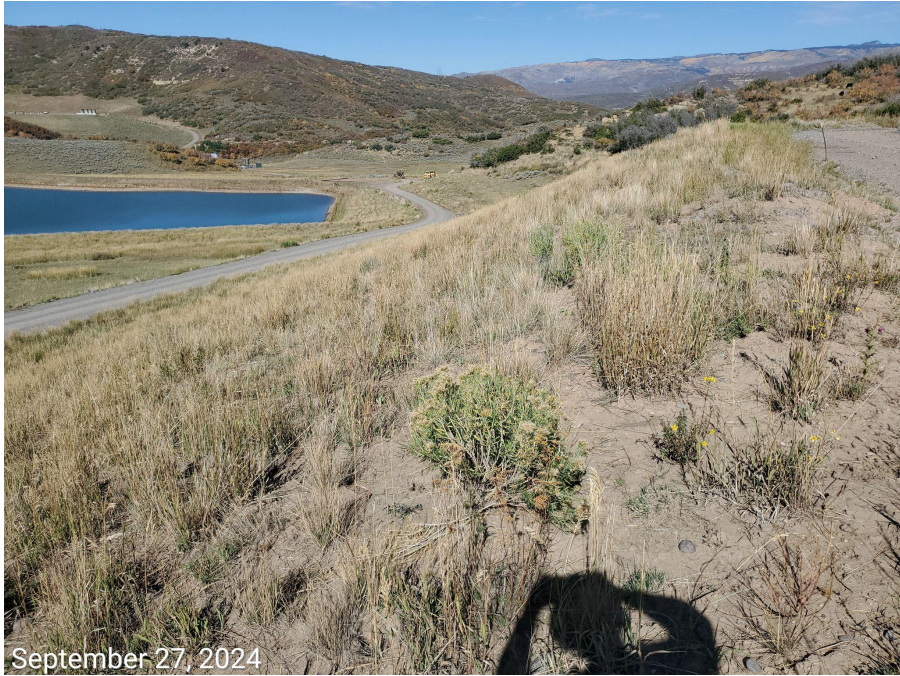
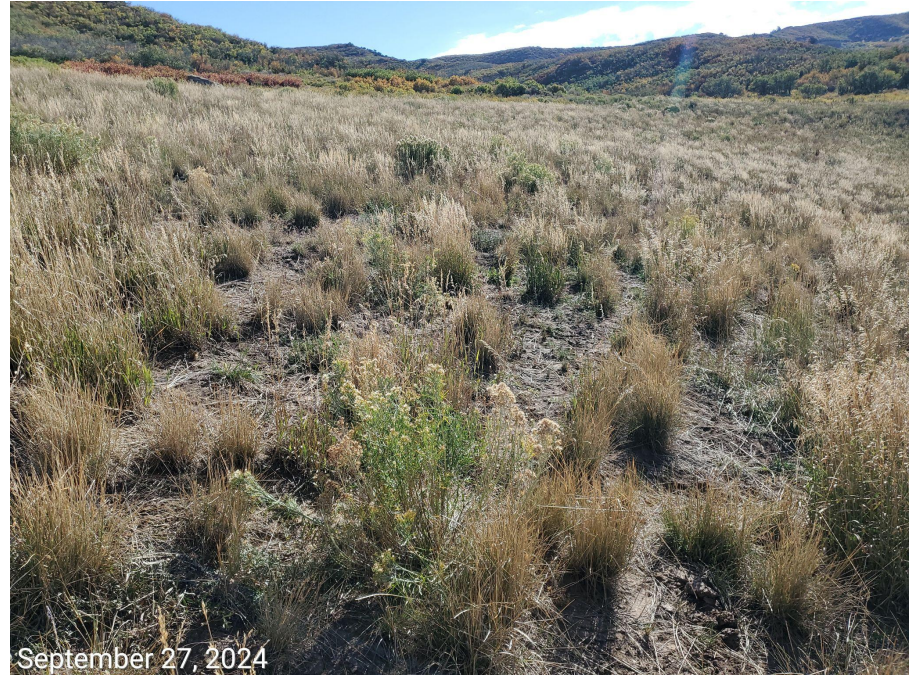
Photo 5: Photos examples showing interim areas on the west and east end of the location- Areas are progressing towards 1003 standards.
