Inspection Photos

Operator: TEP ROCKY MOUNTAIN LLC #96850

Location ID: 335424

Inspection Doc: 696206373

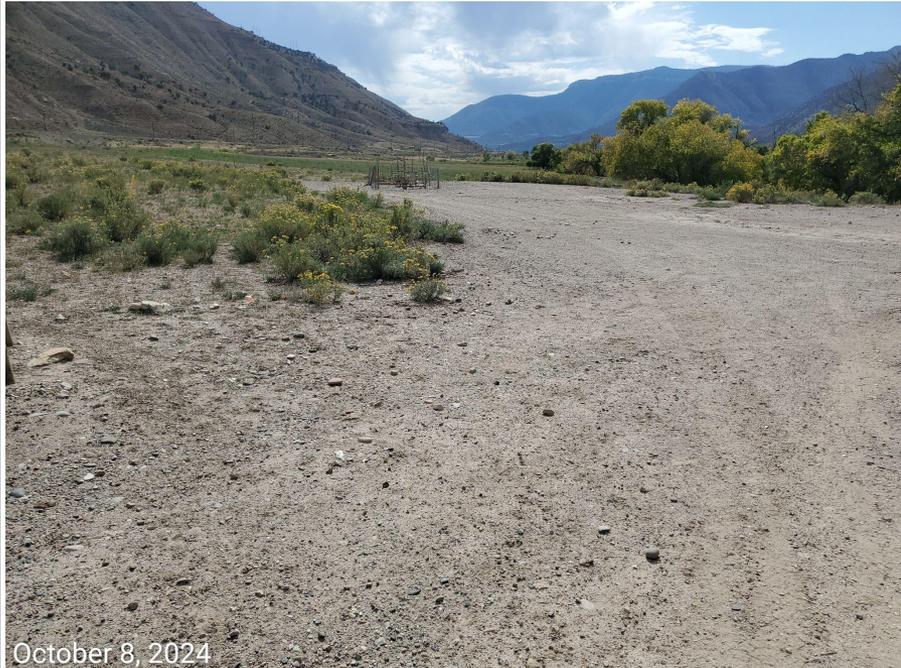
Photo 1: Operator appears to have performed grading operations to address tracking and stabilization concerns. Unclear if controls are adequate to address the tracking and stabilization concerns during wet conditions.

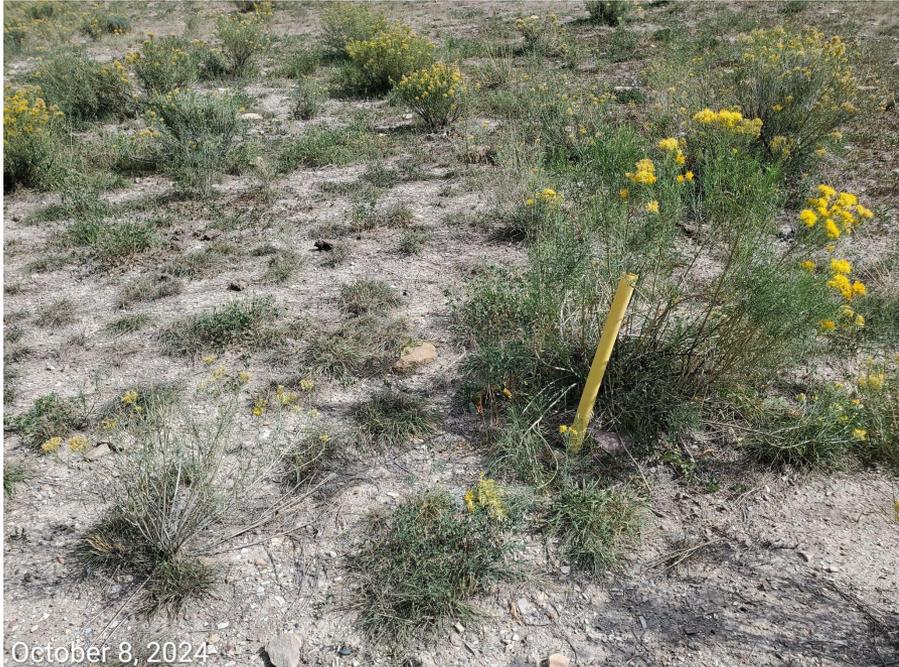
Photo 3: Anchor markers do not comport with 603.j/1003.a requirements.
