Inspection Photos

API: 009-06612

Operator: **CHOLLA PRODUCTION LLC**

Inspection Date: 10/14/2024

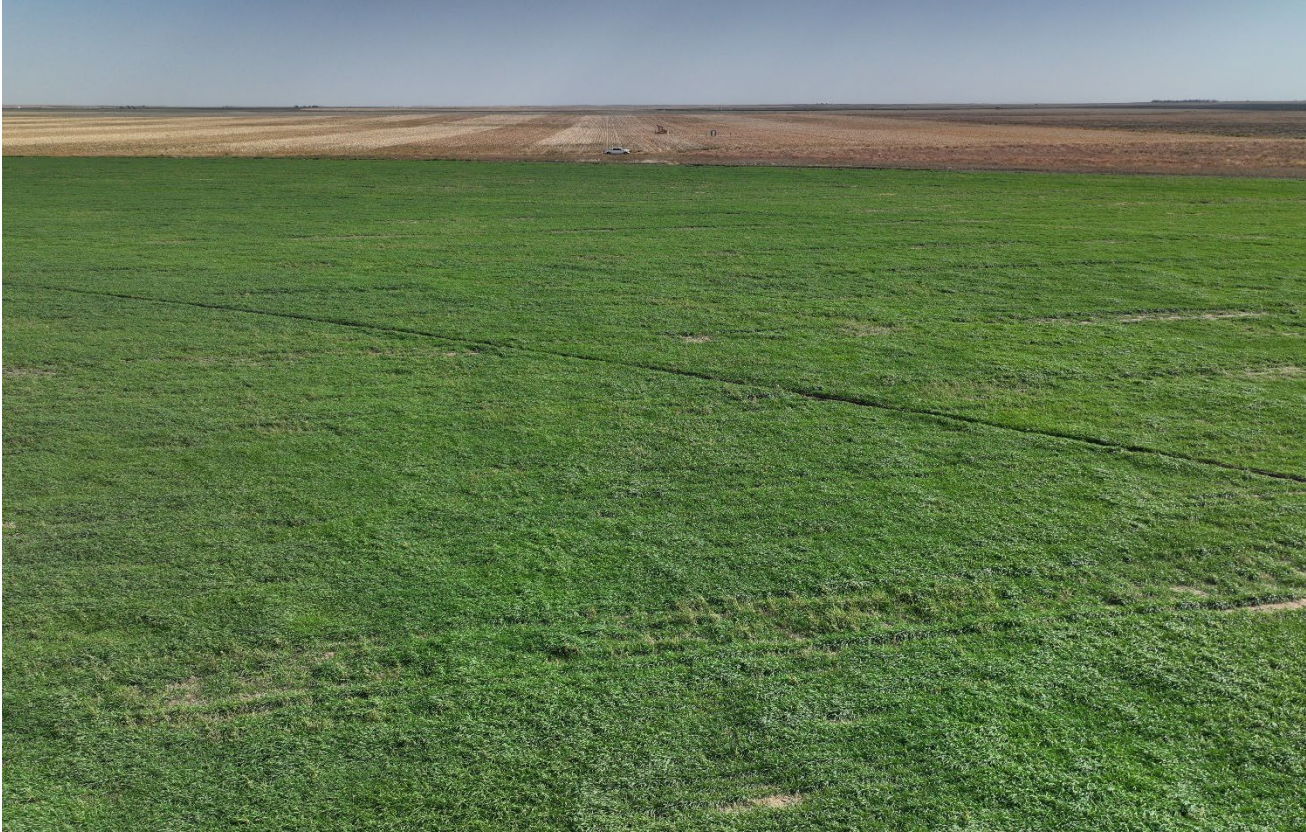
Photo 1. Drone aerial photo facing east. The winter wheat crop appears to be uniformly re-established.

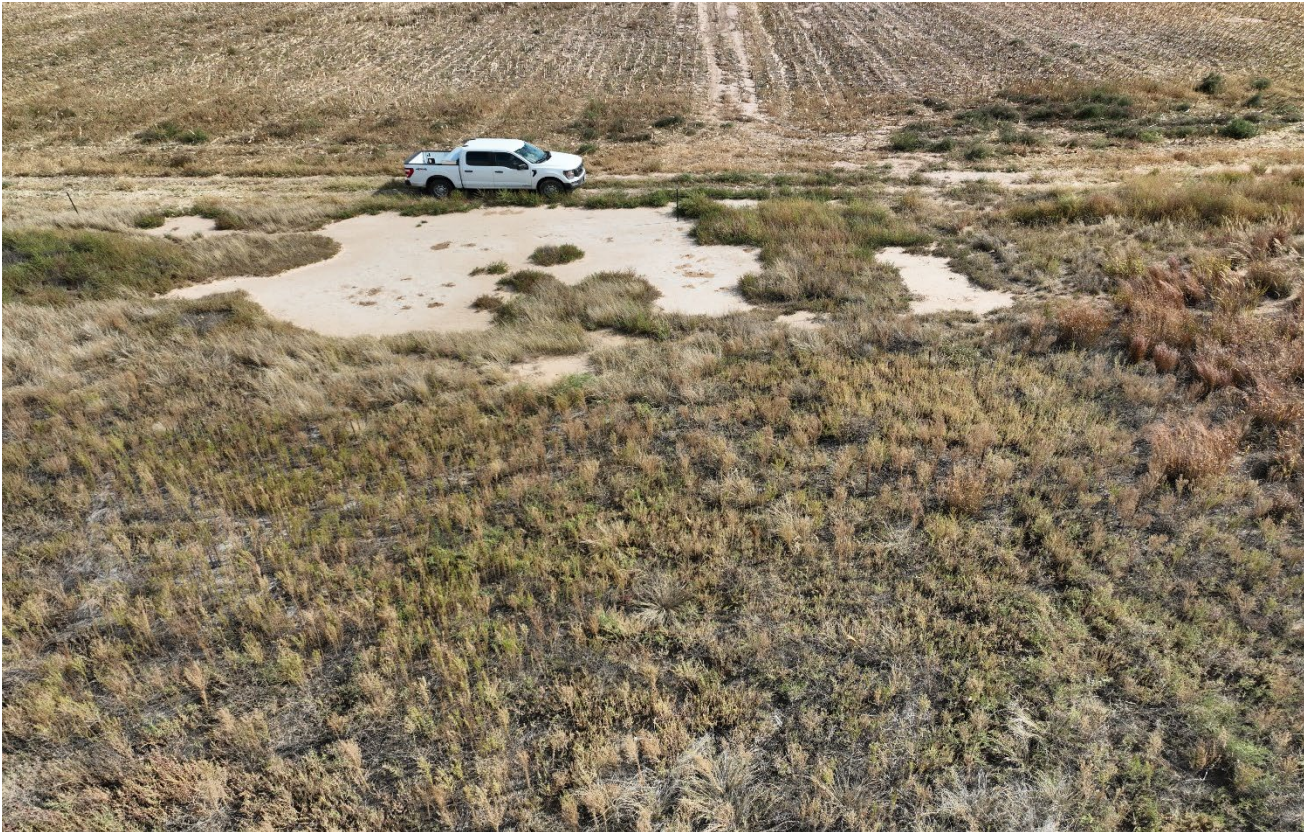
Photo 2. Drone aerial photo facing east. The former tank battery site next to the two track road 600' east of the wellsite. There appears to be impacted soils from the associated tank battery.

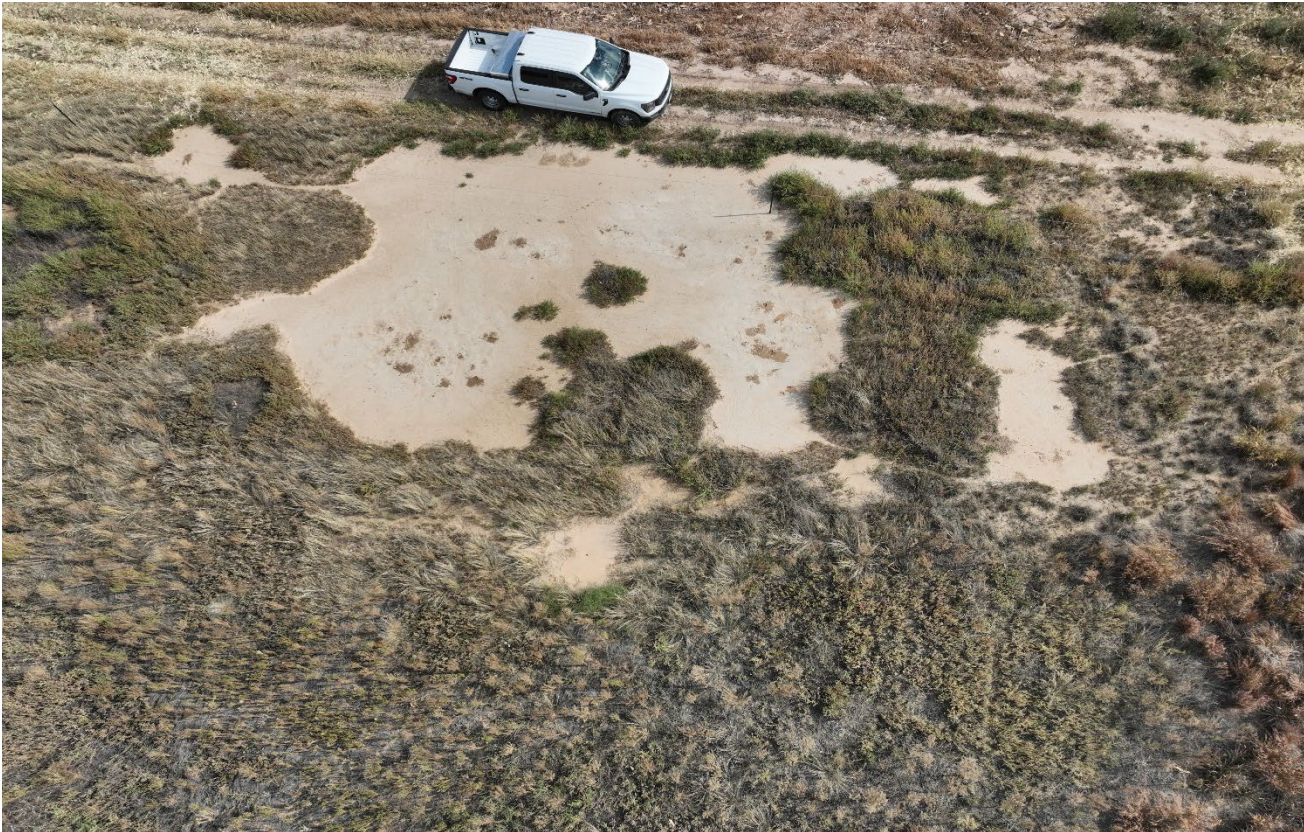
Photo 3. Facing down toward the associated facility location.. There are impacted soils that will need to be remediated.
