Inspection Photos

API: 009-06215

Operator: **SOVEREIGN OPERATING COMPANY LLC**

Inspection Date: 10/14/2024

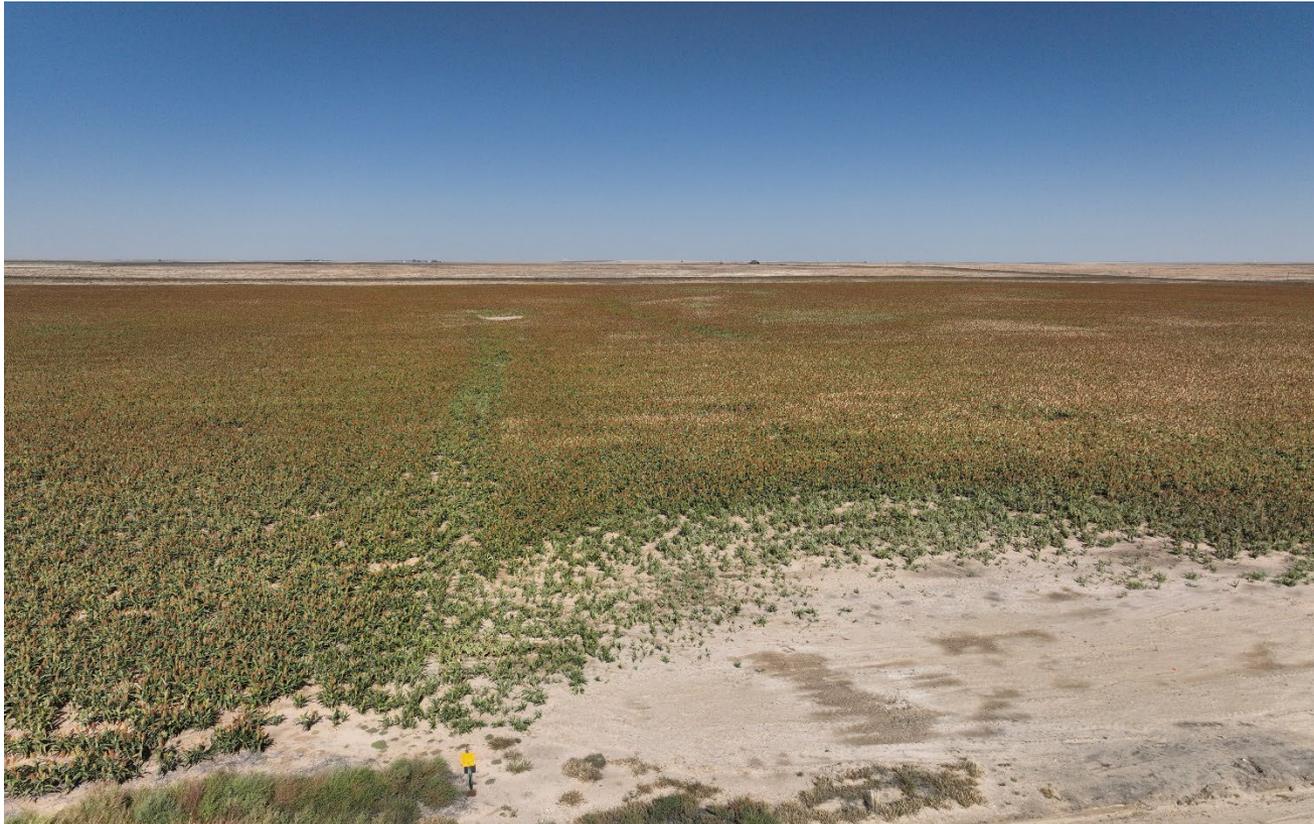
Photo 1. Drone aerial photo facing northeast at the associated tank battery location adjacent to the County Road. The crop has not established at the former tank battery. There appears to be impacted soils that will need to be remediated.

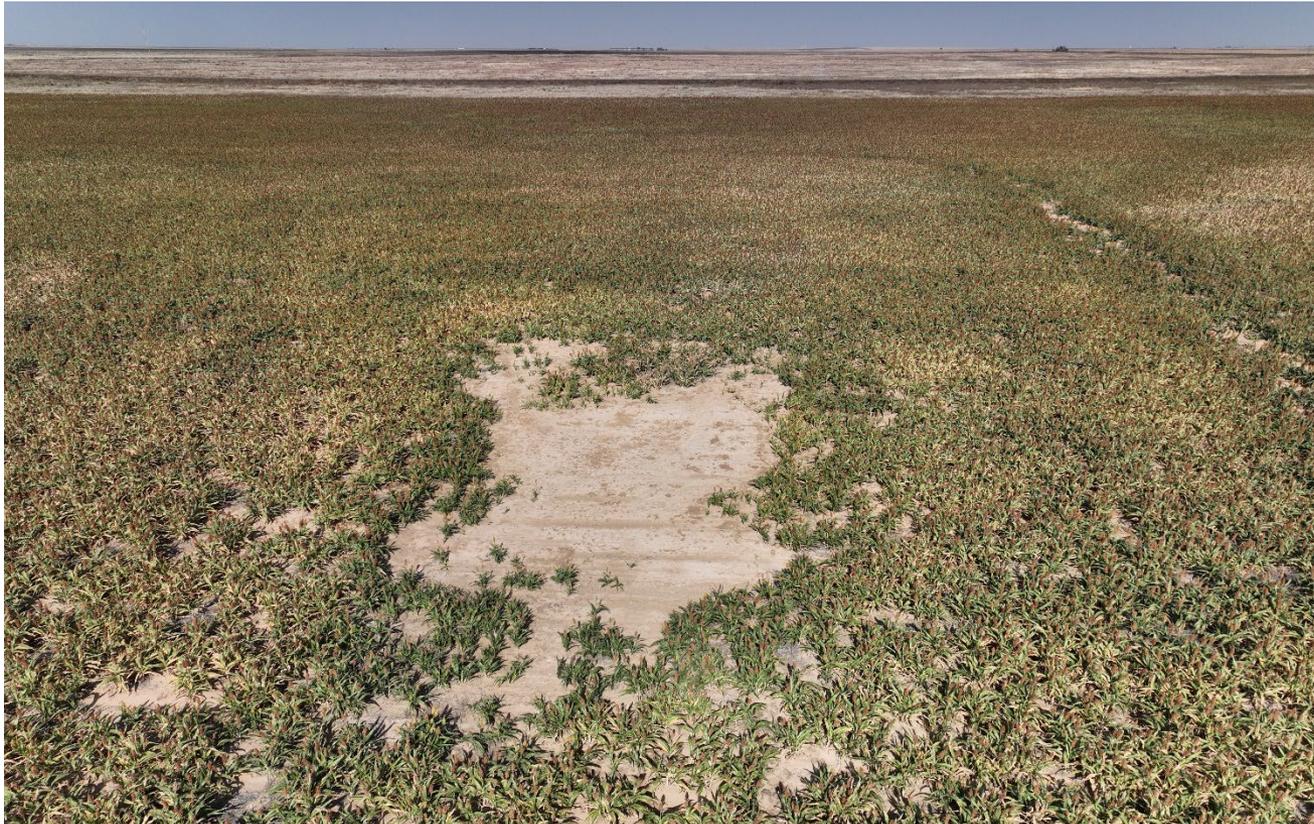
Photo 2. Drone aerial photo facing north. The crop has not established at the former wellsite. There appears to be impacted soils that will need to be remediated.

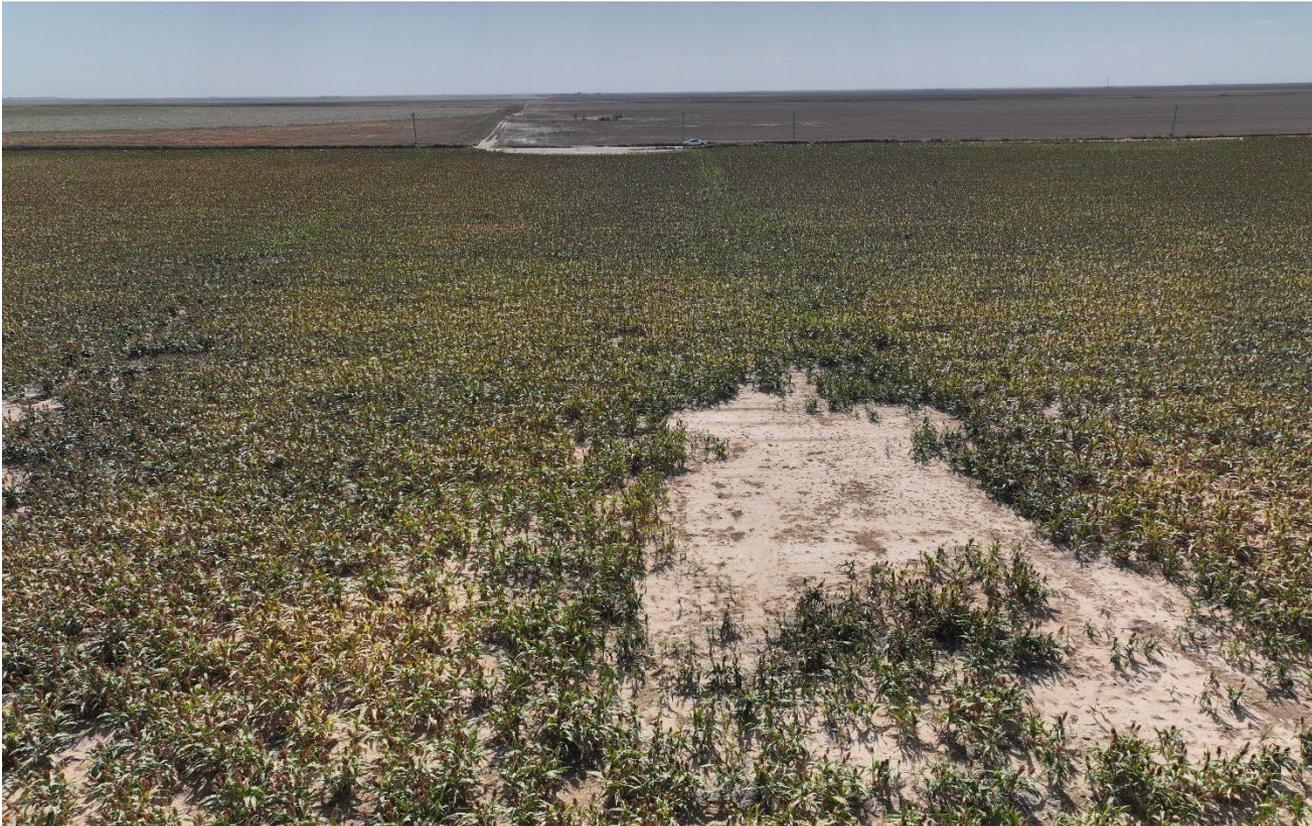
Photo 3. Drone aerial photo facing south. The crop has not established at the former wellsite. There appears to be impacted soils that will need to be remediated.
