Storm Water Management and Erosion control
Location Name: TEP ROCKY MOUNTAIN LLC Duggan RWF 11-32
Location ID: 324118

Location Overview: Location is within High Priority/Density/Black Bear Habitat areas/Bald Eagle Nest Site & in close proximity to NSO Habitat area & Bald Eagle Roost Site. Location is approximately 207 yards from Cache Creek.

Section/Township/Range: 32 6S94W

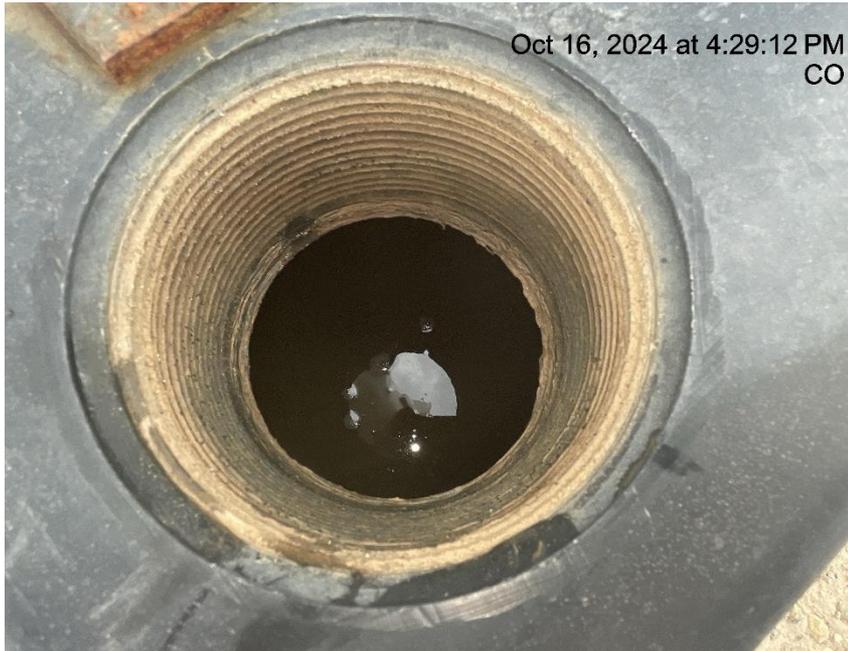
Photo # 6507 Failure to maintain chemical BMP - Chemical tank containment approximately 3/4th full of fluid/BMP insufficient to contain possible spill

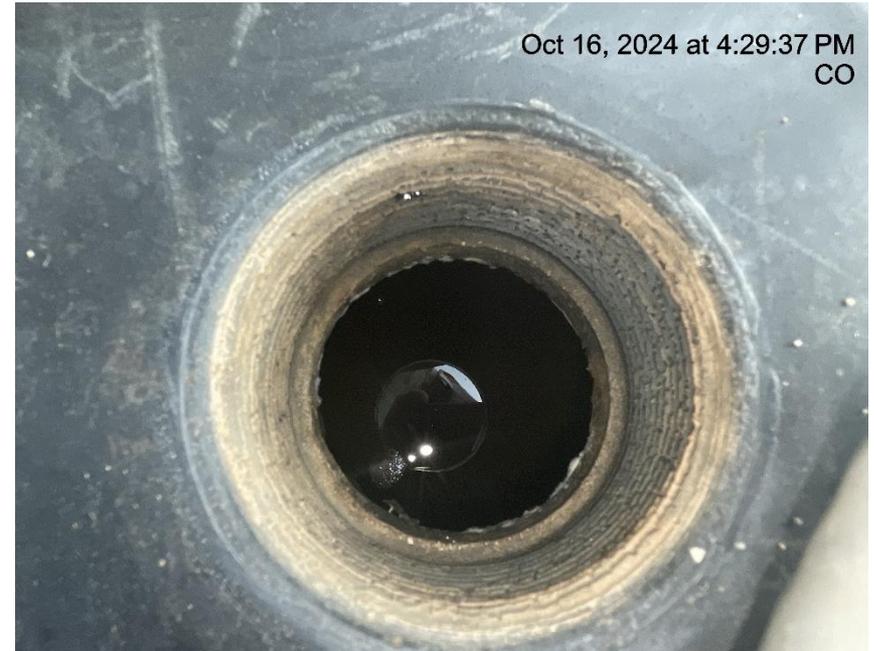
Photo # 6508 Failure to maintain chemical BMP - Chemical tank containment approximately 3/4th full of fluid/BMP insufficient to contain possible spill
