Inspection Photos

Operator: BMG Drilling Corporation - 7650

Location ID: 428734

Inspection Photos
Location Name: Jacques 2
Location ID: 428734

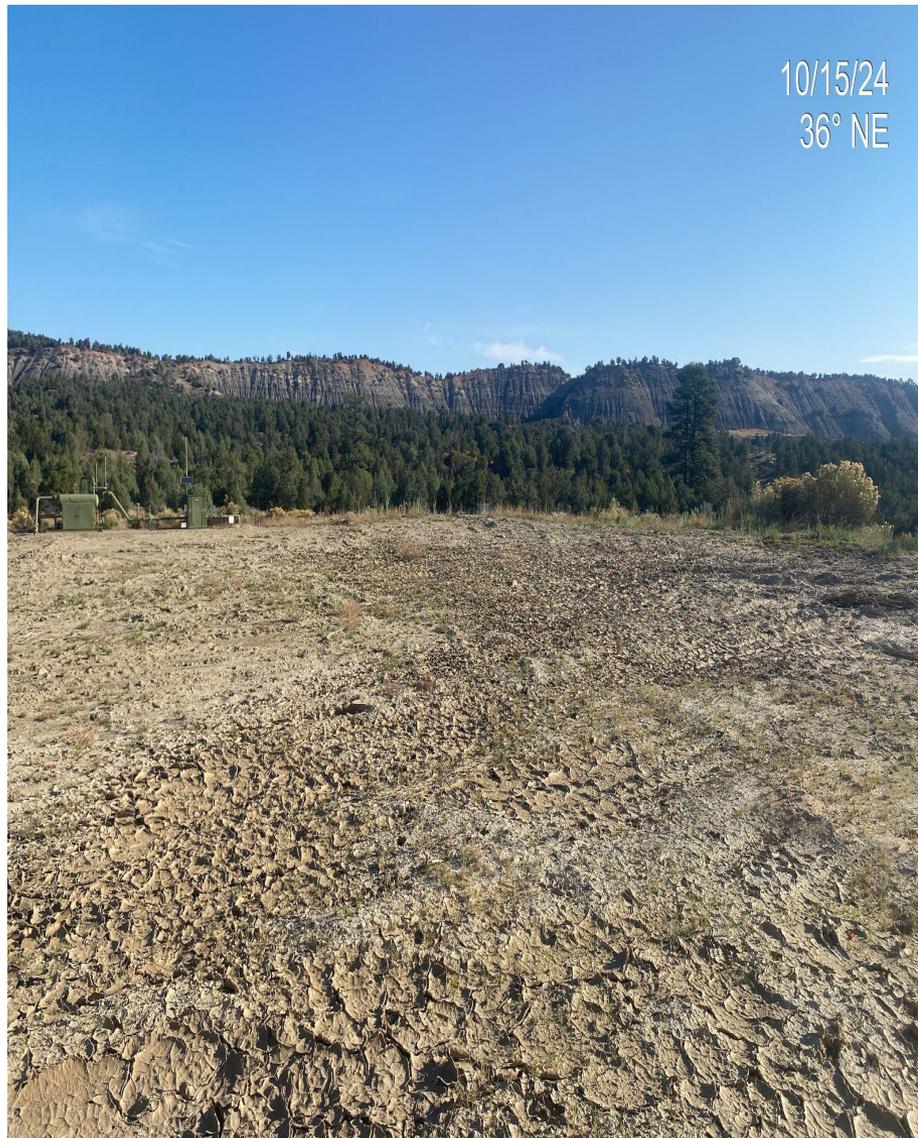
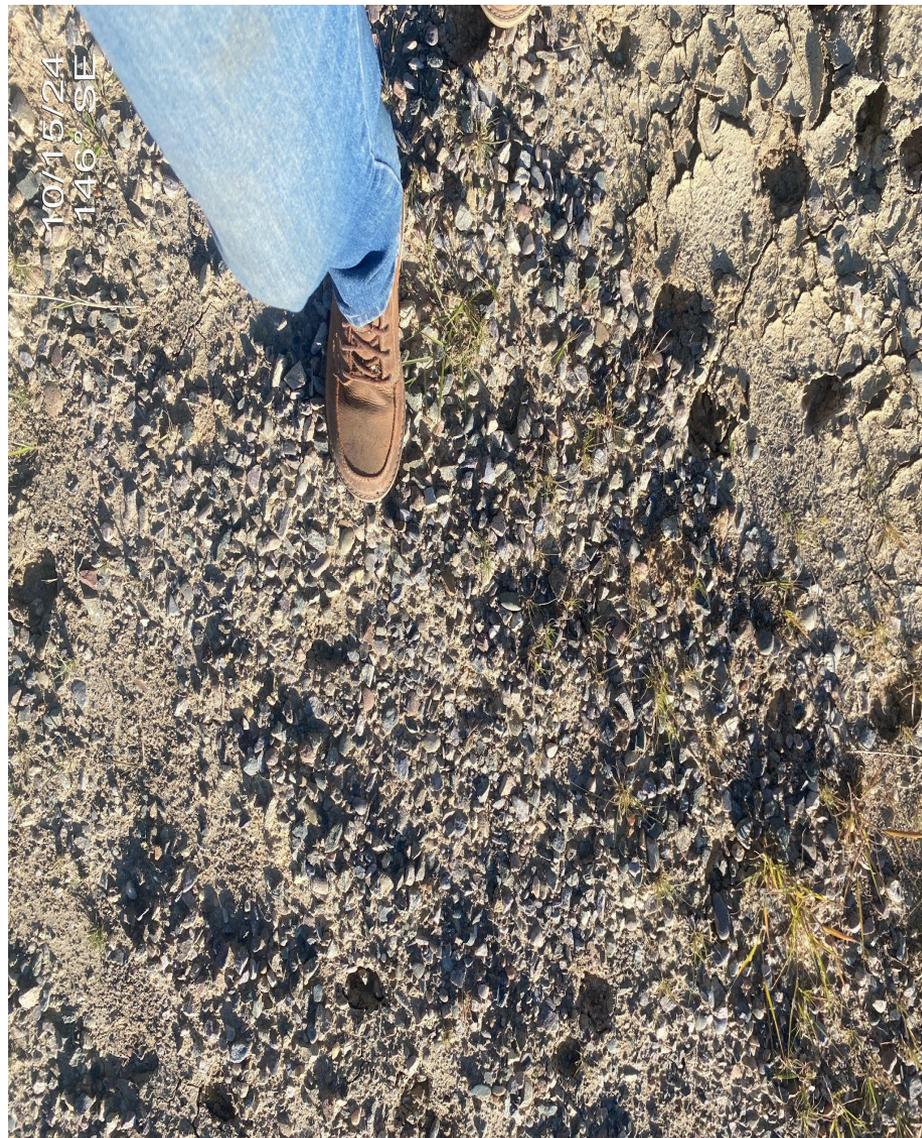
Photo 2. View of the northeast corner of the disturbance. Vegetation establishment is minimal in this area compared to other reclaimed portion. Remnant gravel also observed.

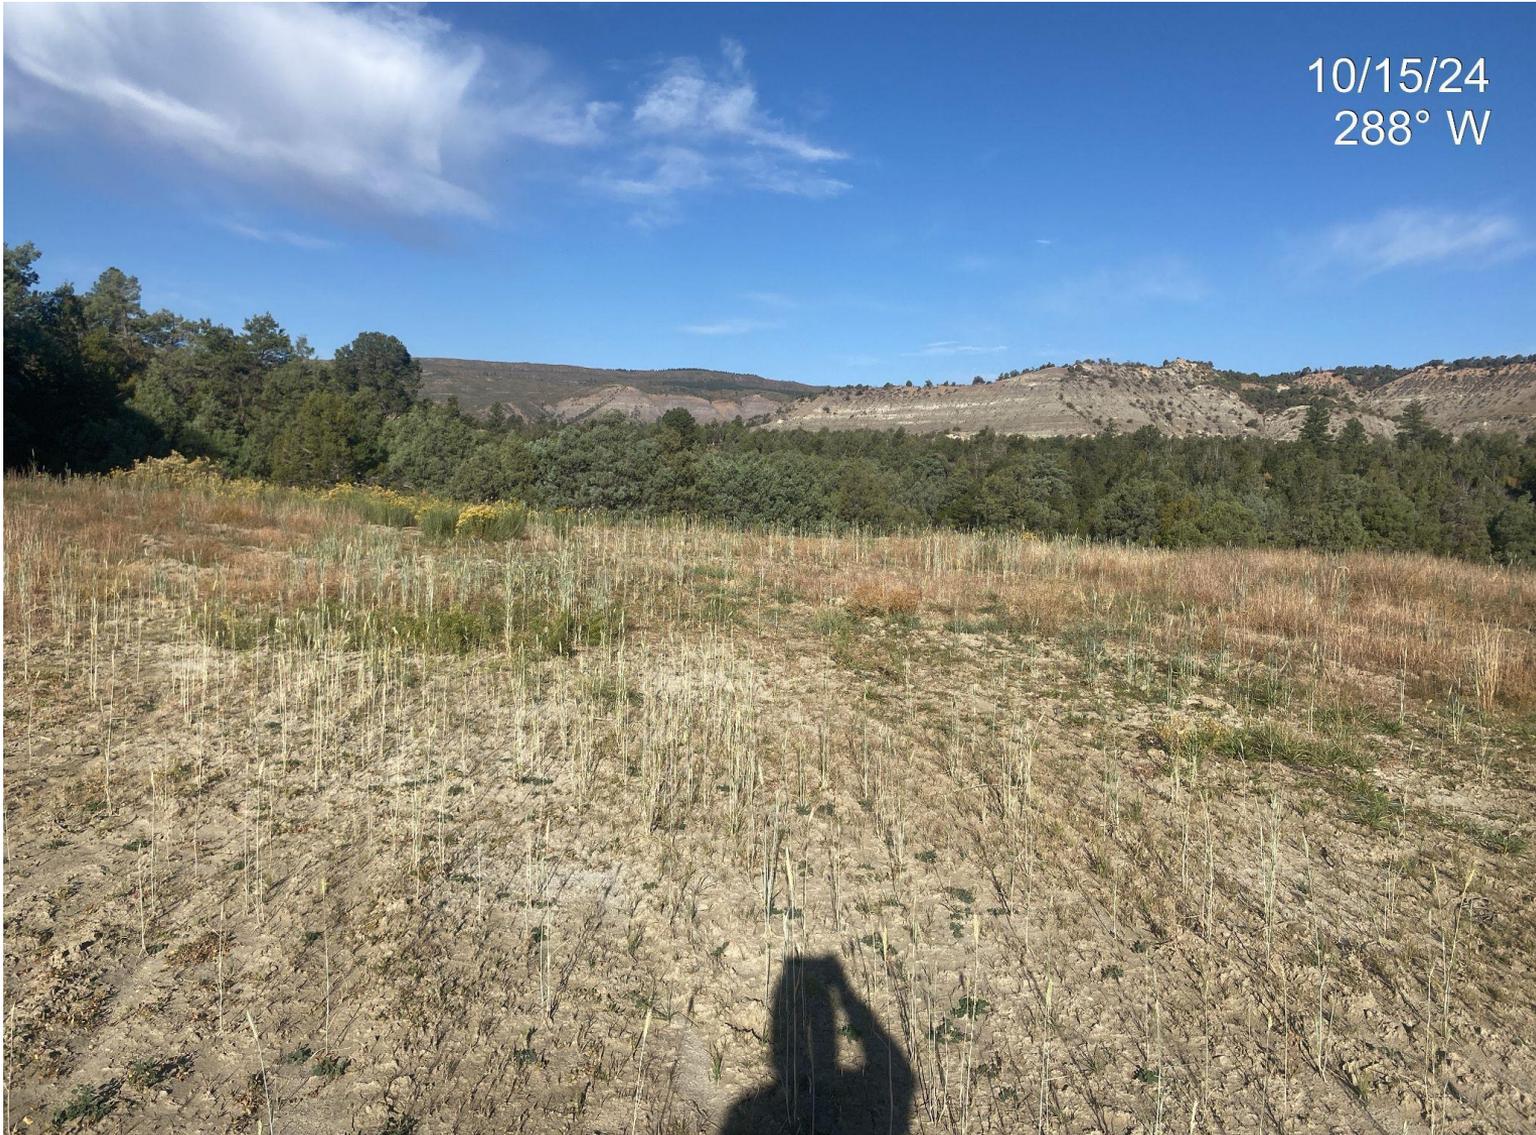
Photo 3. View of the western portion of the disturbance where vegetation establishment appears more successful. Germinating vegetation includes but is not limited to Sand Dropseed, Blue Grama and James Galleta.

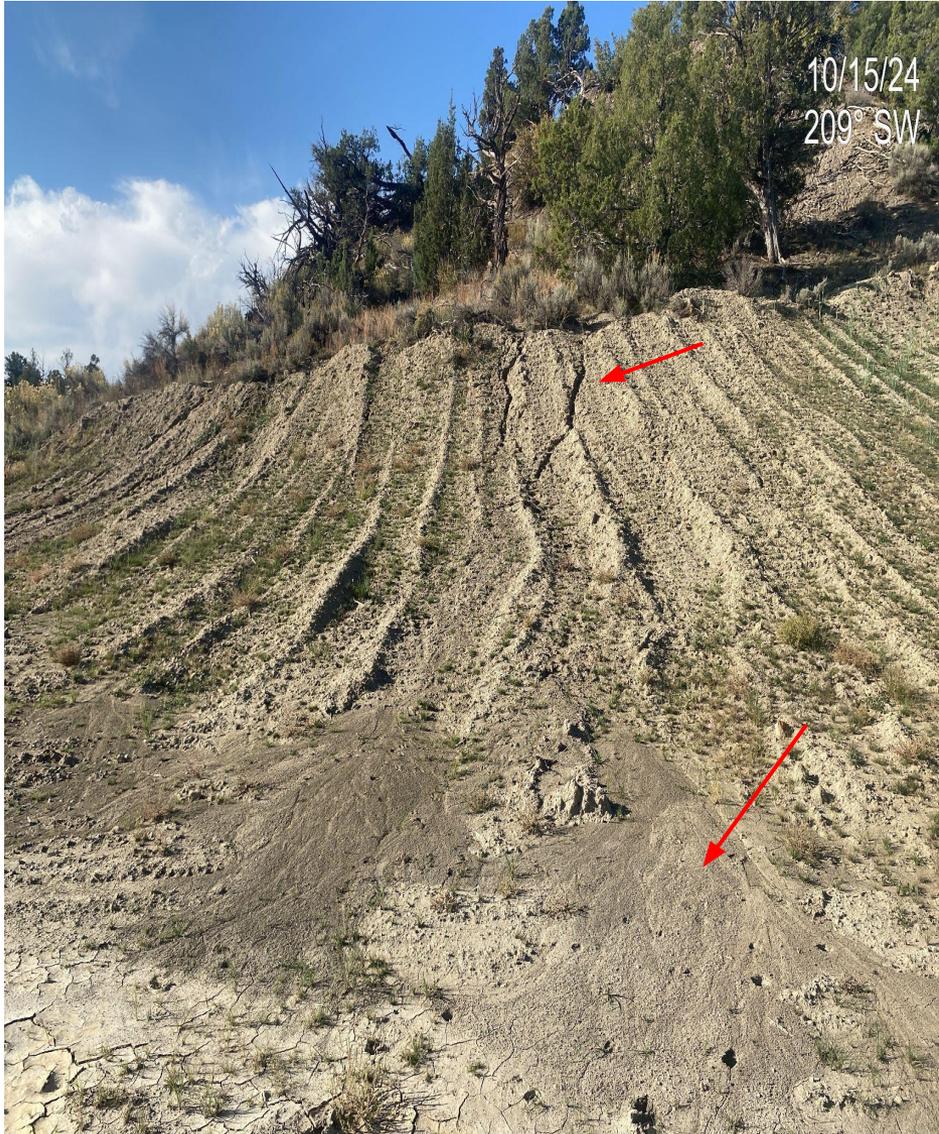
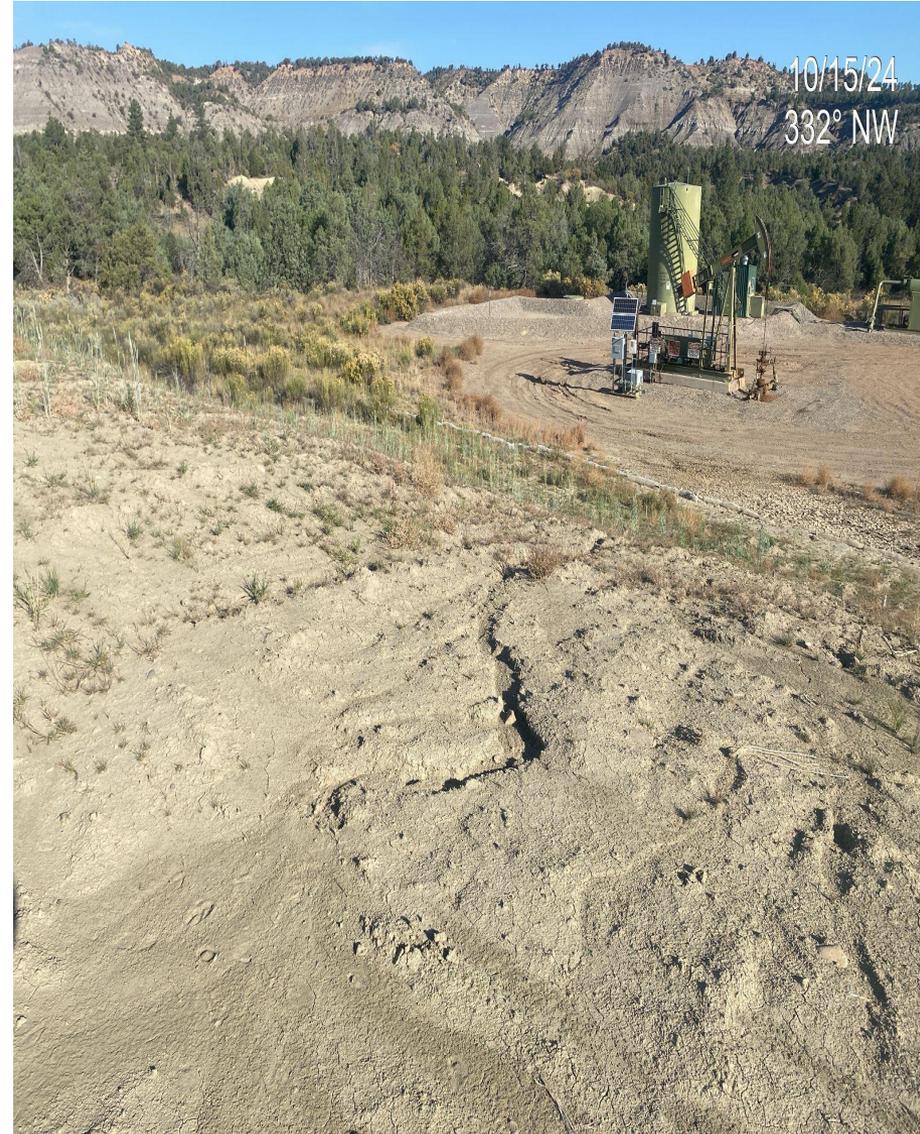
Photo 4. View of rill erosion and sediment transportation observed in the location fill and cut slopes, additional stabilization/stormwater BMPs needed in these areas.

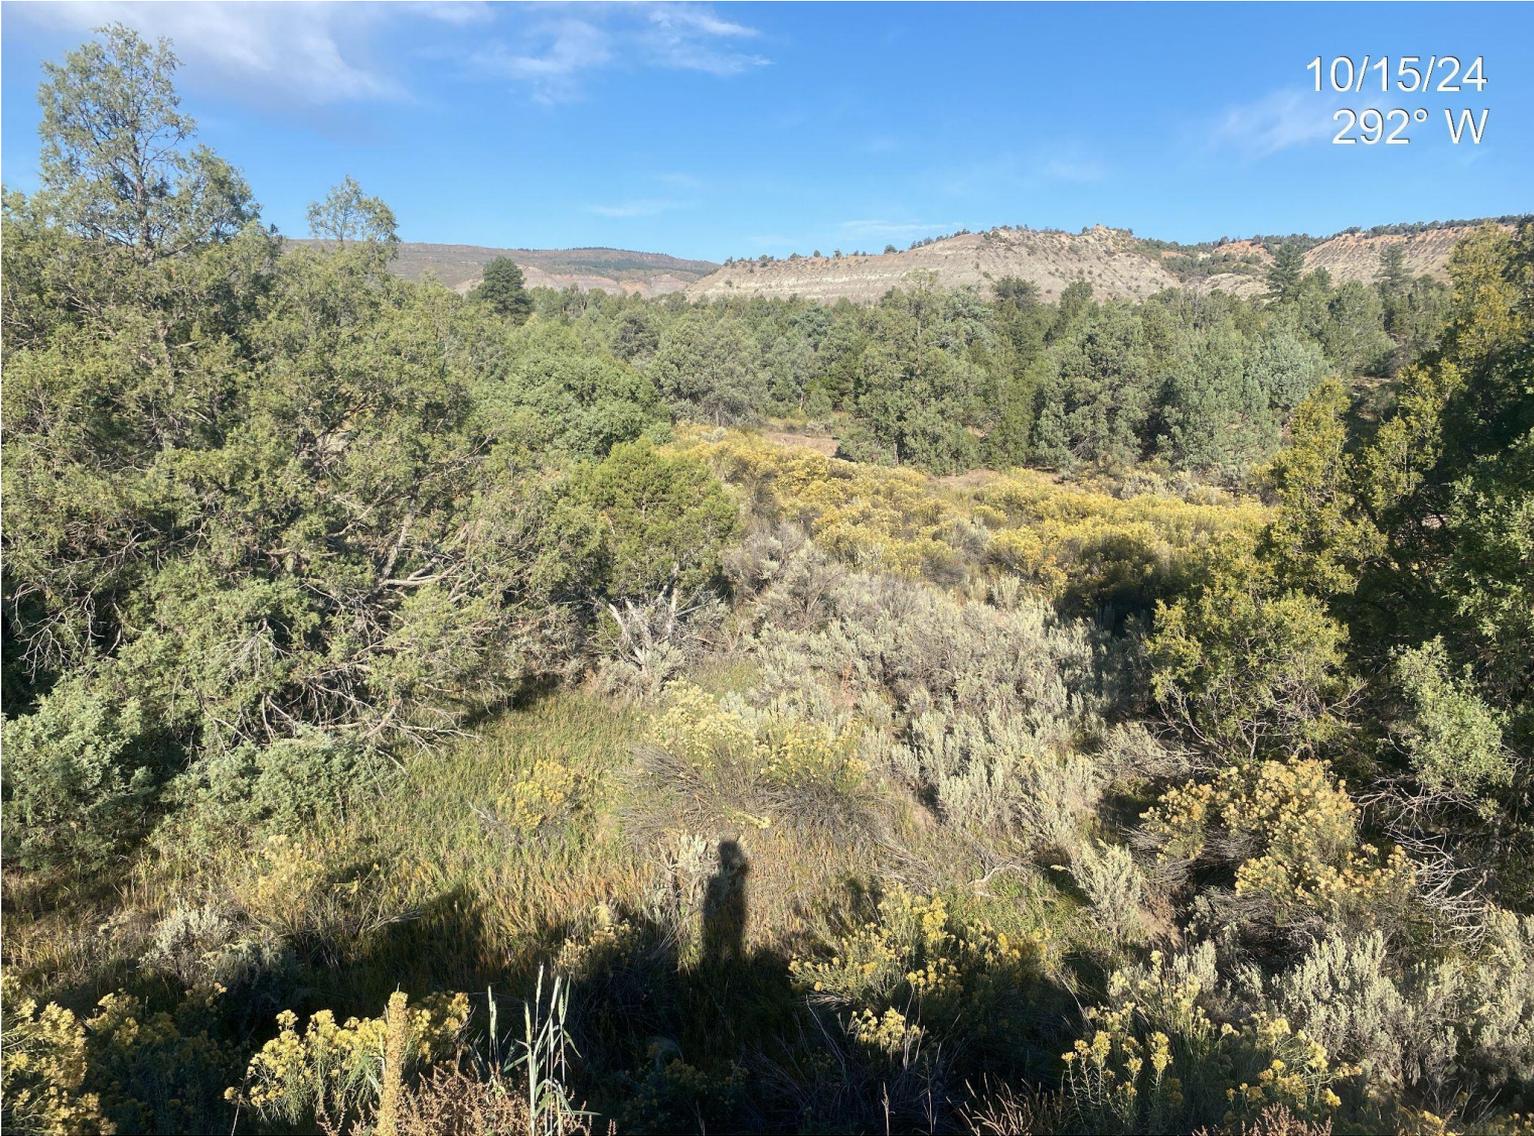
Photo 7. Reference area composed of Sagebrush, Rubber Rabbitbrush and Smooth Brome.
