Inspection Photos

API: 073-06583

Operator: **GRAND MESA OPERATING CO**

Inspection Date: 10/21/2024

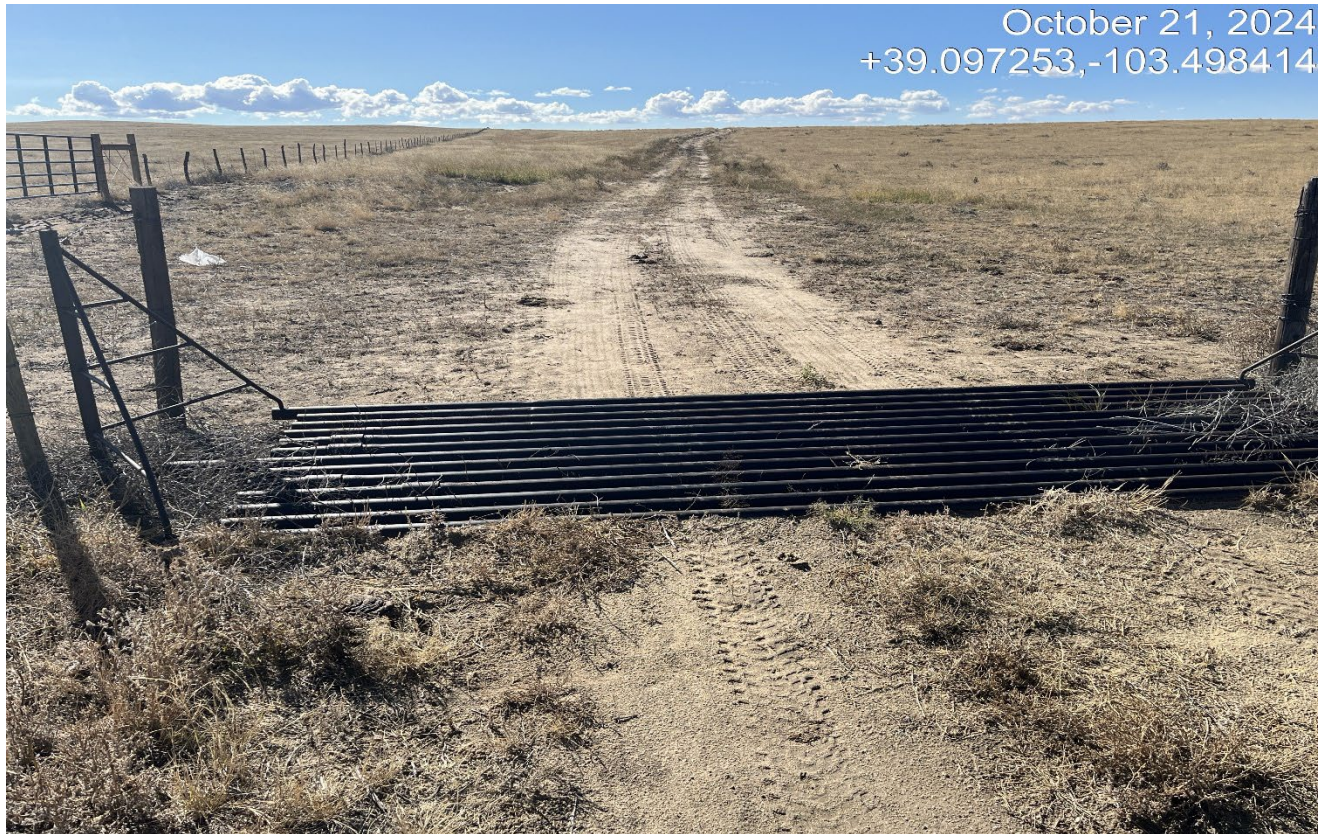
Photo 1. Facing south at the access road. The cattle guard remains and the road has not been reclaimed.

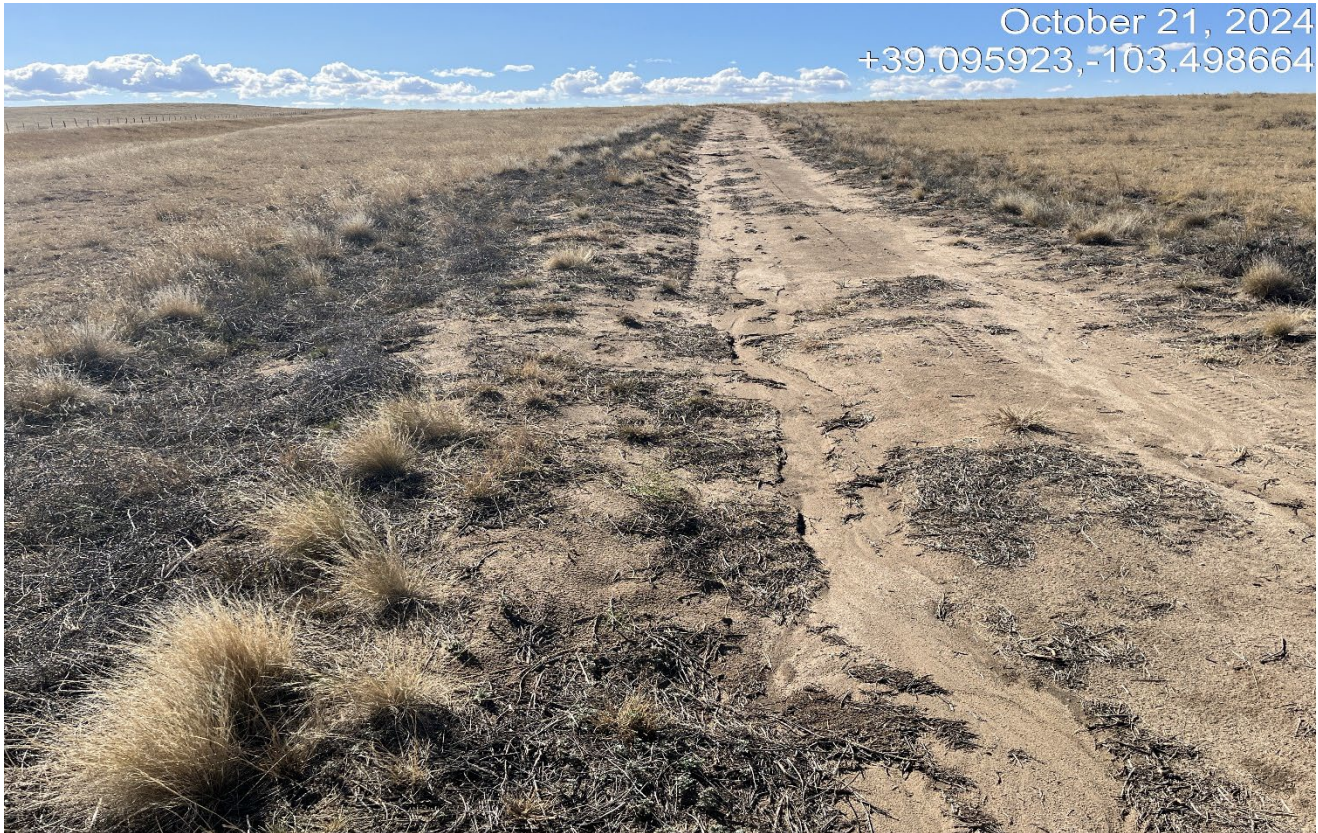
Photo 2. Facing south along the access road that has not been regraded and reclaimed. There are signs of erosion along the road and undesirable weeds.

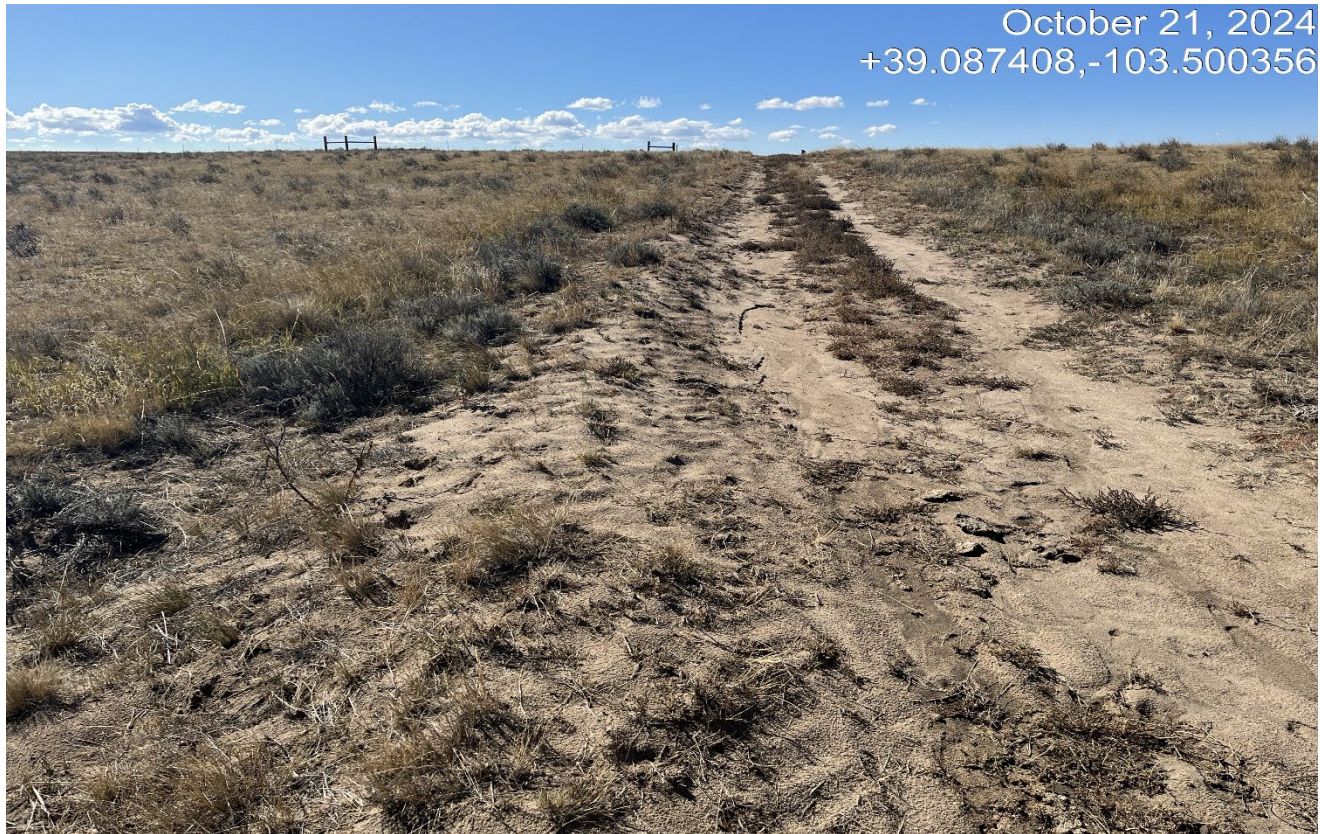
Photo 3. Facing south along the access road near the location. There are signs of erosion along the road which is not stabilized.

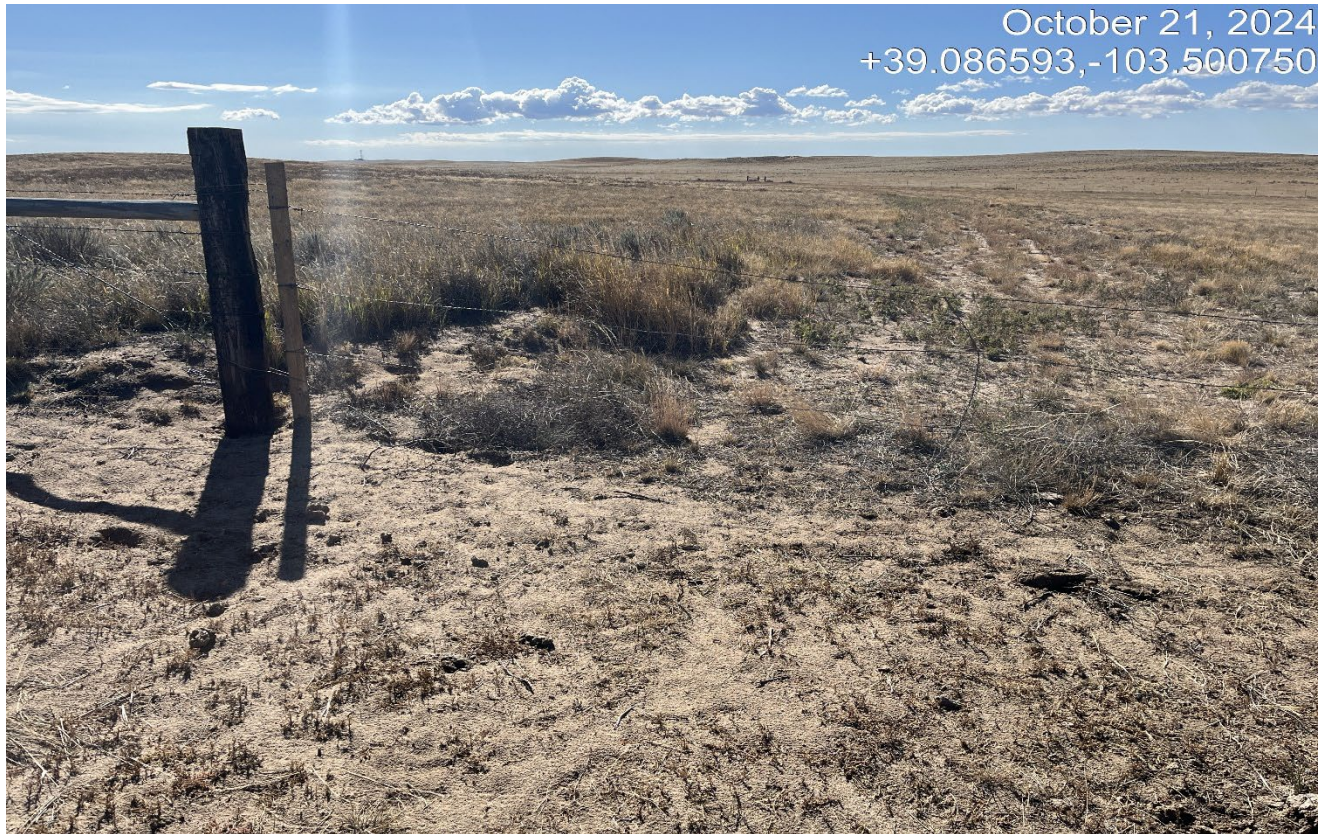
Photo 4. Facing southeast at the location which is fenced.

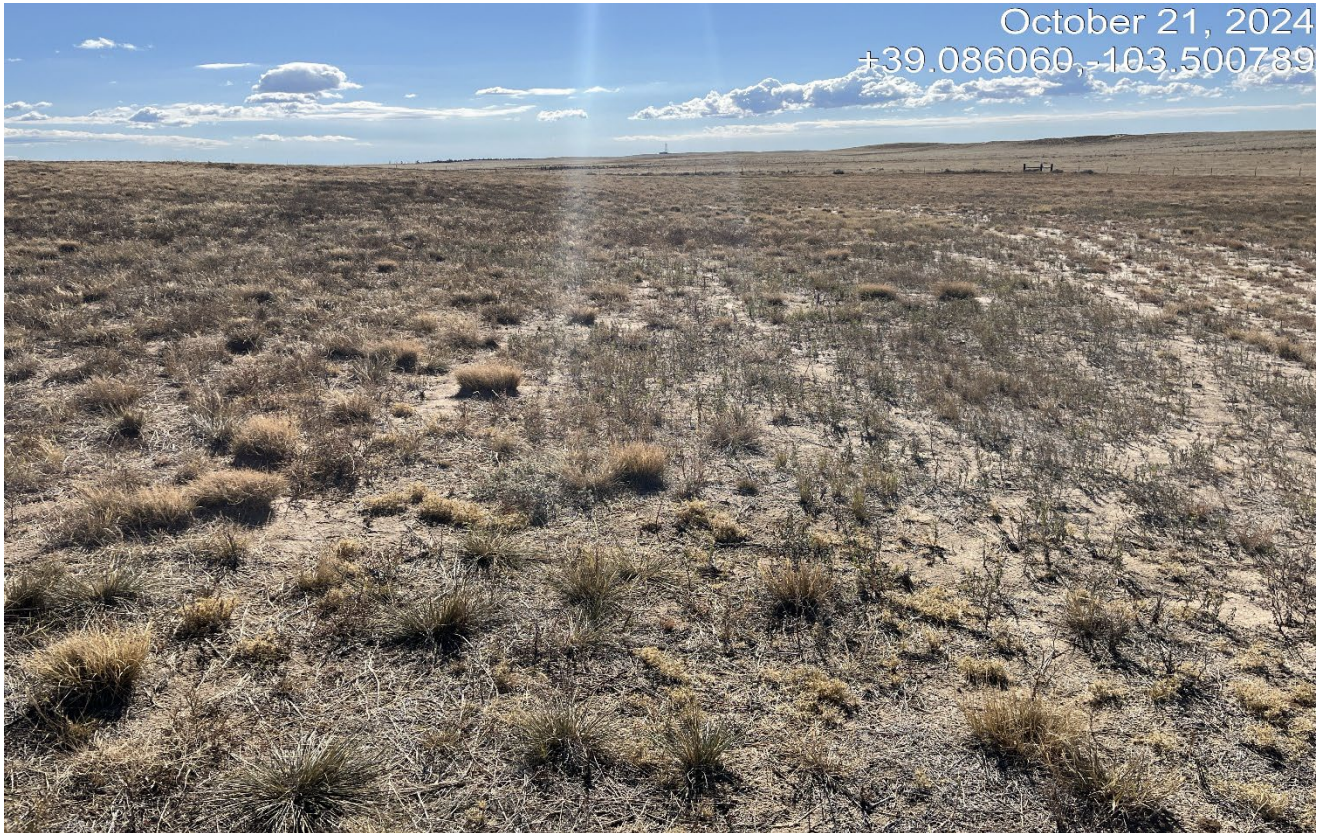
Photo 5. Facing southeast at the reclaimed location. The perennial vegetation is progressing well throughout the location.

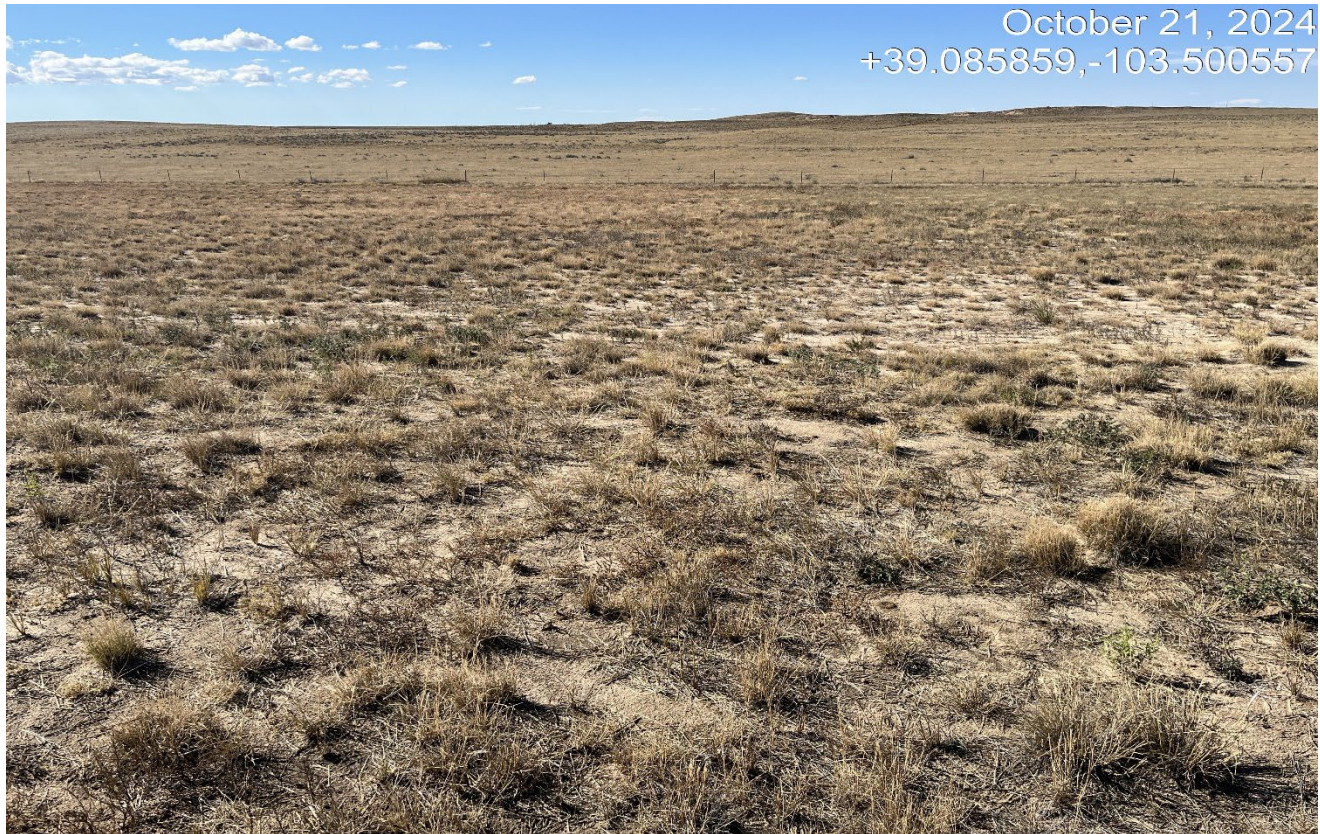
Photo 6. Facing south at the reclaimed location. The perennial vegetation is progressing well throughout the location.

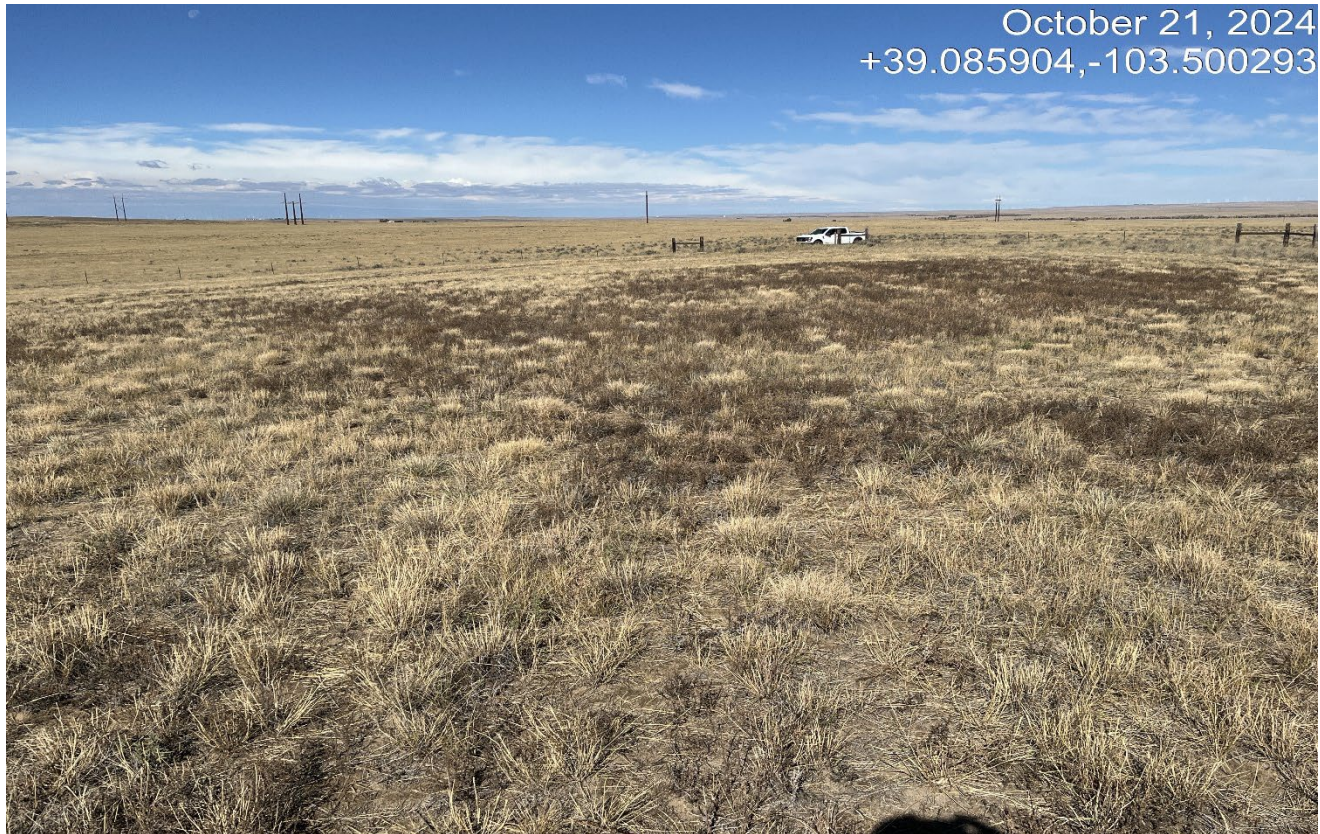
Photo 7. Facing northwest. The brown vegetation is undesirable weeds. Additional seeding and mowing of this area would be beneficial.
