Final Reclamation and Stormwater Inspection

Operator: Crestone Peak Resources Operating LLC -
10633

Location ID: 331898

Inspection Photos
Location Name: Newnam #2-32
Location ID: 331898

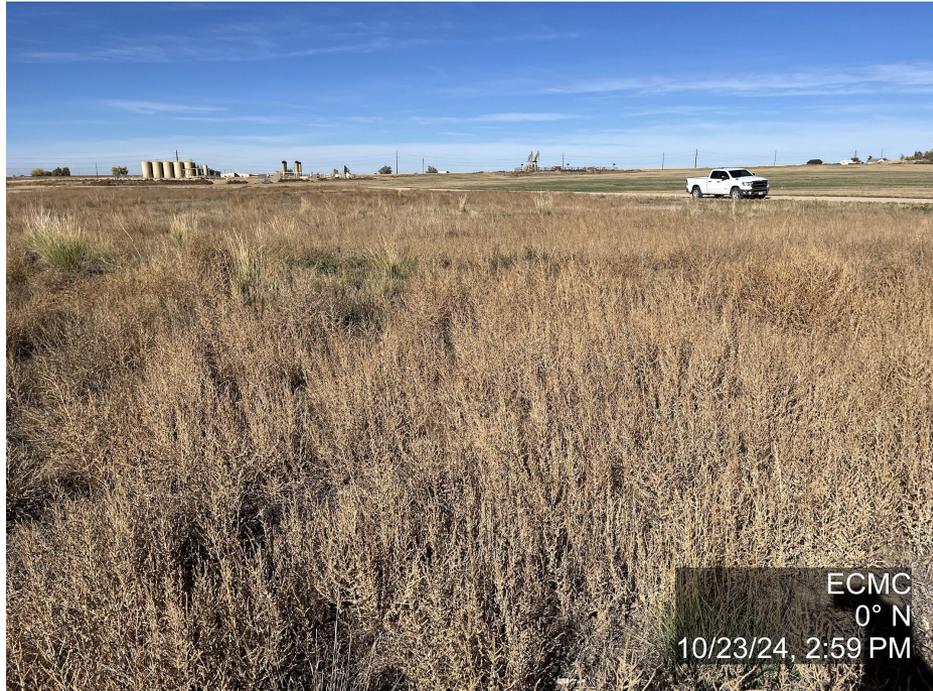
Photo 1. The photo was taken at the well location facing North. The photo illustrates the well location is dominated by kochia, russian thistle and field bindweed.

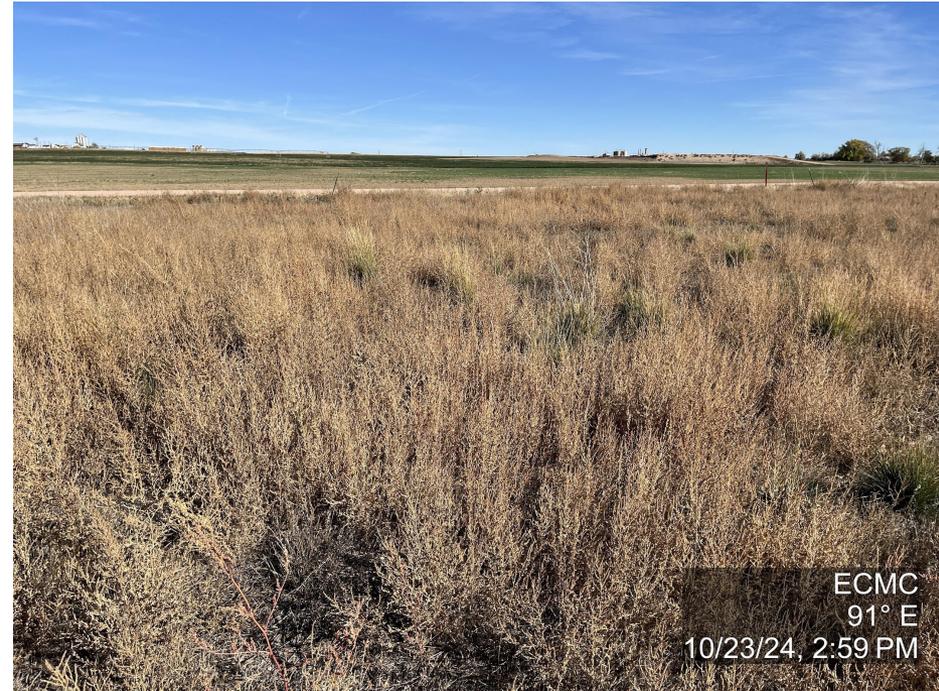
Photo 2. The photo was taken at the well location facing East. Refer to the comment for photo 1.

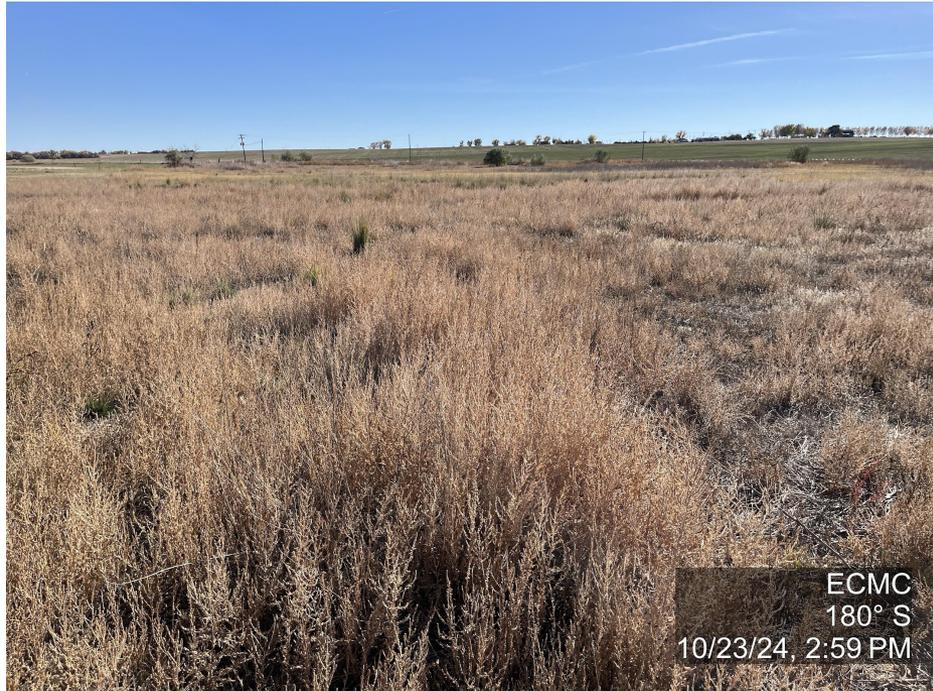
Photo 3. The photo was taken at the well location facing South.
Refer to the comment for photo 1.

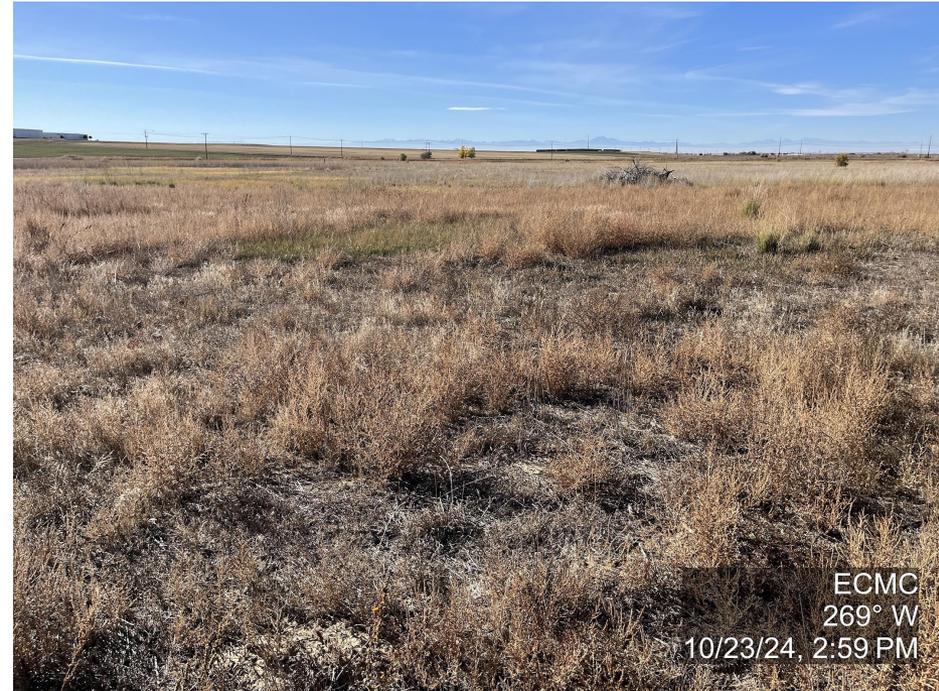
Photo 4. The photo was taken at the well location facing West.
Refer to the comment for photo 1.

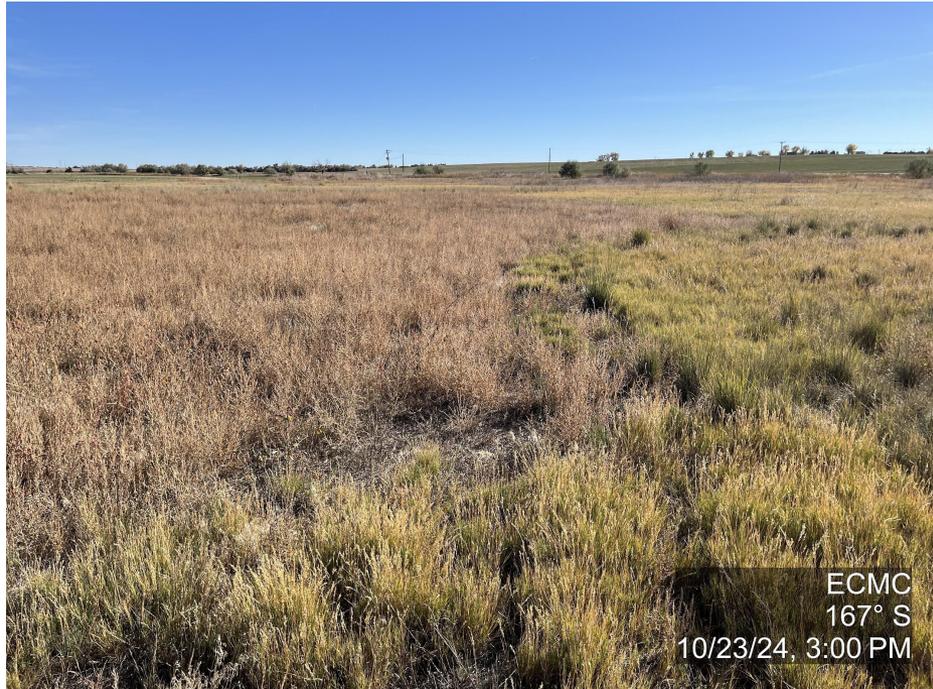
Photo 5. The photo was taken at the well location facing South. The photo illustrates the boundary of the well location disturbance and reference areas.

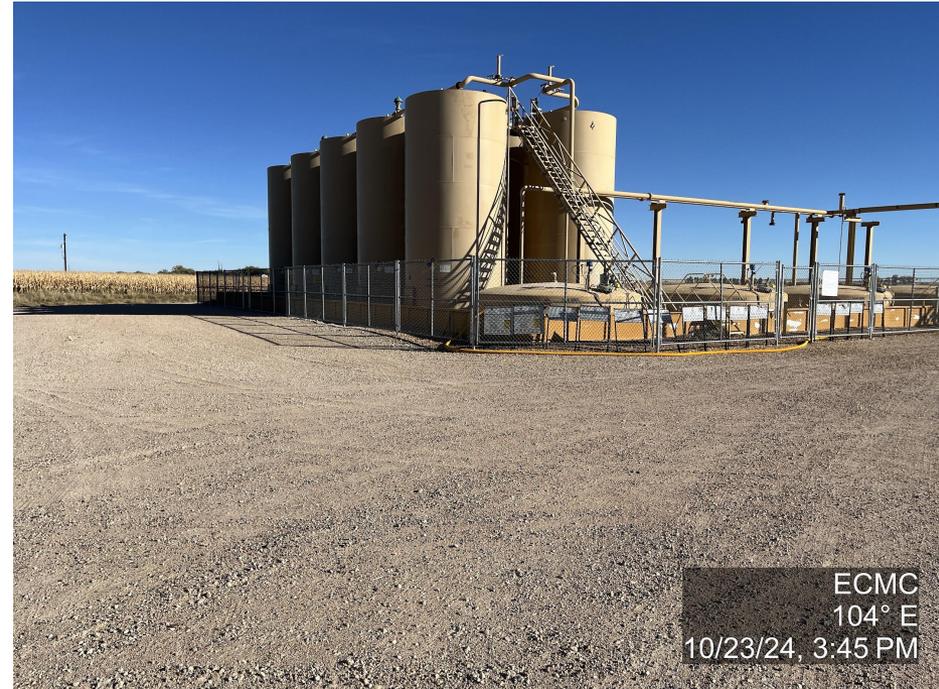
Photo 6. The photo was taken at the tank battery location facing East. The photo illustrates the tank battery location remains active for other wells.

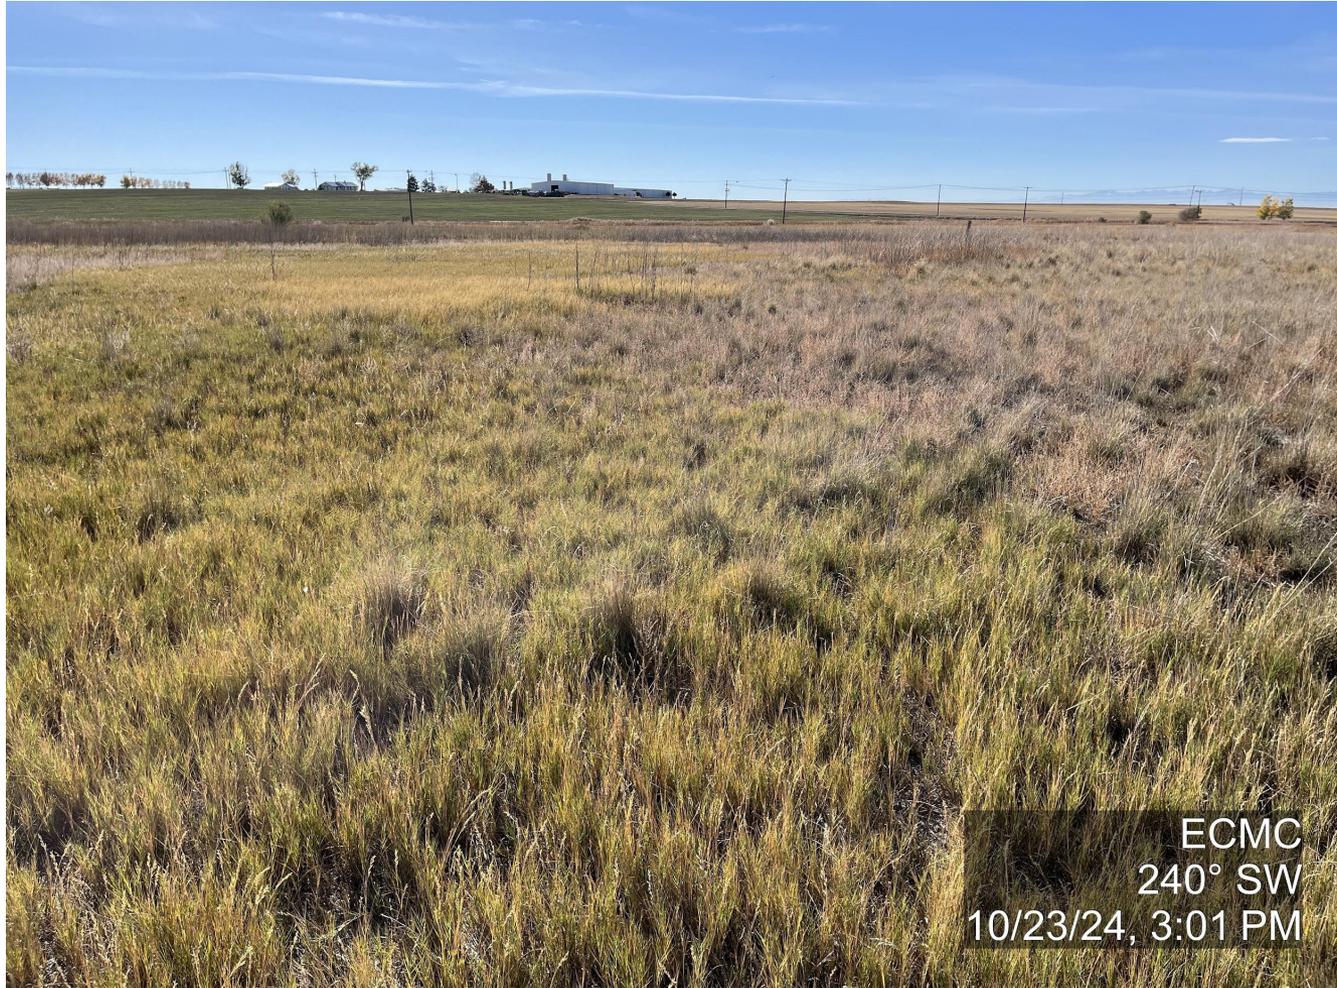
Photo 7. The reference photo was taken west of the well location facing Southwest. The photo illustrates references areas are dominated with saltgrass and other desirable species.
