Inspection Photos

ID: 453010

Operator: OGRIS OPERATING LLC

Inspection Date: 10/28/2024

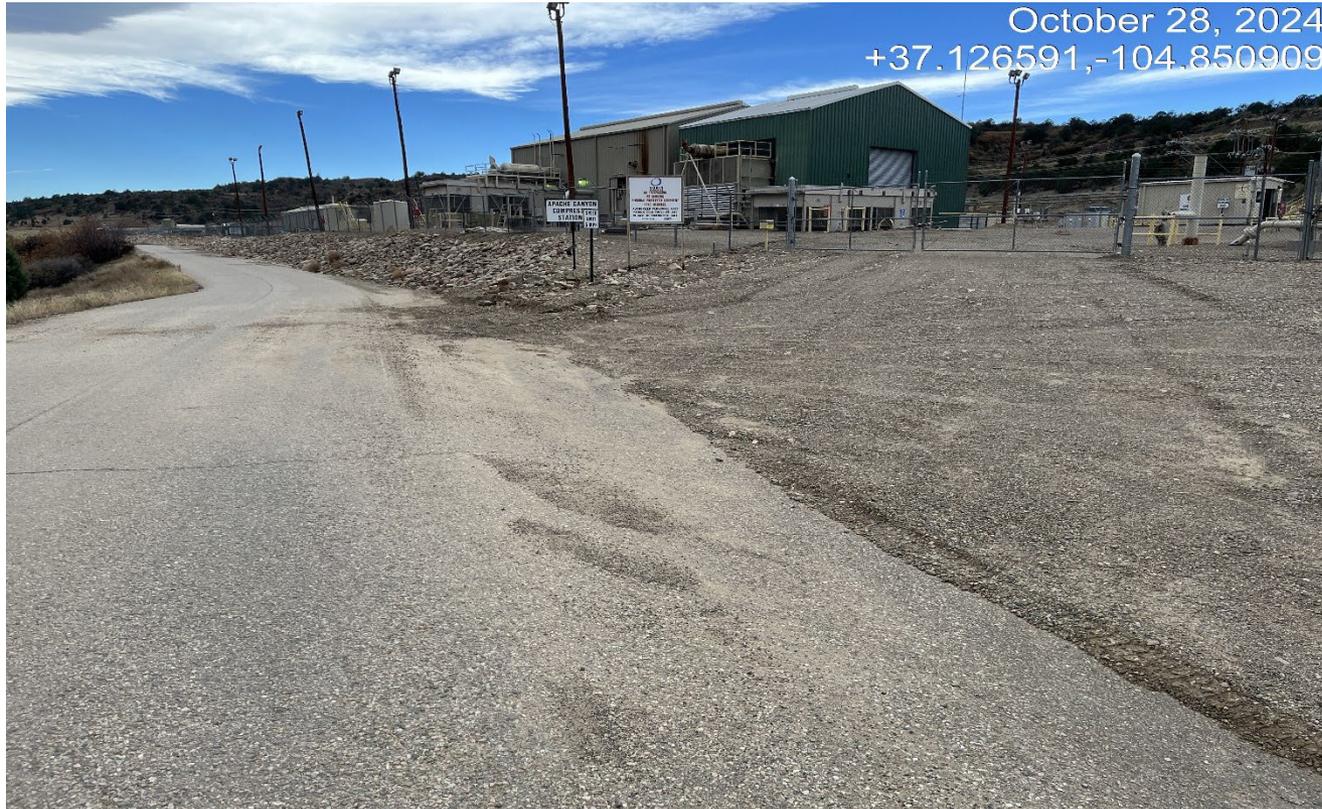
Photo 1. Facing southwest along the main road to the compressor facility. The road was regraded but additional erosion has since occurred.

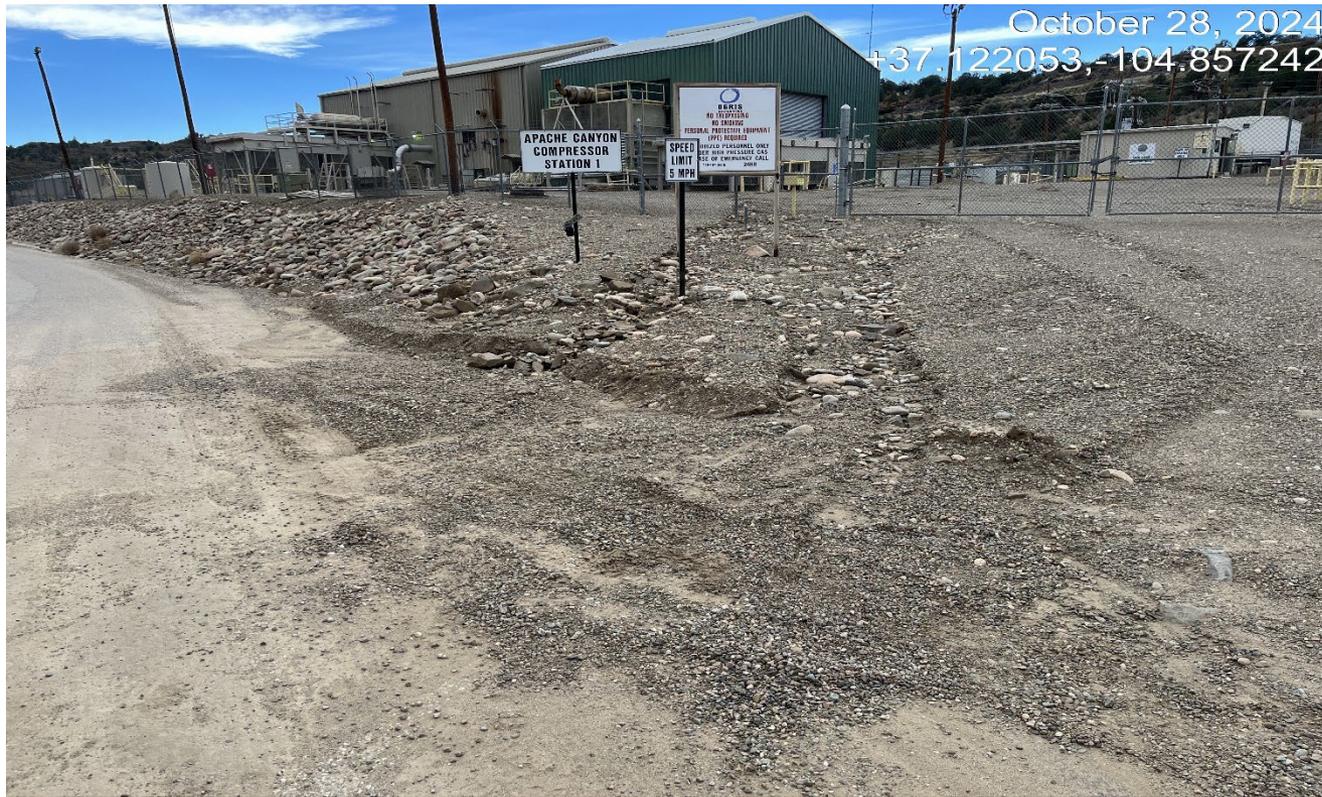
Photo 2. Facing toward the compressor facility. Stormwater erosion is depositing gravel and sediment onto the road. BMP's must be installed to prevent erosion..
