Storm Water Management and Erosion control
Location Name: TEP ROCKY MOUNTAIN LLC FEDERAL RMV 63-19 Pad
Location #: 335176

**Location Overview: Location is within High Priority/Density
Habitat areas. Location is approximately 27 yards from a
drainage that contributes to the Colorado River.
Section/Township/Range: 19 6S94W**

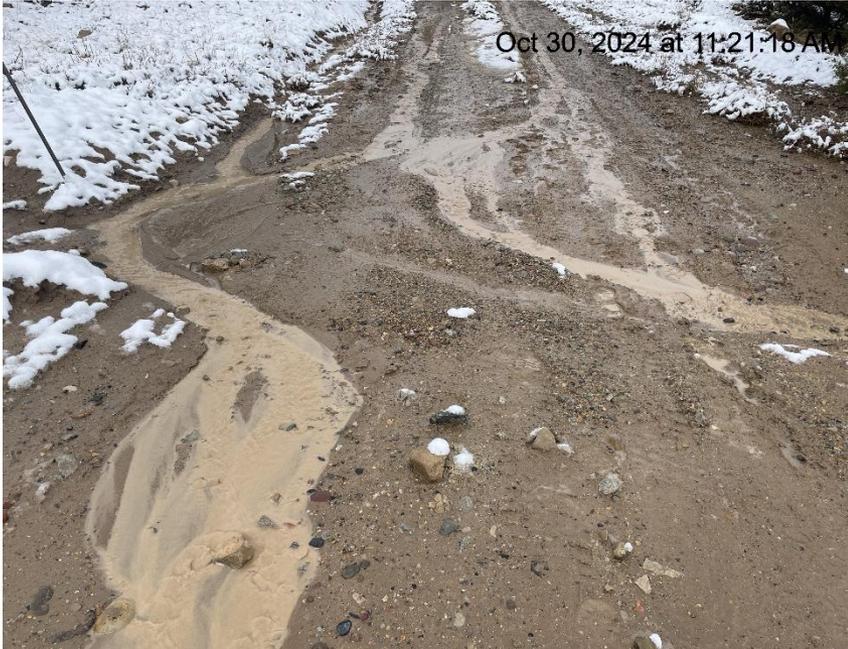
Photo # 8159 Insufficient BMP's at entrance to location /sediment laden stormwater migrating from lease road onto location

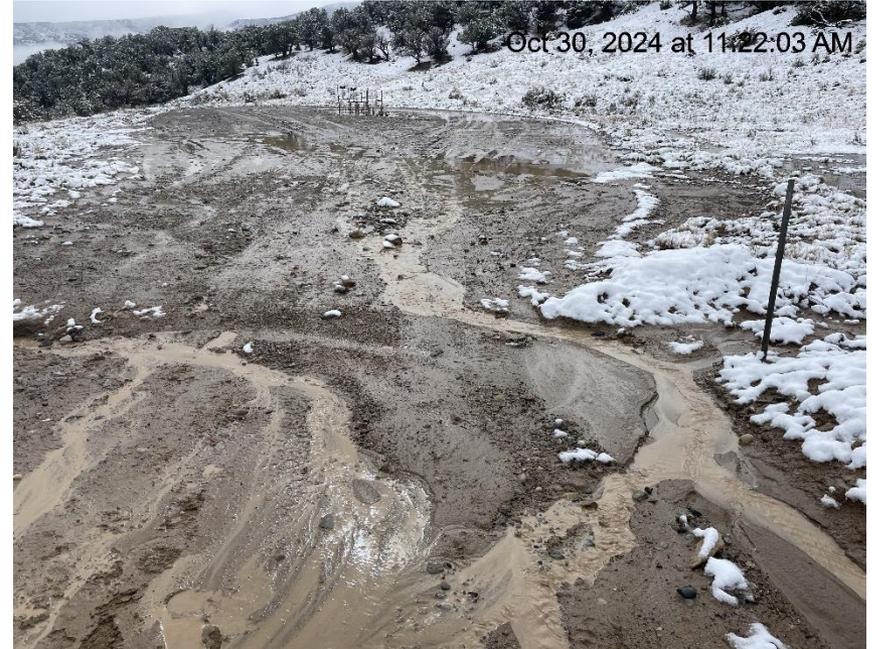
Photo # 8160 Insufficient BMP's at entrance to location /sediment laden stormwater migrating from lease road onto location
