**From:** dylan cohoon <dylancohoon@gmail.com>  
**Sent:** Friday, October 25, 2024 7:59 PM  
**To:** Meghan Grimes  
**Subject:** [EXTERNAL] CA3 (pics 10-15) part 1

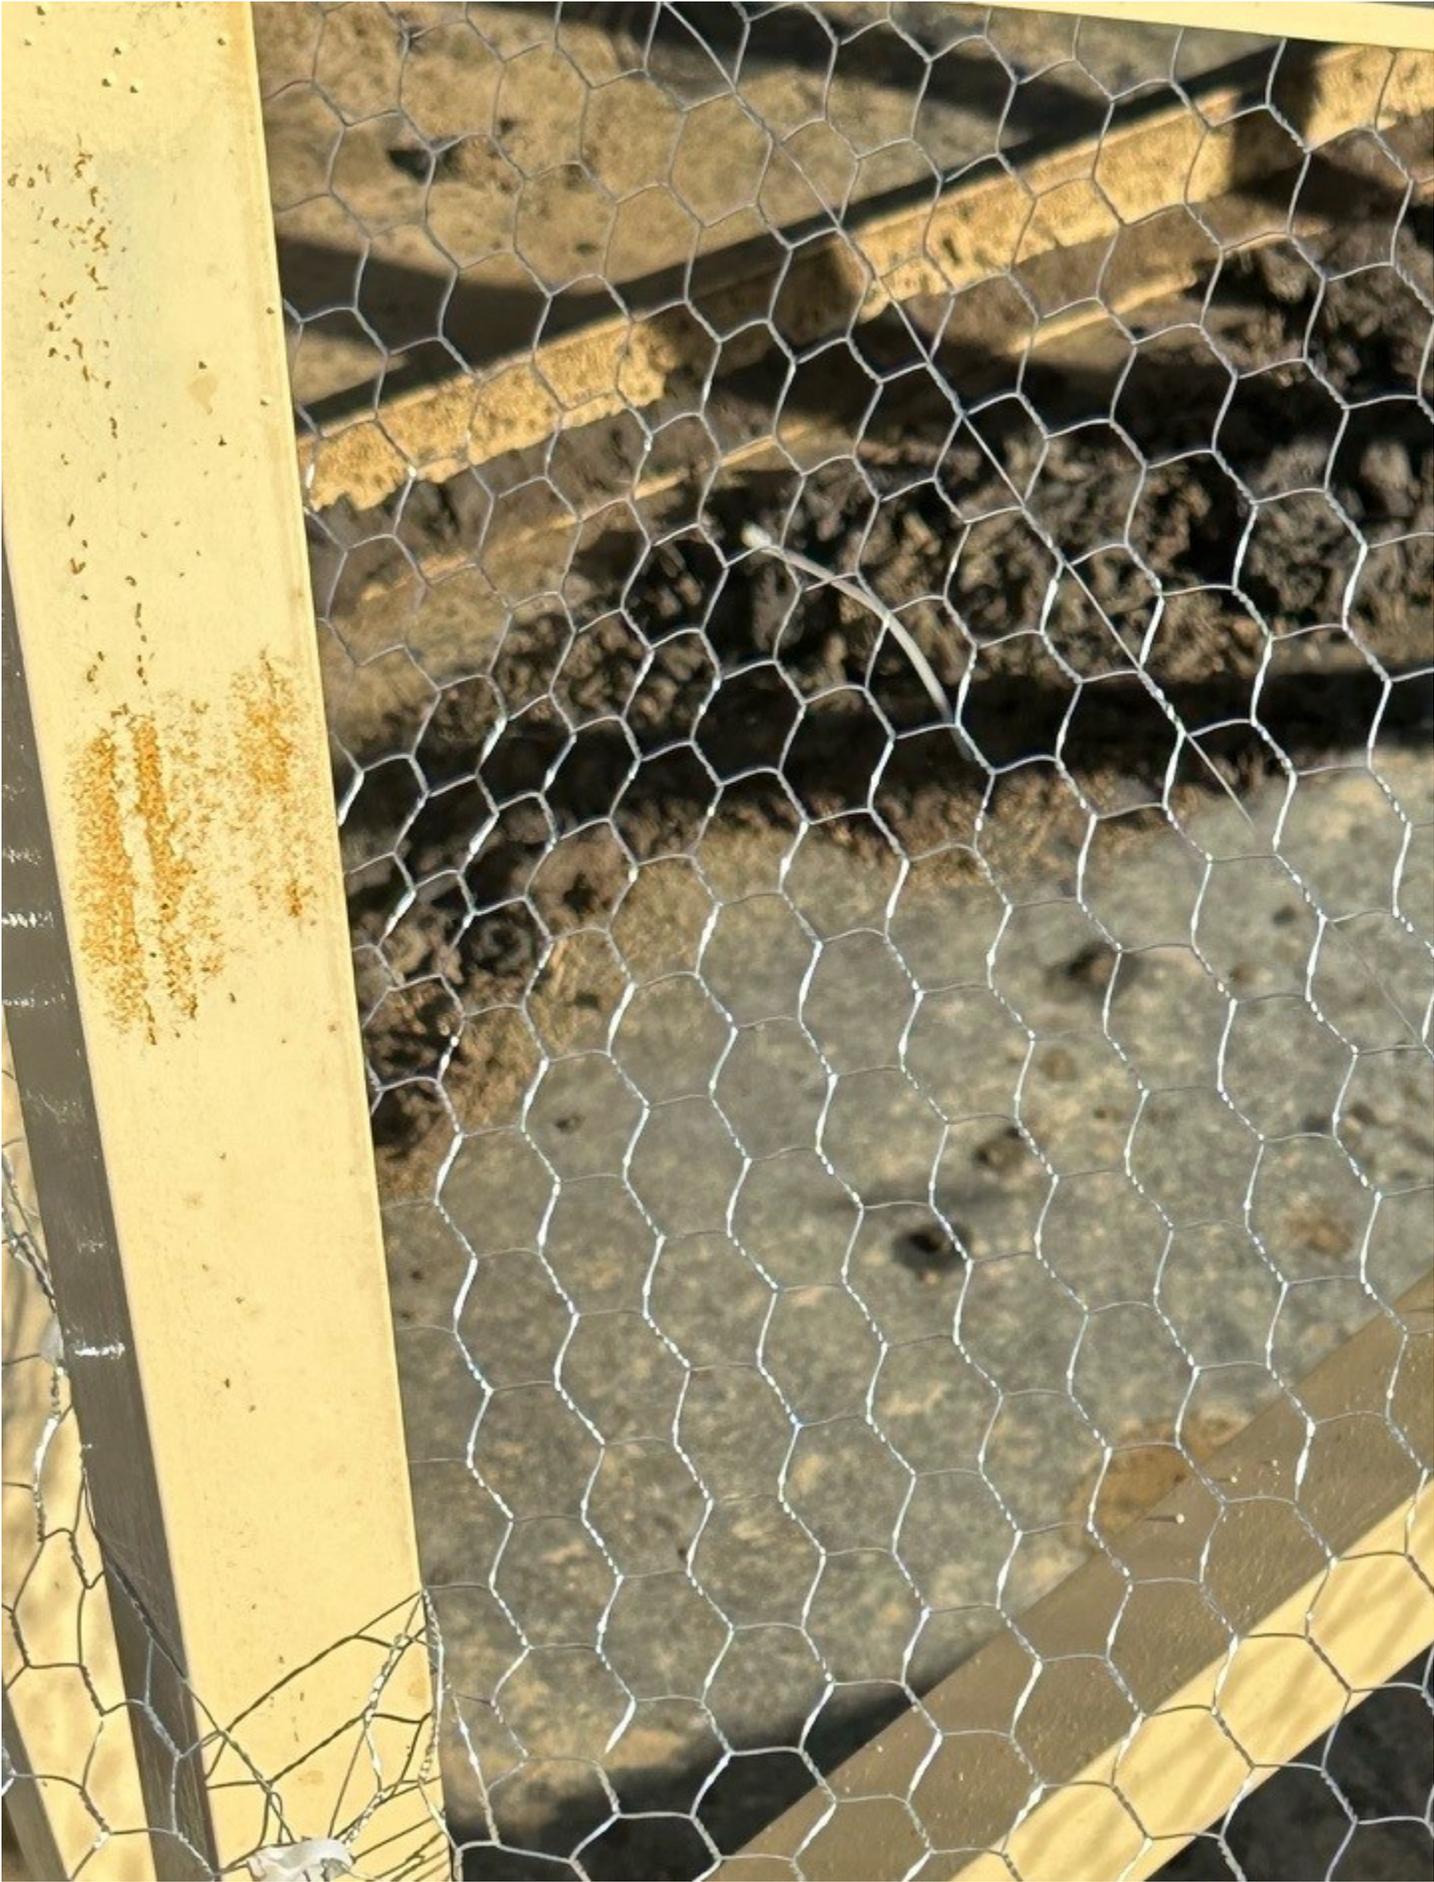
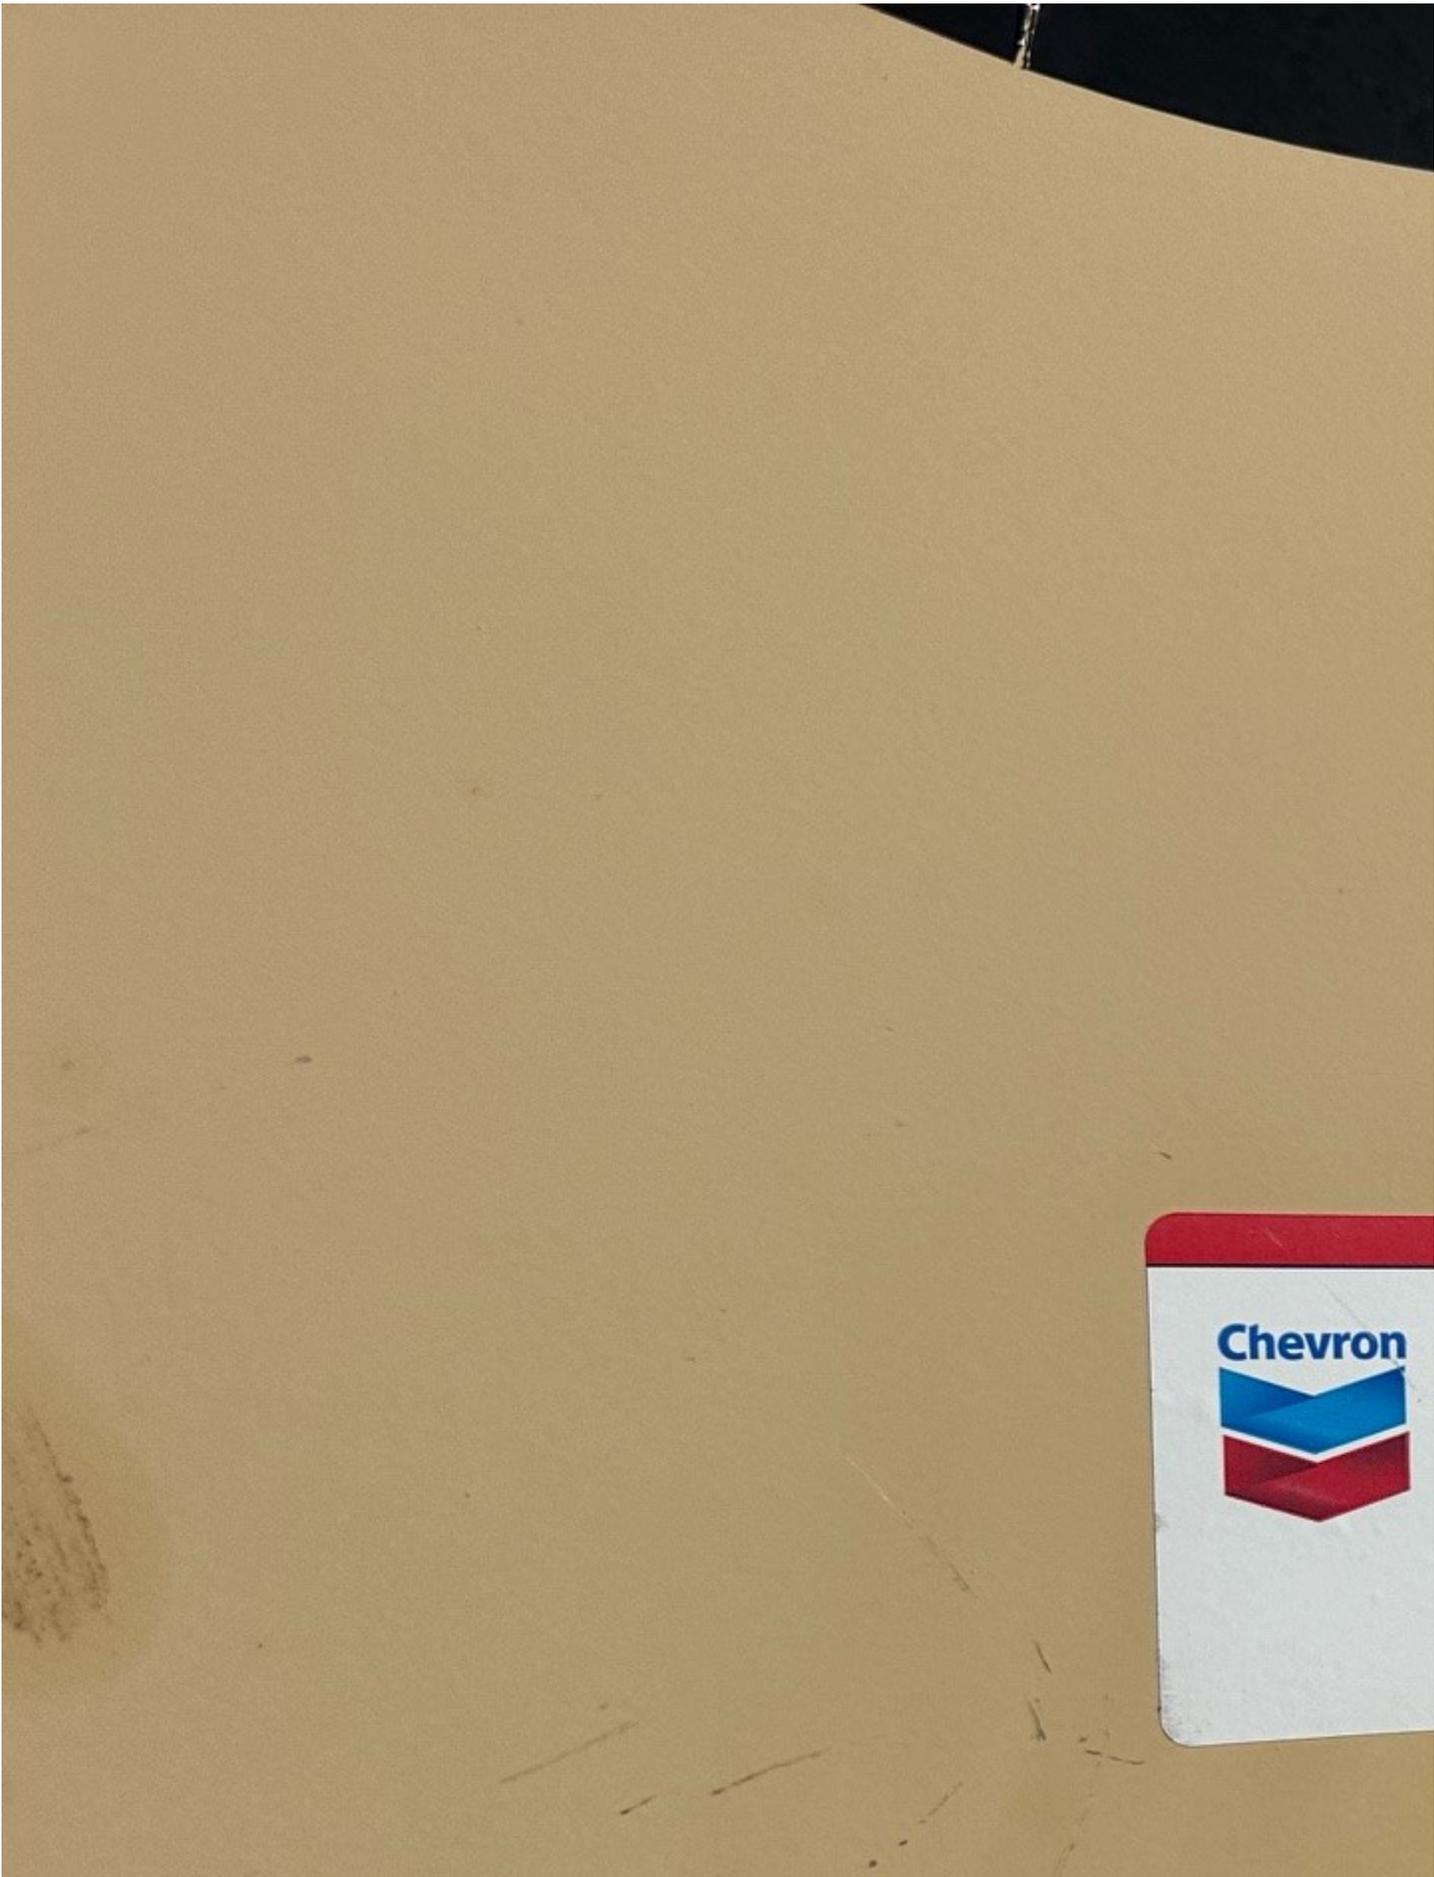
The pilot Thomas tanks nets were saturated in oil which needed to be changed with new clean wire also inside the tanks had a motor oil water combo in them which I also had sucked out also cleaned and removed all contaminated soil around the tanks

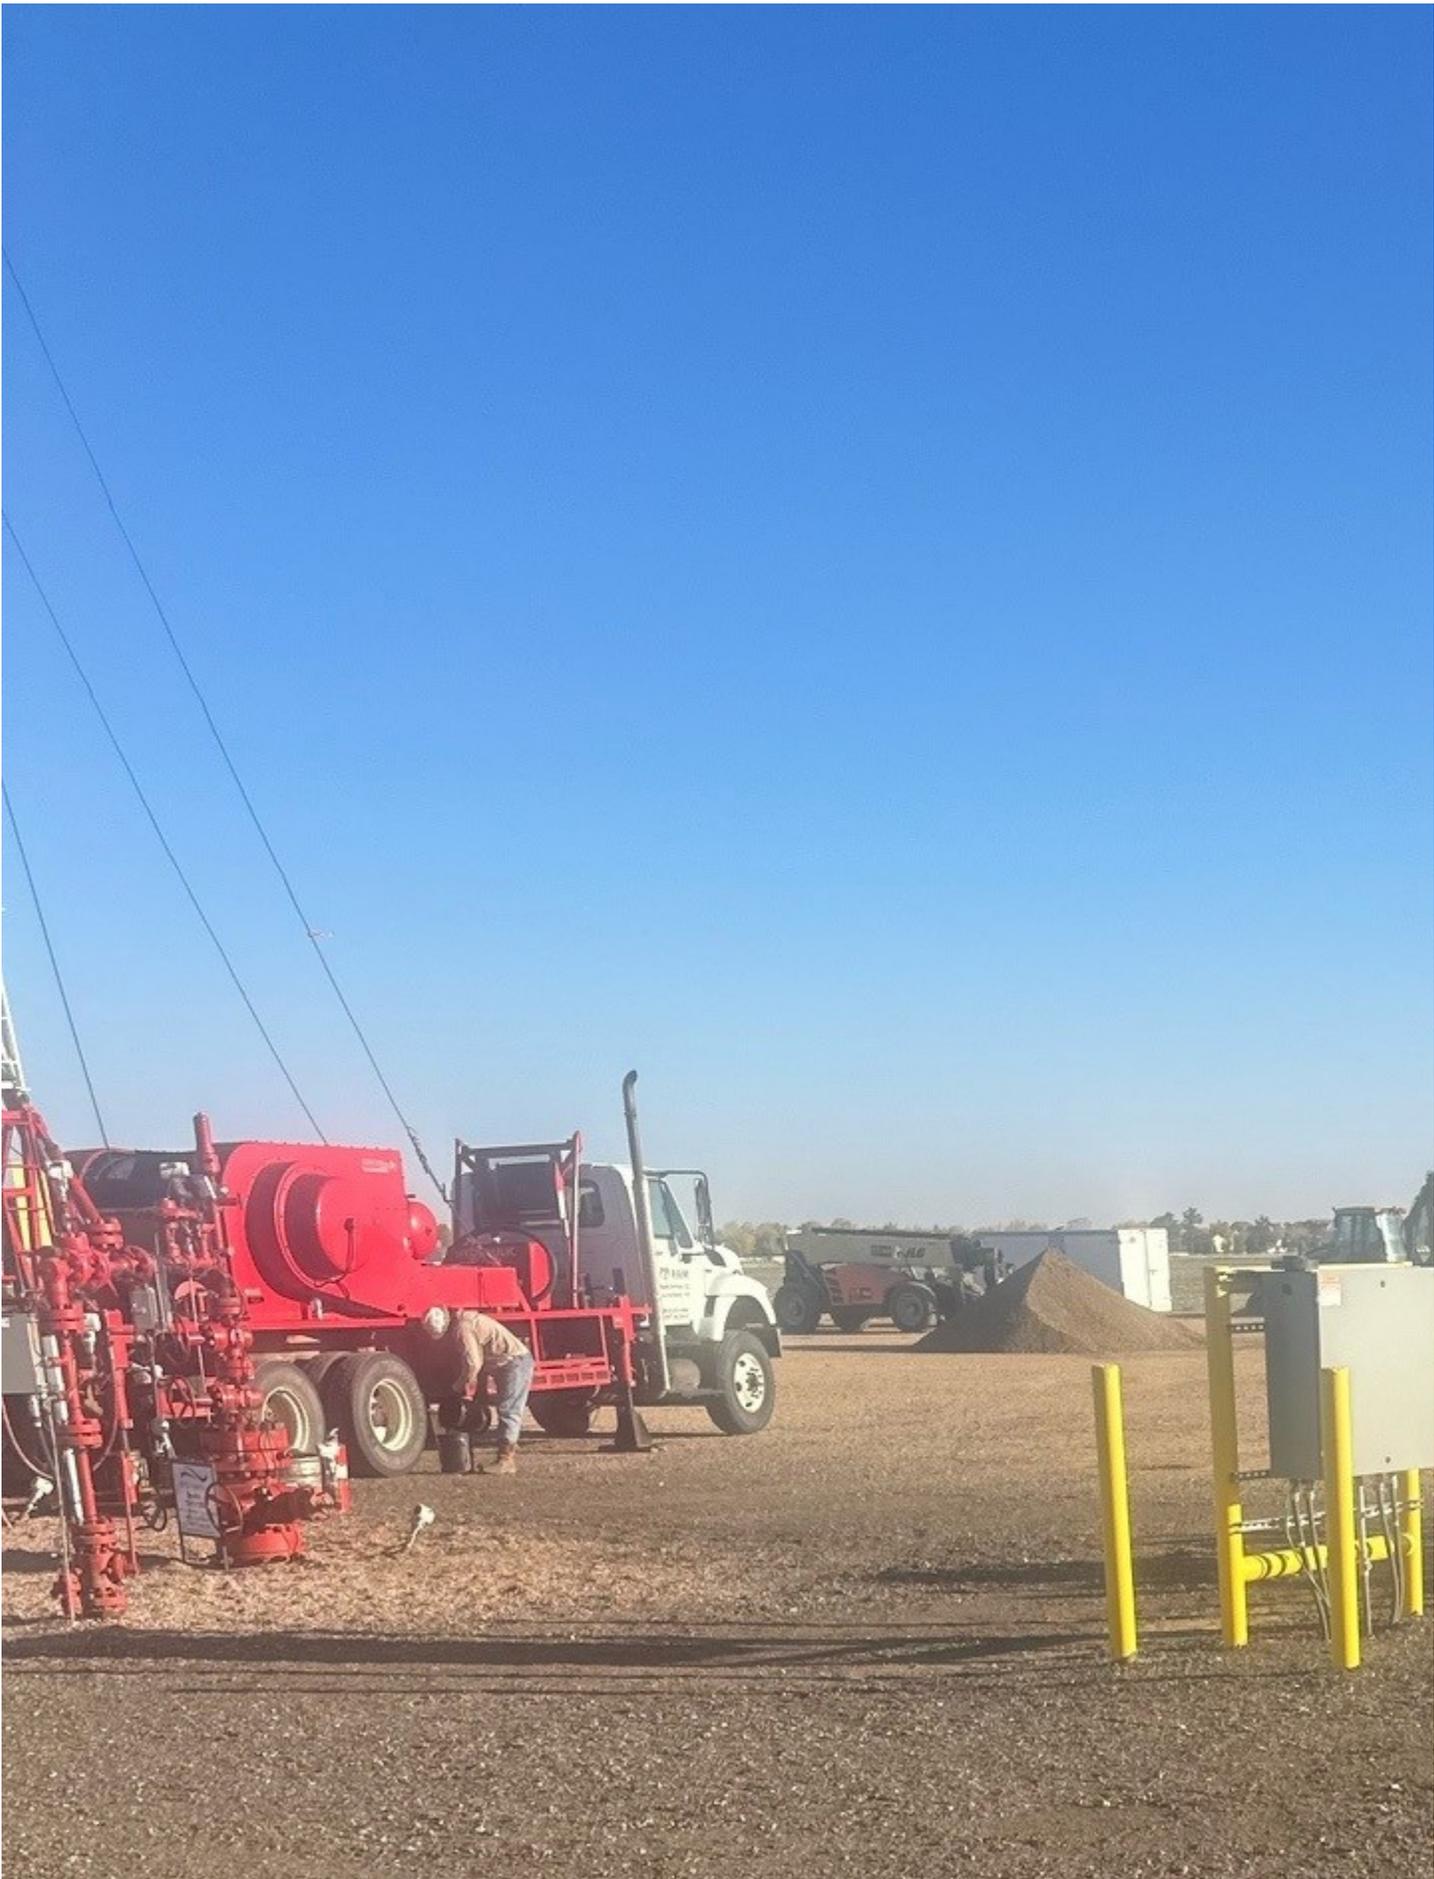
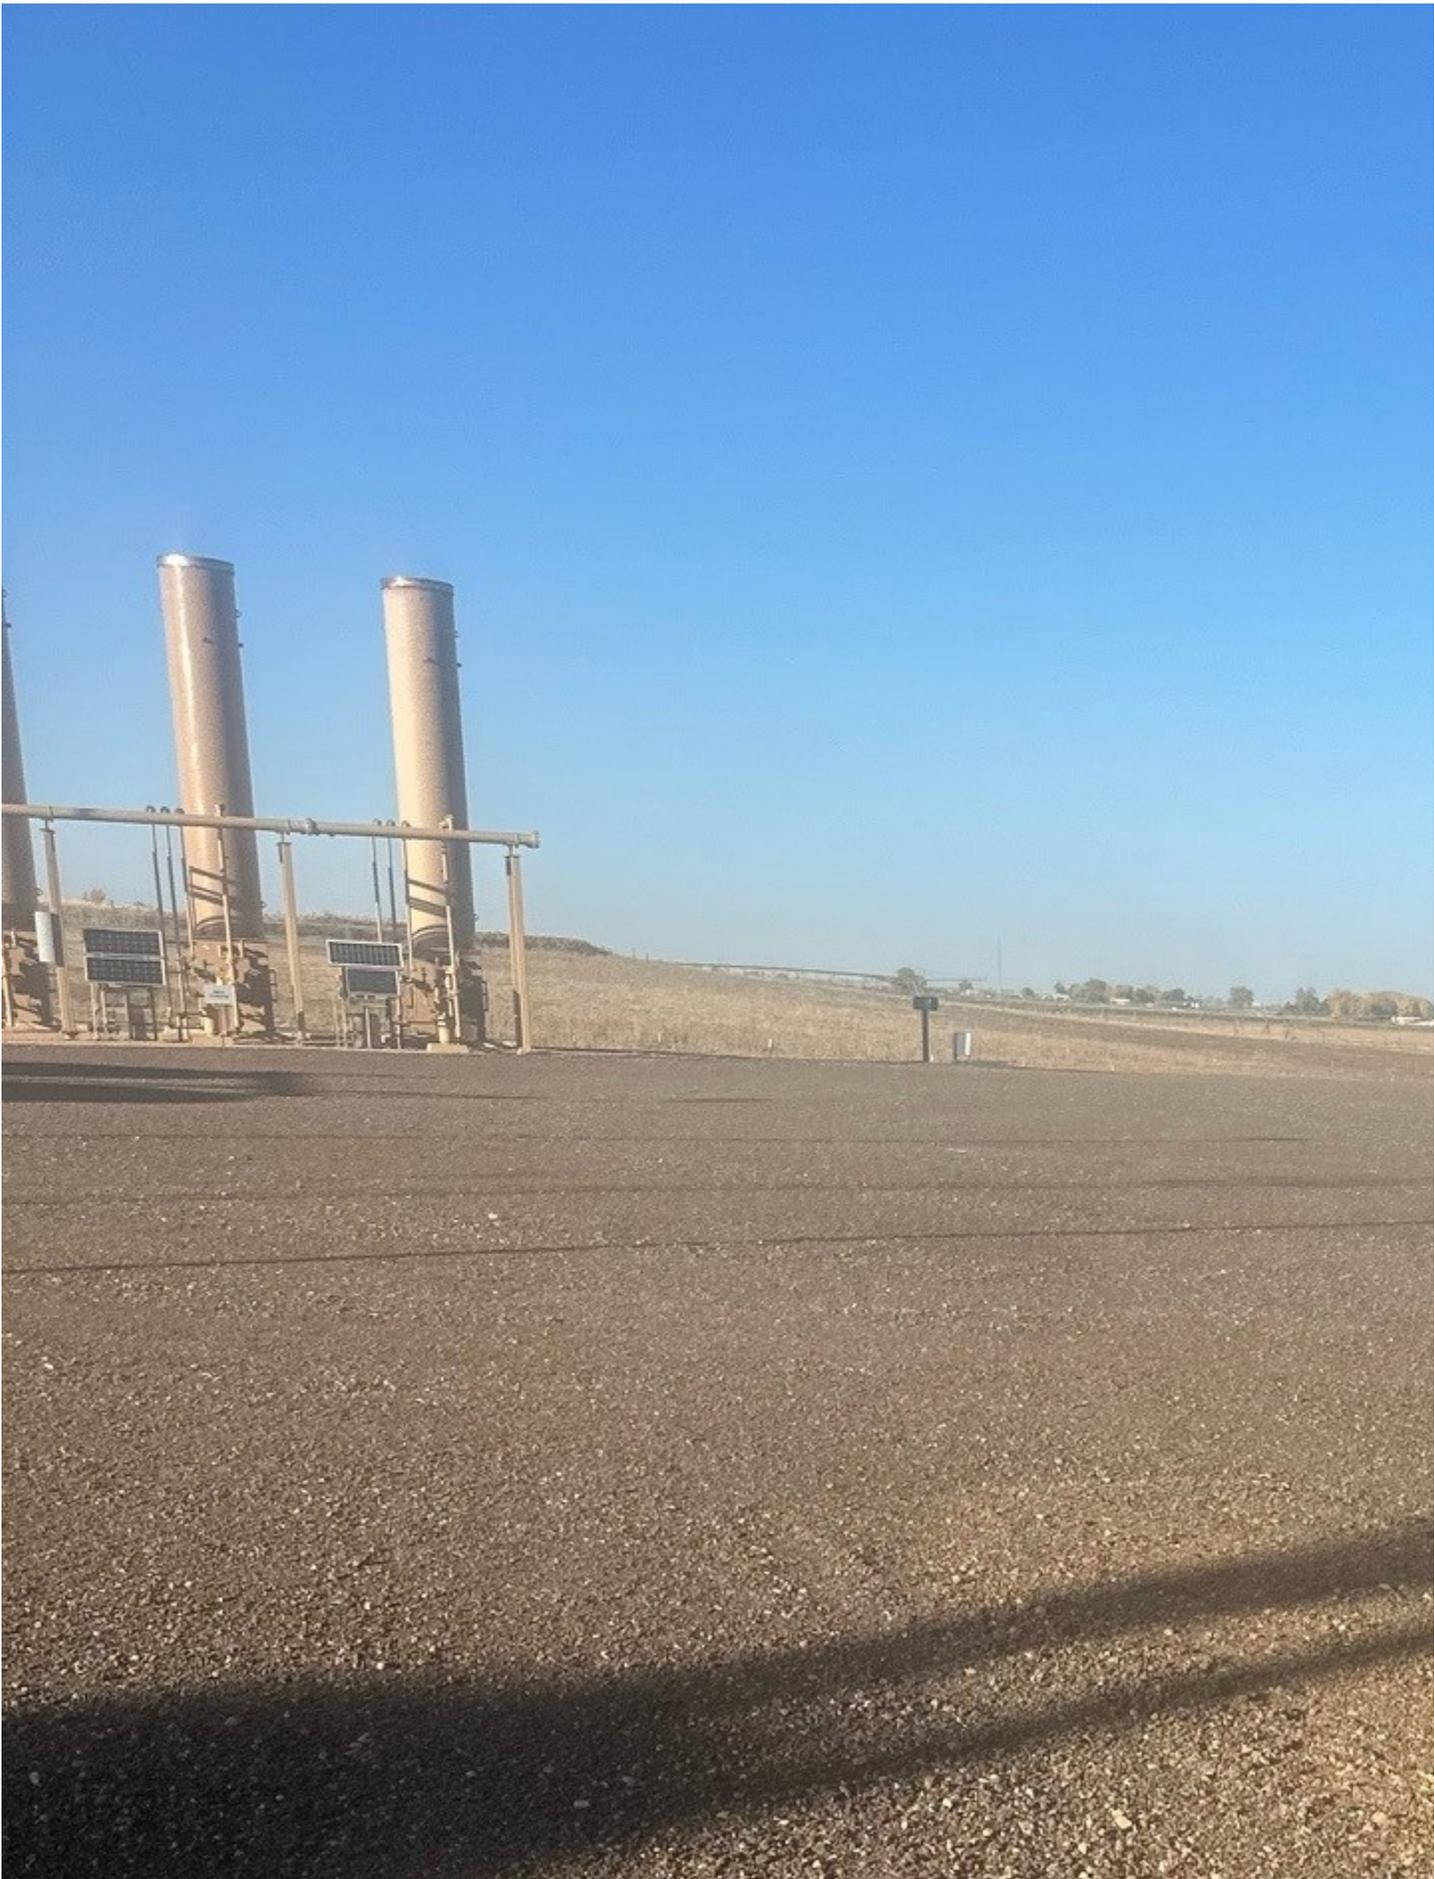
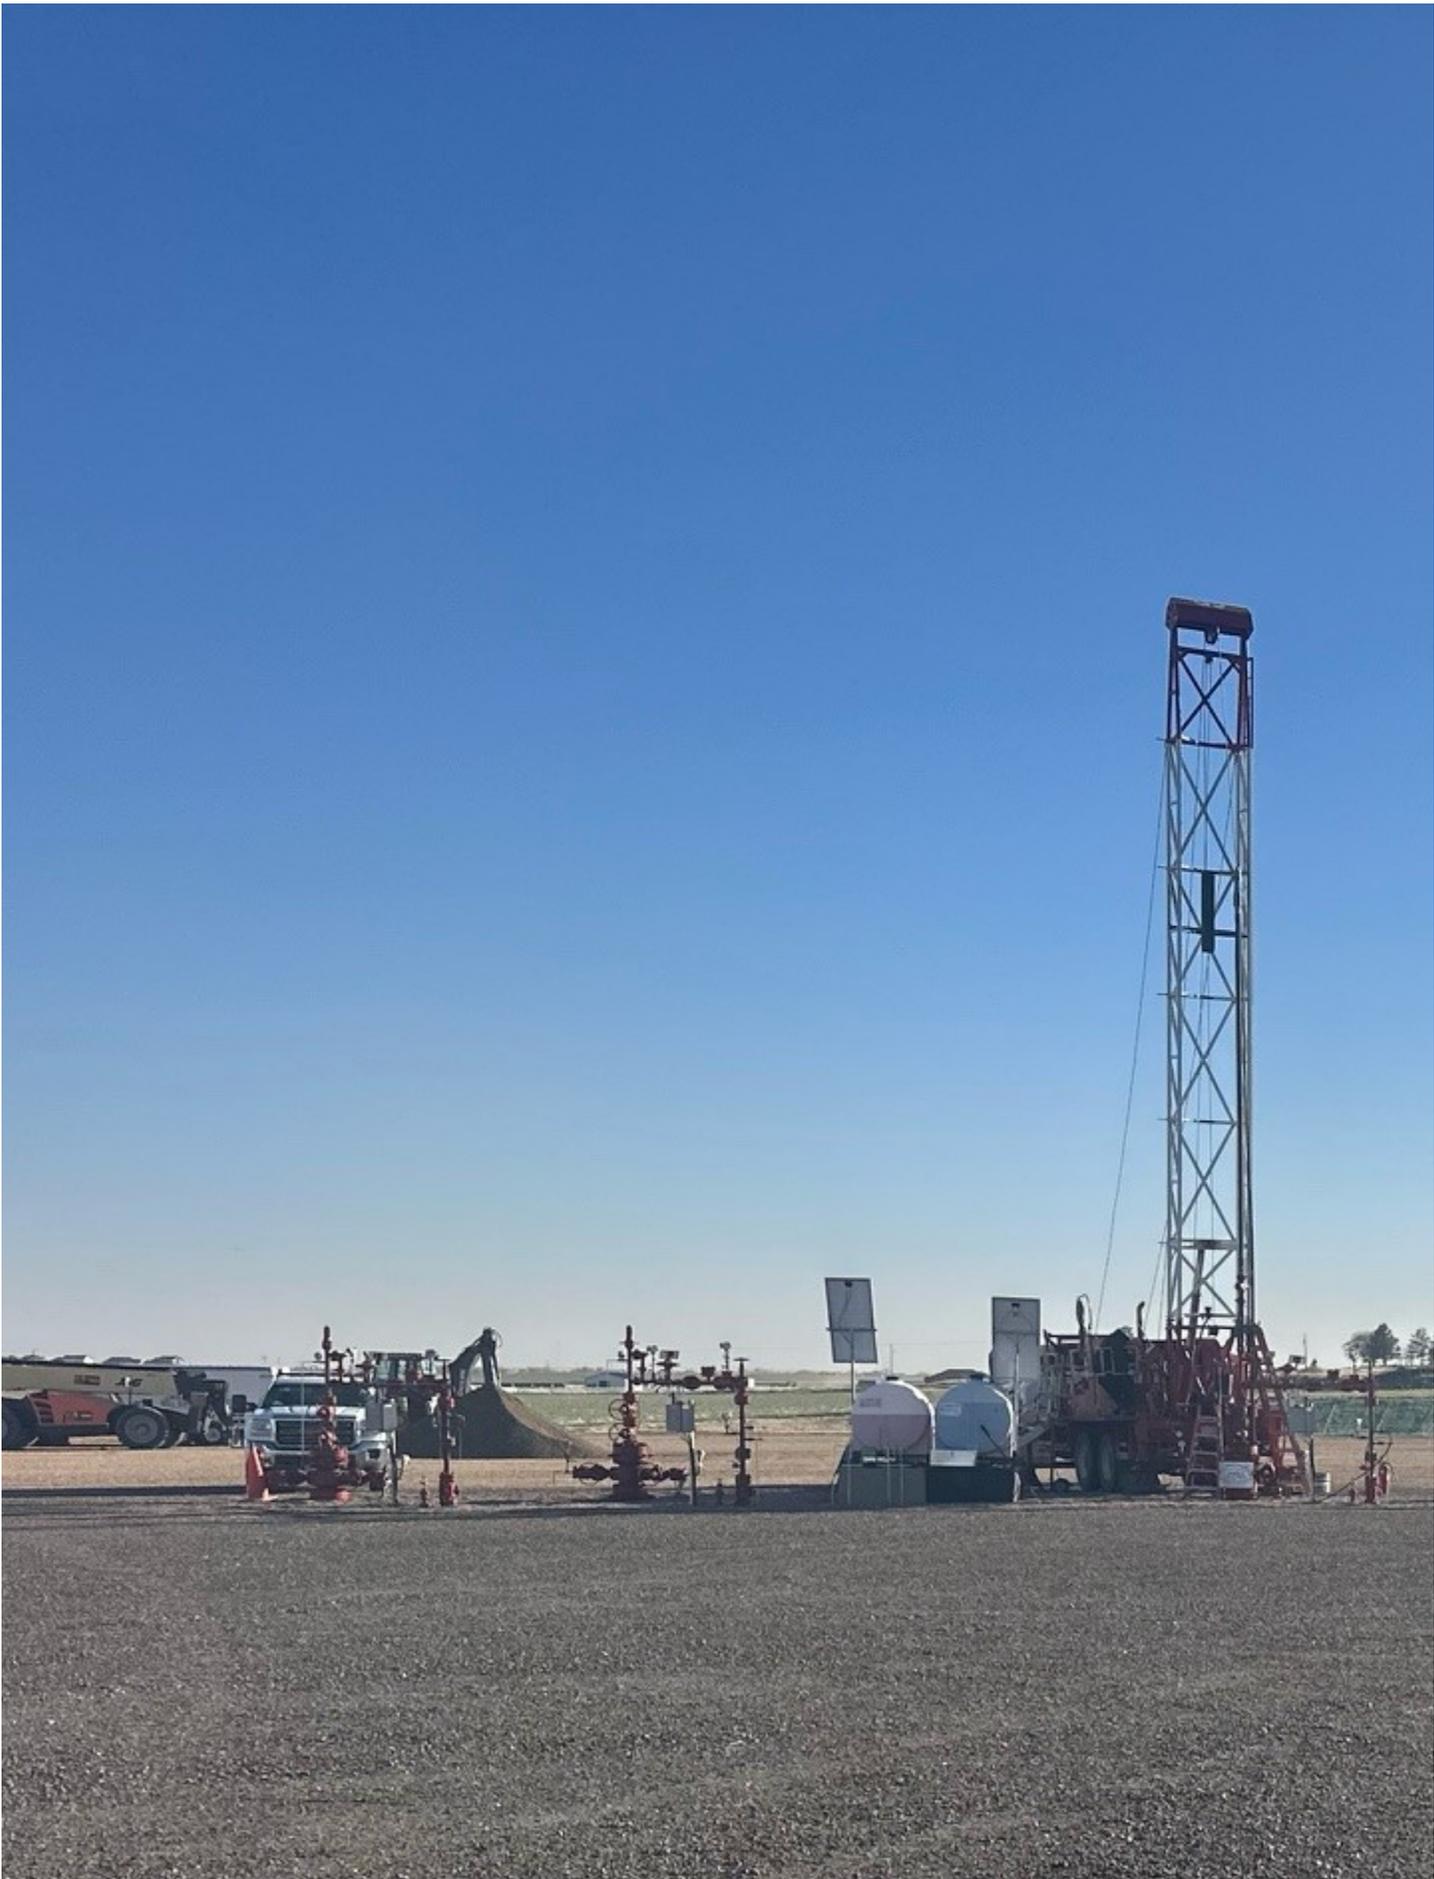
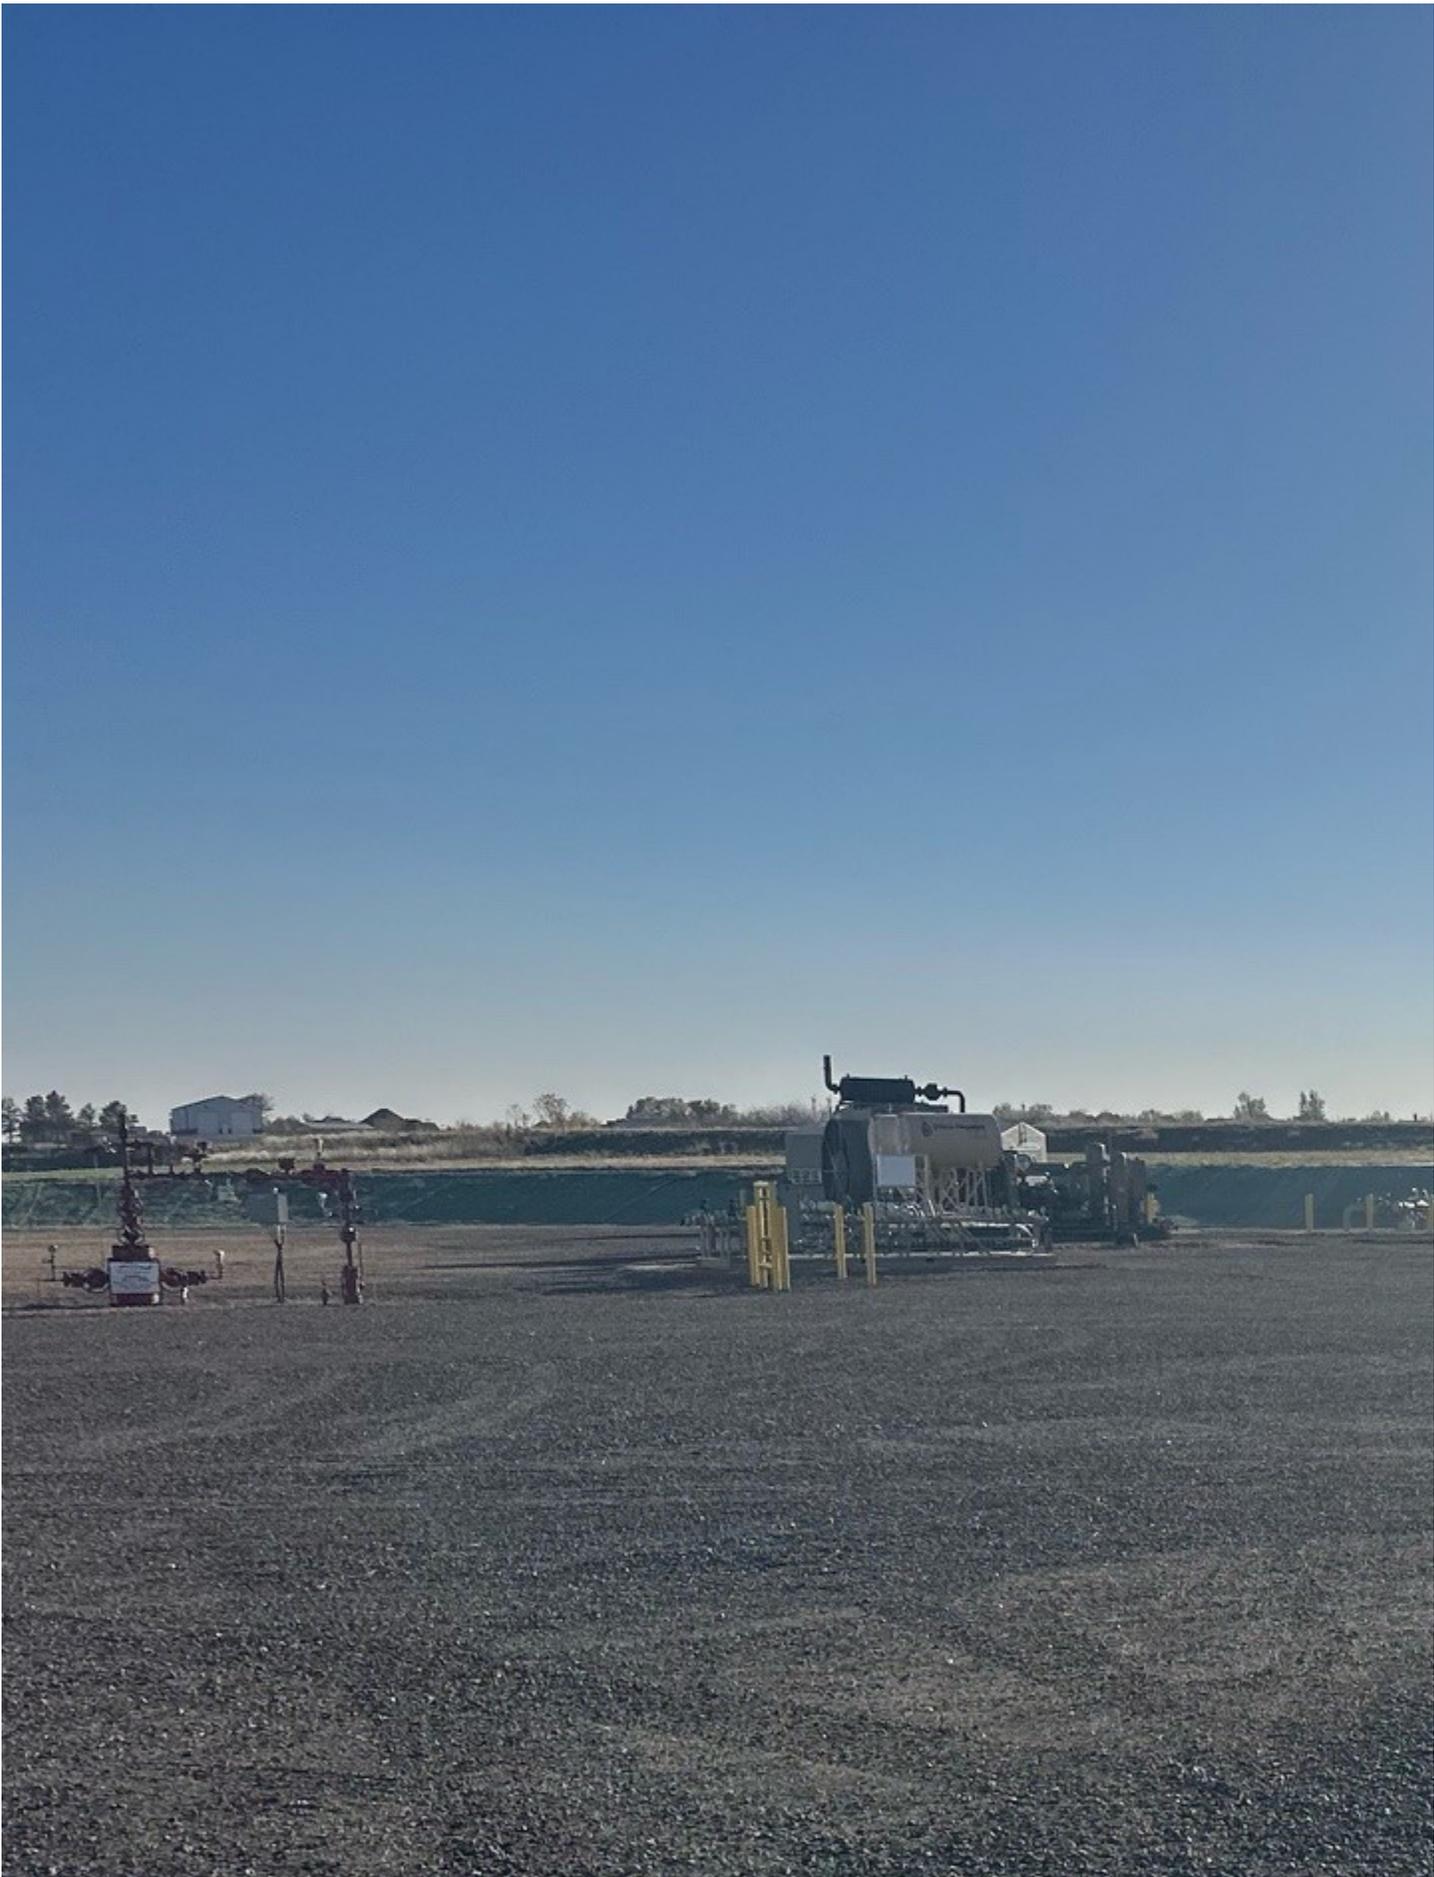
We had a Workover rig on location at the time of inspection as you can see the rig has since moved on the problem pics was coming from the pump skid that needed its packing changed and it was leaking production water and the problem was corrected same day it was found the pics above are the area where the pump skid was and where the rig itself was
