Final Reclamation and Stormwater Inspection

Operator: ANTELOPE ENERGY COMPANY LLC #3250

Location ID: 316746

Inspection Photos
Location Name: STATE-66N89W 15NWNE
Location ID: 316746

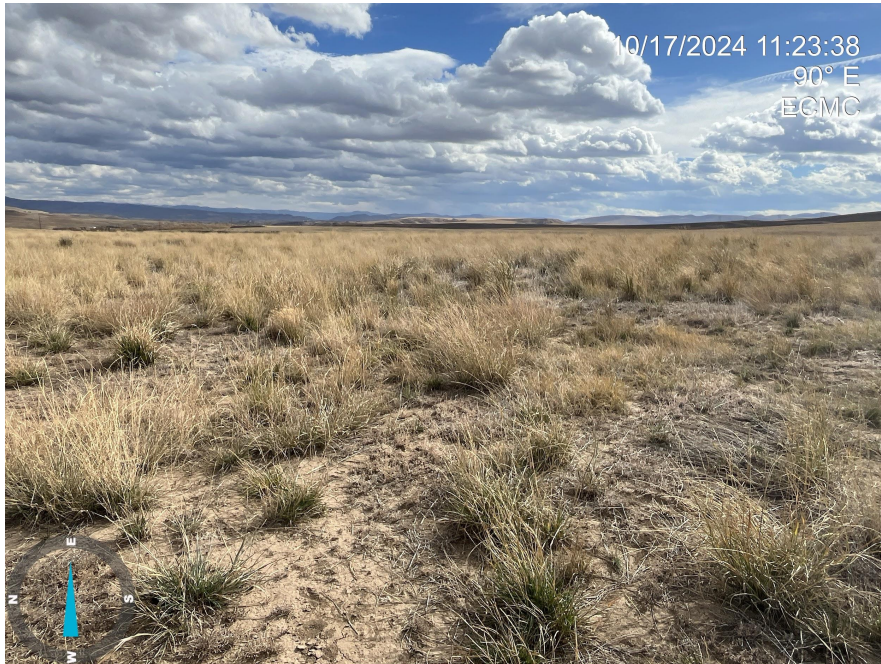
Photo 1. Photo taken from the Location entrance on the west end of the site, facing east. Photo provides an overview of the Location.

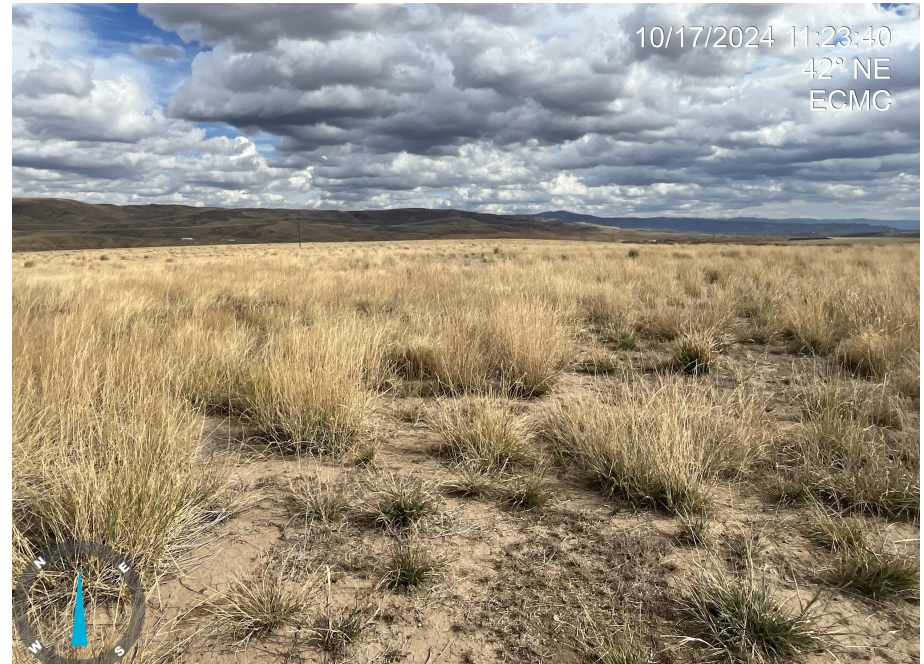
Photo 2. Photo taken the entrance of the Location, facing northeast. Photo illustrates that not all areas have achieved uniform vegetation across the Location.

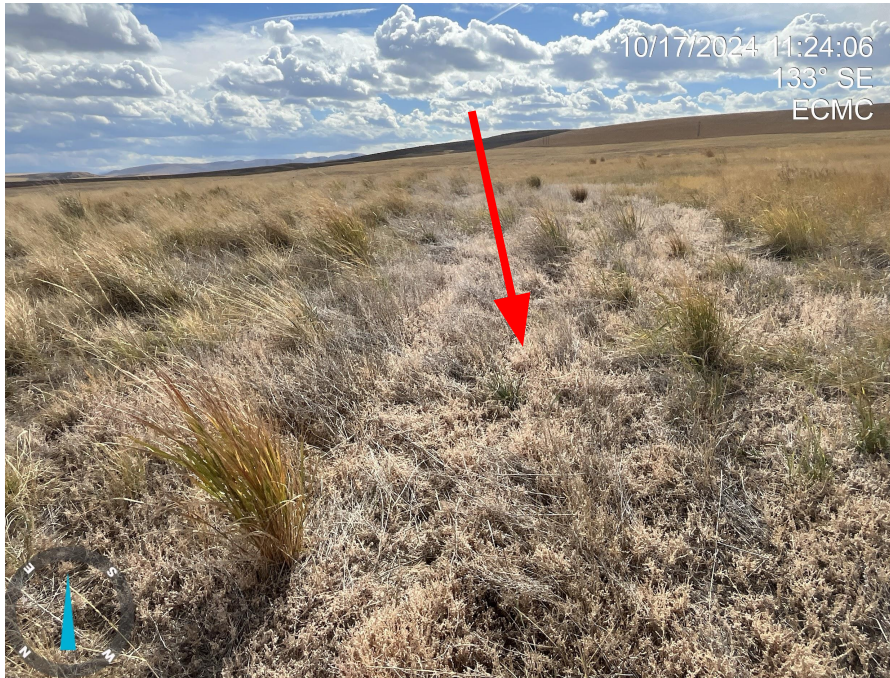
Photo 3. Photo taken from center of Location, facing southeast. Lighter vegetation (red arrow) seen in photo is Kochia, and Undesirable Plant Species not reflective of the reference area vegetation. Location is not progressing towards a uniform, desirable perennial vegetative cover, and additional reclamation efforts are required.

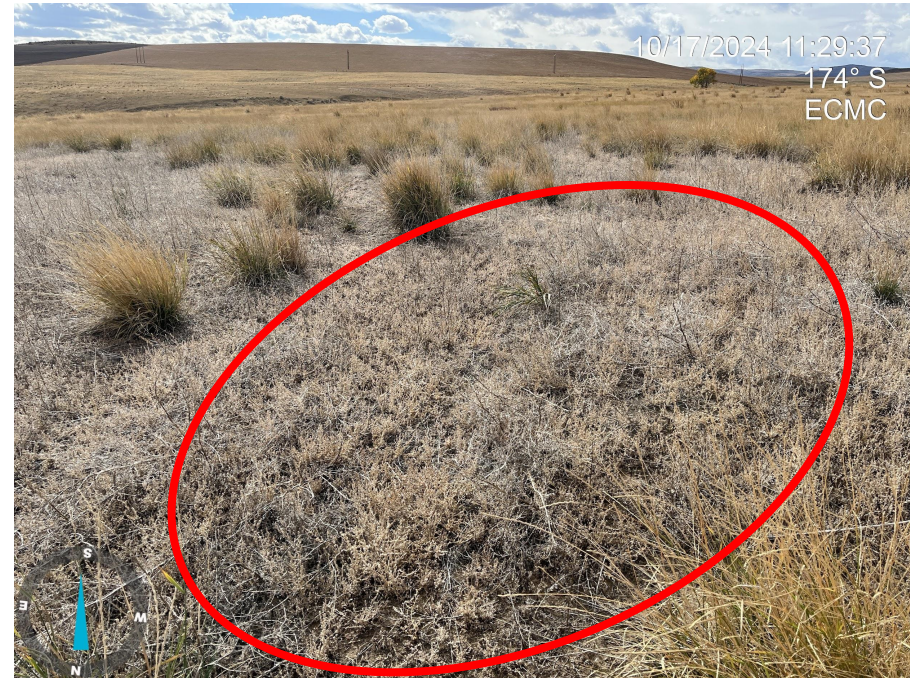
Photo 4. Photo taken from the eastern area of pad, facing south. Photo illustrates dense patches of undesirable plant species, circled in red (kochia).

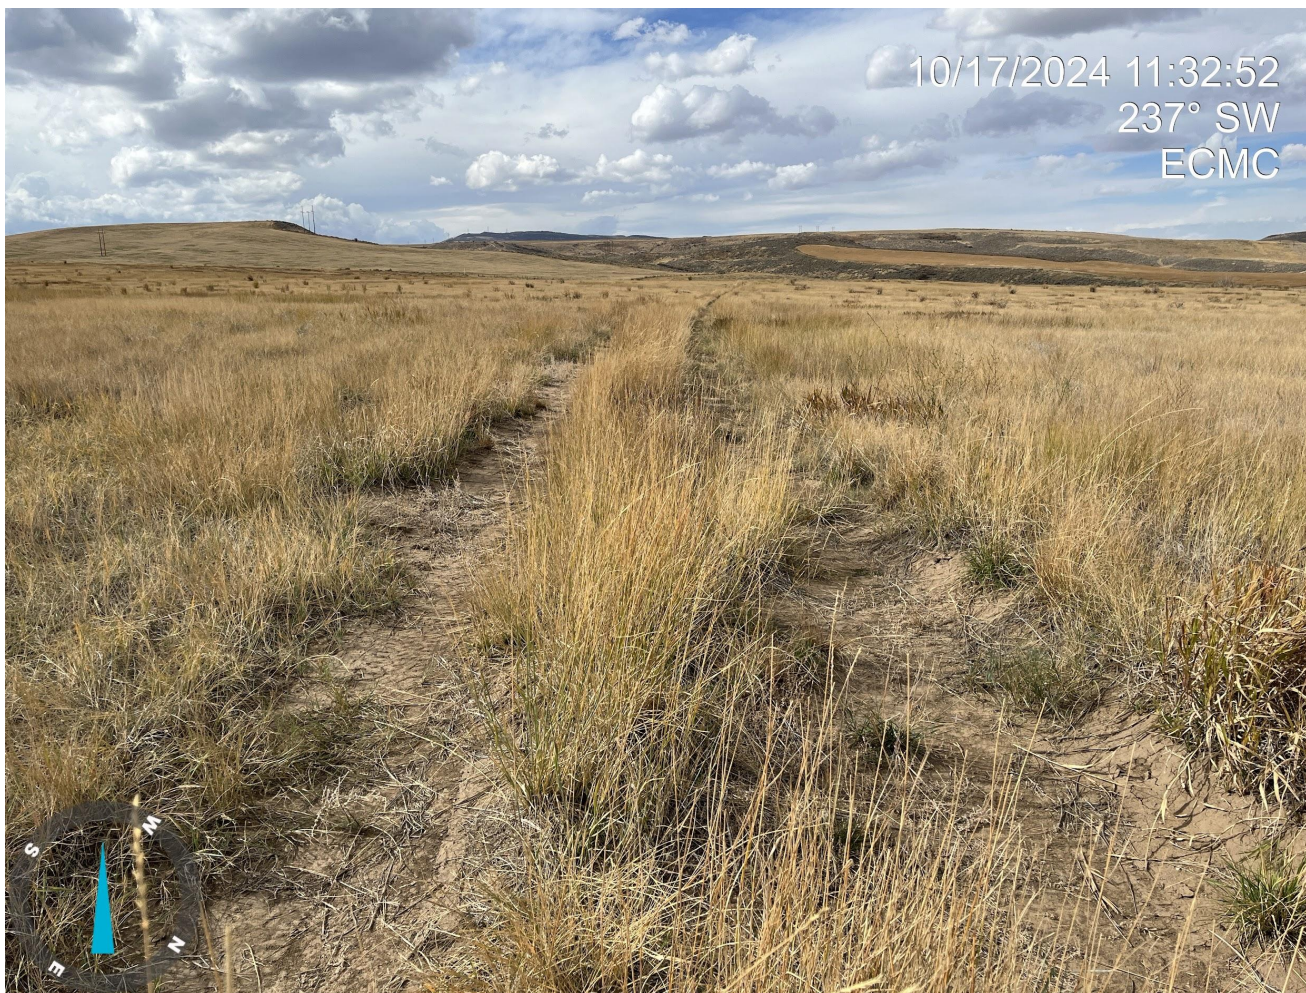
Photo 5. Photo taken from entrance of Location, facing access road towards the southwest. Perennial vegetation is failing to establish in the tracks. Compaction issues likely exist.

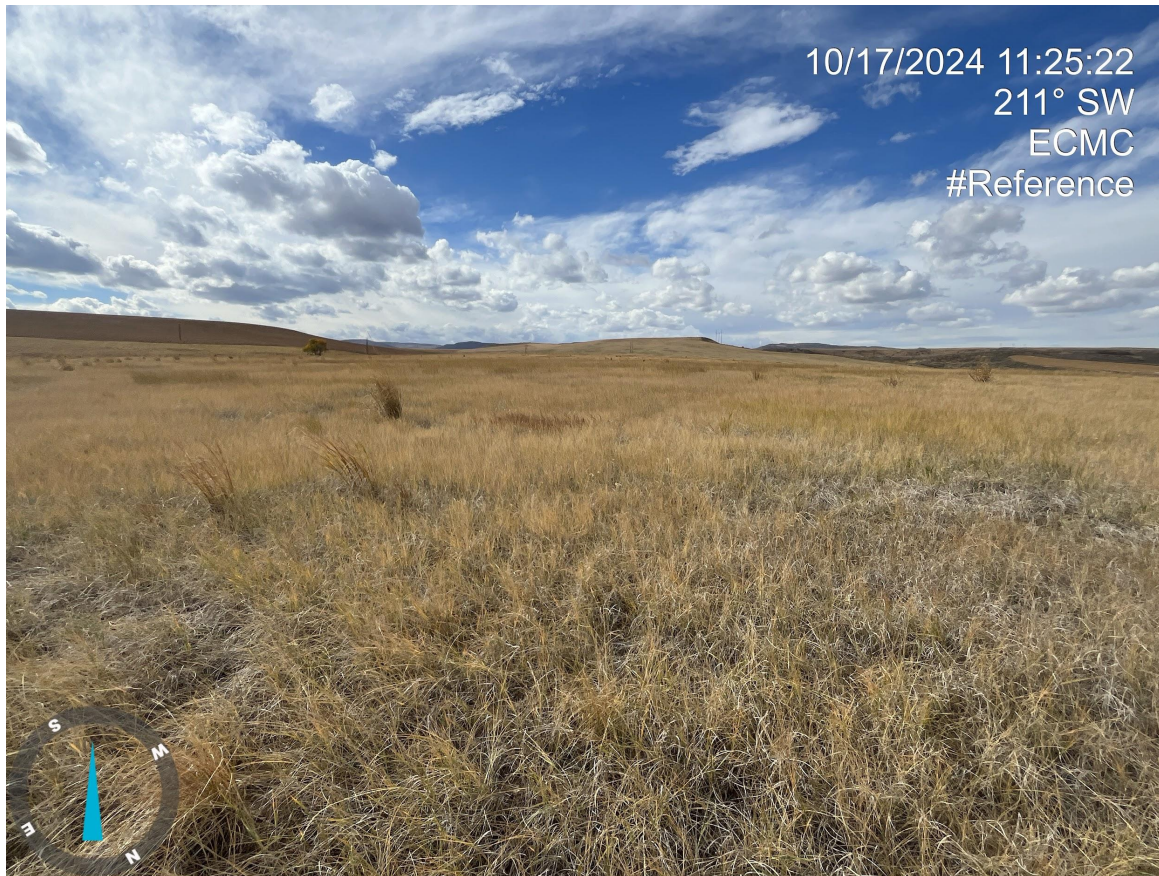
Photo 8. Photo taken from the south of the Location, facing southwest. Photo illustrates reference area vegetation (Western wheatgrass, Basin wildrye).
