# Final Reclamation and Stormwater Inspection

Operator: TRUE OIL LLC #90450

Location ID: 418821

Location Name: Breeze Unit 23-15

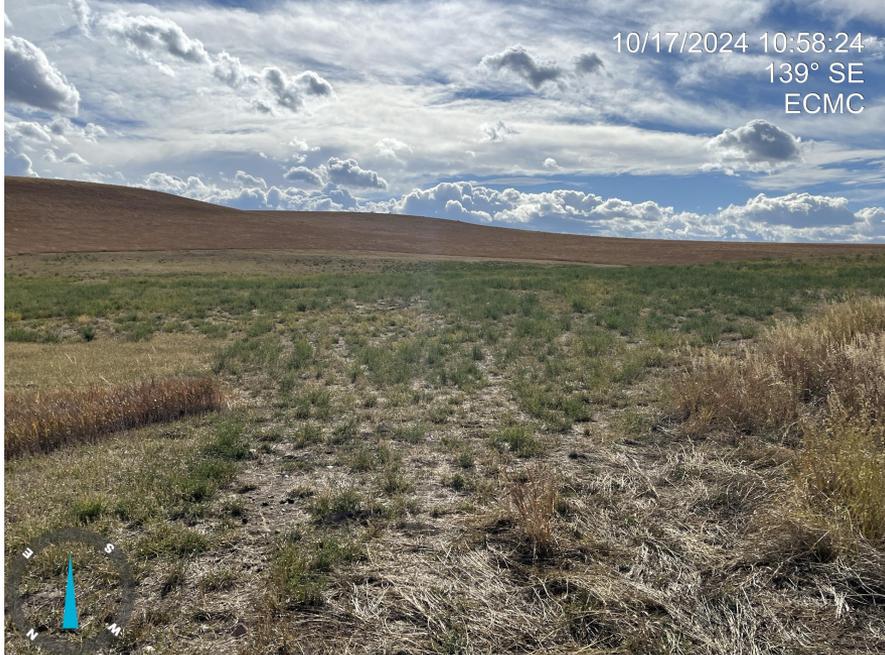
**Photo 1.** Photo taken from the Location entrance on the west end of the site, facing southeast. Photo provides an overview of the Location.

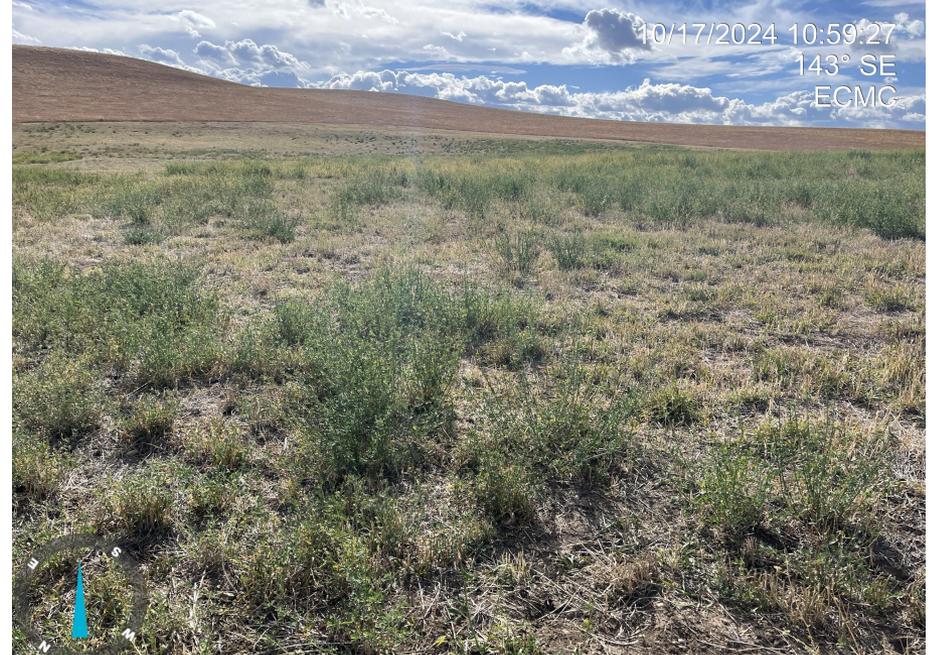
**Photo 2.** Photo taken from the western portion of the Location, facing southeast. Photo illustrates that not all areas have achieved uniform vegetation; vegetation in disturbance (alfalfa, sweet clover) is not reflective of reference area vegetation (smooth brome).

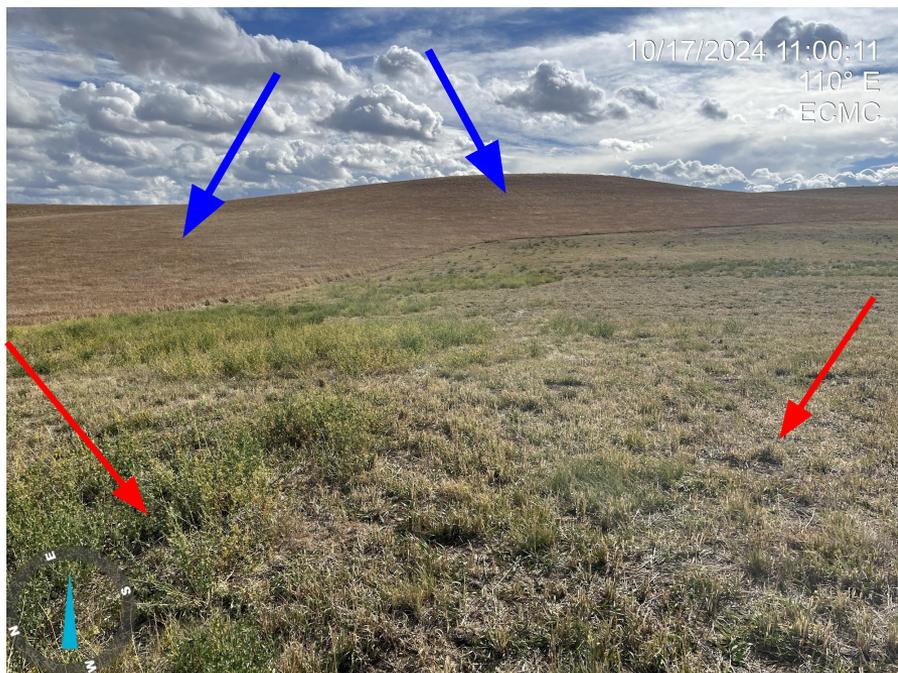
**Photo 3.** Photo taken from center of Location, facing east, illustrating an overview of the location, and indicating differences in the disturbance area (red arrow) and reference area (blue arrow).

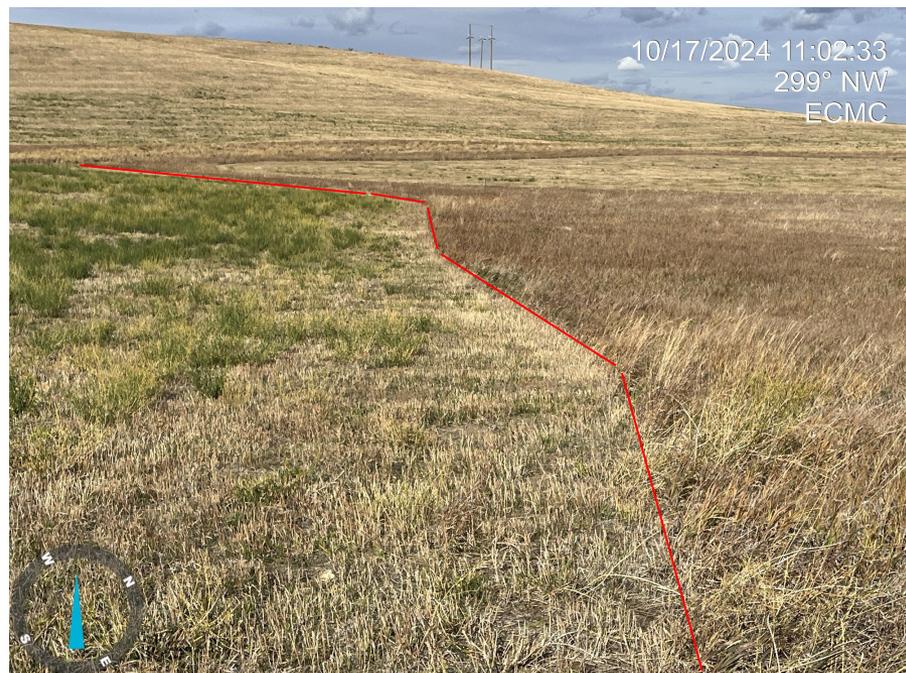
**Photo 4.** Photo taken from the northern area of pad, facing northwest, illustrating the difference between the disturbance and reference area vegetation. Areas to the left of the red line illustrate the disturbance area (sweet clover; alfalfa); areas to the right of the red line illustrate reference area vegetation (smooth brome).

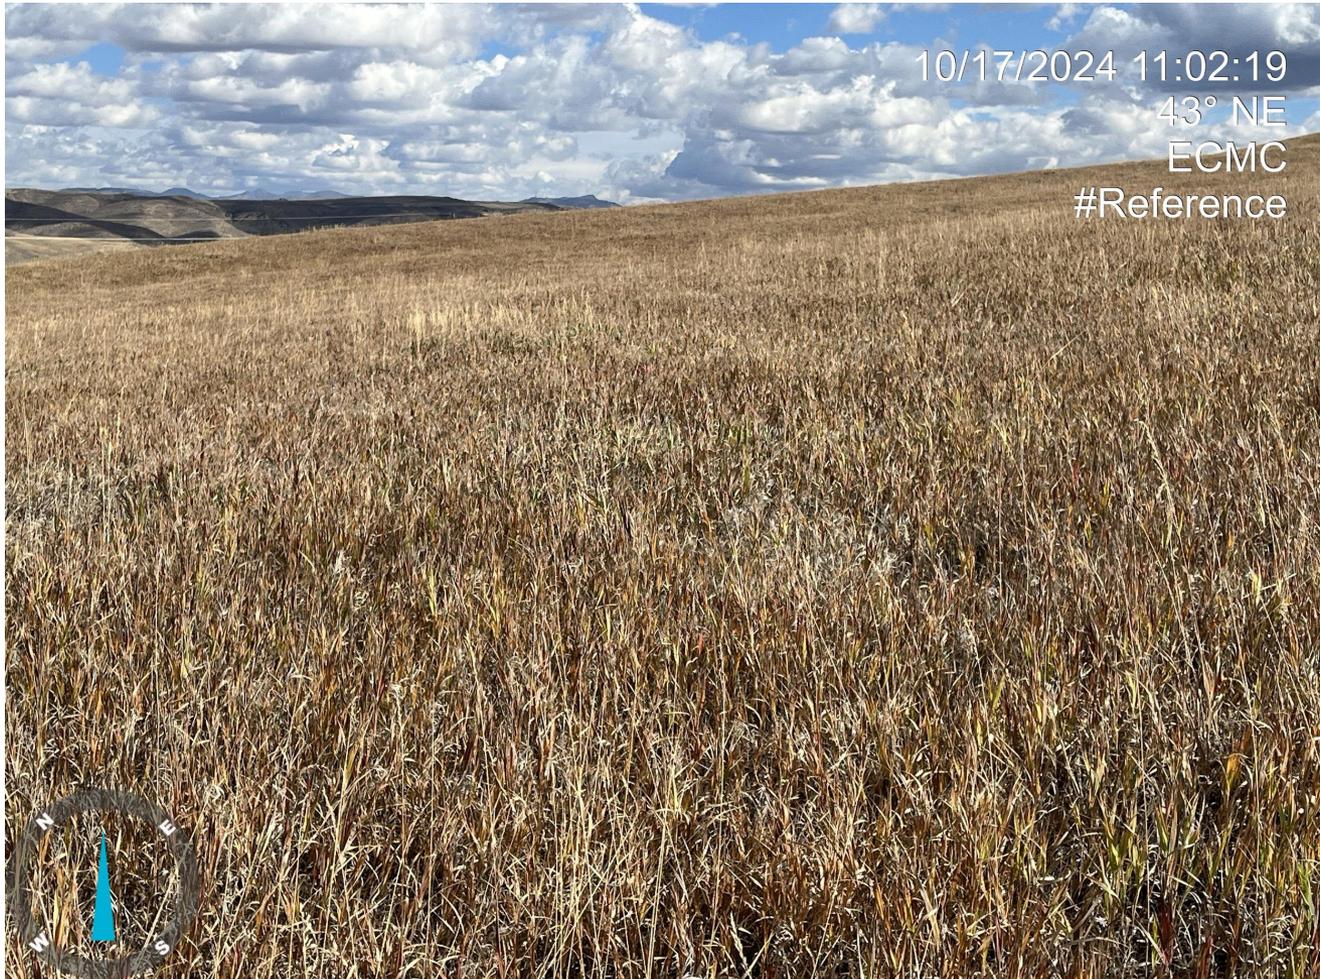
**Photo 5.** Photo taken from northeastern edge of Location, facing reference area. Reference area appears to be mostly Smooth Brome.

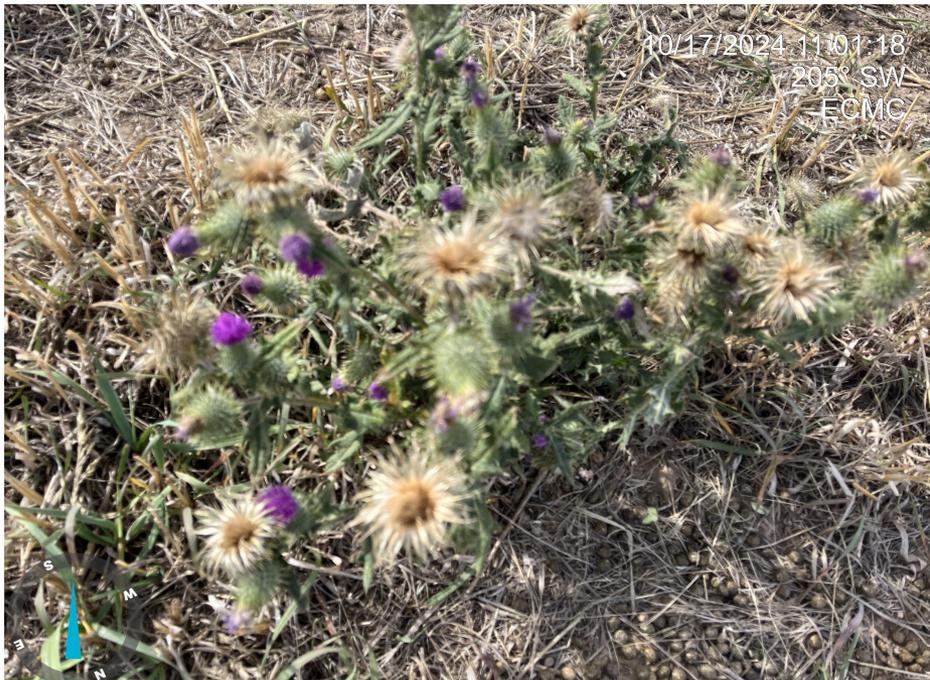
**Photo 6.** Photo illustrates Undesirable weed species (Class B Noxious Weed - Bull Thistle). Comply with Rule 1004.e and Rule 606. Conduct weed management to prevent further establishment and spread of Undesirable Plant Species; ongoing weed management required until location passes final reclamation.

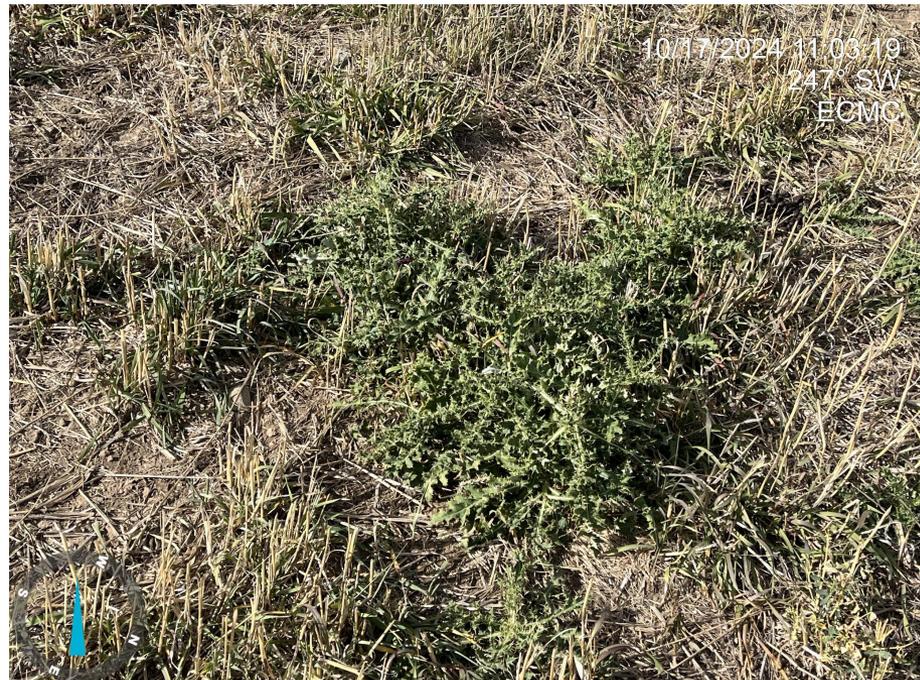
**Photo 7.** Photo illustrates Undesirable weed species (Class B Noxious Weed - Canada Thistle).

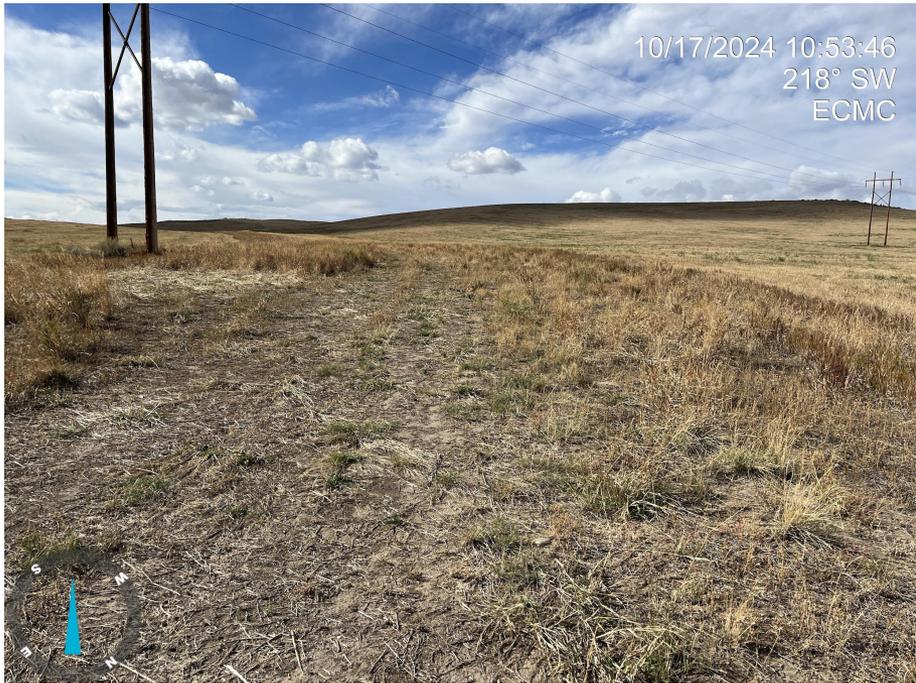
**Photo 8.** Photo taken of access road, facing southwest. It appears that the access road has not been reclaimed; compaction issues likely exist.

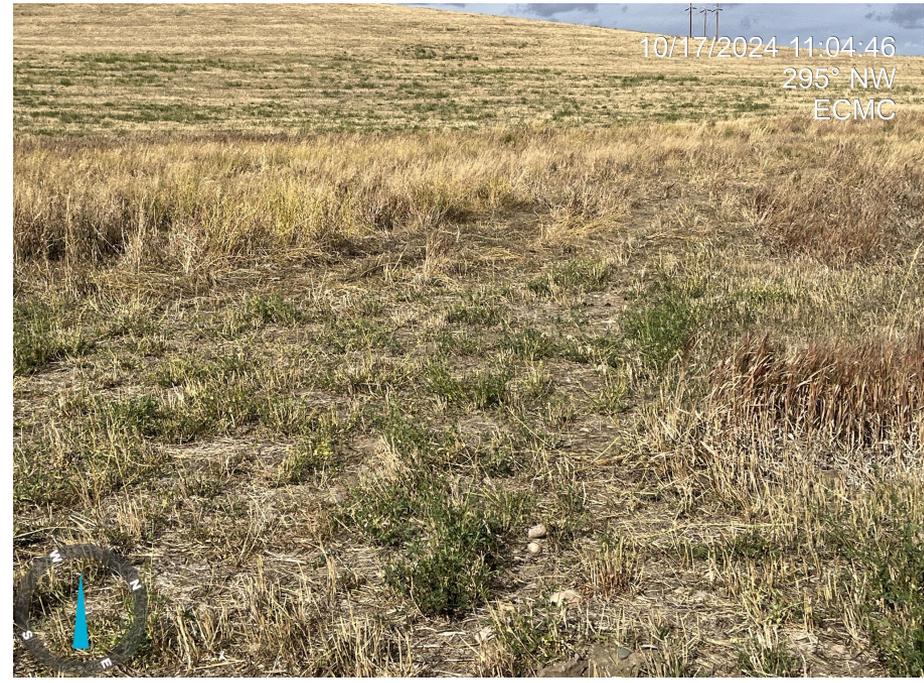
**Photo 9.** Photo taken of access road, facing northwest. Cheatgrass was observed along edges of road.
