# Site Specific Final Reclamation Completion Notice – Cropland Drone Imagery

## Permit Closure Report – Cropland

**Location ID:** 310577

**Location Name:** Maxey/SE-24

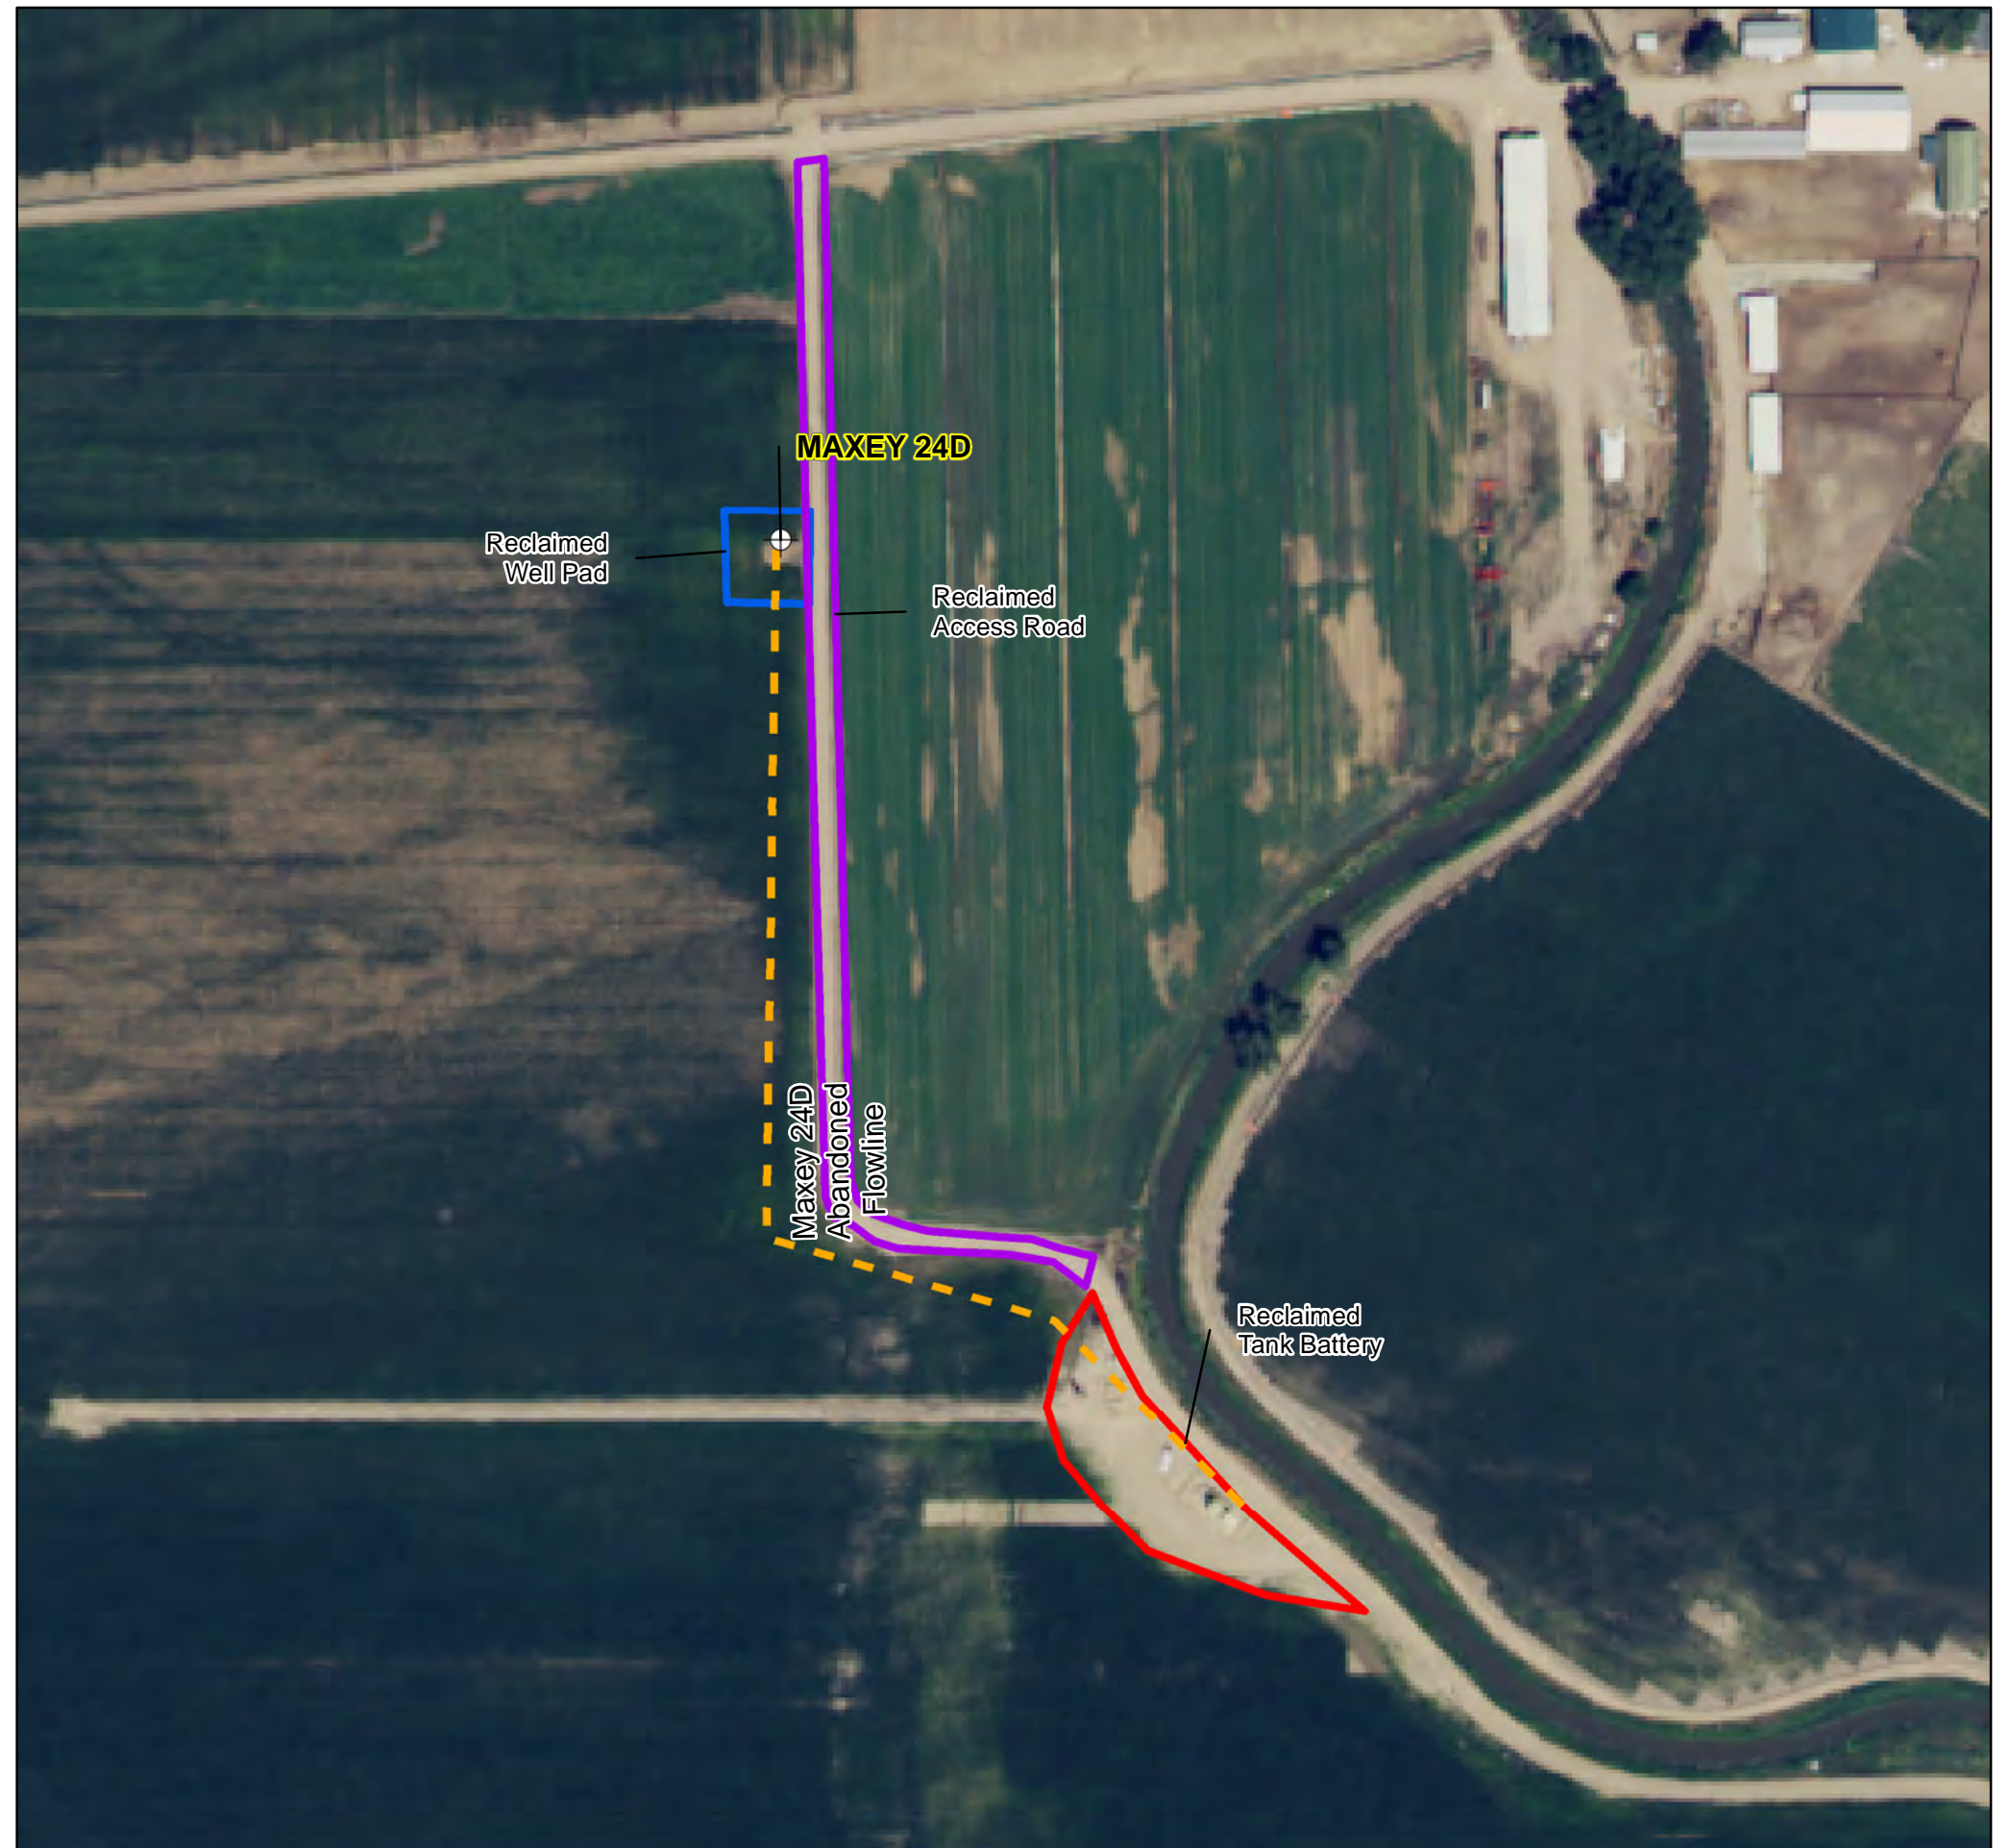
# PDC Form 4 Final Reclamation - Pre Plugging Overview

- Former Tank Battery Disturbance
- Reclaimed Well Pad Disturbance
- Reclaimed Access Road Disturbance
- Flowline - Abandoned
