# Inspection Photos

Loc: 483886

Operator: BNL (ENTERPRISE) INC

Inspection Date: 12/16/2024

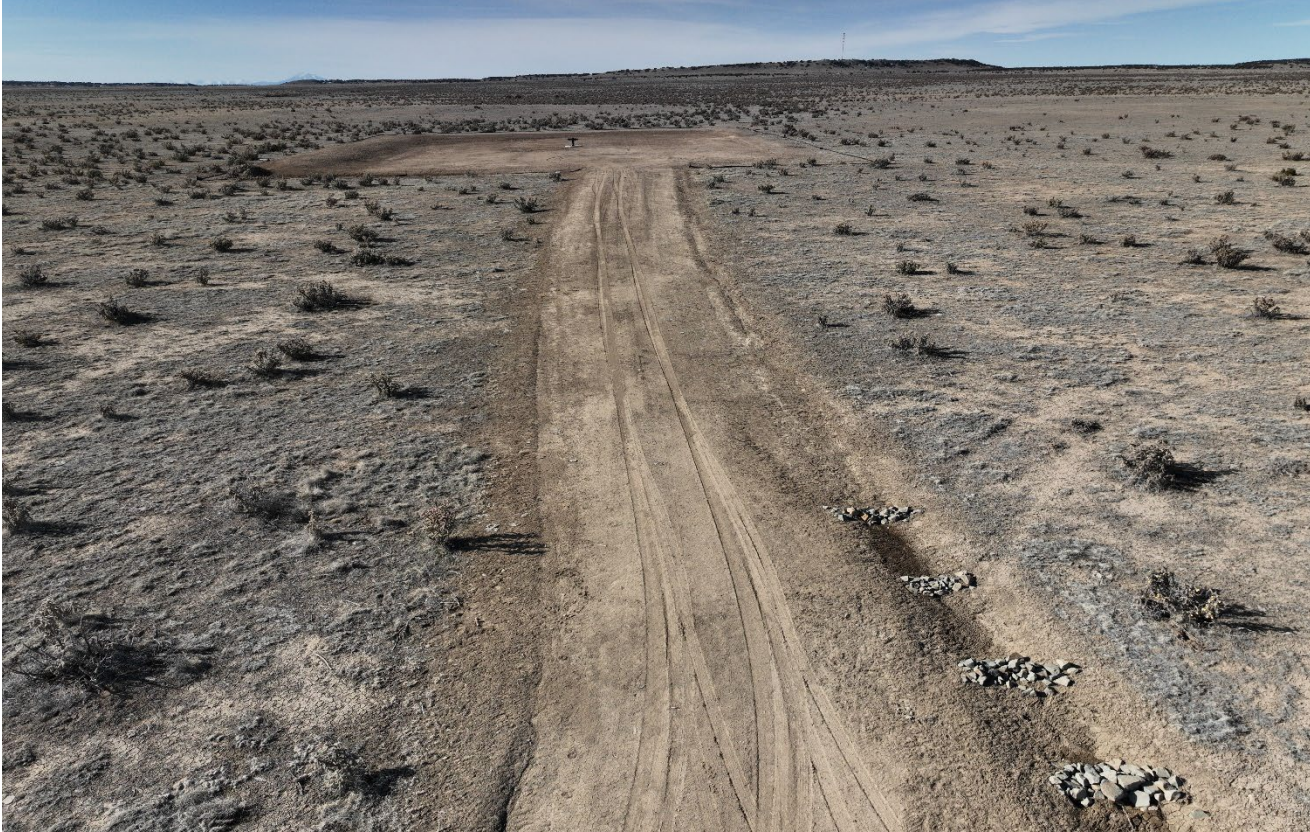
**Photo 1.** Drone aerial image facing west along the access road.

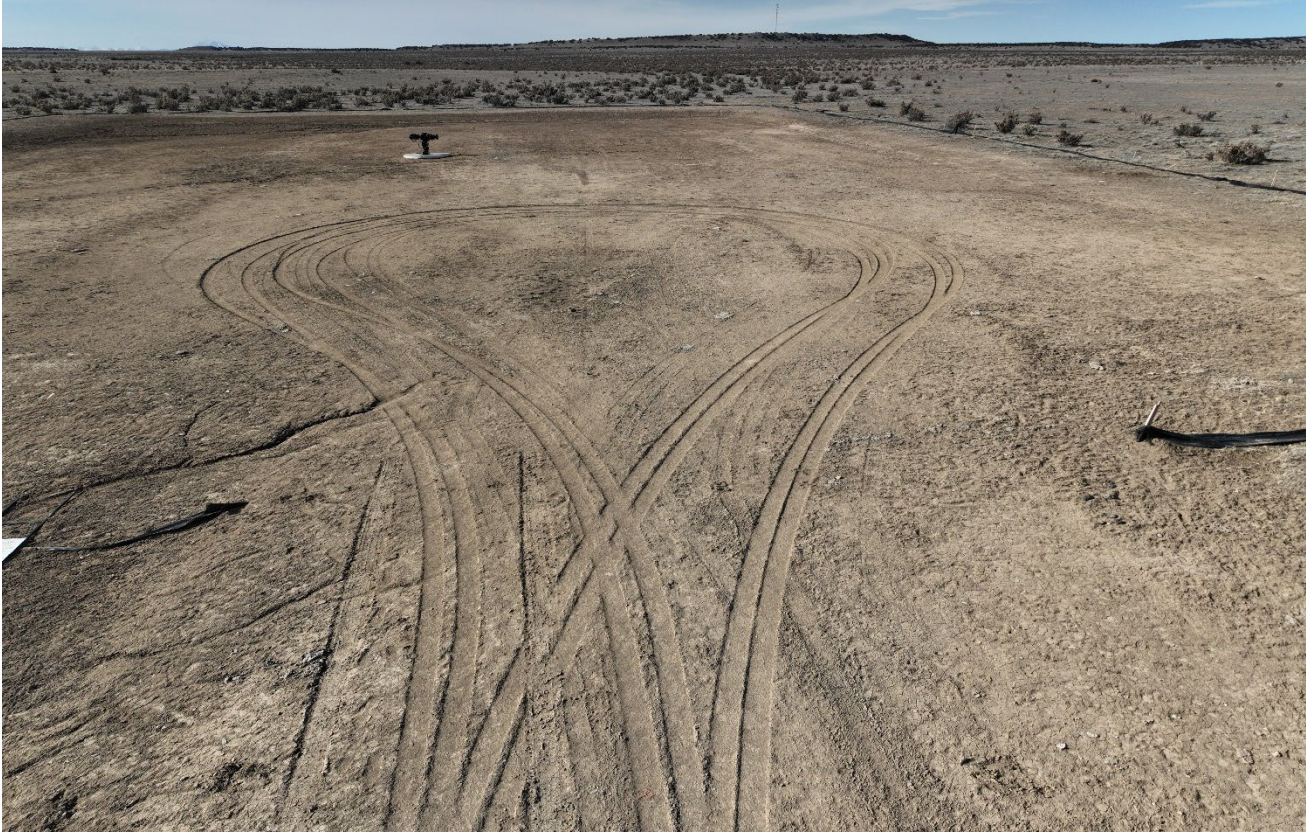
**Photo 2.** Facing west toward the location.

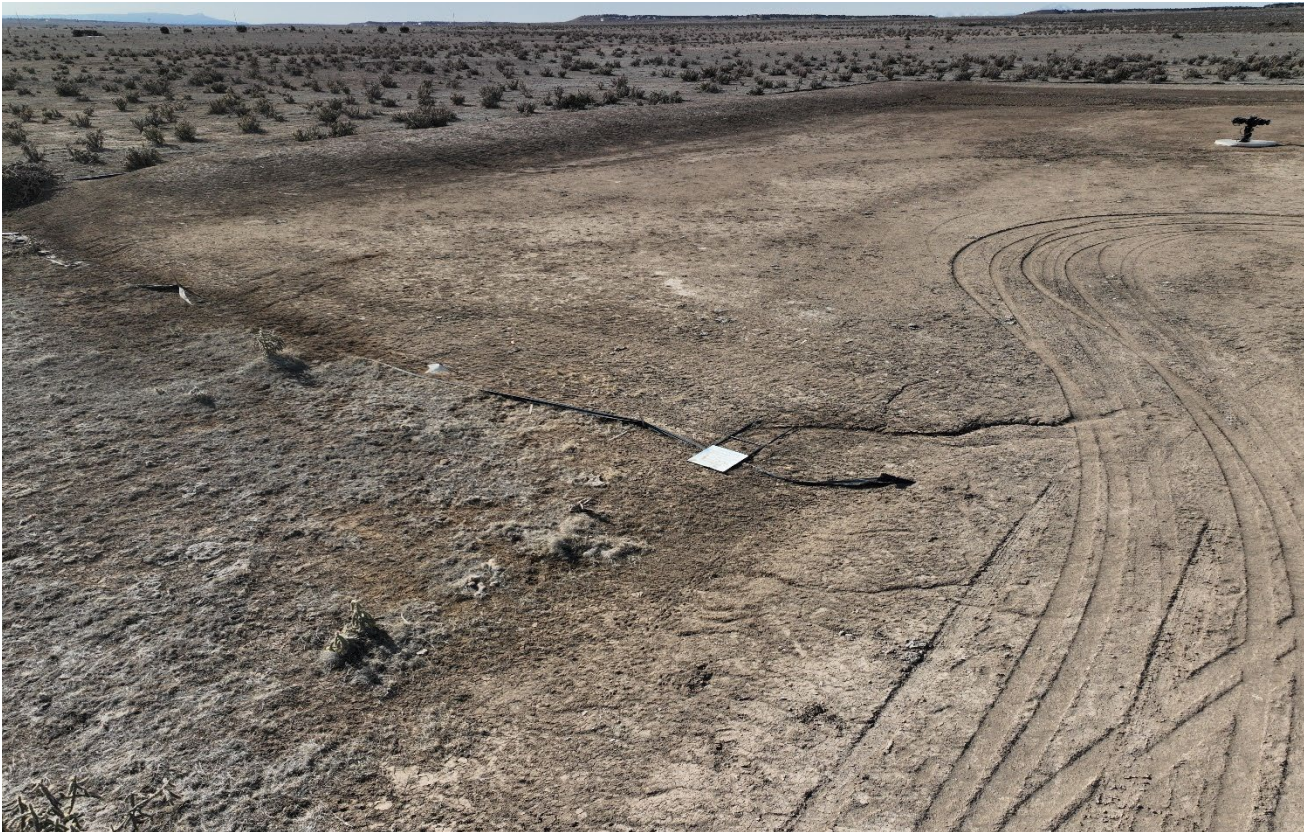
**Photo 3.** Facing southwest toward the location. The sign has fallen over and the silt fence is down and not maintained. Previous CA was not completed.

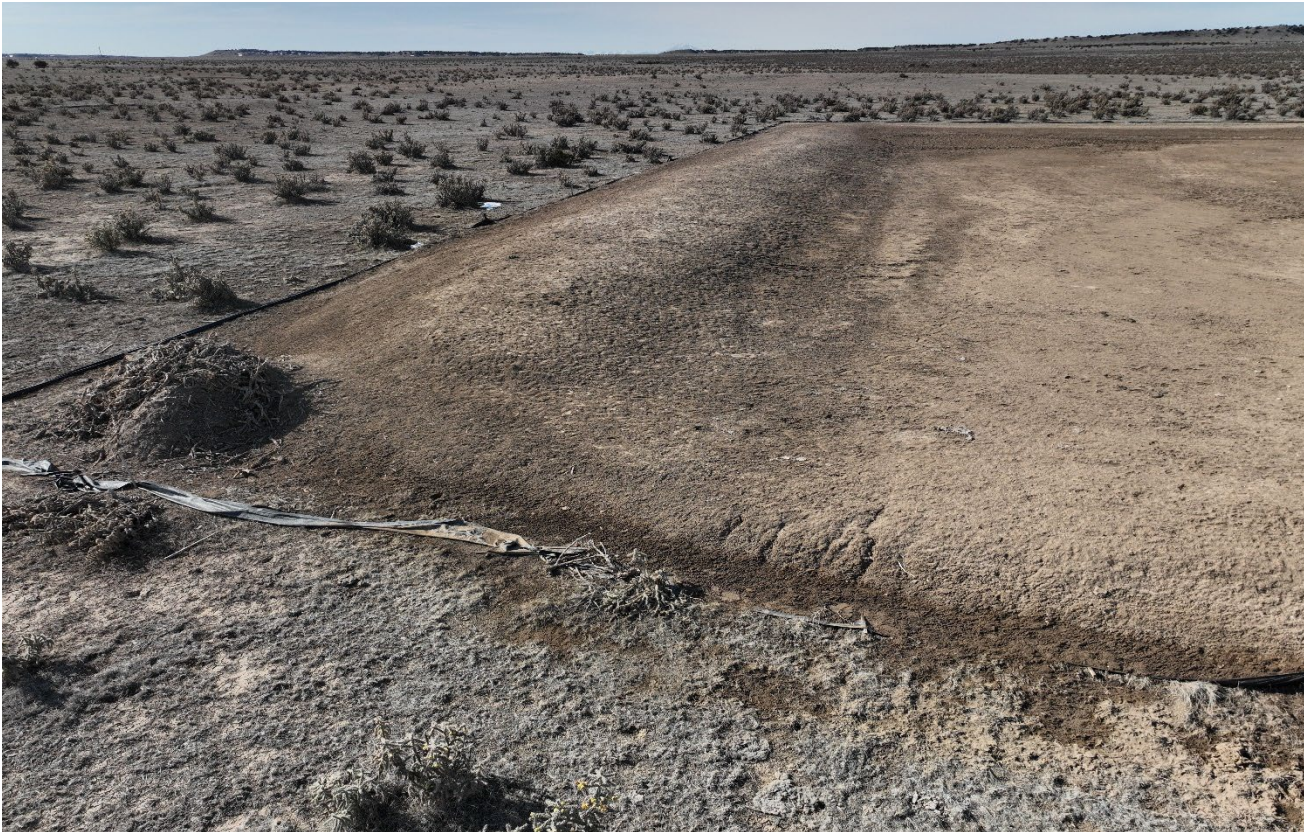
**Photo 4.** Southeast corner of the location facing southwest. The silt fence is down and not maintained. The pile of debris in the corner has not been removed.

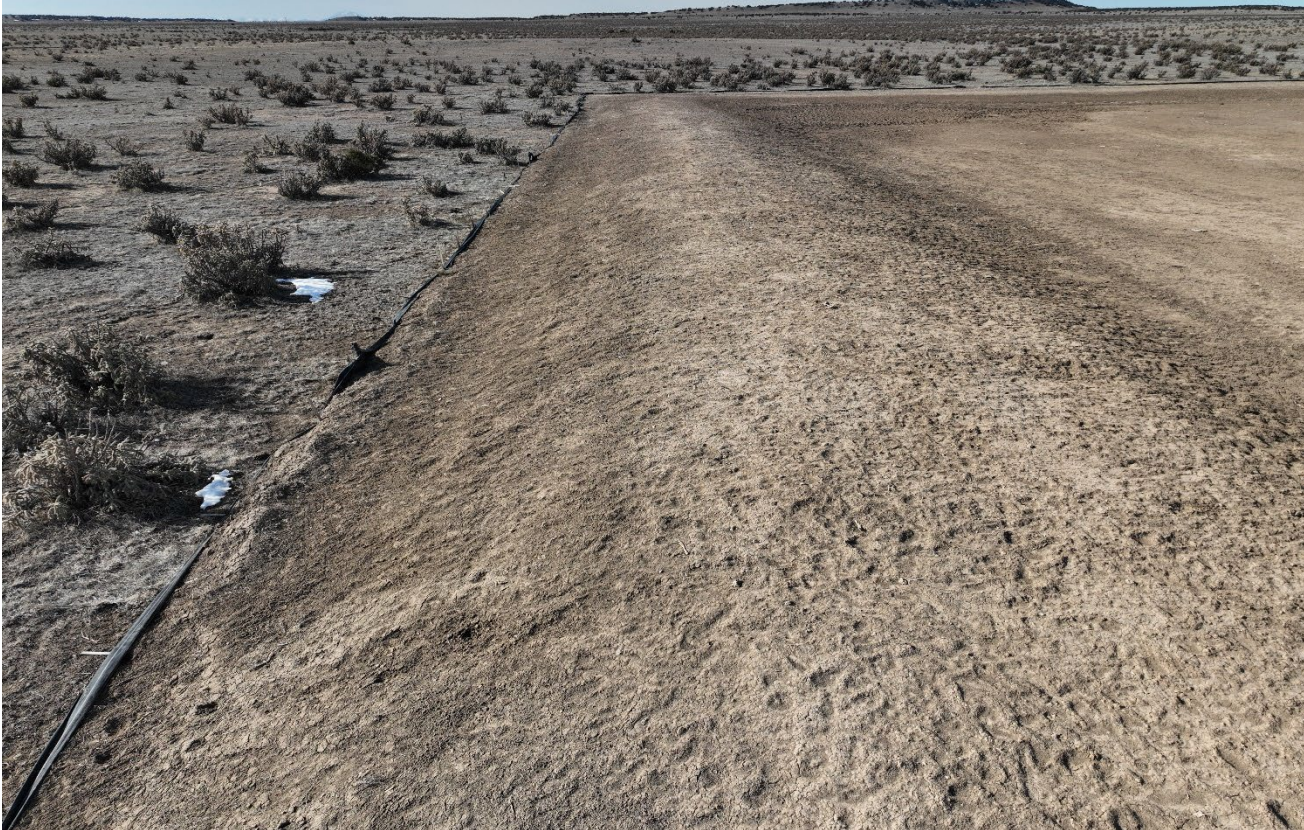
**Photo 5.** Facing toward the soil stock pile. The topsoil has not been seeded and stabilized and the silt fence is in disrepair.

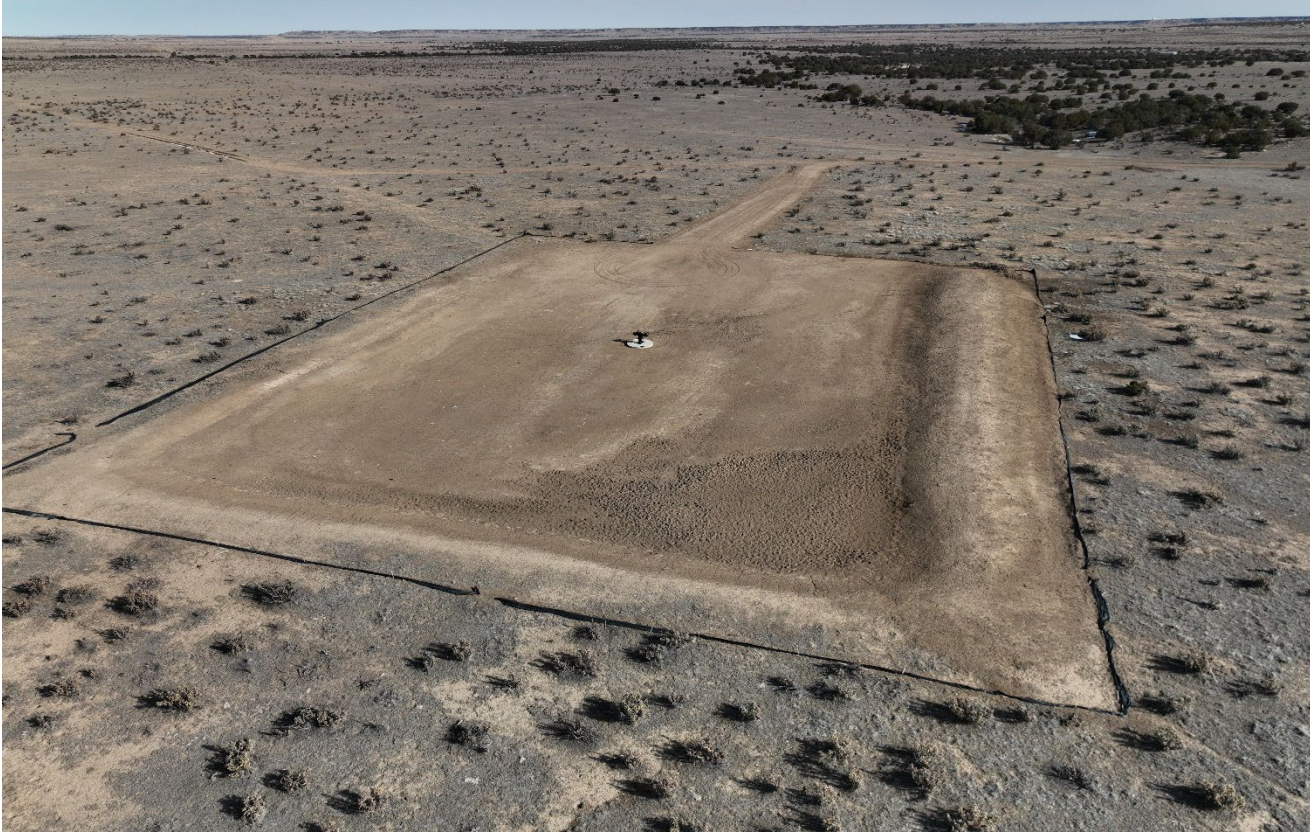
**Photo 6.** Drone aerial image overlooking the location toward the northeast.

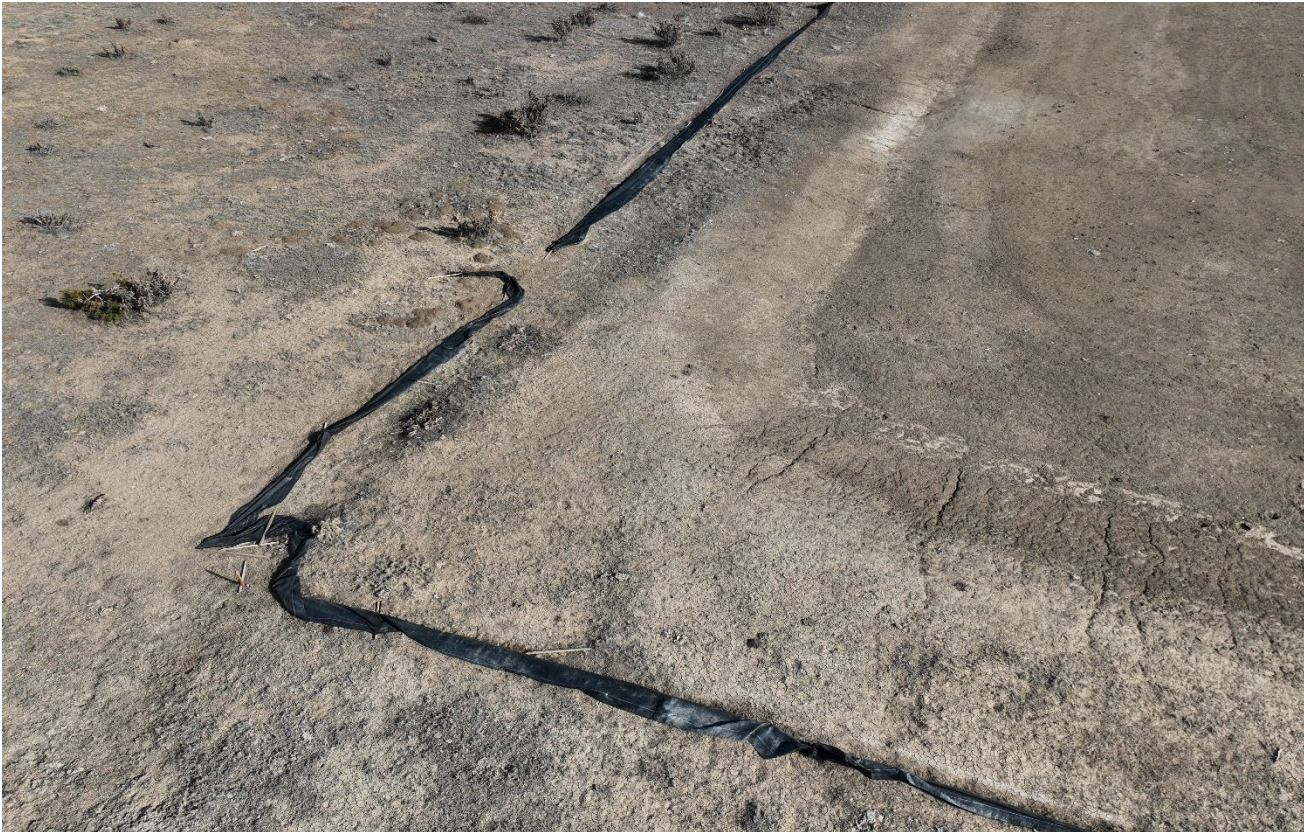
**Photo 7.** Facing down toward the northwest corner showing the silt fence is not maintained and there is erosion riling along the cut slope.
