Inspection Photos

Loc: 485654

Operator: BNL (ENTERPRISE) INC

Inspection Date: 12/16/2024

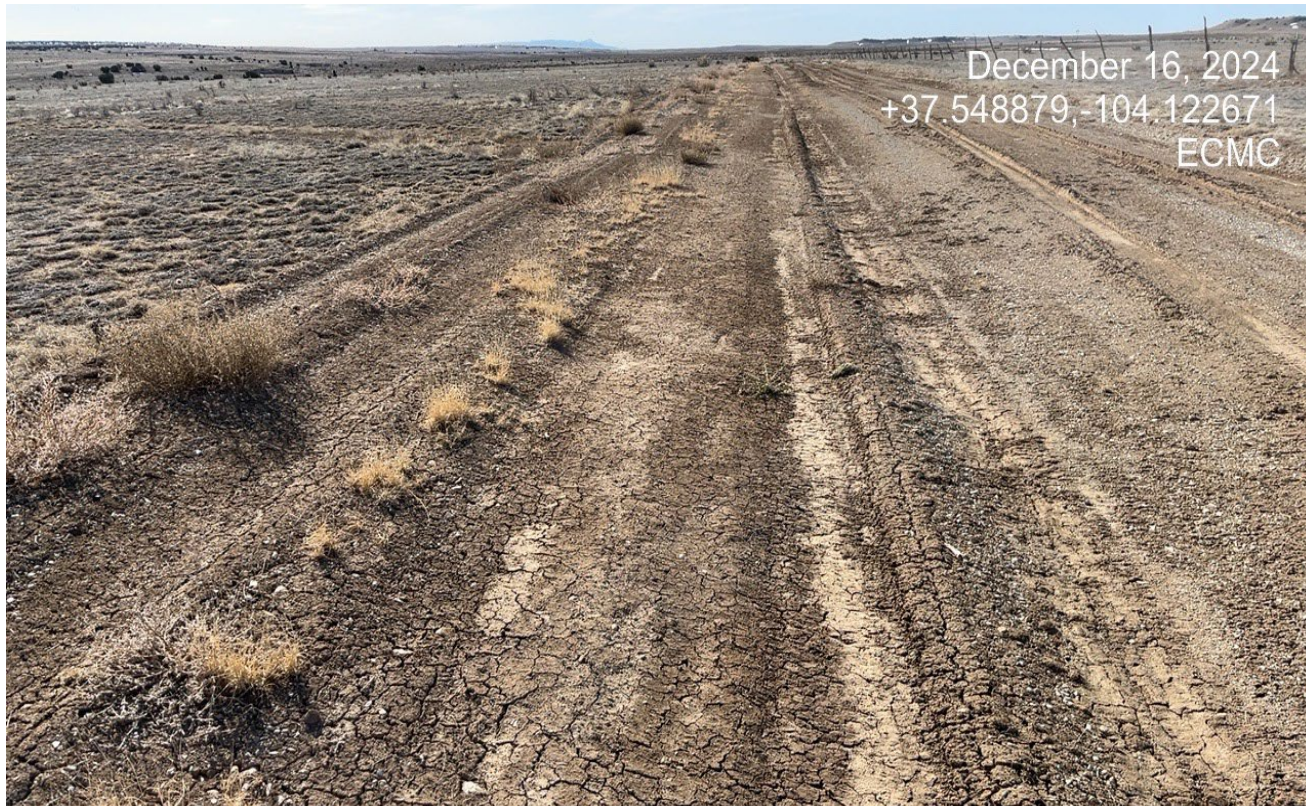
Photo 1. Facing south along the access road. The sides of the road will need to be reclaimed. Previous Ca for stabilization was not completed.

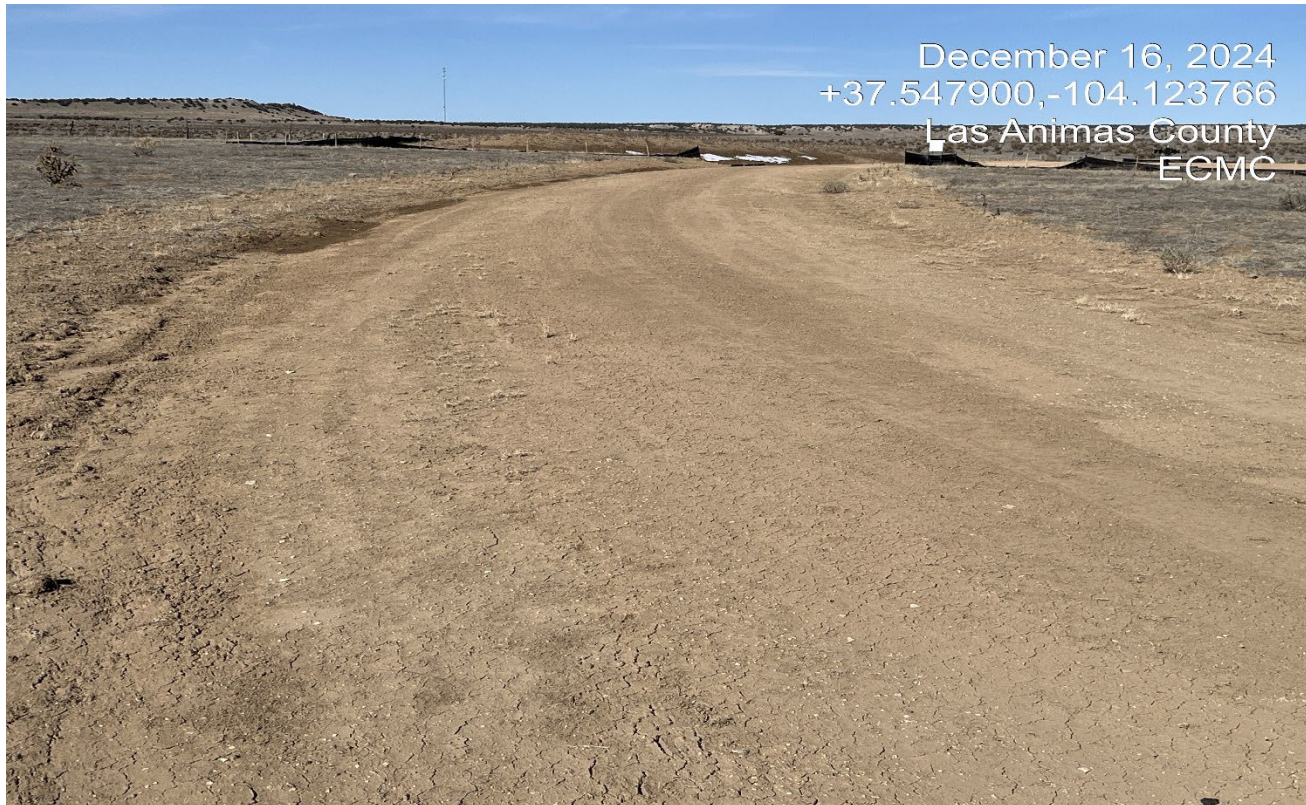
Photo 2. Facing west toward the access road. The side of the road needs to be seeded and stabilized. Previous corrective action was not completed.

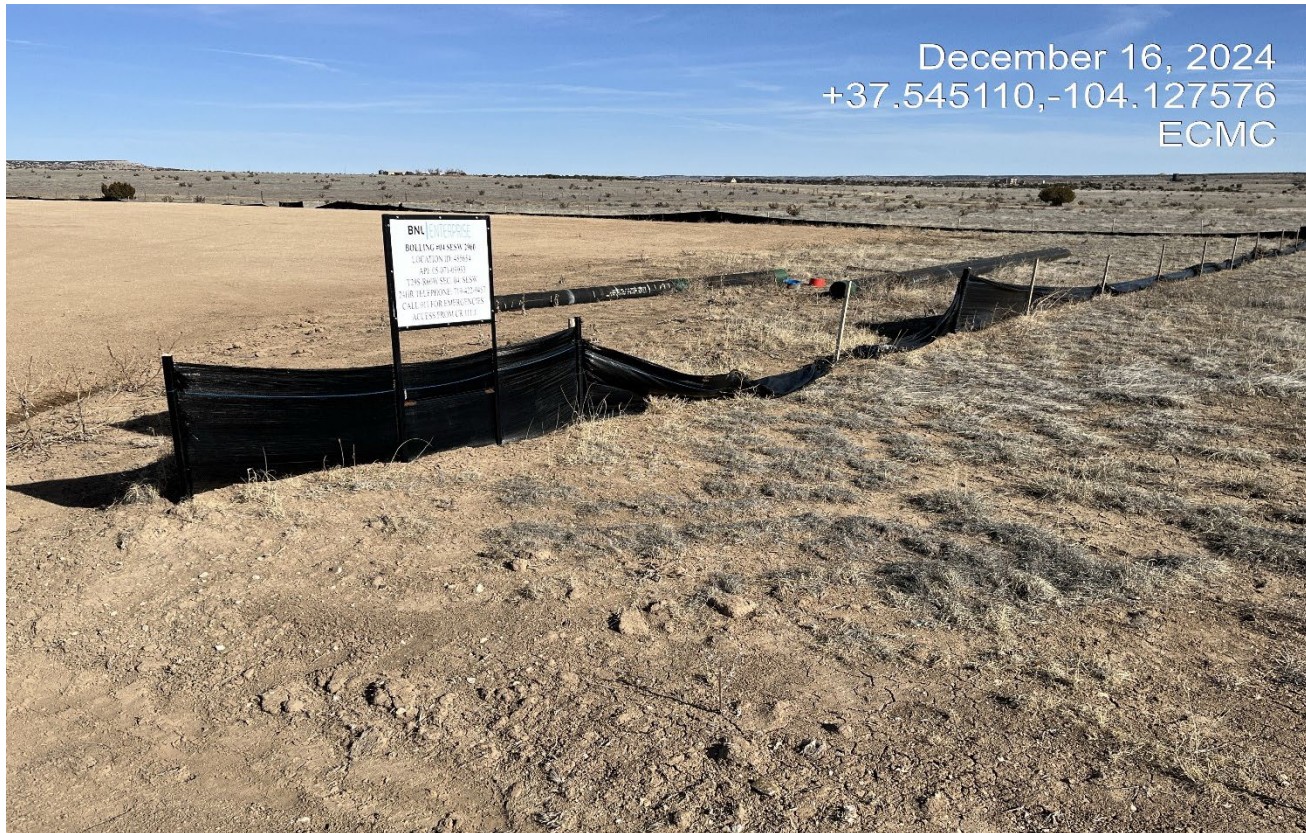
Photo 3. Facing northwest toward the location. Sign posted at entrance. The silt fence is not maintained. Unused equipment and pipe have not been removed.

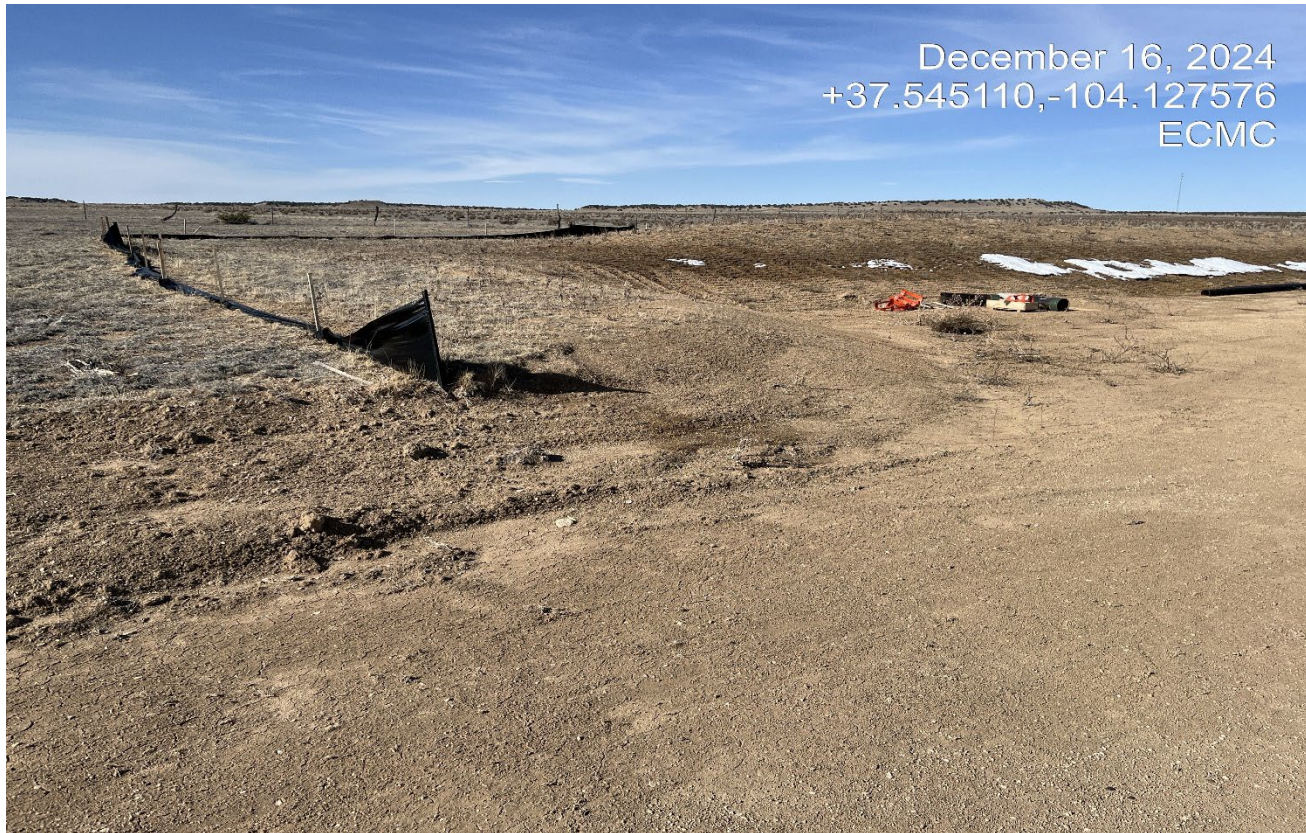
December 16, 2024
+37.545110,-104.127576
ECMC

Photo 4. Facing southwest at the location. The silt fence is not maintained. Unused equipment and pipe have not been removed.

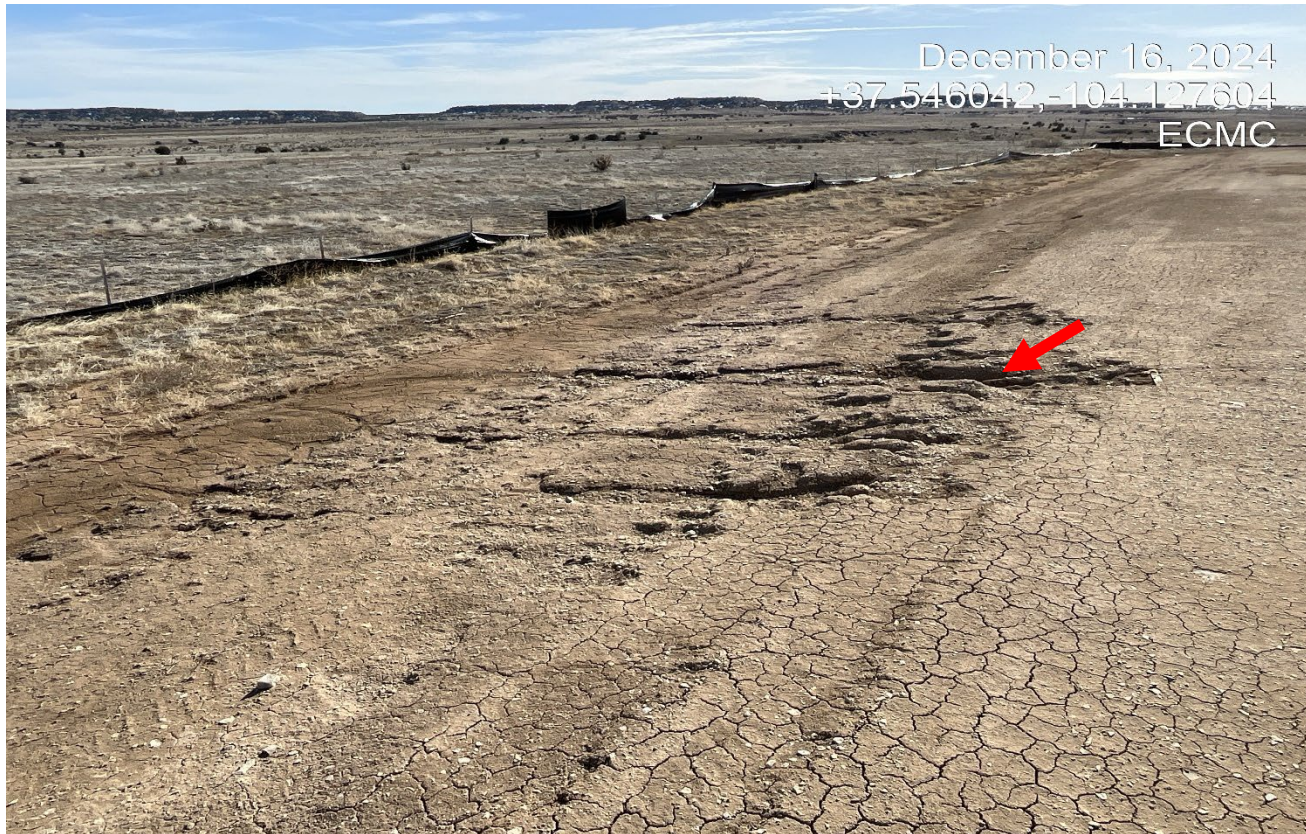
Photo 5. Facing southeast along the fill slope. There is erosion occurring shown at red arrow. Silt fence is not maintained.

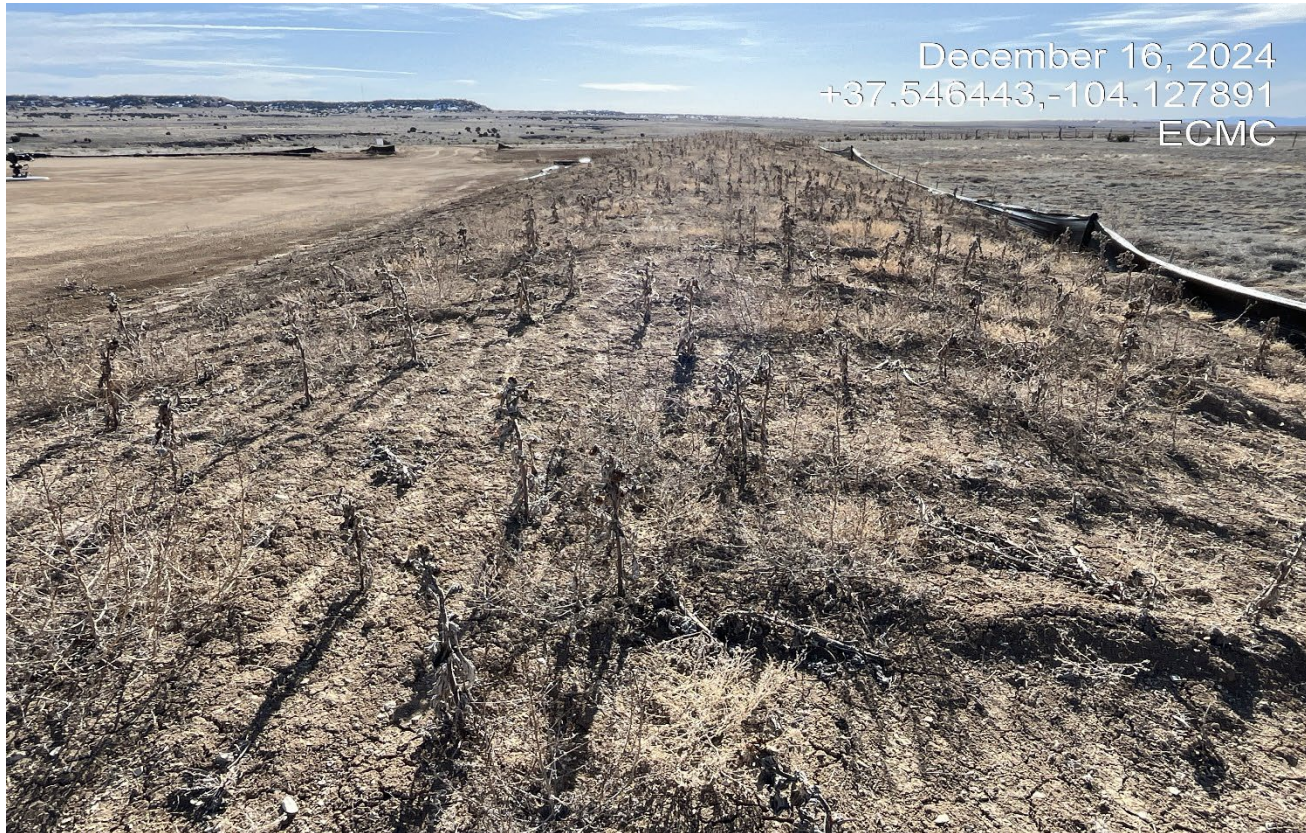
Photo 6. Facing toward the soil stock pile. The topsoil has not been seeded and stabilized and there are weeds established along the topsoil.

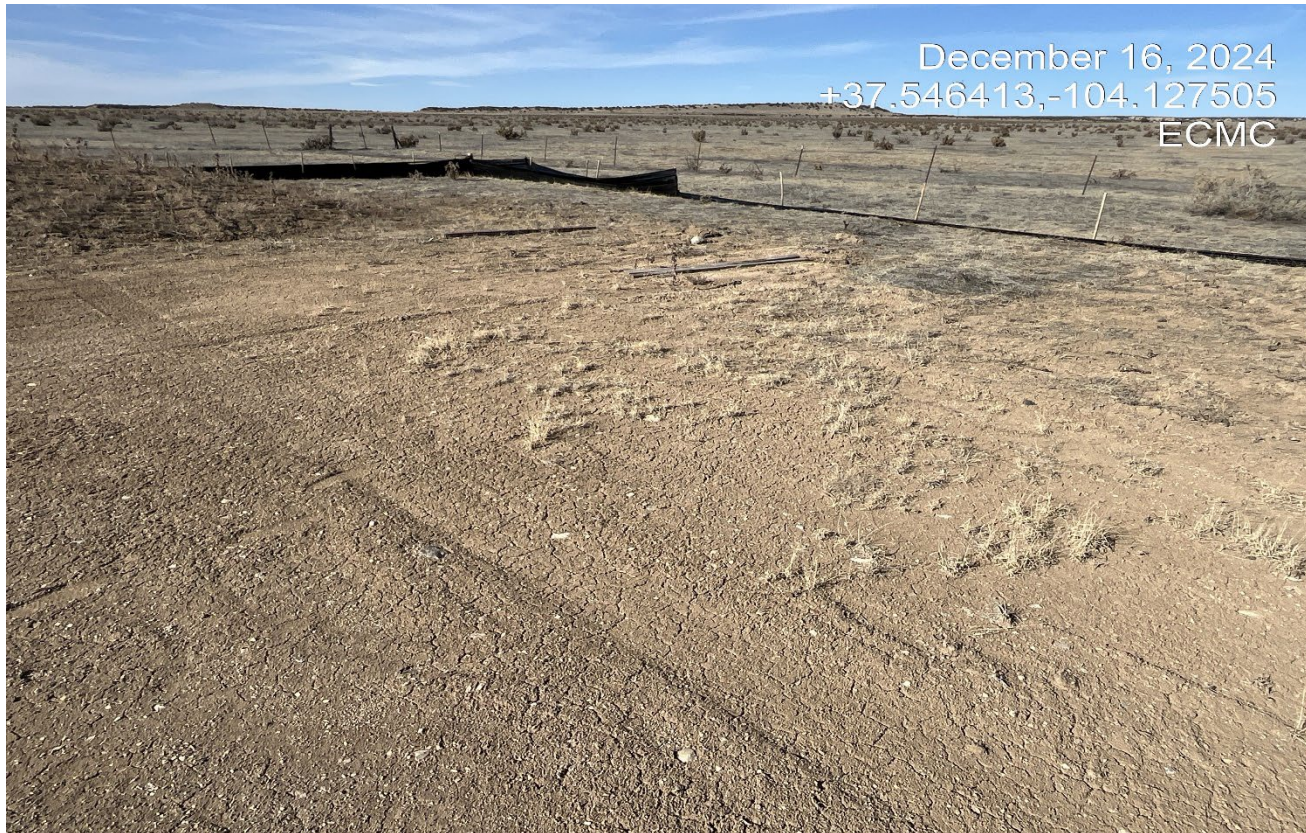
Photo 7. Facing toward the west corner of the location. The silt fence still remain down in this area.
