Inspection Photos

API: 071-06237

Operator: EVERGREEN NATURAL
RESOURCES LLC

Inspection Date: 1/10/2025

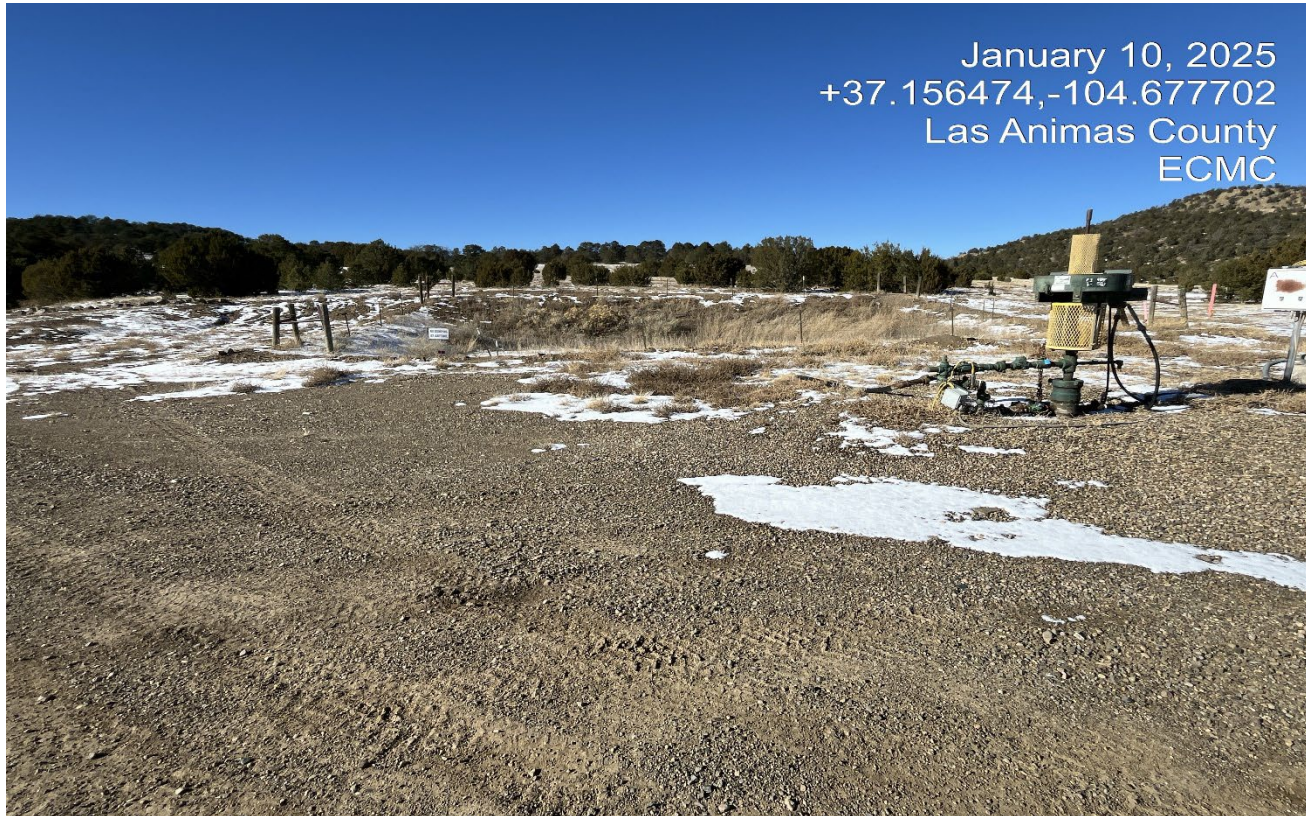
Photo 1. Facing northwest toward the wellsite.

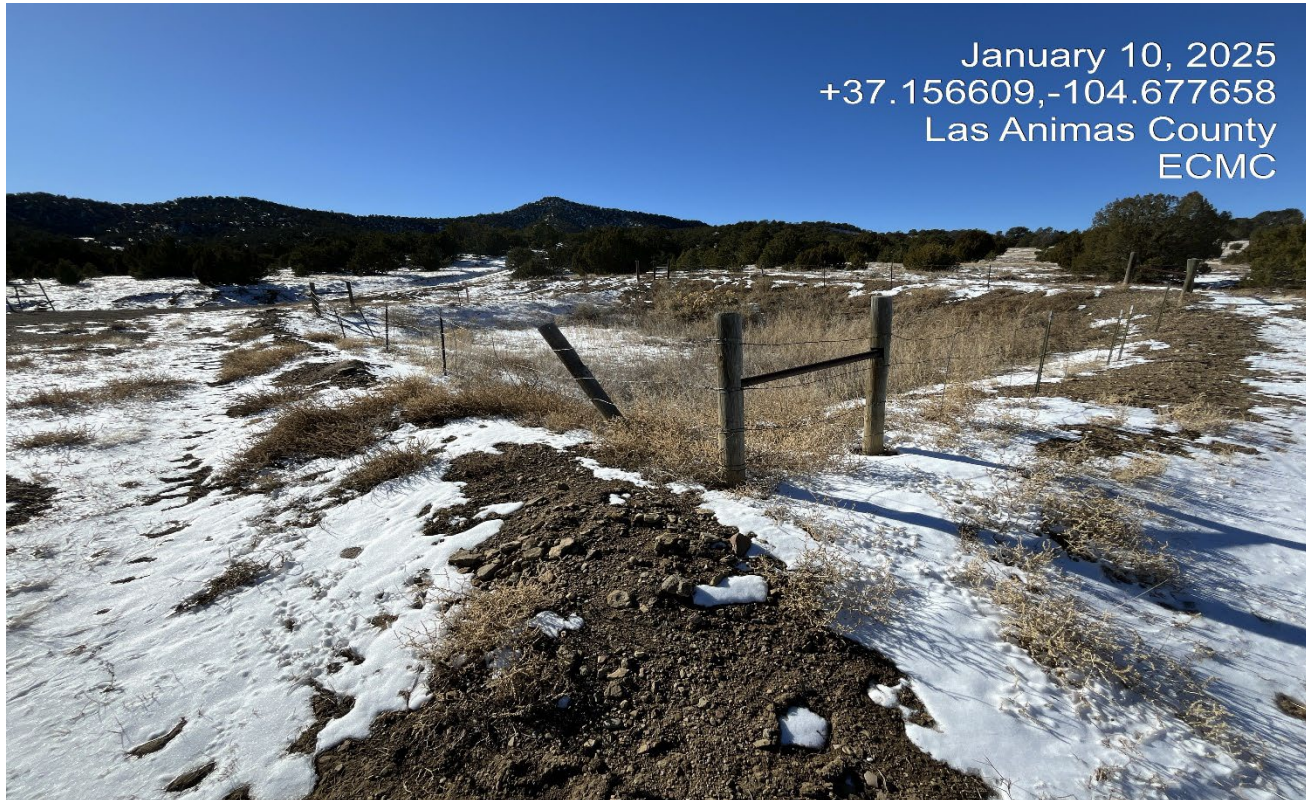
Photo 2. Facing toward the PW pit. Fence around the pit is maintained.

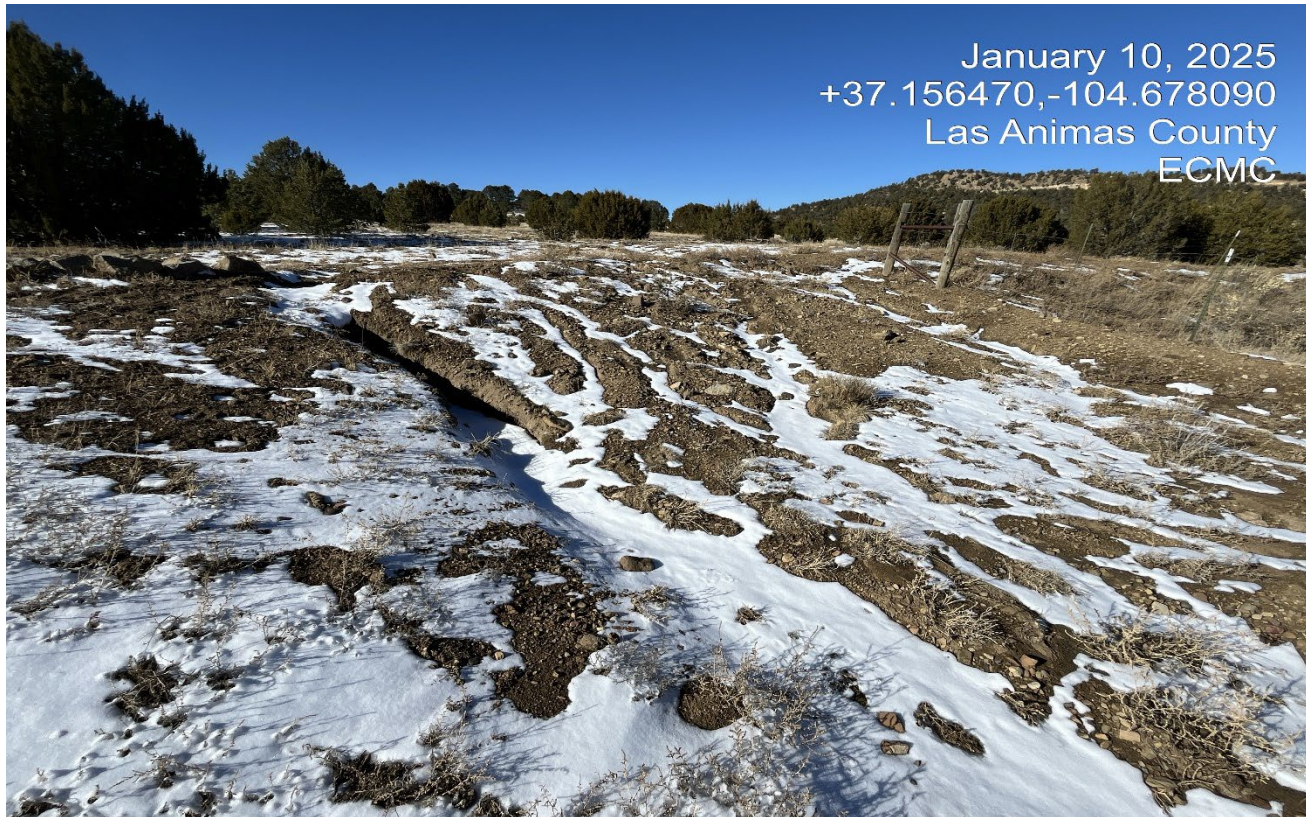
Photo 3. Facing toward the northwest side of the location. There is erosion occurring along this area which will need to be repaired and stabilized.

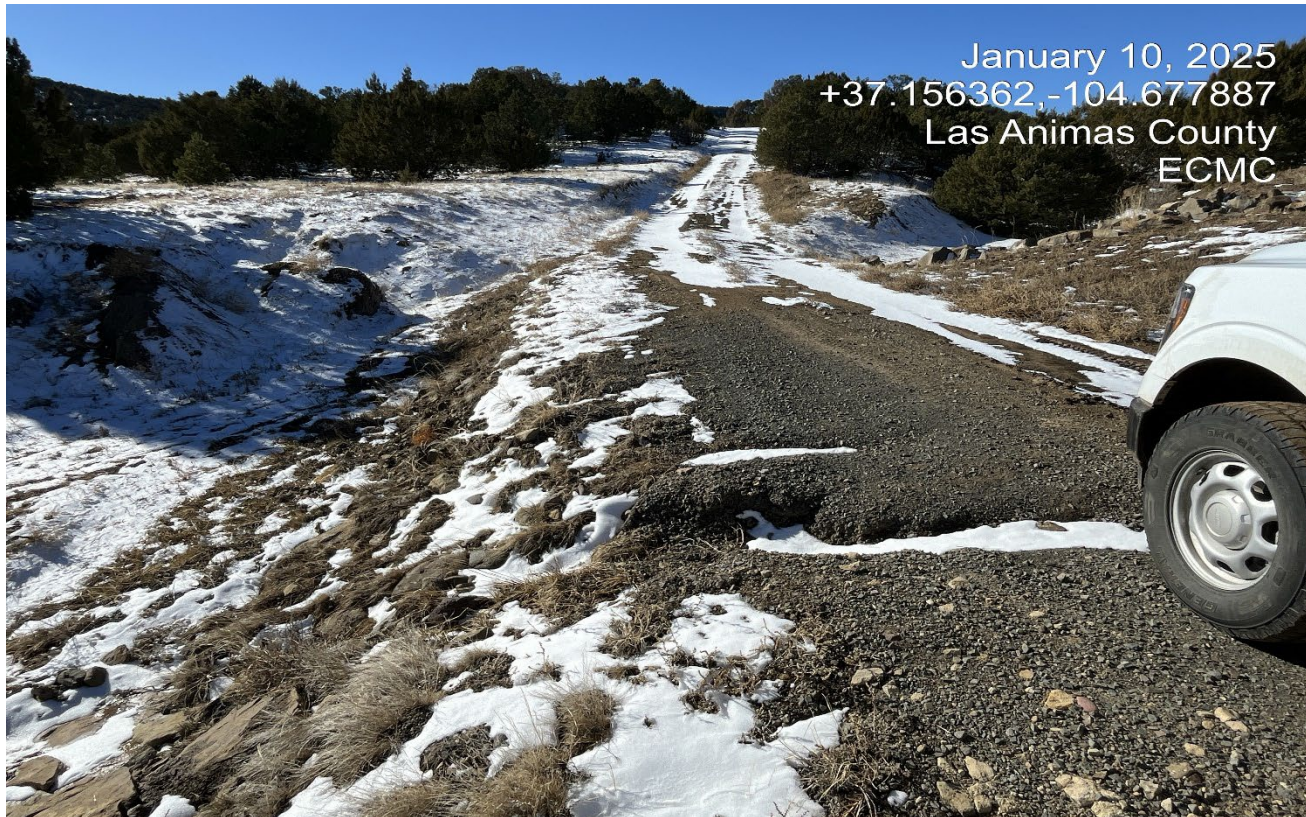
Photo 4. Facing southwest at the drainage crossing at the west side of the location. The culvert has filled in with sediment and stormwater has begun to erode the road.
