Inspection Photos

API: 071-07259

Operator: EVERGREEN NATURAL
RESOURCES LLC

Inspection Date: 1/10/2025

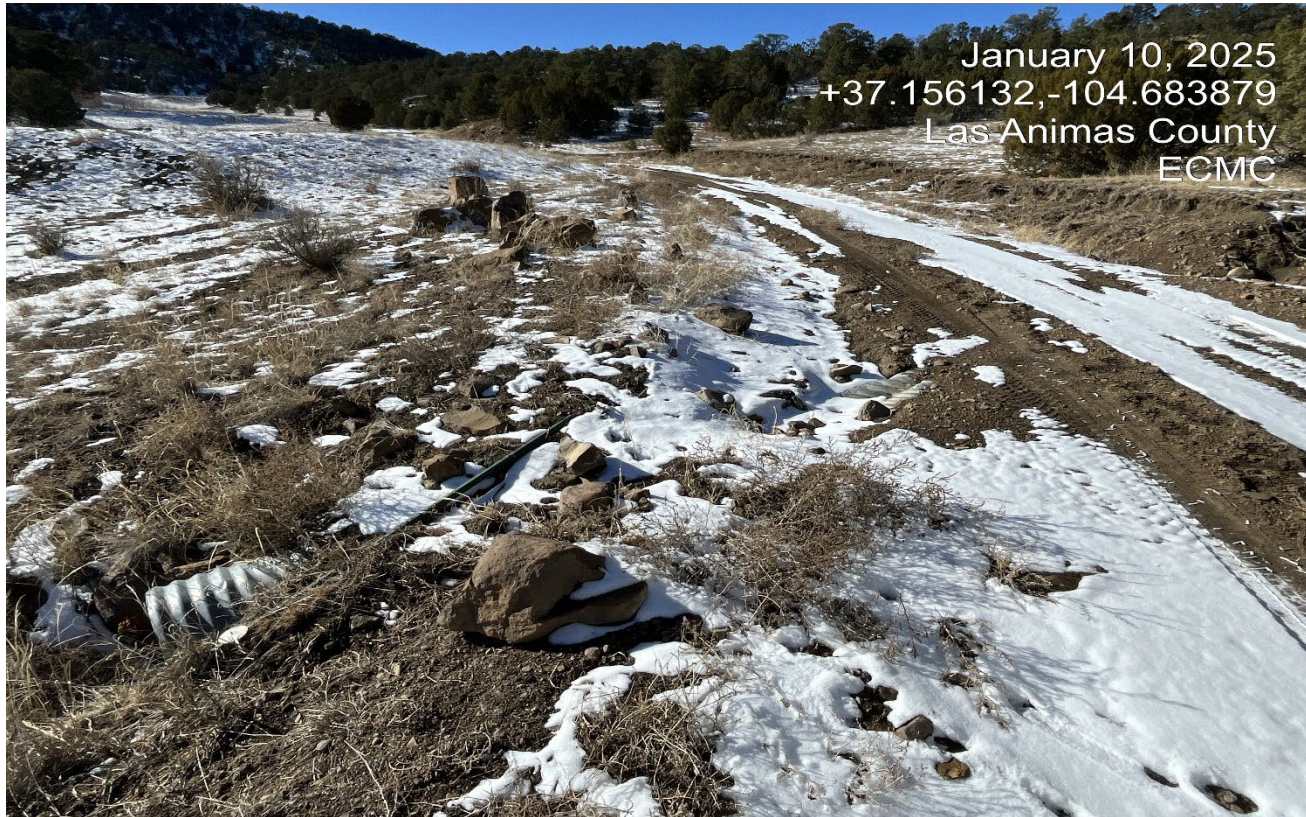
Photo 1. Facing west along the access road. There is erosion along the road that needs to be repaired and stabilized..

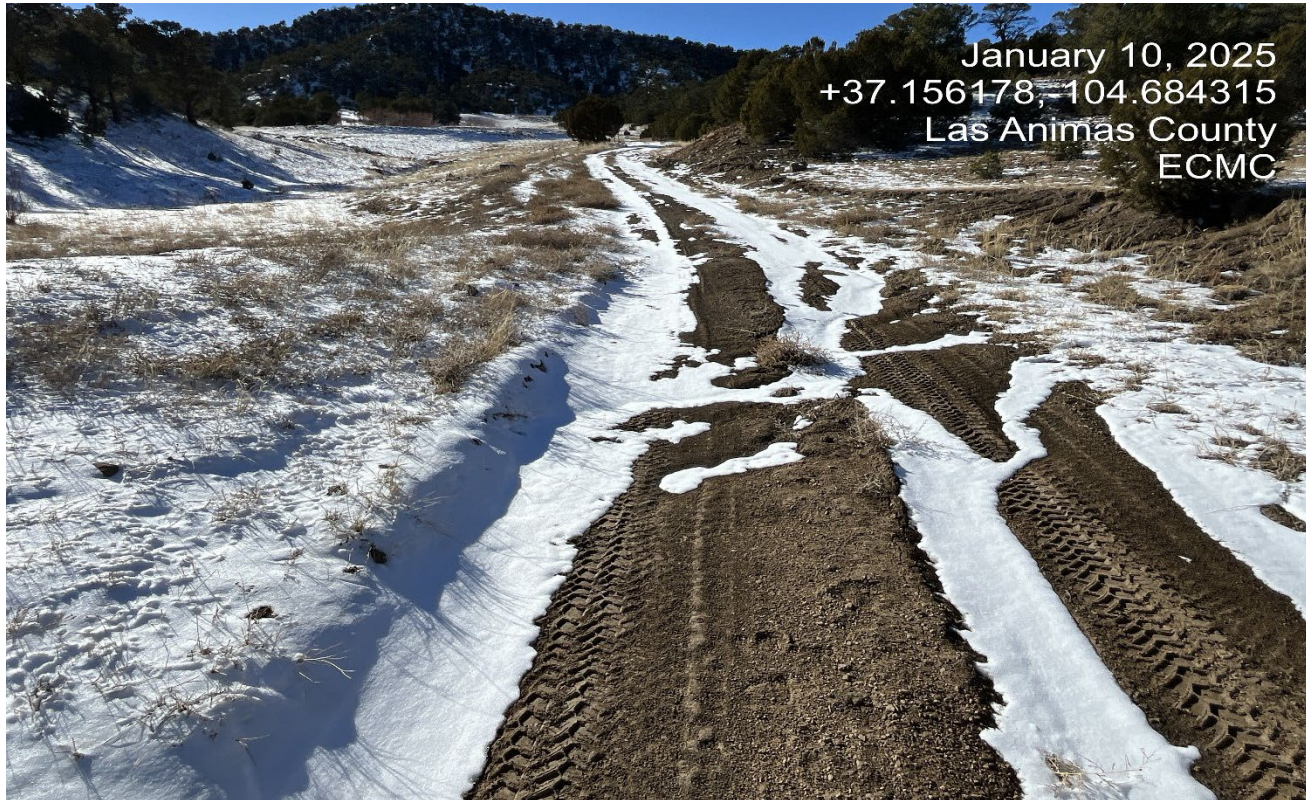
Photo 2. Facing west further along the access road. There is erosion along the road that needs to be repaired and stabilized.

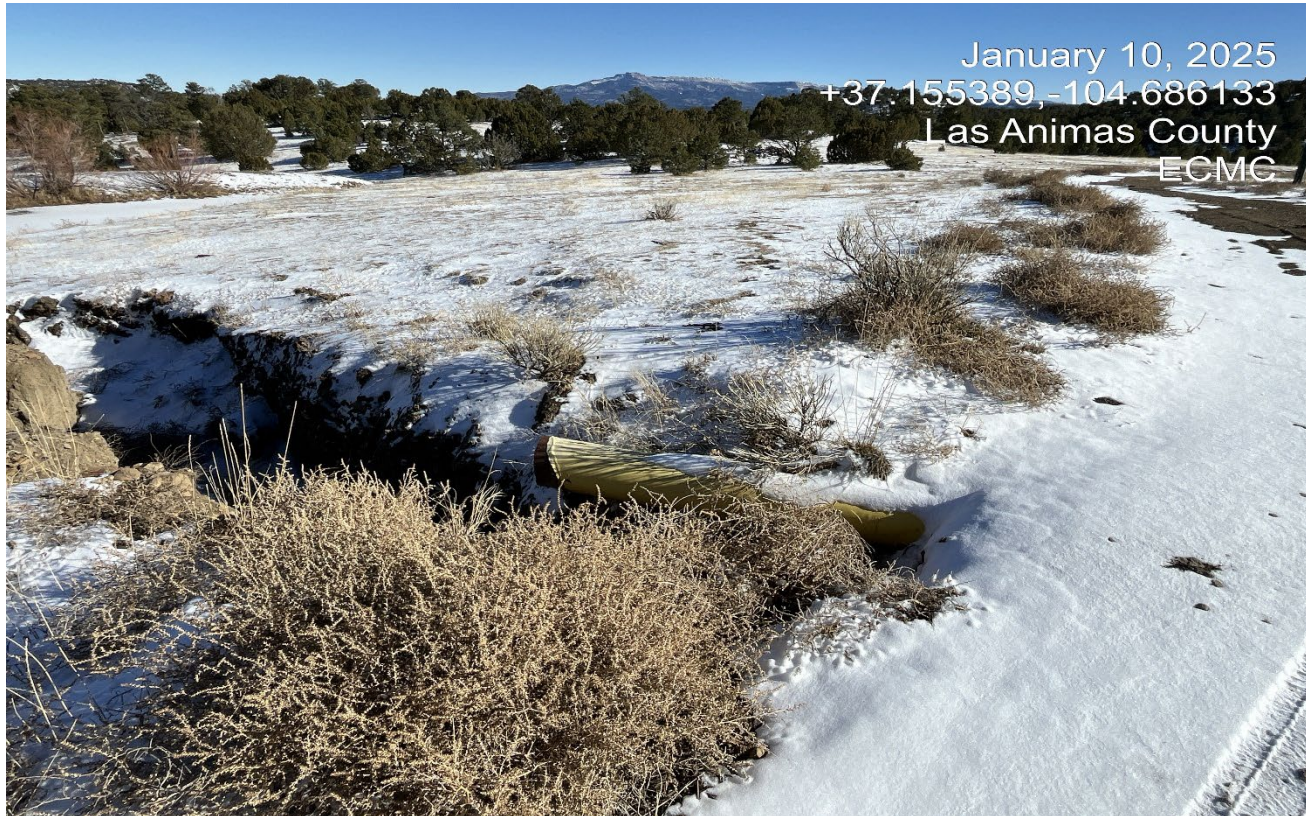
Photo 3. Facing east at the culvert outlet along the road. The culvert outlet has eroded and needs to be repaired and outlet protection installed.

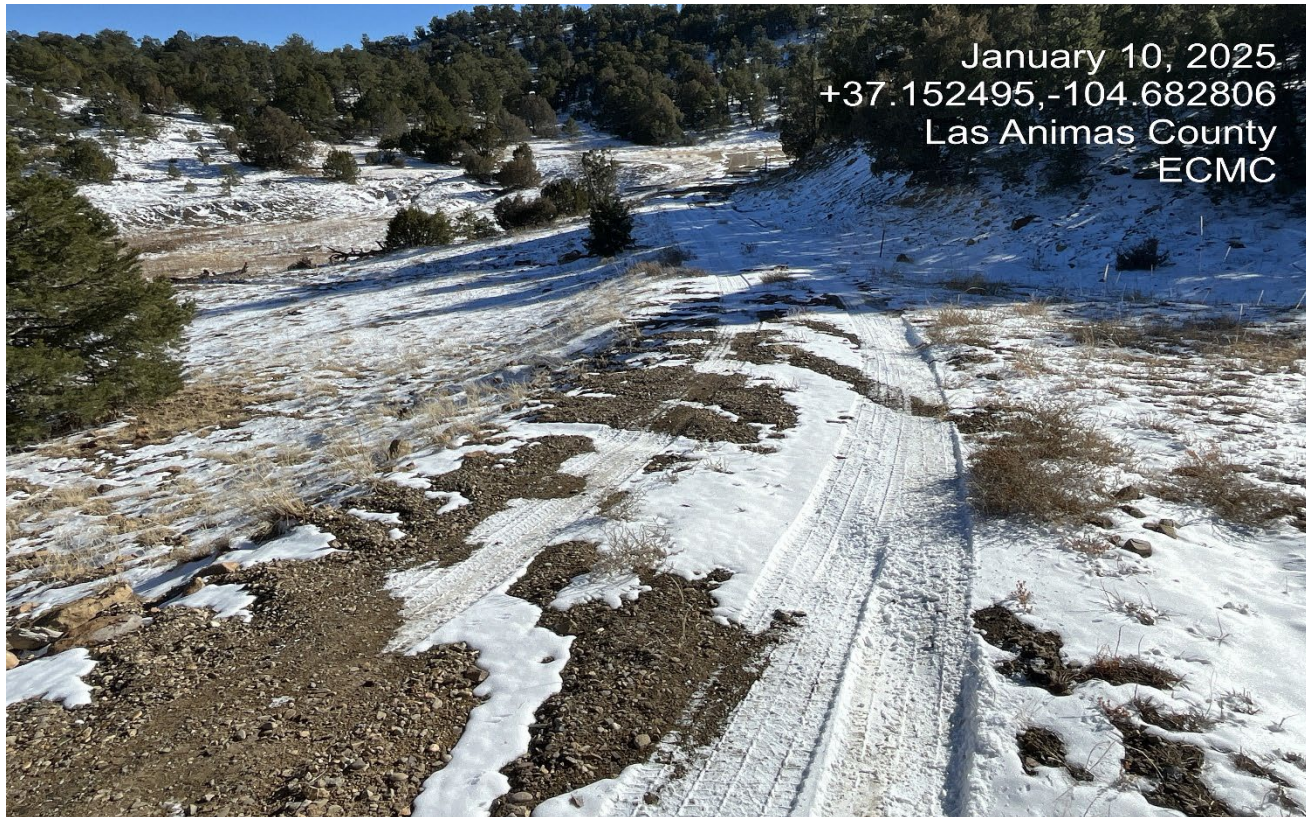
Photo 4. Facing southwest along the access road. There is erosion occurring across the road at this area.

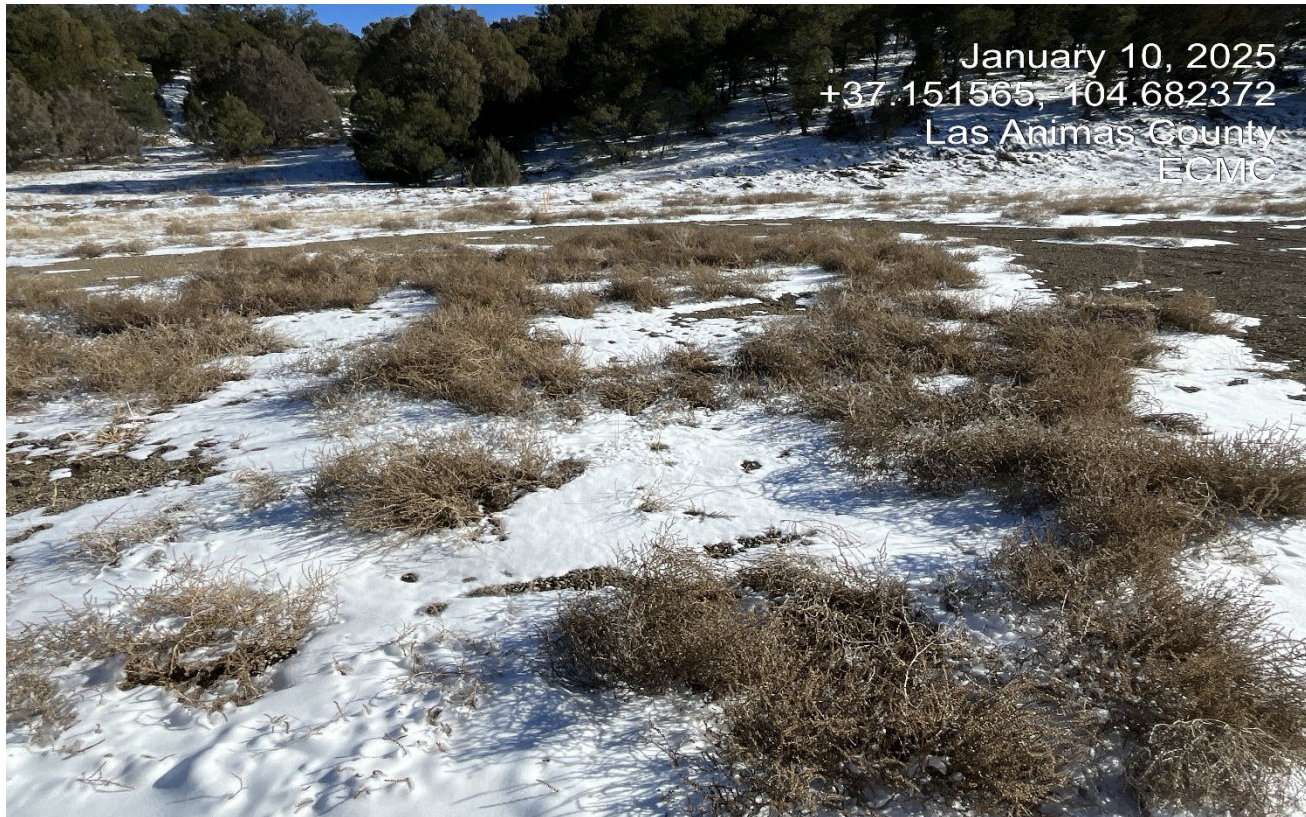
Photo 6. There are undesirable Russian thistle weeds at this location which may require control in the upcoming growing season.
