Inspection Photos

Operator: TEP ROCKY MOUNTAIN LLC - 96850

Location ID: 311677

Inspection Doc: 718100193

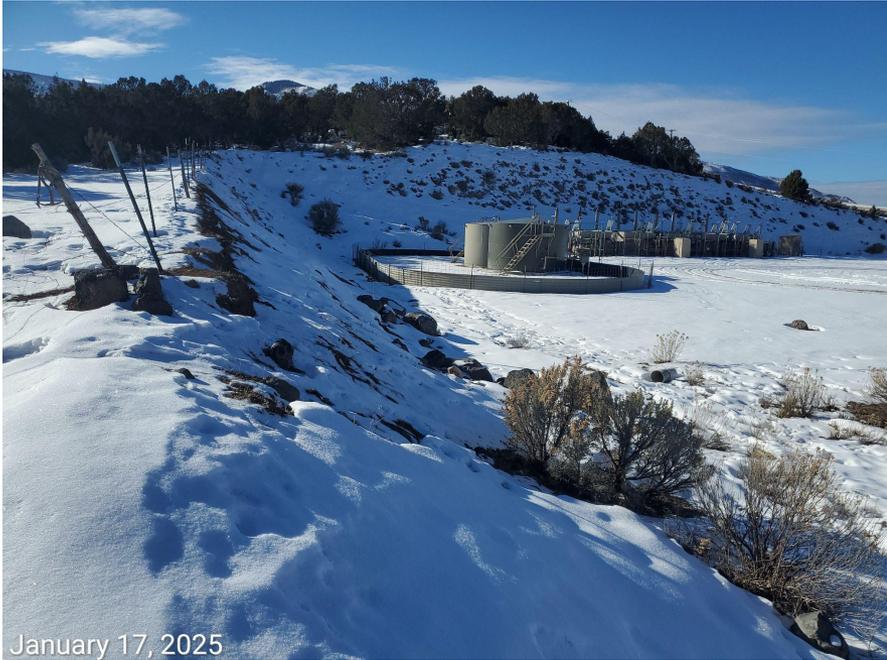
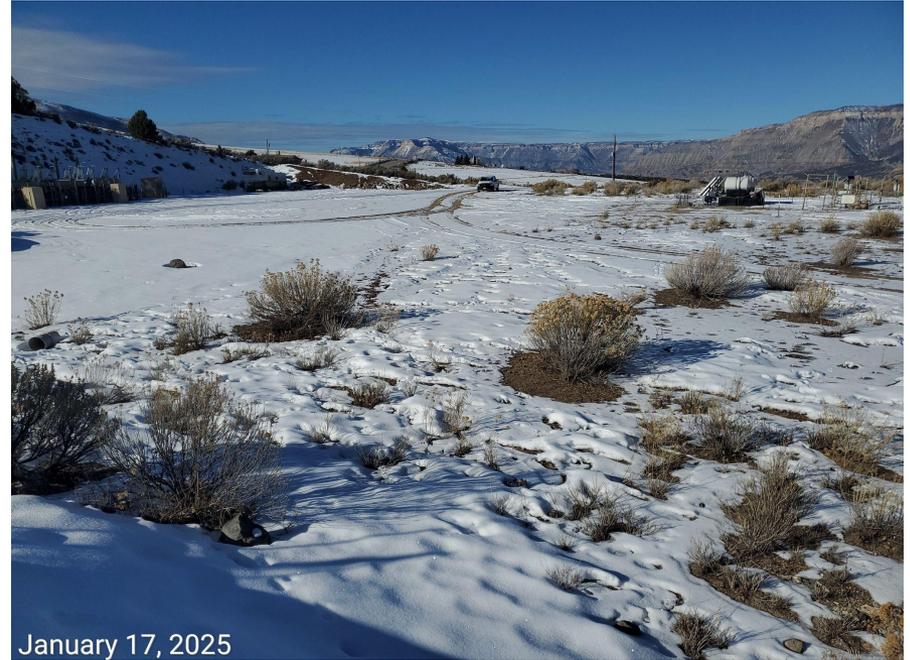
Photo 1: Photos 1-2 taken from the east end of the Location. Photos provide an overview of the Location from south, southwest, northwest to north. Photos also show interim reclamation pursuant to 1003 requirements has not been performed; photos also examples showing trash/debris/vehicles/trailers, and other various items that are not necessary for production being stored on the Location.

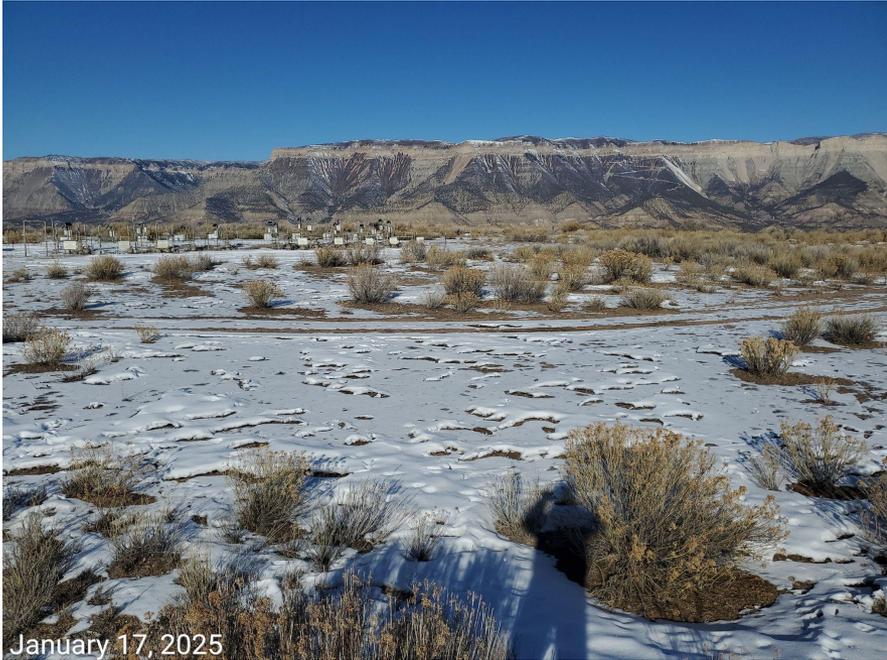
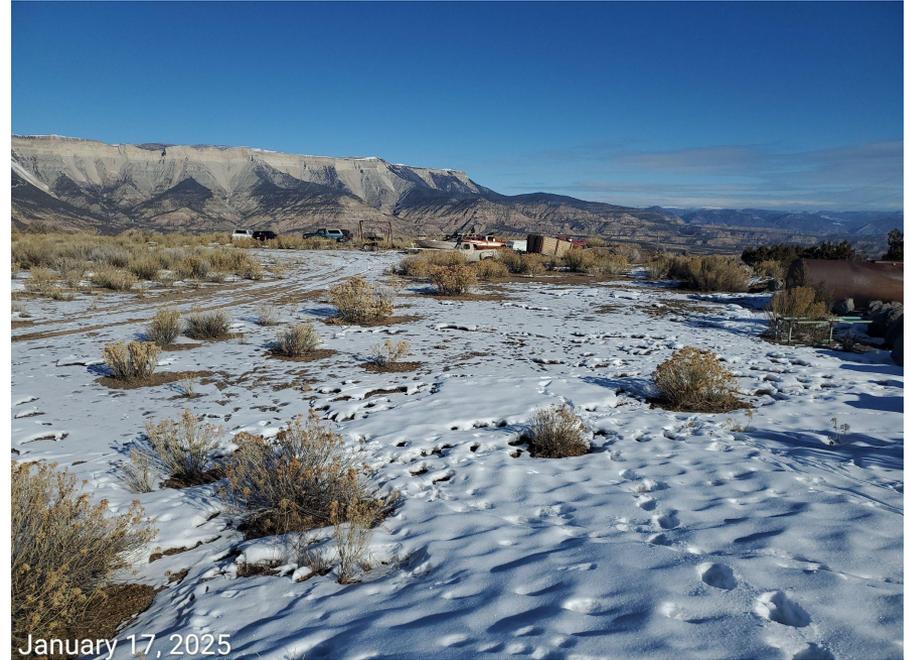
Photo 2: See comments under photo 1.

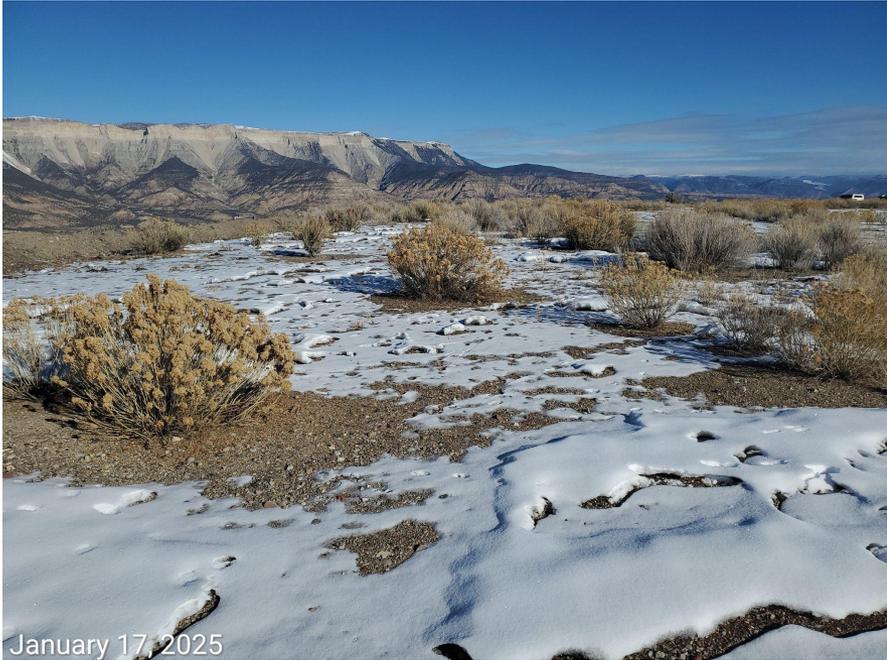
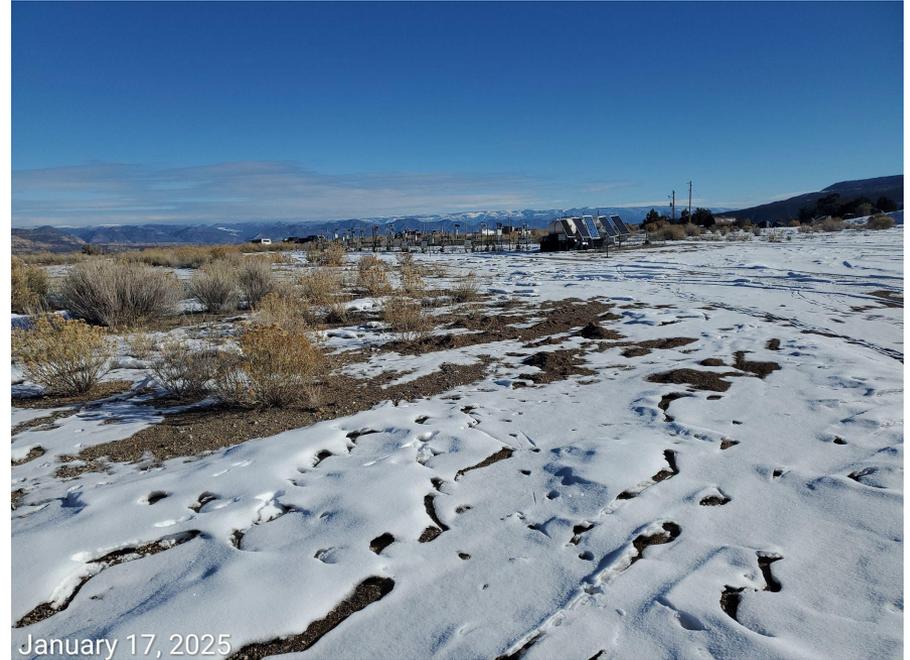
Photo 3: Photos 3-4 taken from the west end of the Location. Photos provide an overview of the Location from north, northeast, southeast to south. Photos also show interim reclamation pursuant to 1003 requirements has not been performed; photos also examples showing trash/debris/vehicles/trailers, and other various items that are not necessary for production being stored on the Location.

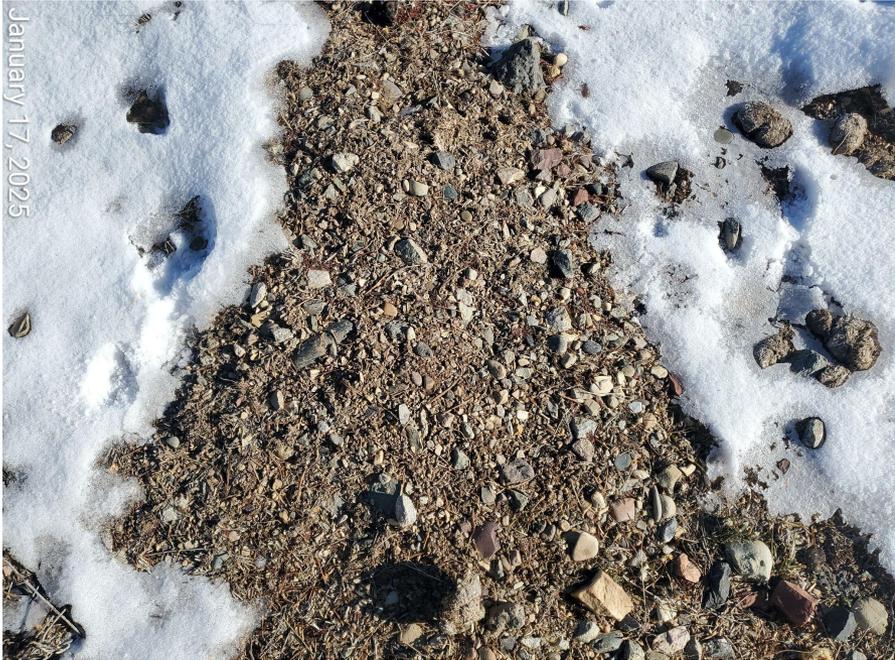
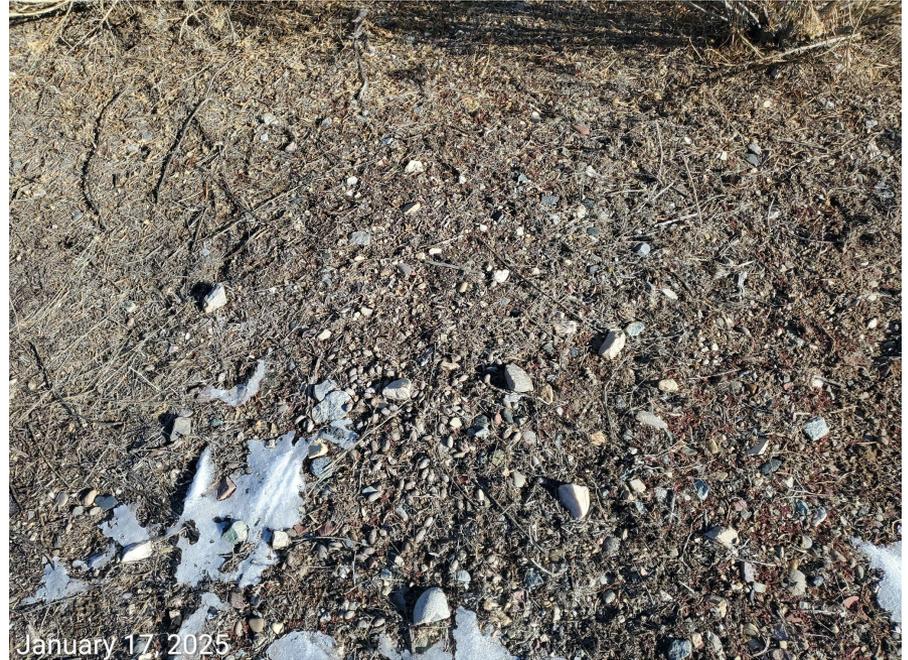
Photo 5: Photo examples of the soil surface along the unused areas of the Location; gravel/road base material has not been removed, areas have not been decompacted, recontoured/regraded and reclaimed.

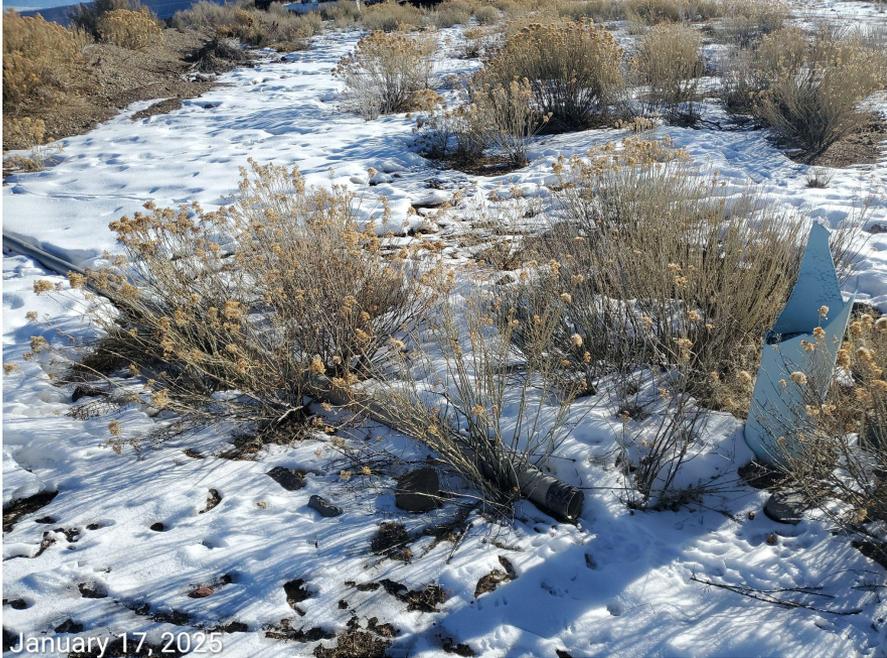
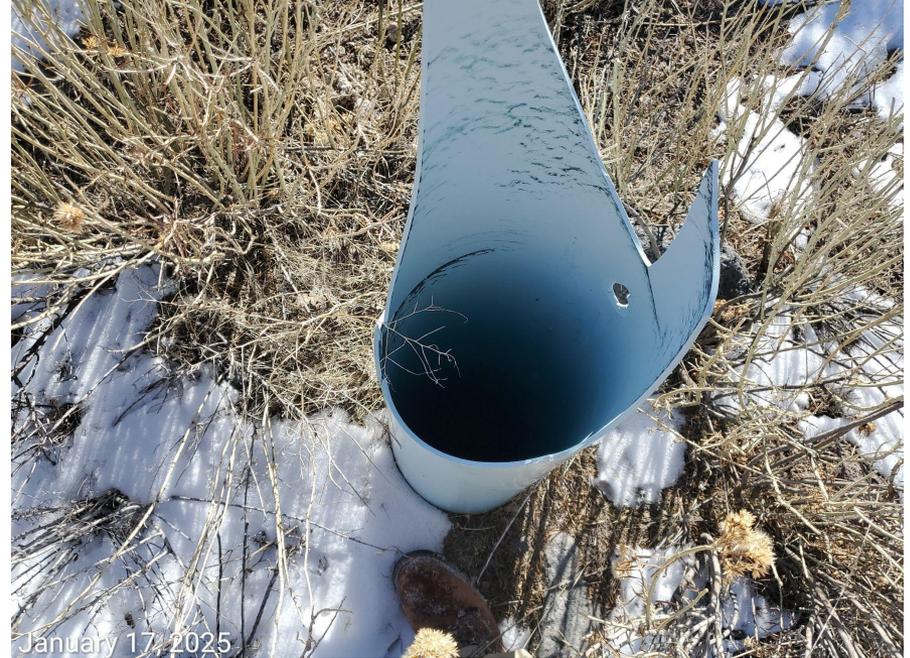
Photo 6: Photo taken from the north end of the Location. Photo shows unused/unneeded pipe stored on the Location. Pipe is open and a potential wildlife entrapment issue.

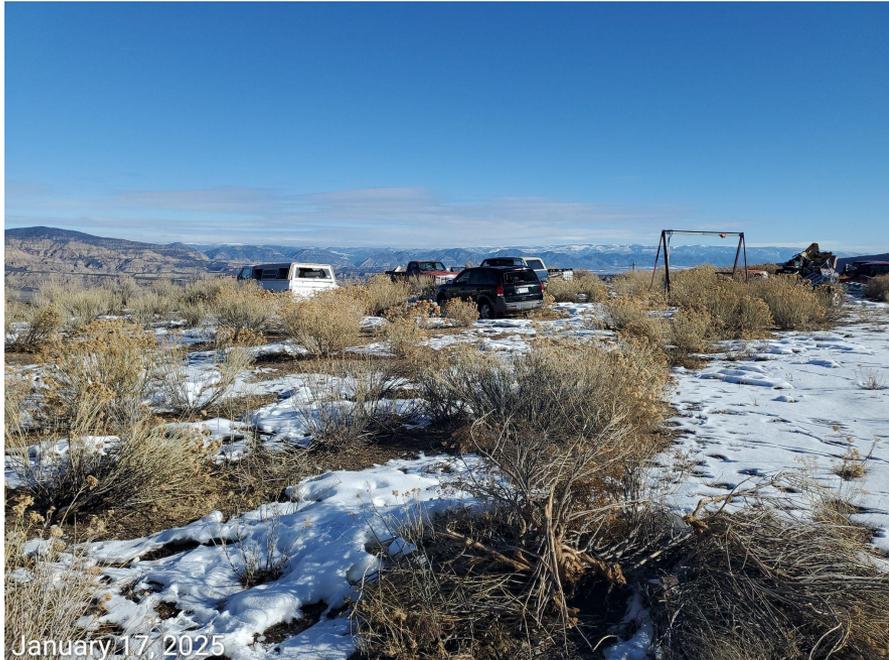
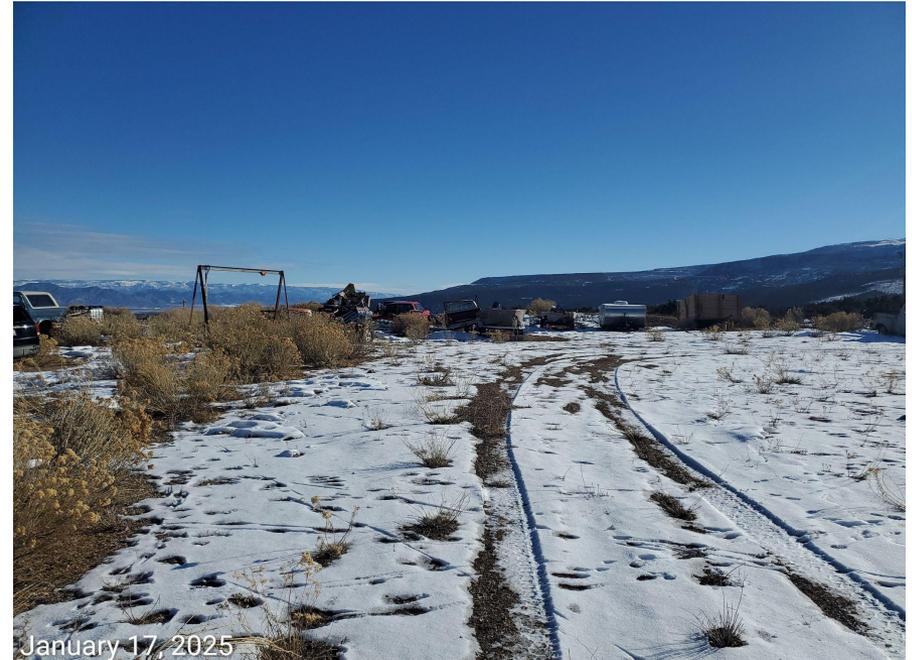
Photo 7: Photos 7-10 taken from the north and eastern areas of the current pad area. Photos examples showing trash/debris/vehicles/trailers, and other various items that are not necessary for production, being stored on areas of the Location subject to 1003 reclamation requirements.

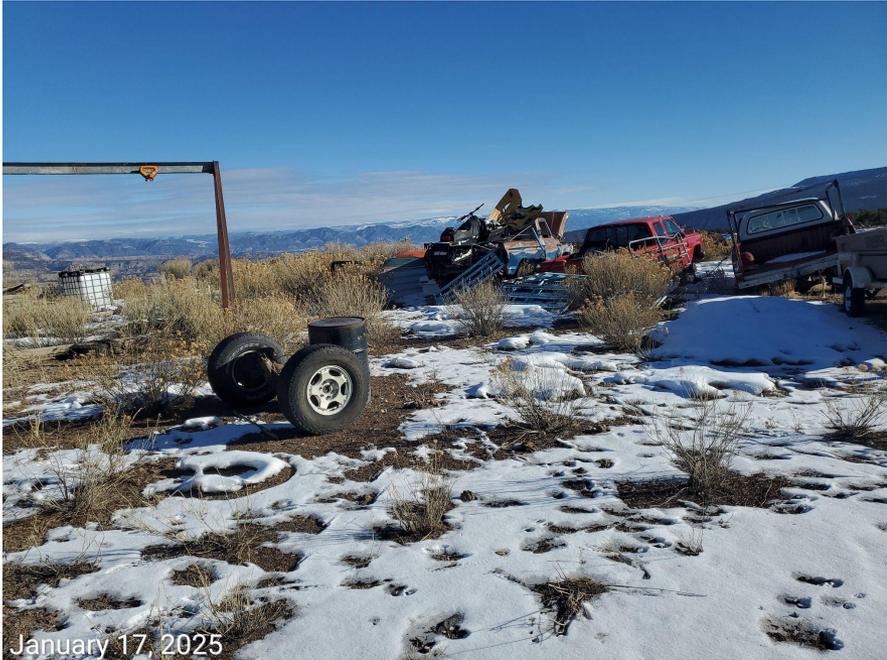
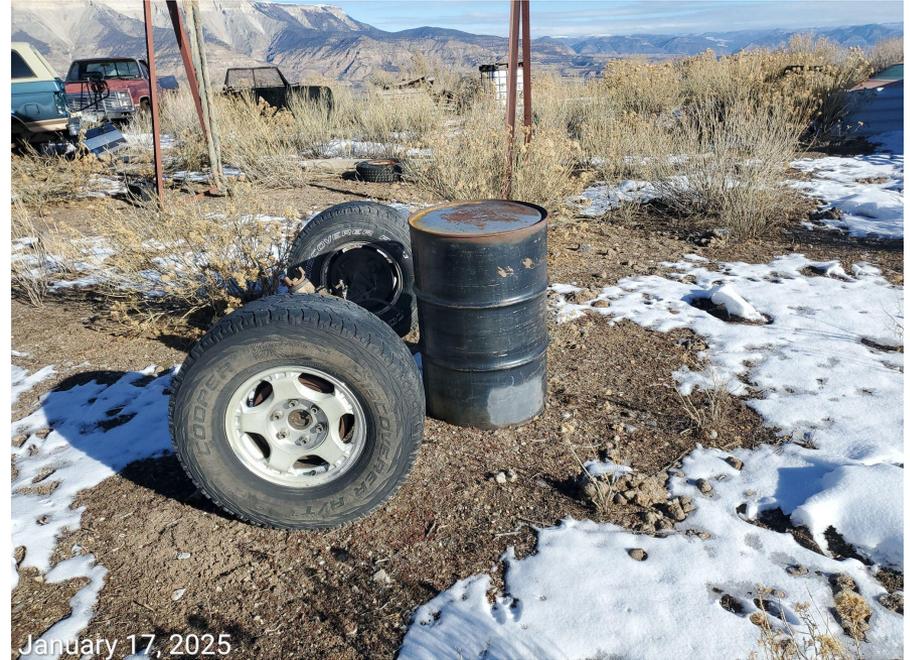
Photo 8: See comments under photo 7.

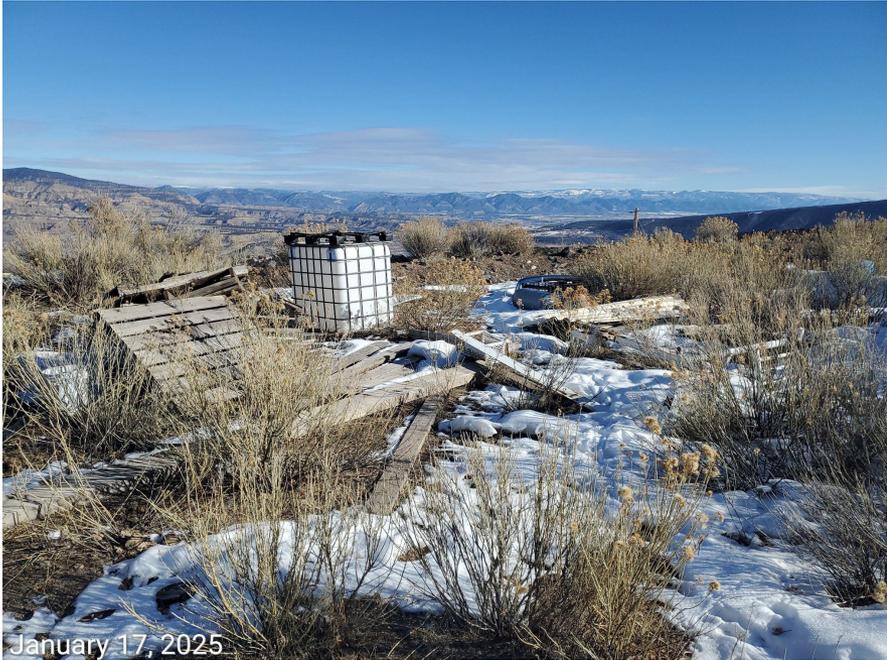
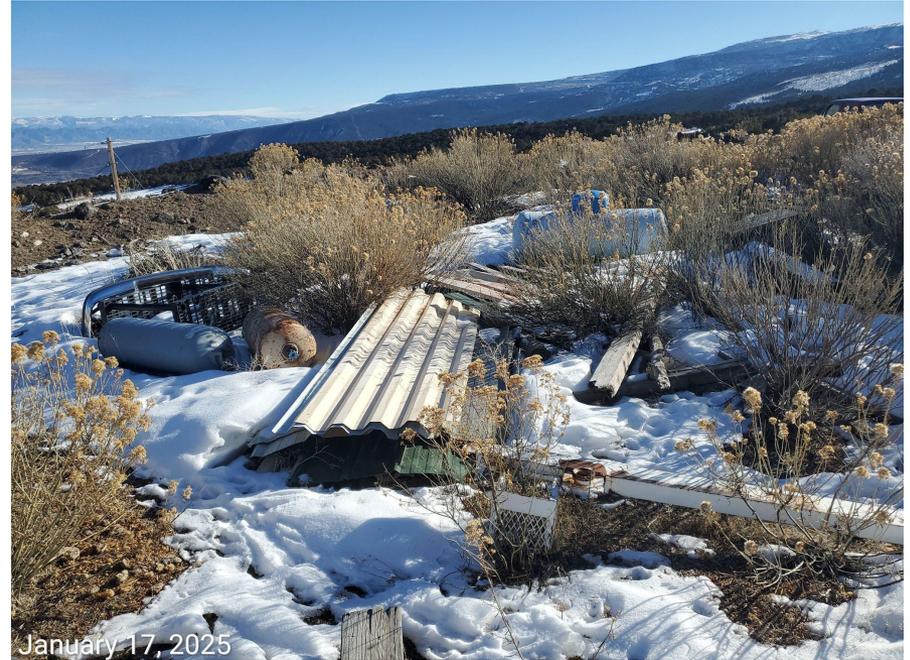
Photo 9: See comments under photo 7.

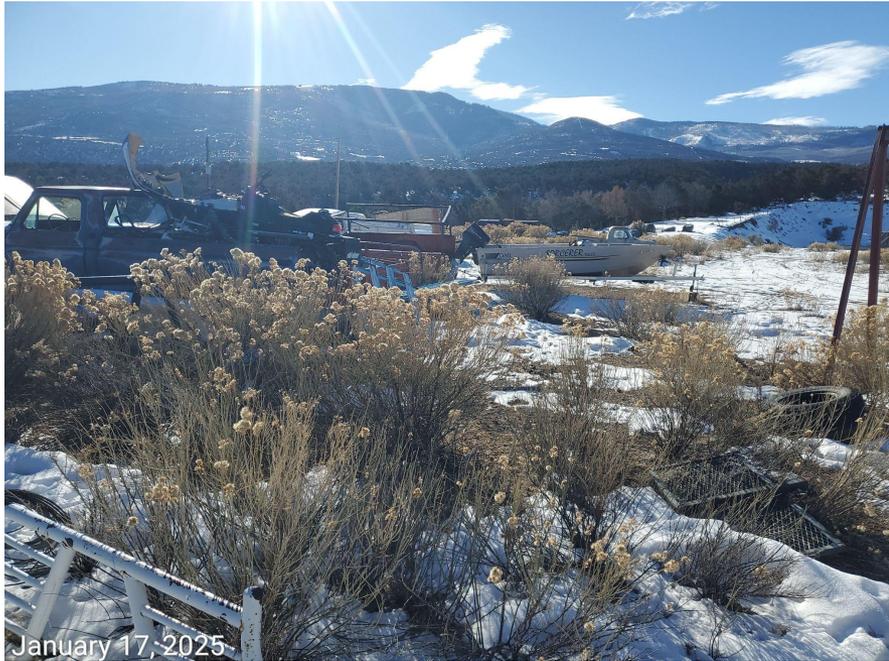
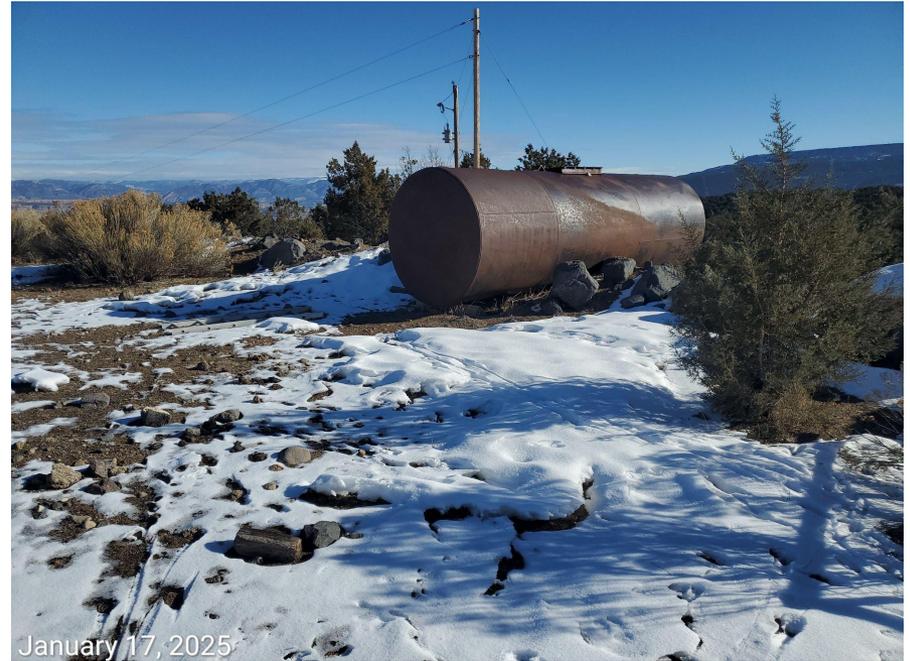
Photo 10: See comments under photo 7.

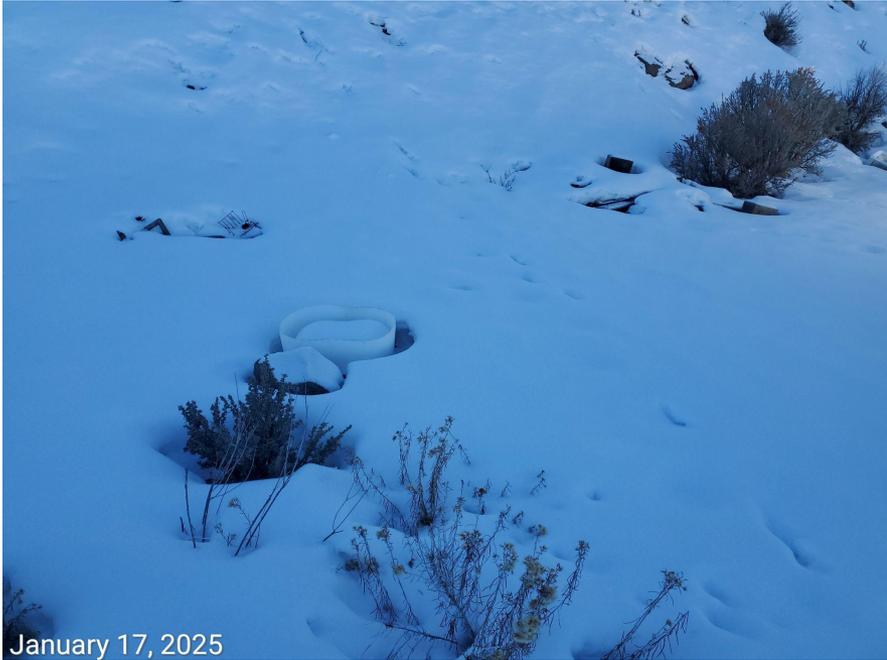
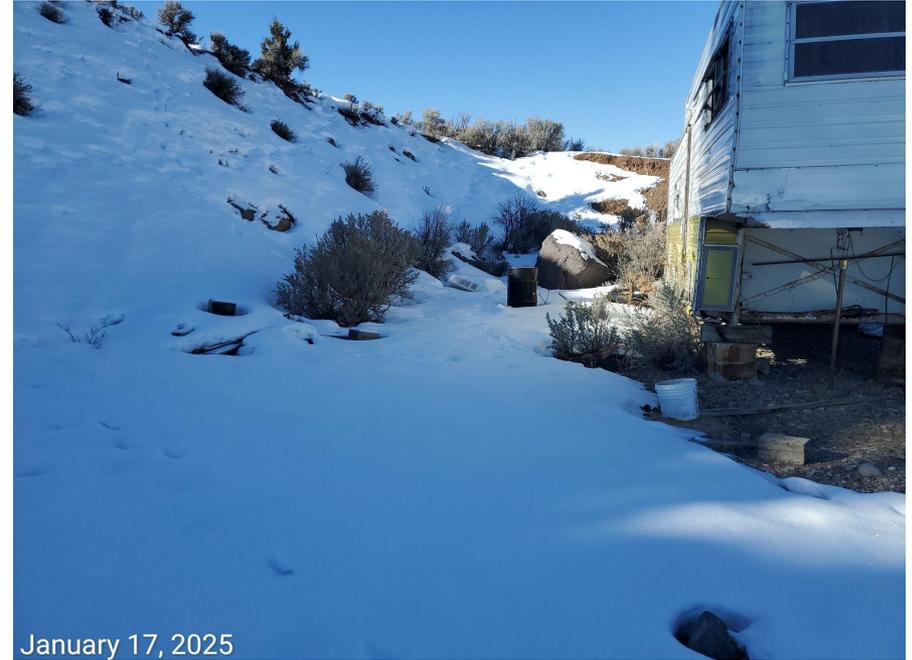
Photo 11: Photos 11-12 taken from the southwestern areas of the current pad area. Photos examples showing trash/debris/vehicles/trailers, and other various items that are not necessary for production, being stored on areas of the Location subject to 1003 reclamation requirements.

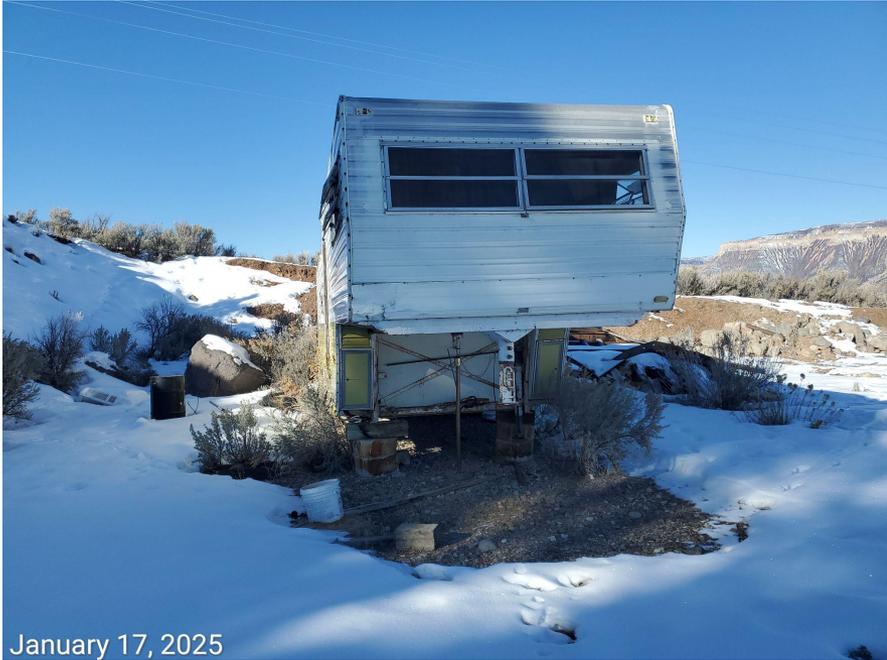
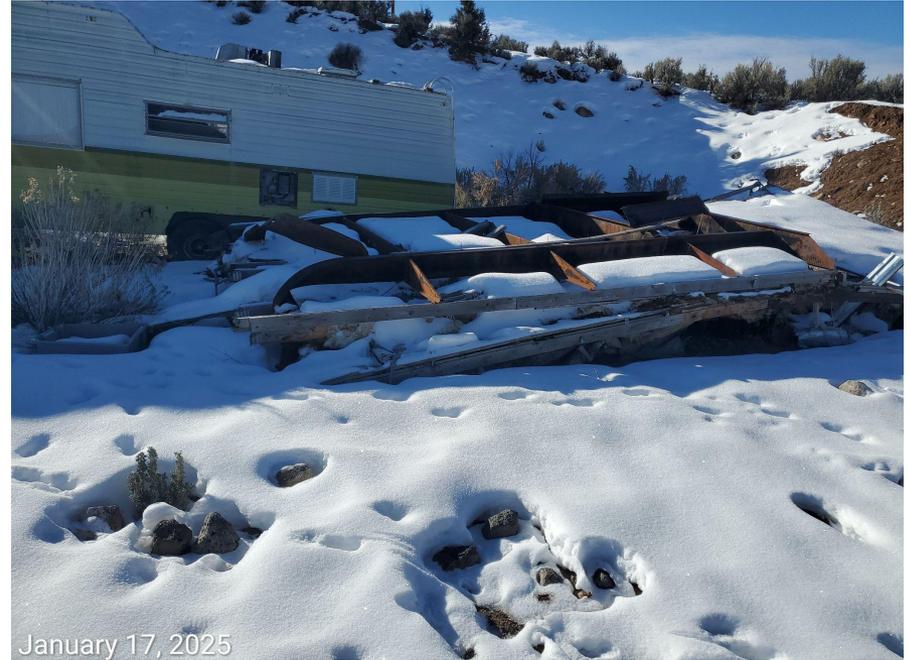
Photo 12: See comments under photo 11.

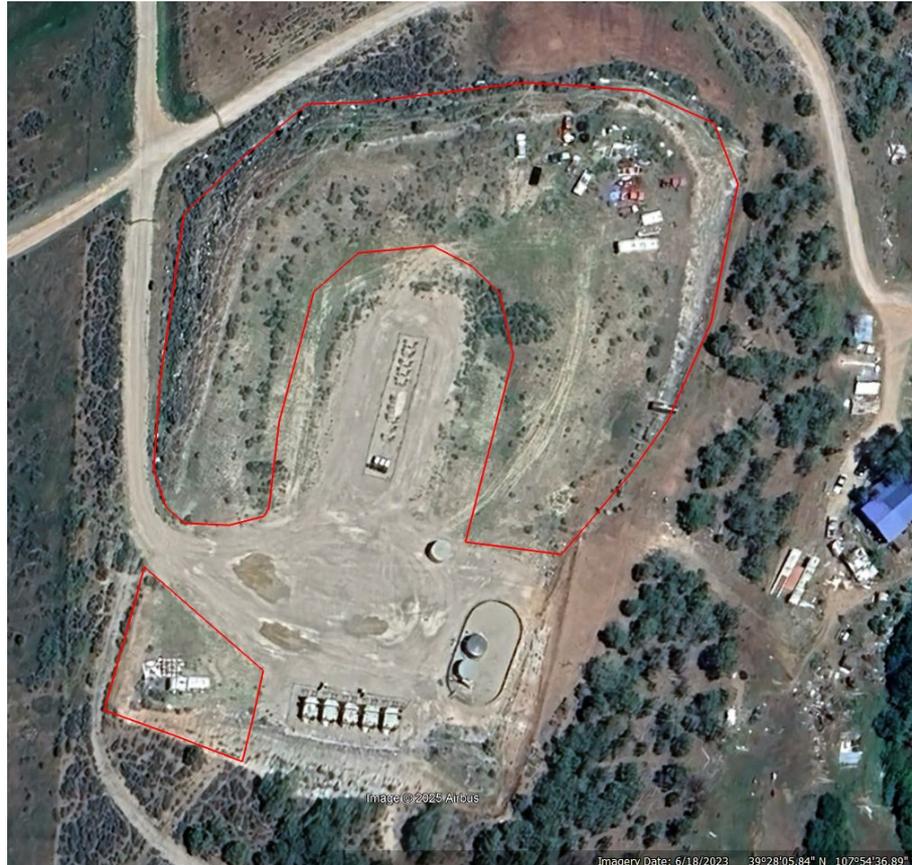
Photo 13: 2023 Google Earth aerial imagery. Red polygons (~2.5 acres) represent approximate areas of the Location not necessary for production subject 1003 to reclamation requirements- reclamation work including, but not limited to, compaction alleviation, recontouring/regrading the cut and fill slopes, and revegetation of areas not necessary for production has not been performed.
