Inspection Photos

Operator: CAERUS PICEANCE LLC #10456

Location ID: 413476

Inspection Doc: 718100211

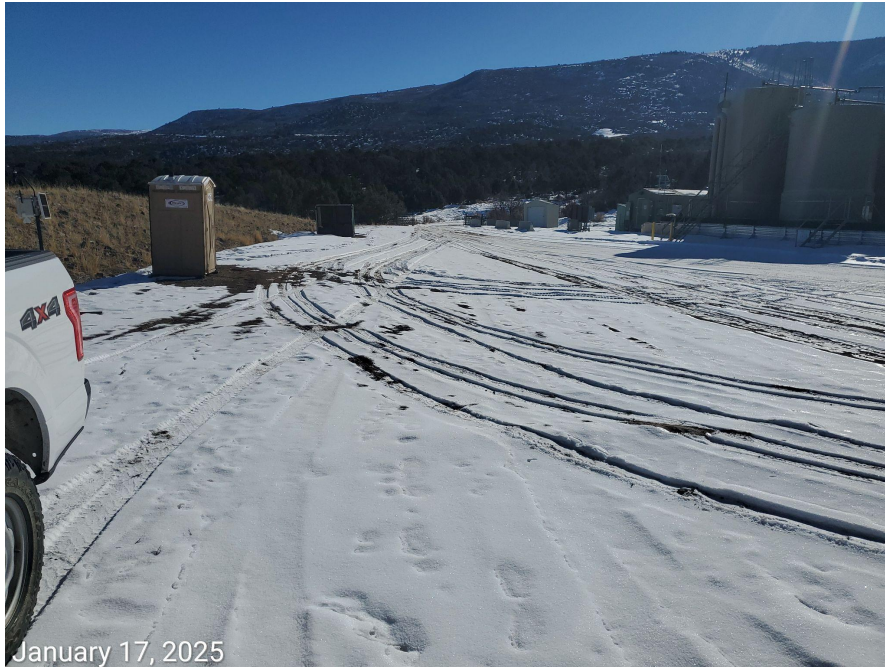
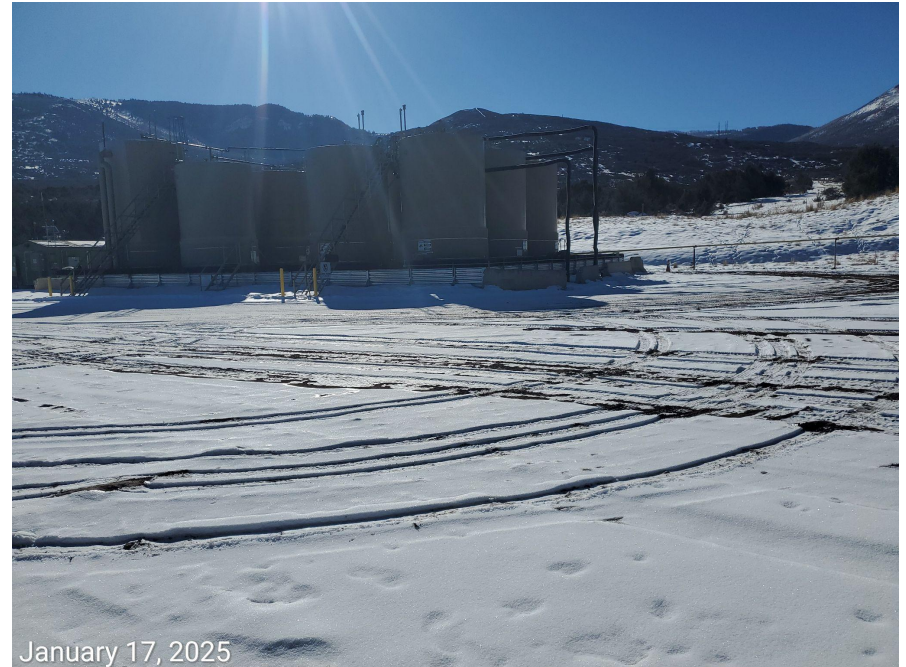
Photo 1: Photos 1-2 taken from the north end of the location. Photos provide an overview of the Location from east, southeast, southwest to west.

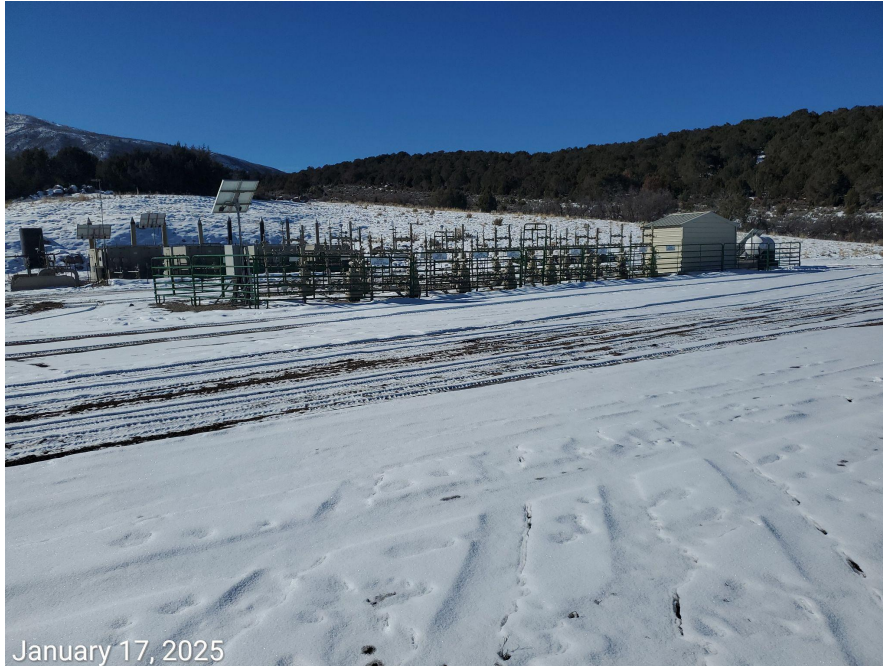
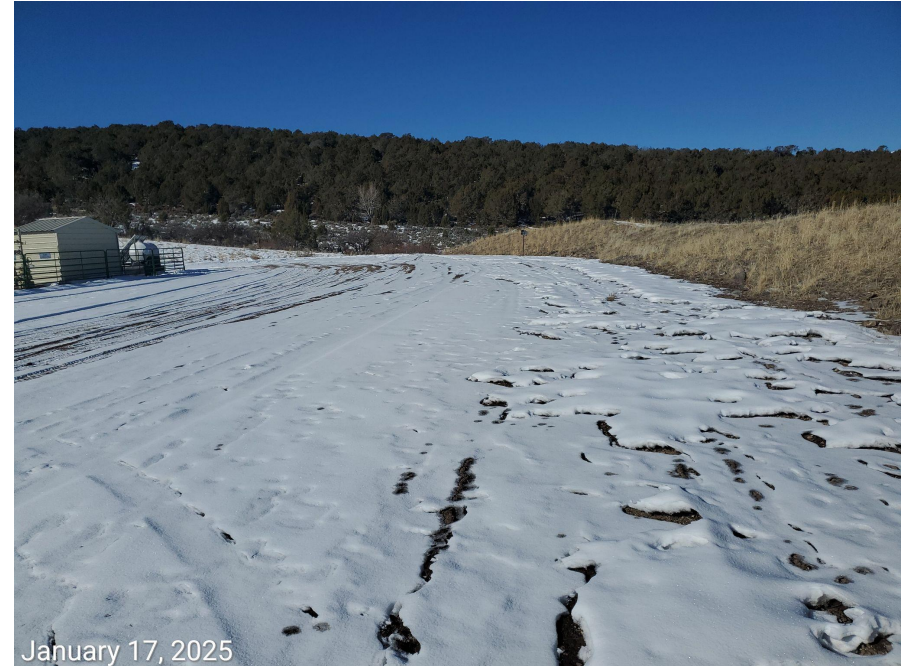
Photo 2: See comments under photo 1.

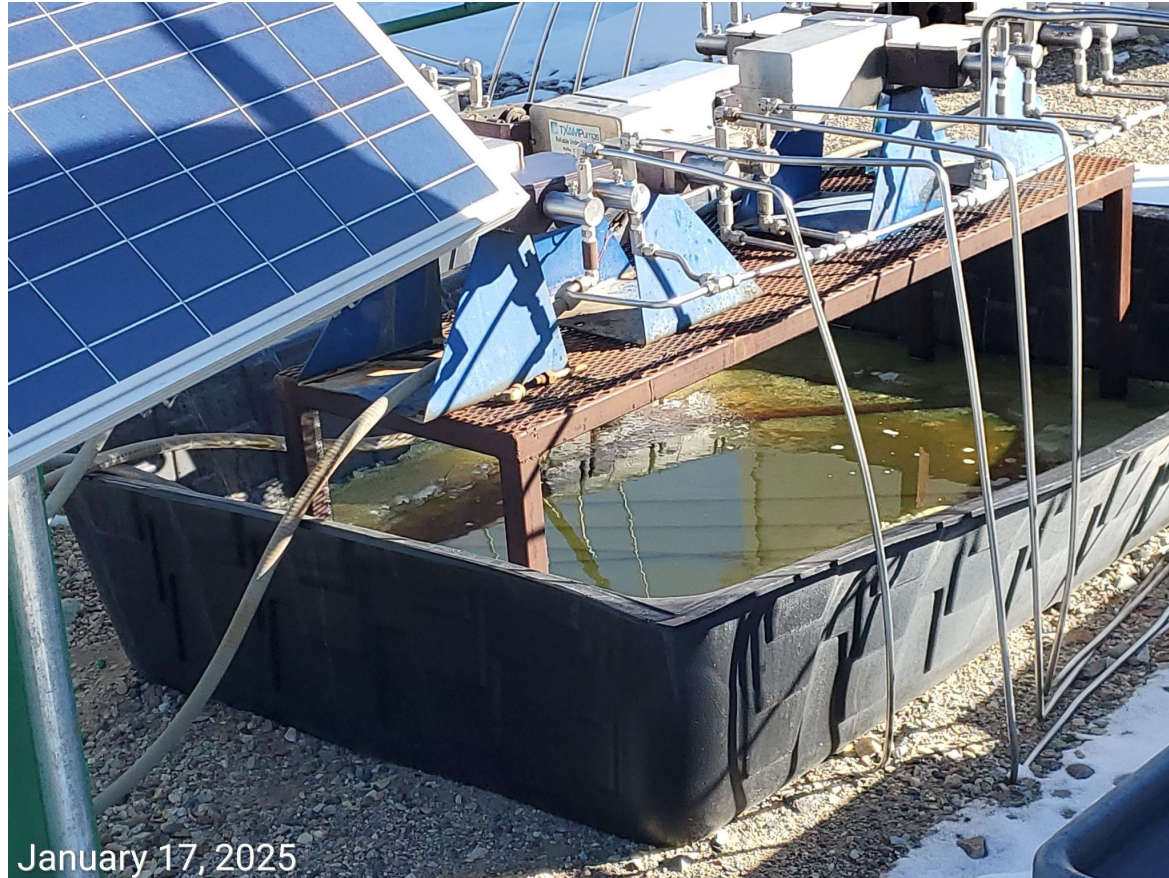
Photo 3: Fluids from the methanol pumps appears to have spilled into containment. Wildlife protection BMPs missing from containment measures.
