# Inspection Photos

API: 011-05057

Operator: RENEGADE OIL & GAS COMPANY LLC

Inspection Date: 2/4/2025

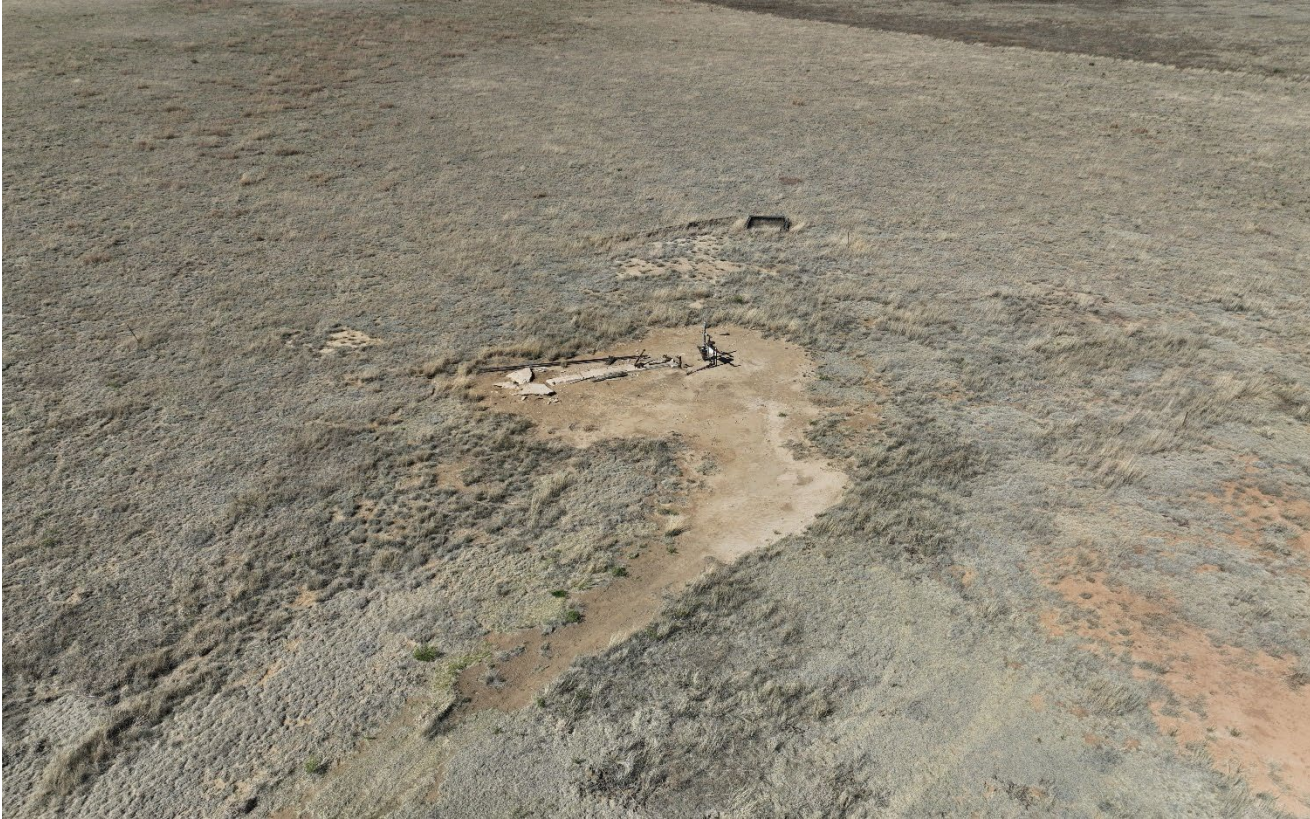
**Photo 1.** Drone photo (taken on 5/8/24) facing down toward the wellsite. There is an area with no vegetation which appears impacted soil from a historical spill.

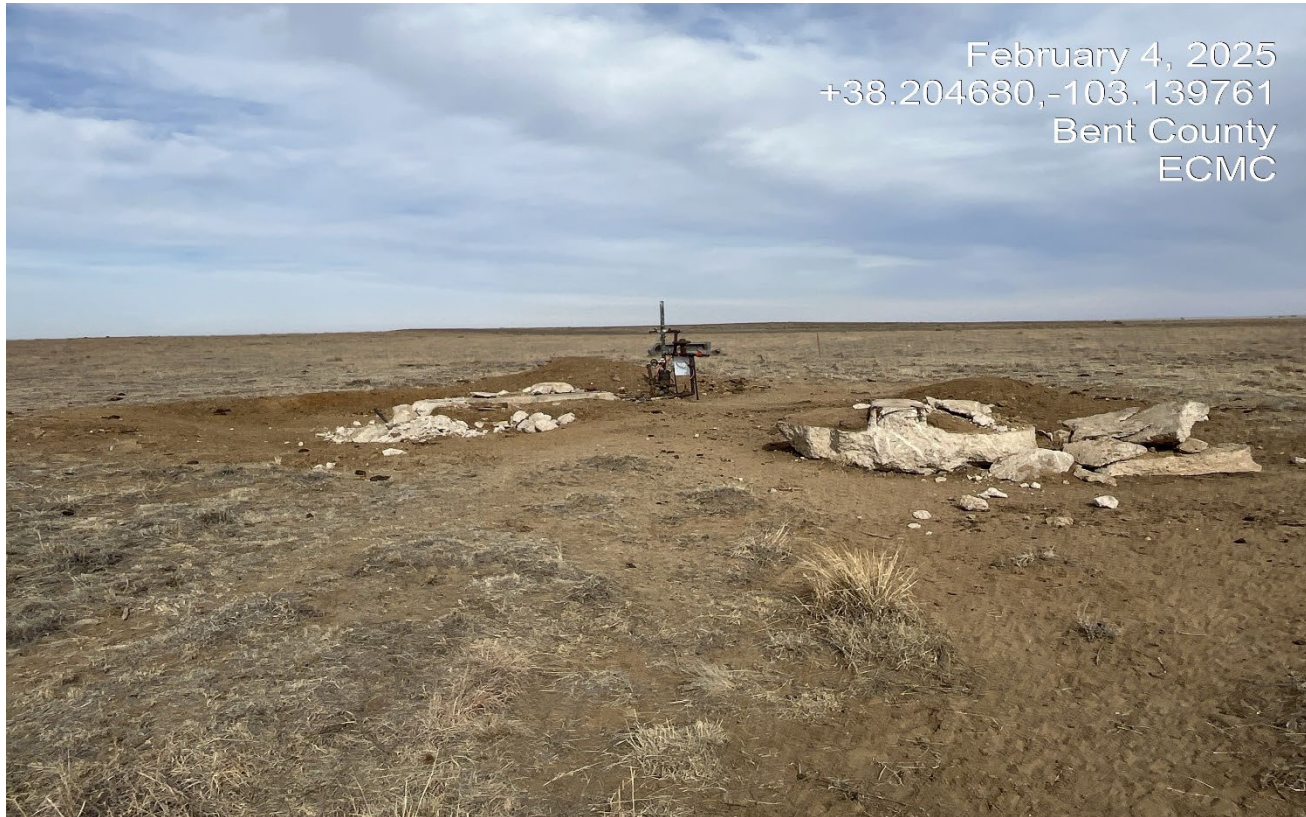
**Photo 3.** Facing northeast toward the wellsite. The concrete has been busted up and piled on location.

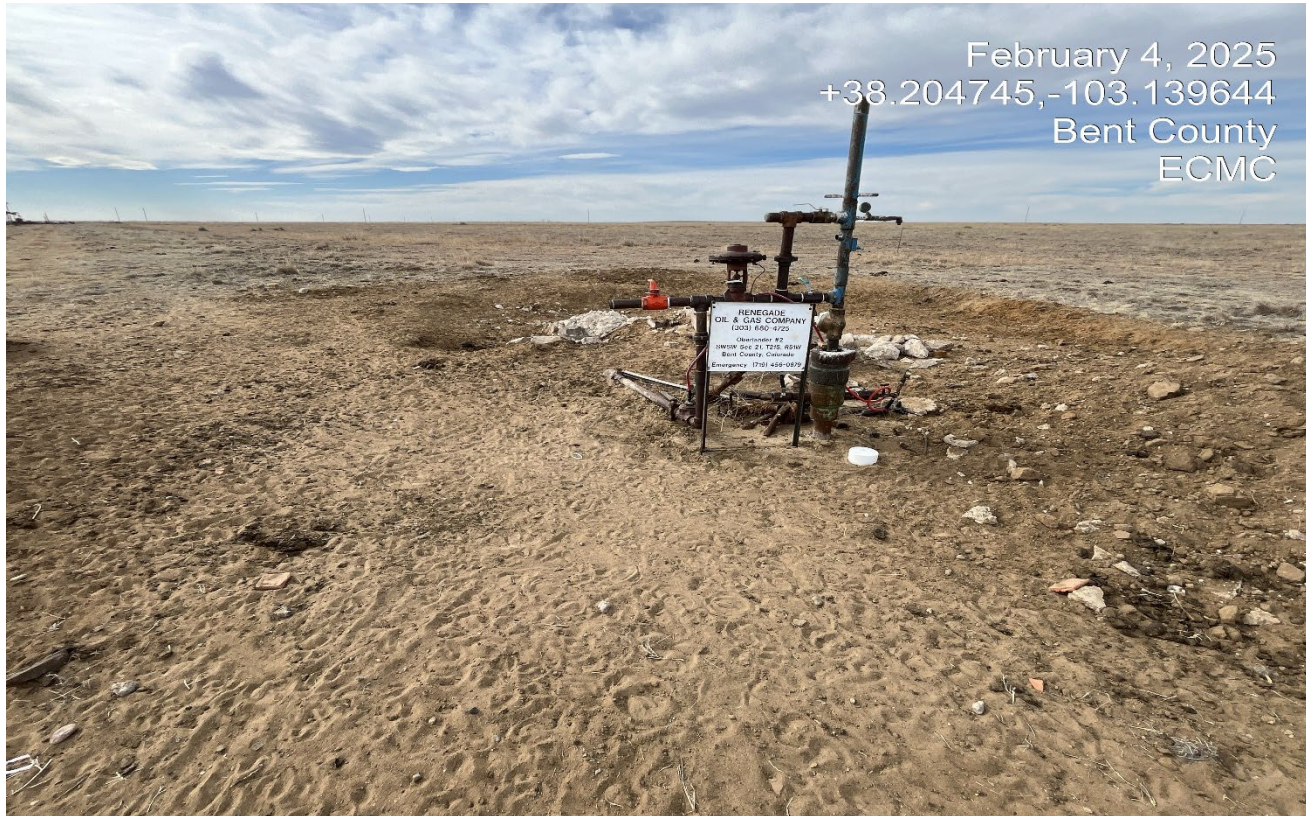
**Photo 4.** Facing toward the wellhead. There was a hissing gas leak heard at this well. The Operator was immediately notified. The emergency number list was disconnected.
