Operator: 8 North

Location Name: SUSIE-610N61W/9NWNW

Loc ID: 318999

Inspection: 709100370

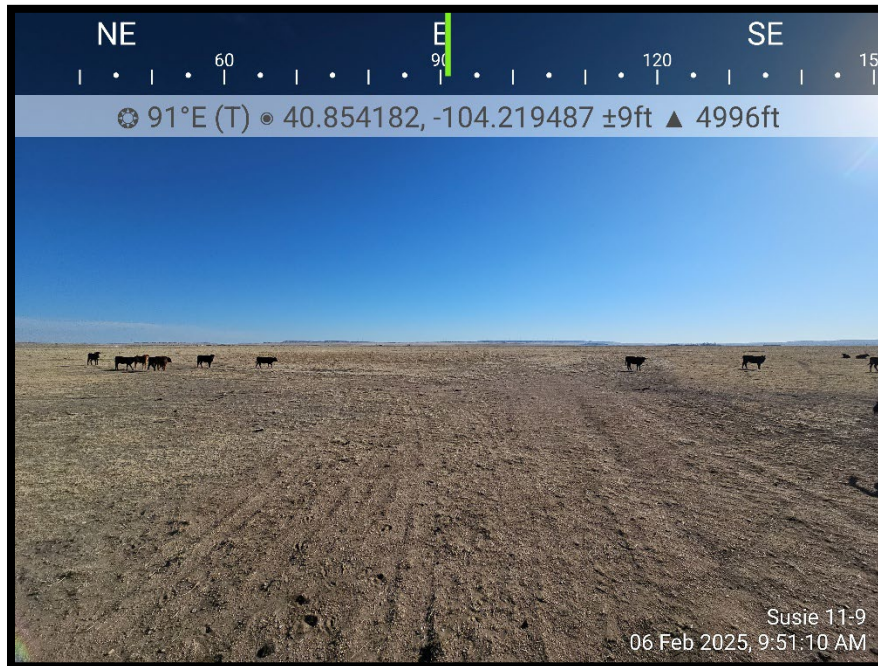
Exhibit A

CA: Location observed to have sparse vegetation growing (potential salt kill or sediment transport) south of location (photo 12 of Photo Log). Operator shall investigate the area by collecting soil sample(s) within the sparse vegetative area and compare the analytics using the Table 915-1 Protection of Groundwater Soil Screening Level Concentrations. If exceedances exist, remediate impacts to Table 915-1 standards. Documentation must include a figure showing area with sample locations plus laboratory results. This information shall be submitted within a Form 19 submittal.

CA Resolution: Operator has addressed the issue with Form 19 doc # 403092884, and it is under a current remediation # 22270, with Form 27 doc #402938857.
