Operator: CIVITAS NORTH LLC
Location Name: Grotheer 5-61 11A
Loc ID: 454760
Inspection: 718700165

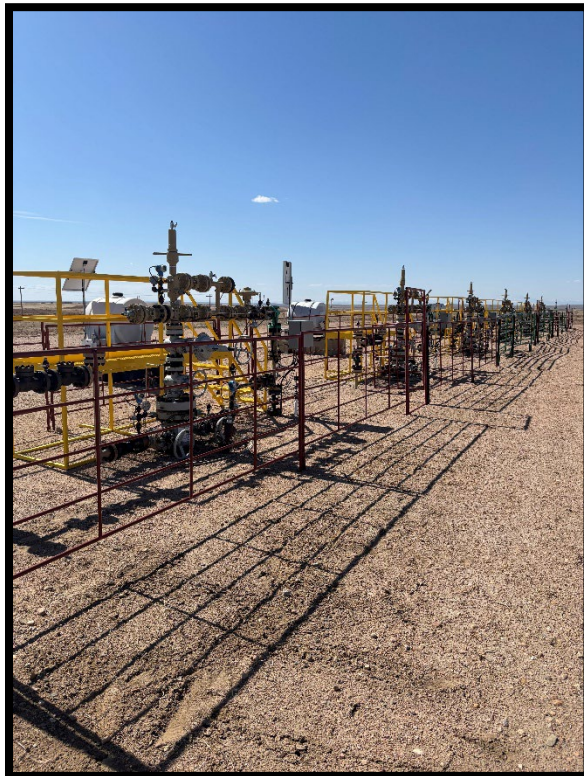
Exhibit A

CA: Stained soil observed under separator. Refer to attached inspection photos. Properly dispose of oily waste in accordance with Rule 905.e.

CA Resolution: Operator has reported that the debris on location has now been appropriately removed to comply with ECMC Rule 606, as well as, stained soil disposed of to comply with Rule 905.e.

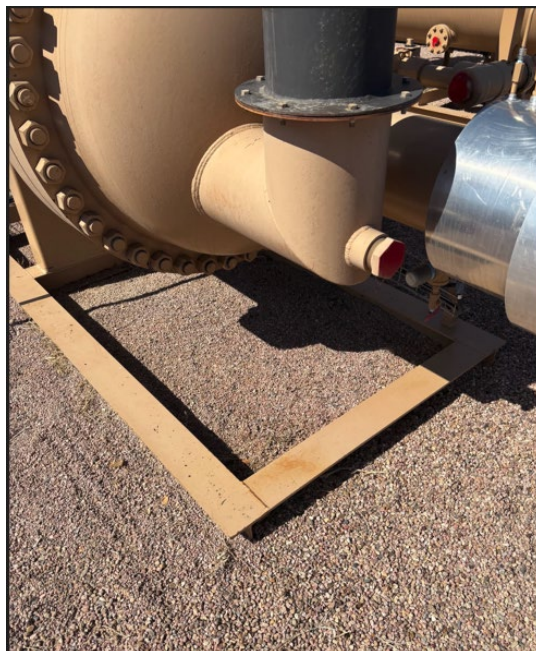
Exhibit B

Noted Comment: Tumbleweed debris observed throughout the location and within equipment. Refer to attached inspection photos. Comply with Rule 606 and remove all debris.
