Final Reclamation and Stormwater Inspection

Location ID: 320179

Well Name: GREEN #1

Inspection Document #: 718600379

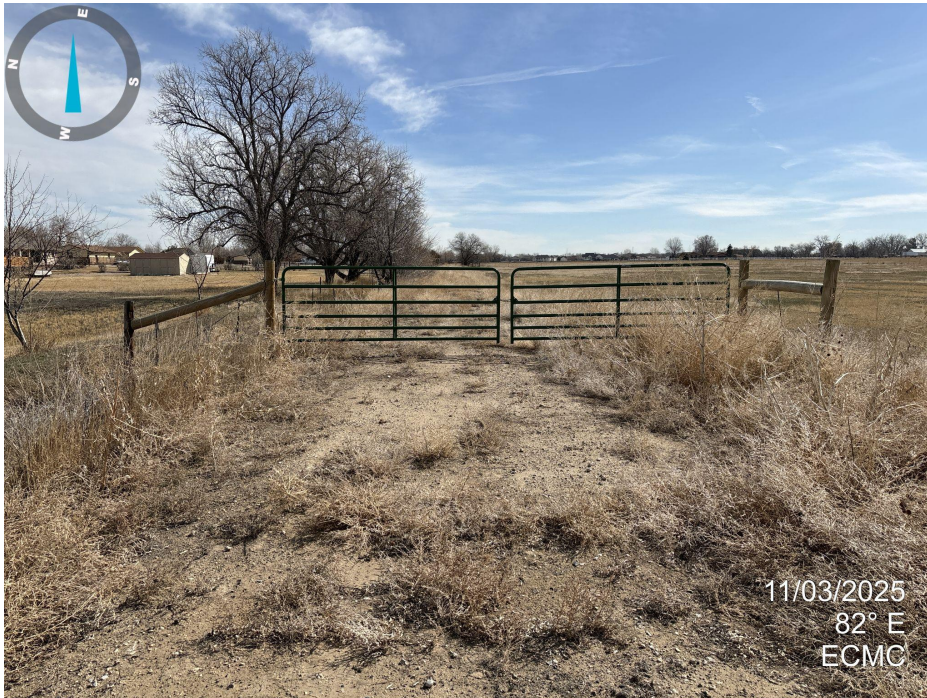
Photo 1. Looking east down access road. Two gates, gravel and culvert remain in place. Access road appears to be primary access to property. Undesirable weed Kochia is present along the access road.

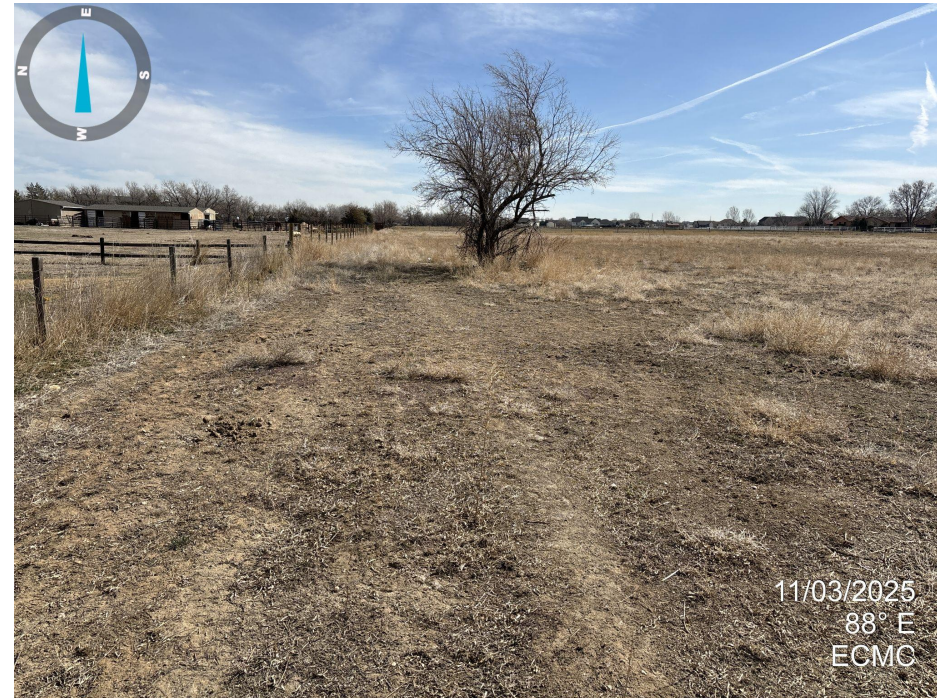
Photo 2. Looking east down former access road near well location. This section of access road appears to have had reclamation work conducted. Larger patches of bare soil are present with little desirable vegetation establishment.

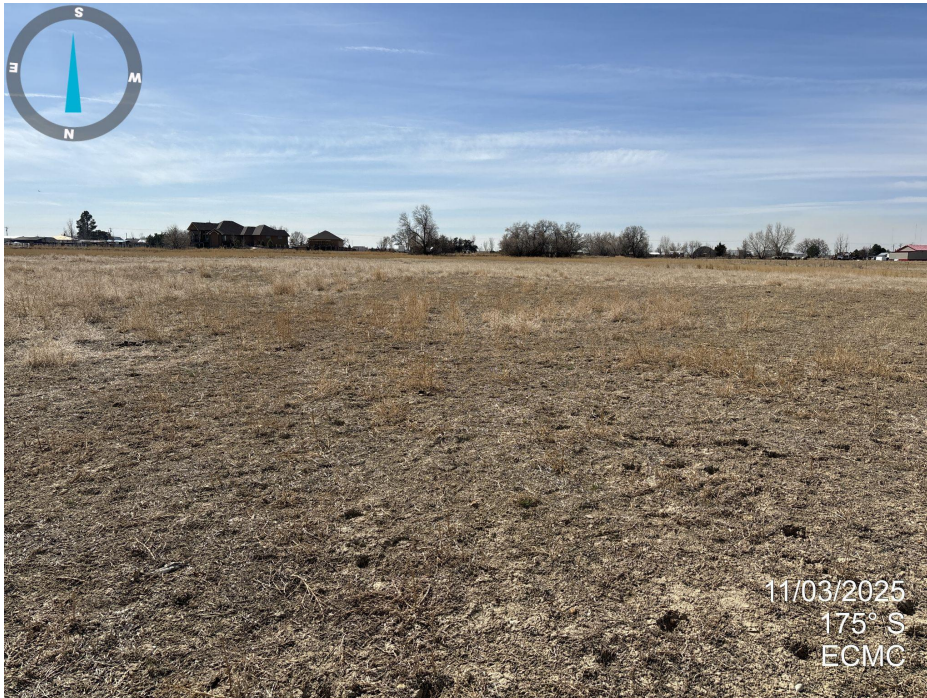
Photo 3. Overview of location. Looking south across former tank battery and well location from north side of location on access road. Undesirable weeds Kochia and Russian Thistle are present throughout the location. There appears to be very little desirable vegetation establishment.

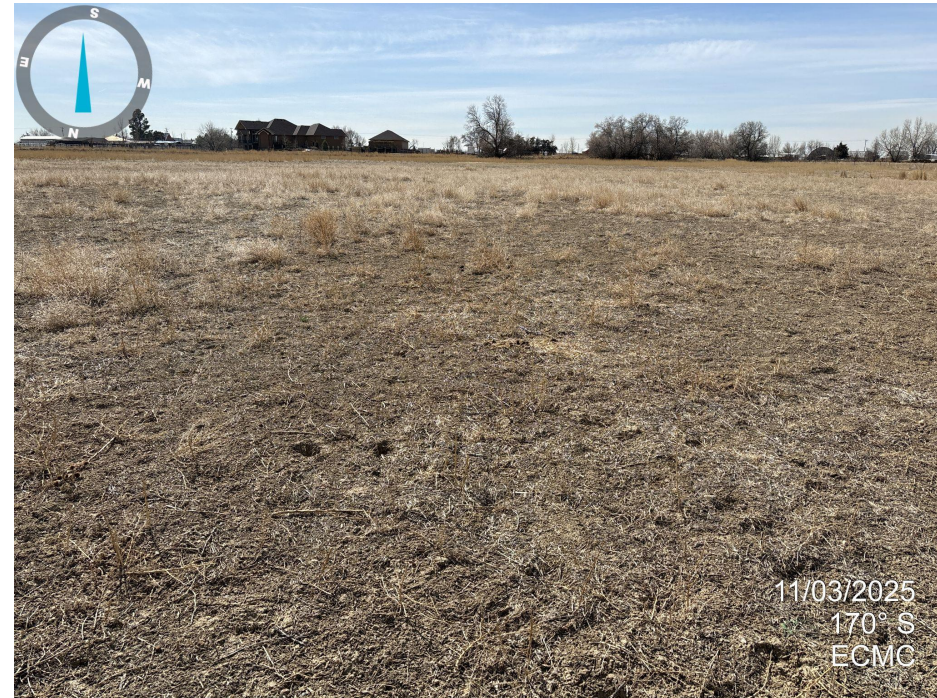
Photo 4. Looking south across tank battery from the north edge of battery. No oil and gas equipment remains. See photo 3 comments.

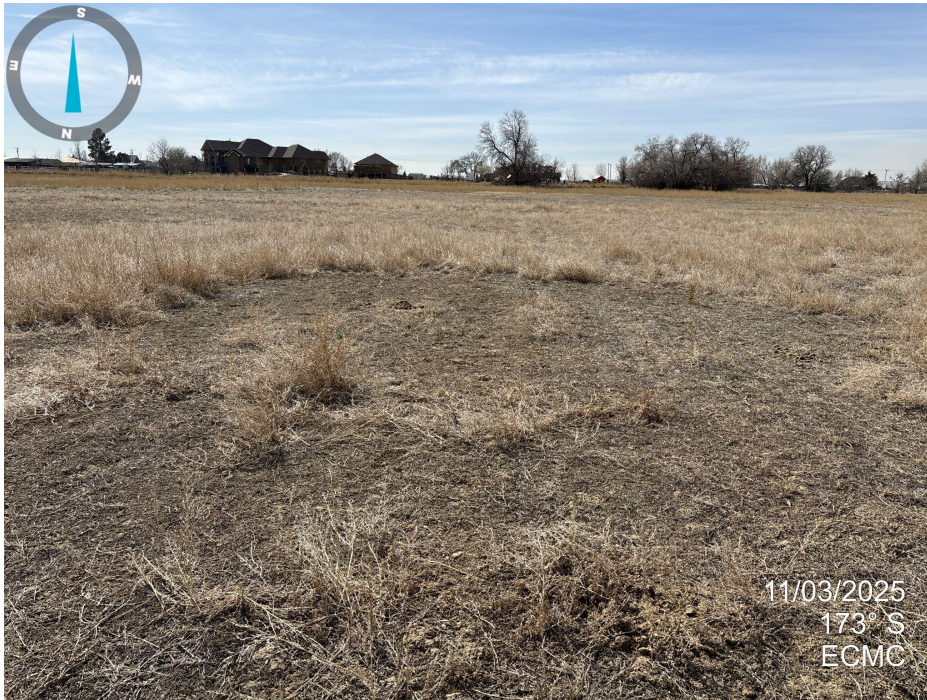
Photo 5. Looking south across the wellbore. No oil and gas equipment remains. See photo 3 comments.

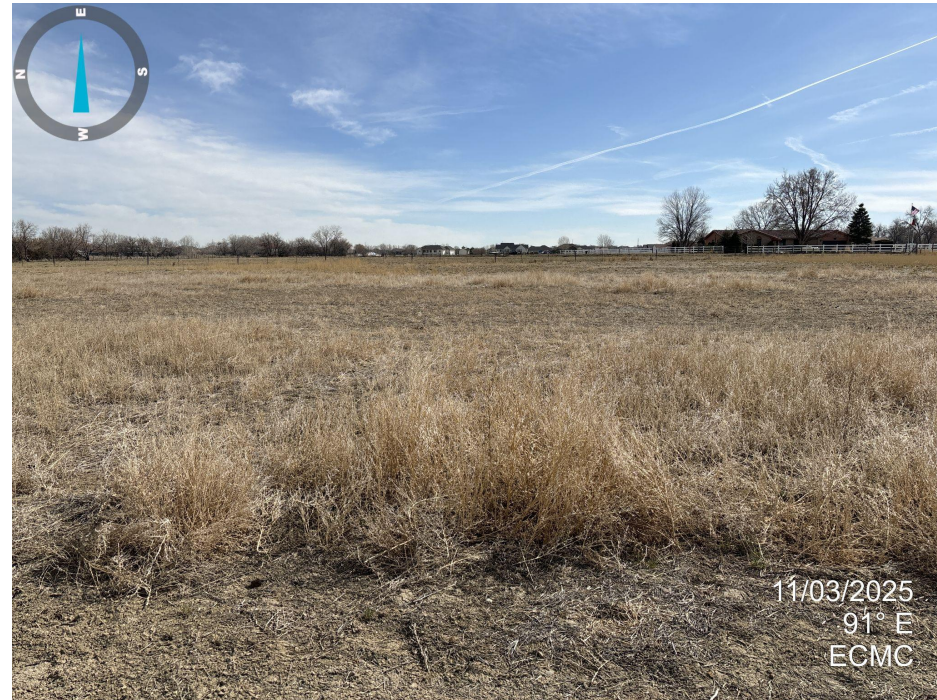
Photo 6. Looking east from wellbore. See photo 3 comments.

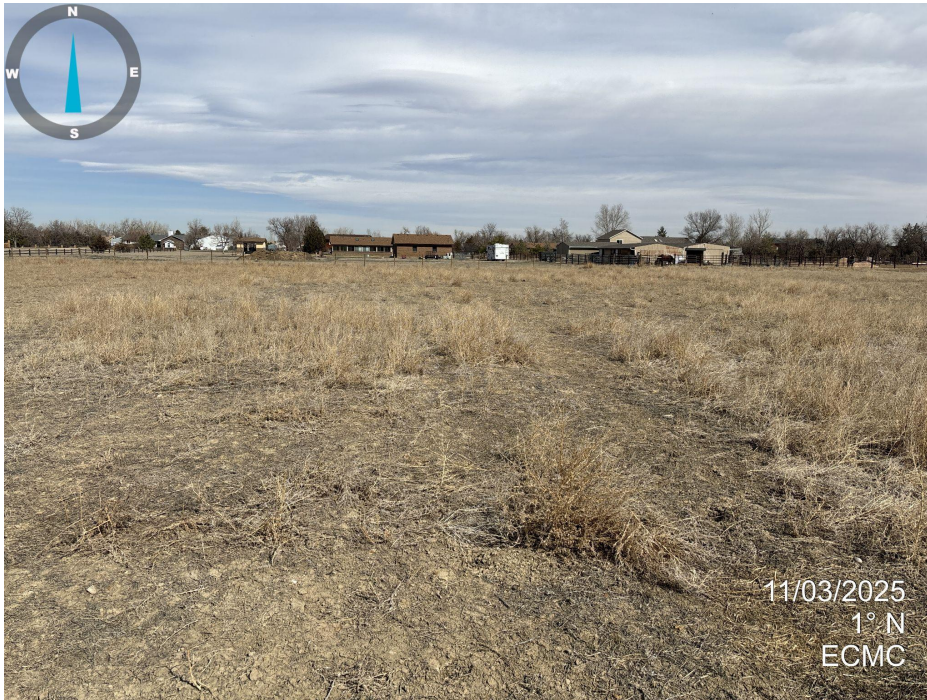
Photo 7. Looking north from wellbore. See photo 3 comments.

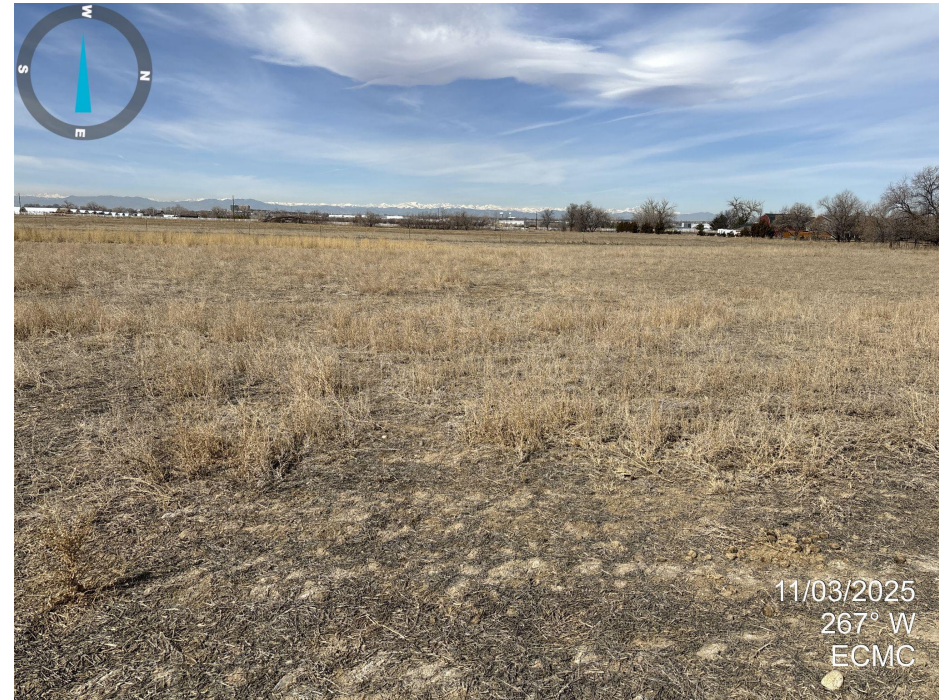
Photo 8. Looking west from wellbore. See photo 3 comments.

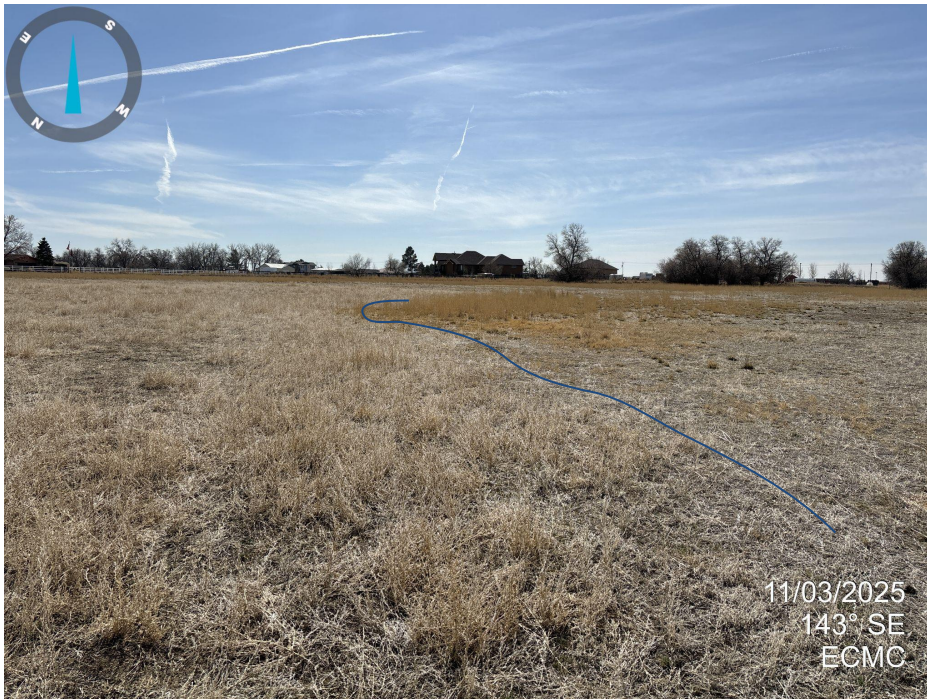
Photo 9. Photo taken from the west side of location looking southeast. Illustrating difference in vegetation from reclaimed area to pasture. (To the right of blue line is pasture).

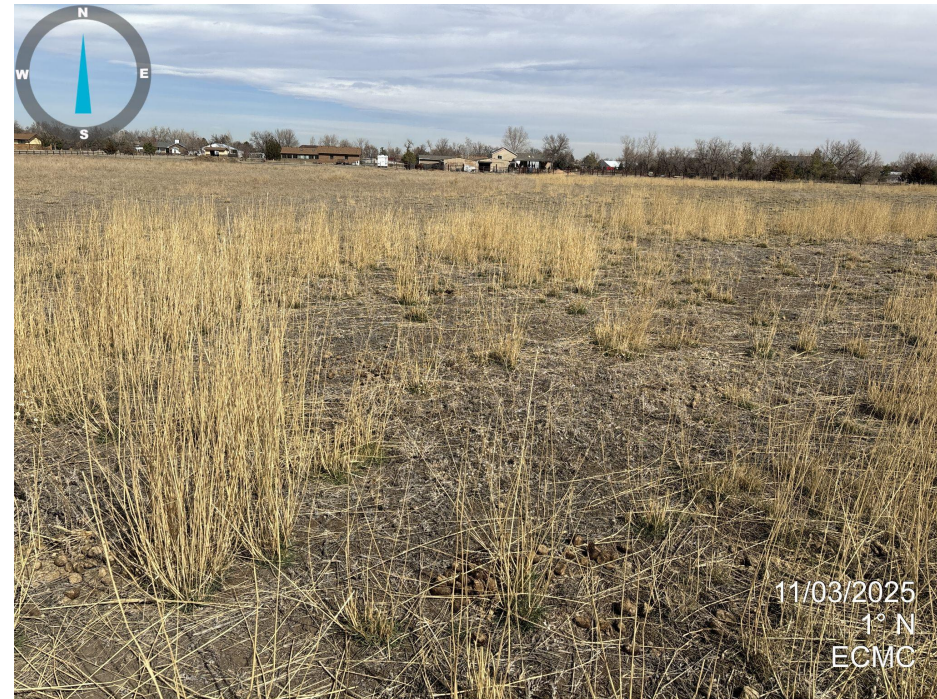
Photo 10. Reference vegetation to the east of well location within pasture. Vegetation is relatively poor however there are desirable perennial species present.

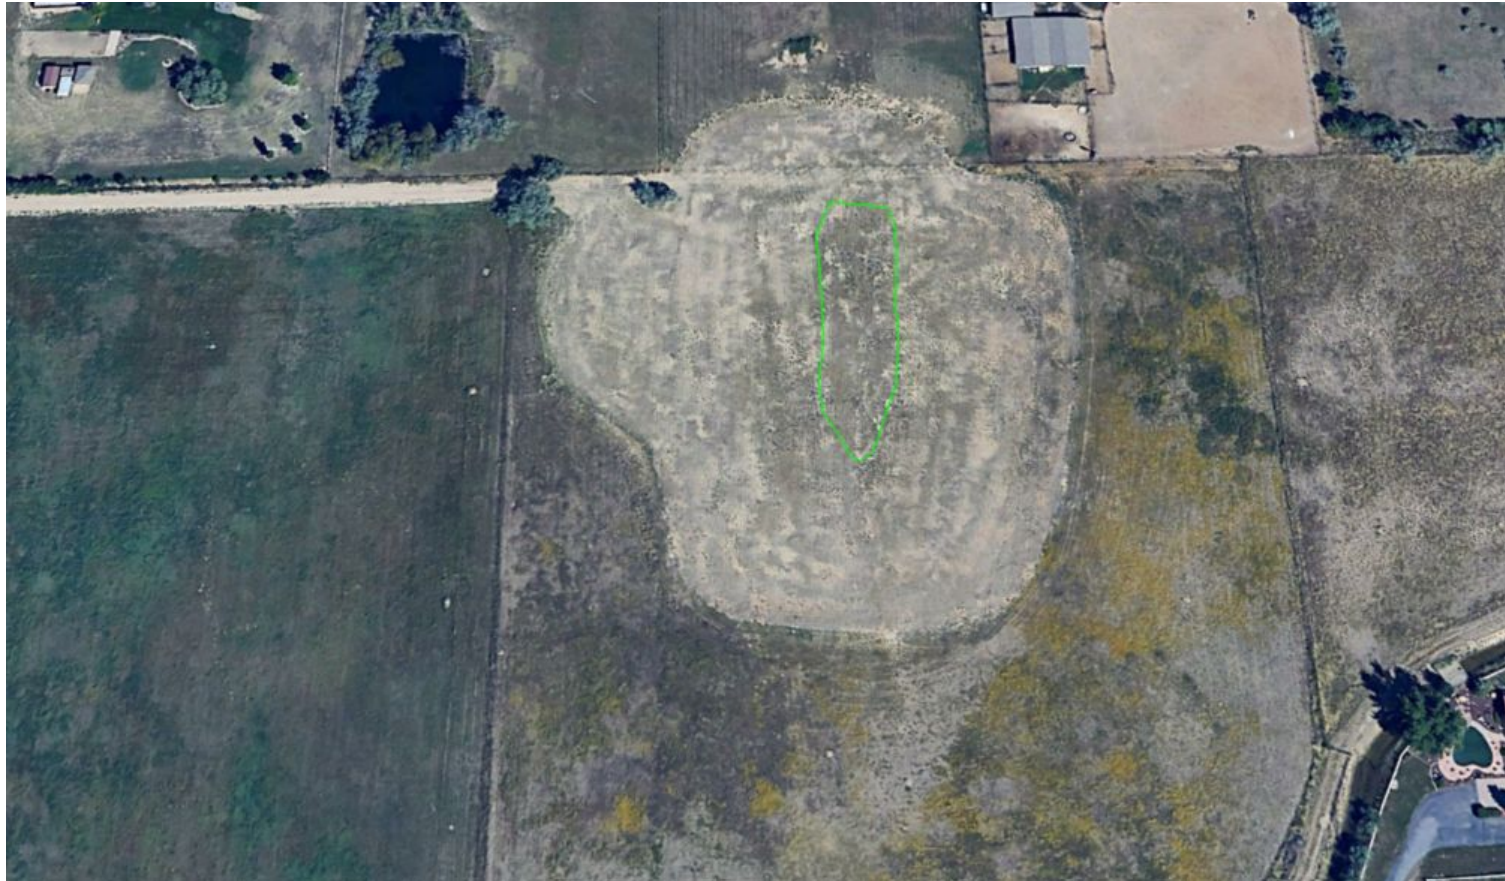
Photo 11. Google aerial imagery taken 09/2023. Illustrating large reclamation area due to remediation project. (Green outline former tank battery and well footprint).
