# Inspection Photos

API: 071-07312

Operator: WAPITI OPERATING LLC

Inspection Date: 3/20/2025

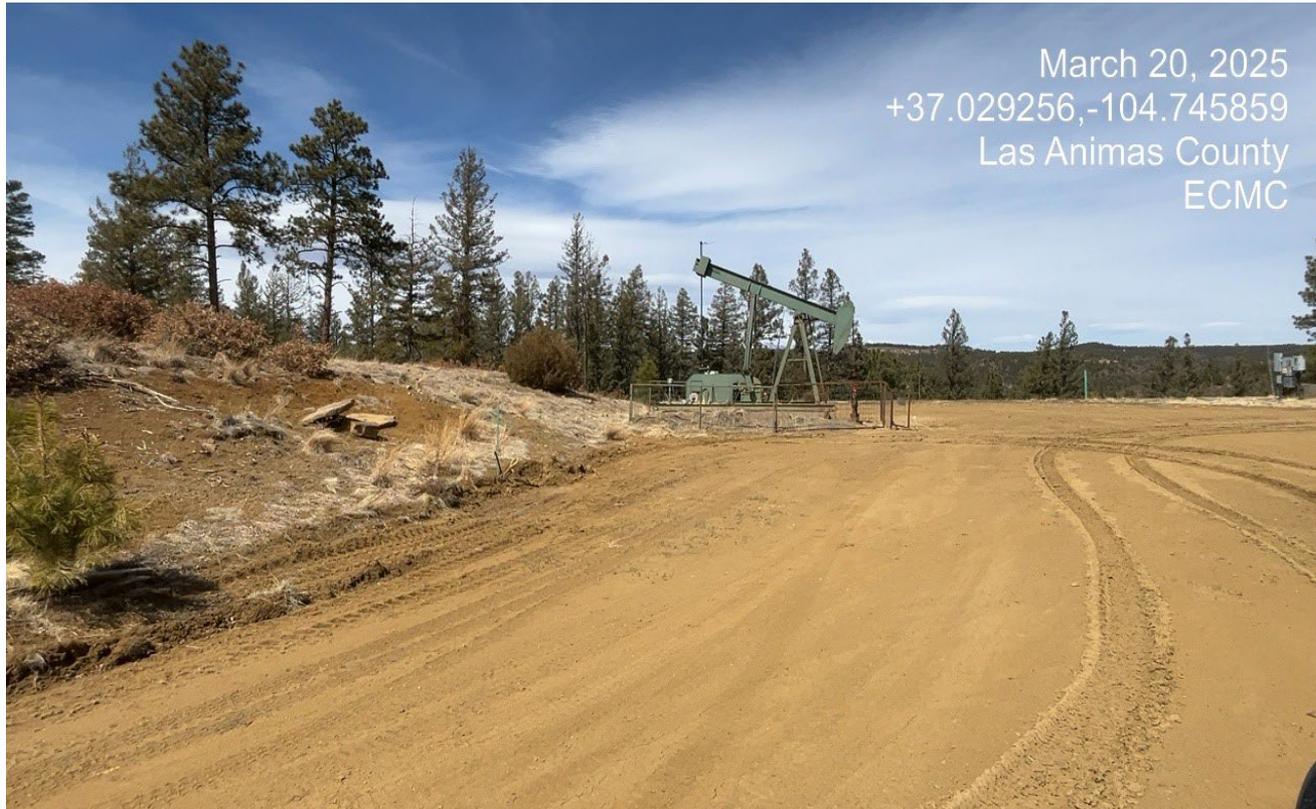
**Photo 1.** Facing north toward the wellsite.

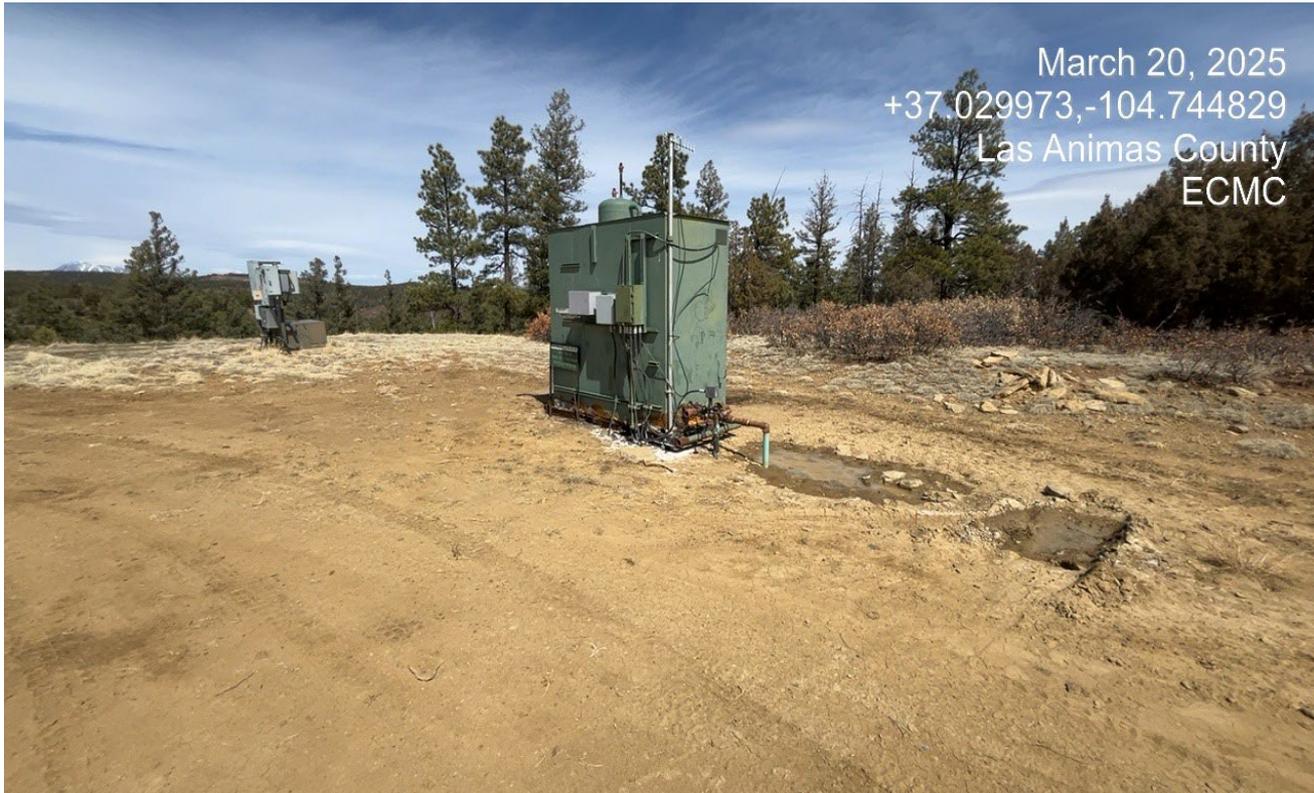
**Photo 2.** Facing northeast toward the meter shed. There is a produced water leak coming from the meter shed that needs to be fixed and cleaned up.

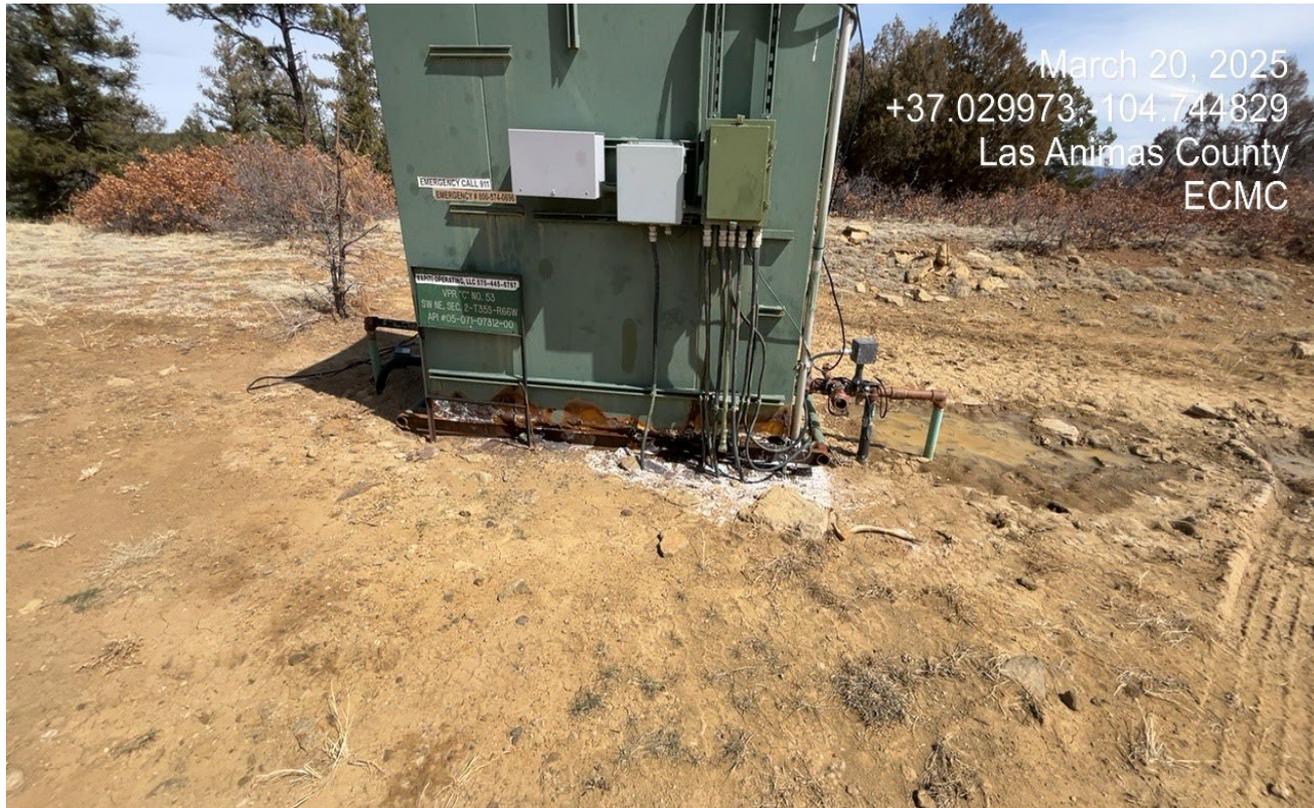
**Photo 3.** There is a dripping water leak at the meter shed. The base of the meter shed is all rusted out from the ongoing leak.

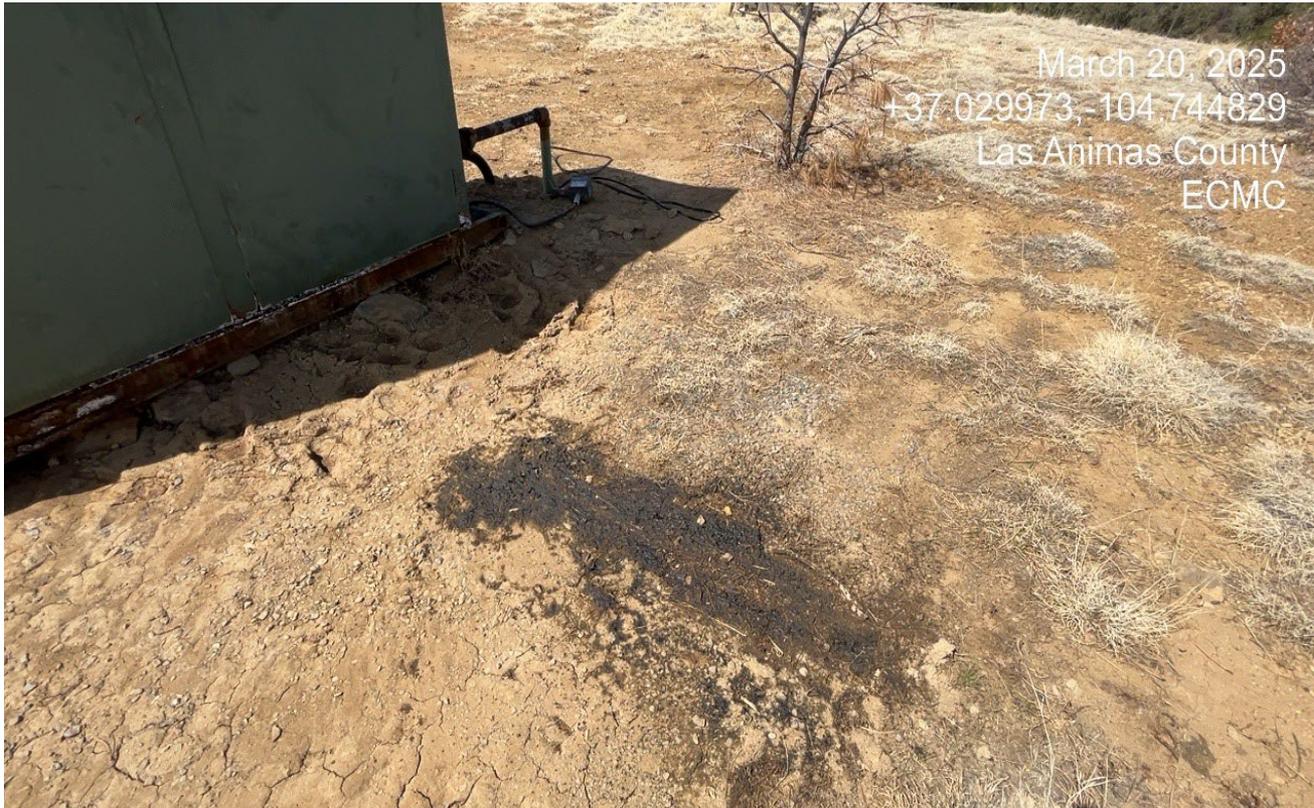
**Photo 4.** There is a hydrocarbon stain at the backside of the meter shed that needs to be cleaned up..
