WETLAND ASSESSMENT

Cloud Break Pad

Wetland Delineation Site Map

Cloud Break Pad
SECTION 22, TOWNSHIP 8N, RANGE 62W,
WELD COUNTY, CO

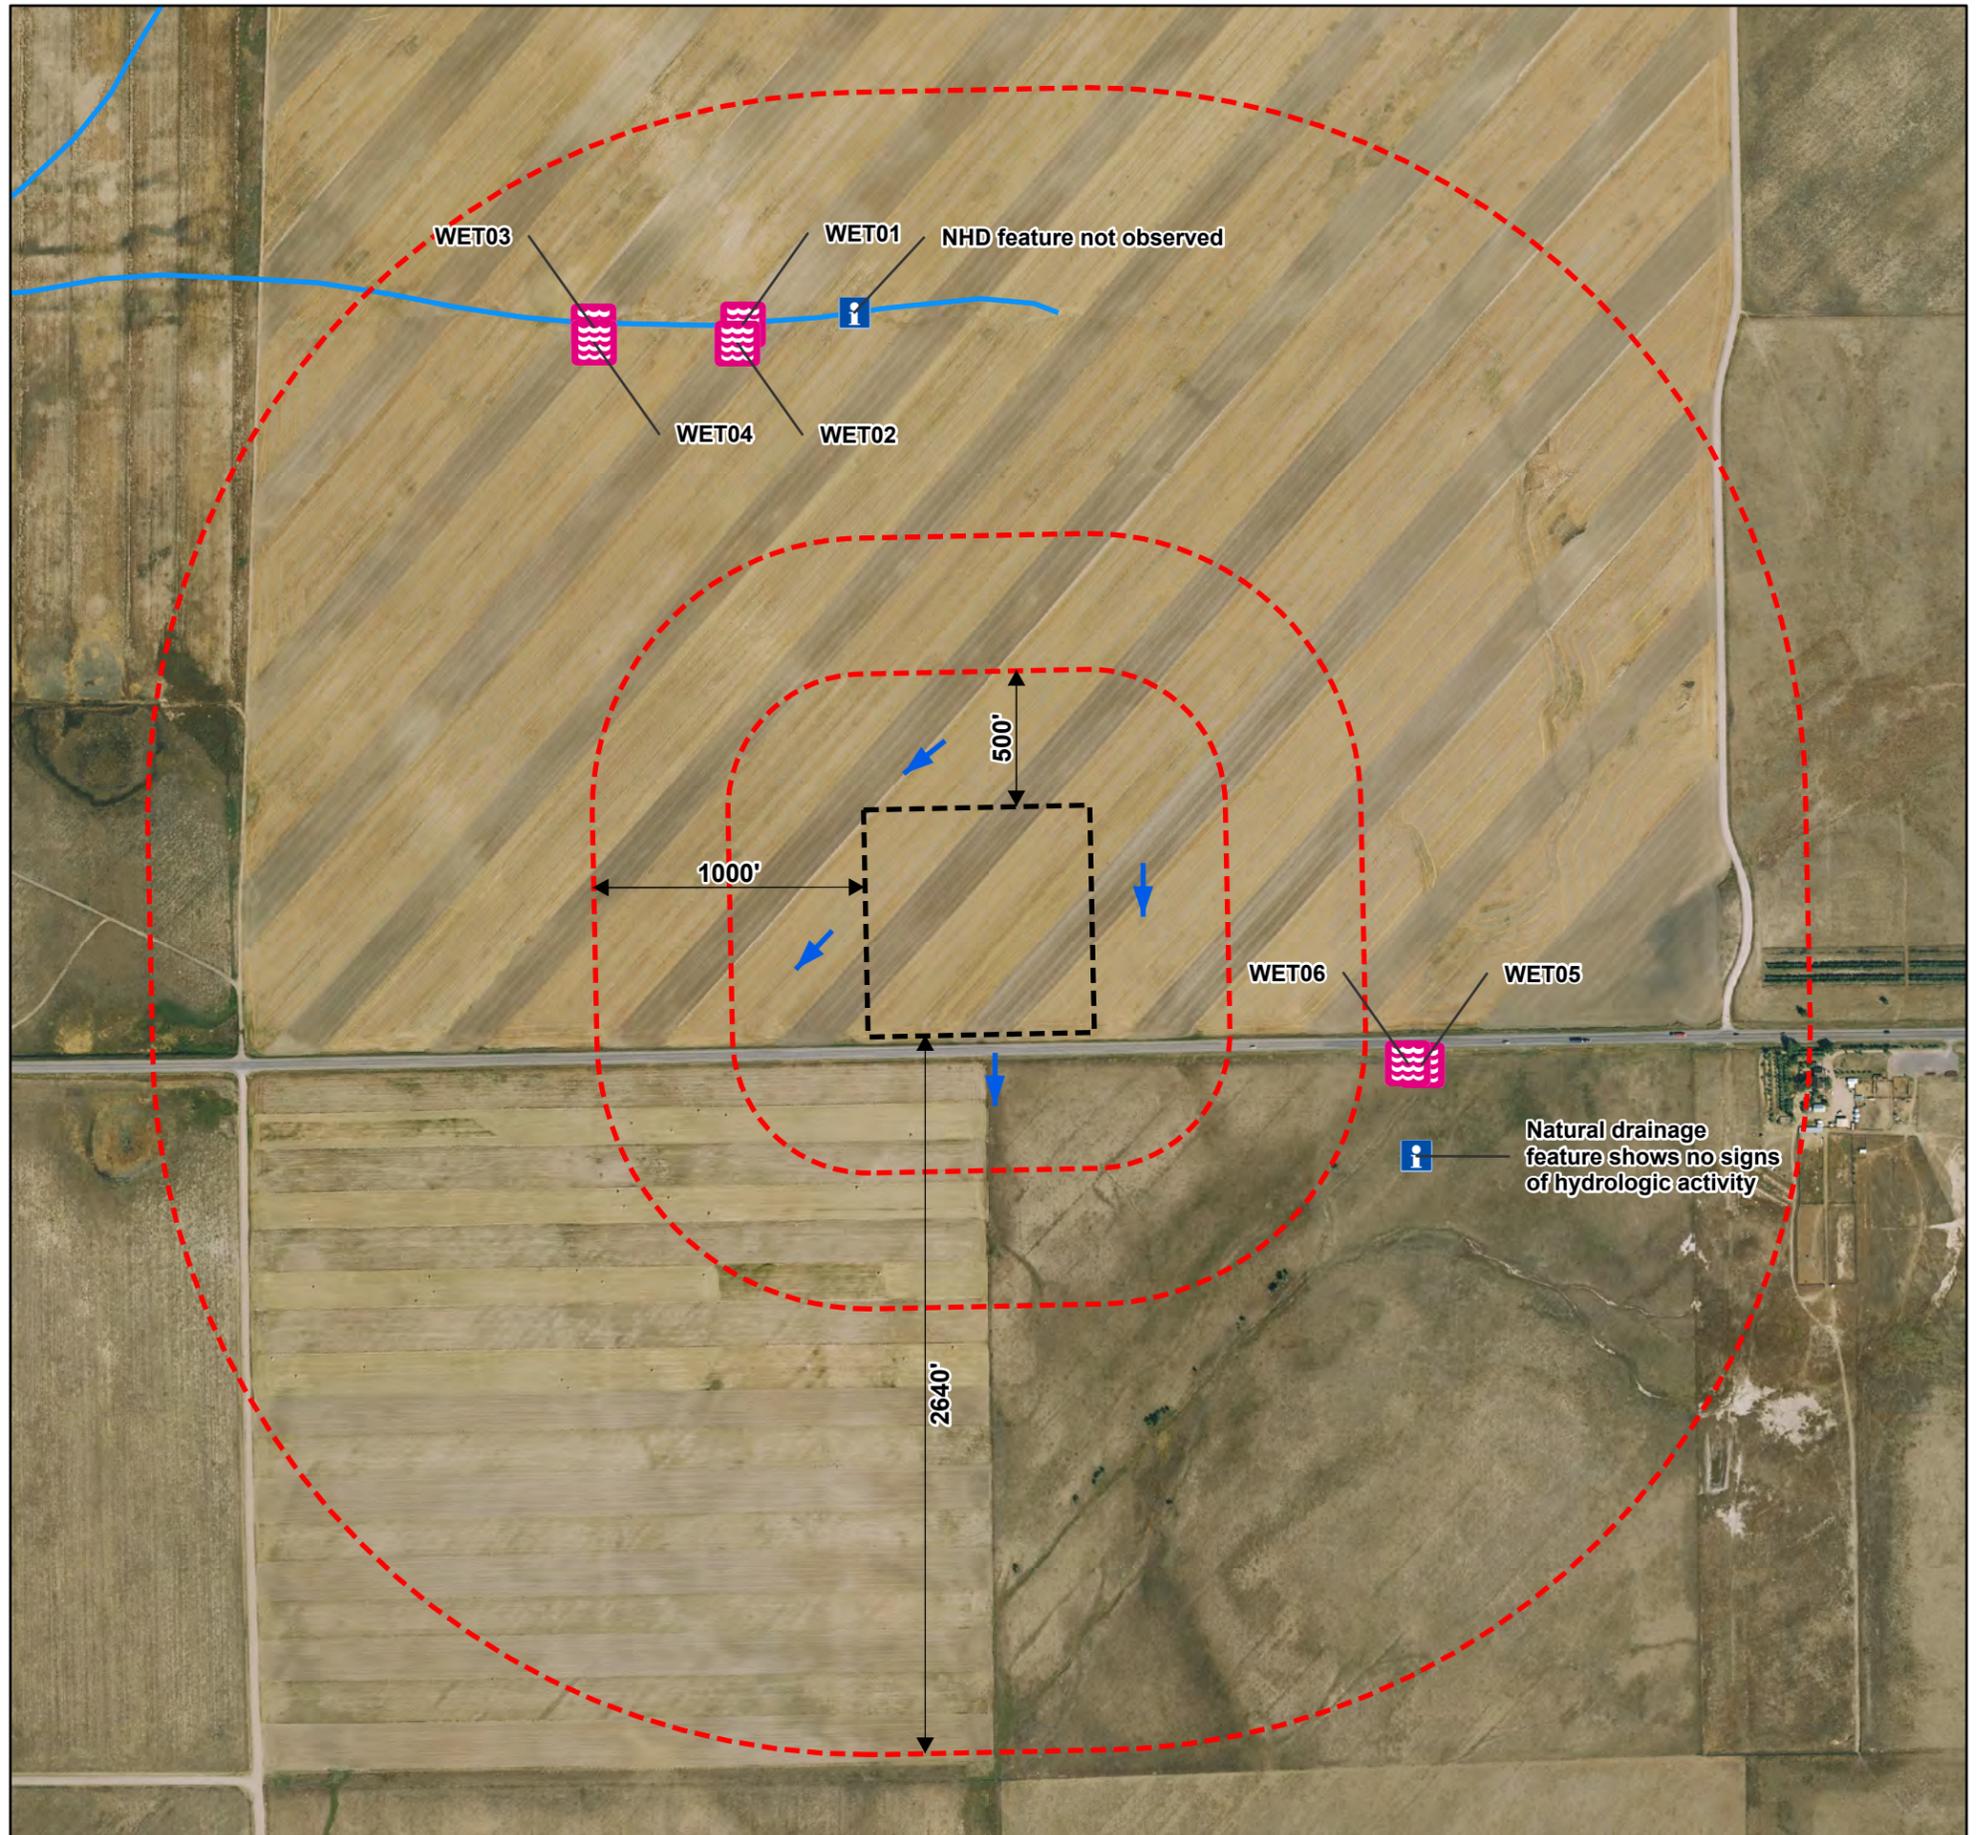
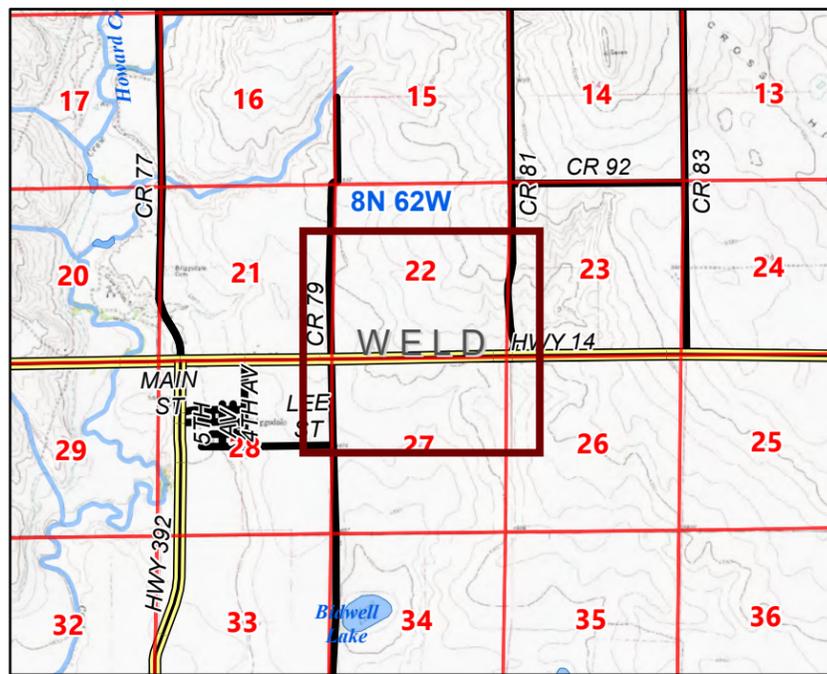
- Wetland Data Point
- Information
- Construction Boundary
- Buffer
- Flow
- Distance
- NHD Mapped Stream

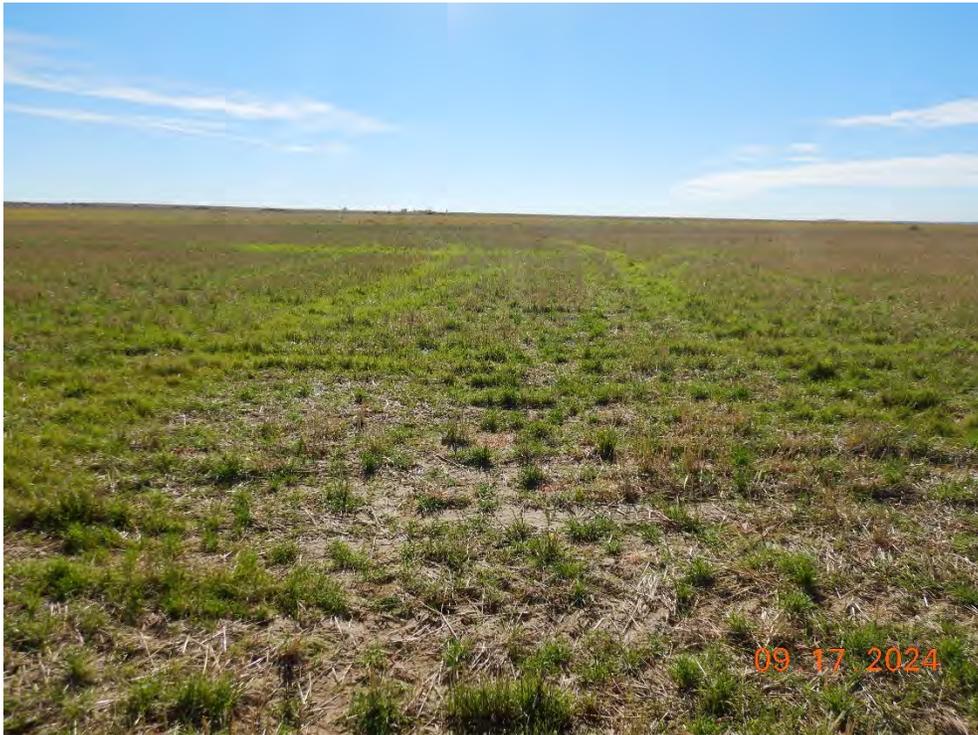
WET01 – Facing upslope (E)

Remarks: Area is located in an actively cultivated agriculture field.
Location lacked wetland indicators for vegetation, soil and hydrology; non-wetland.

Remarks:
Compacted clay layer discovered at 15".

Remarks:
Single secondary indicator of potential wetland hydrology present; No wetland hydrology present.

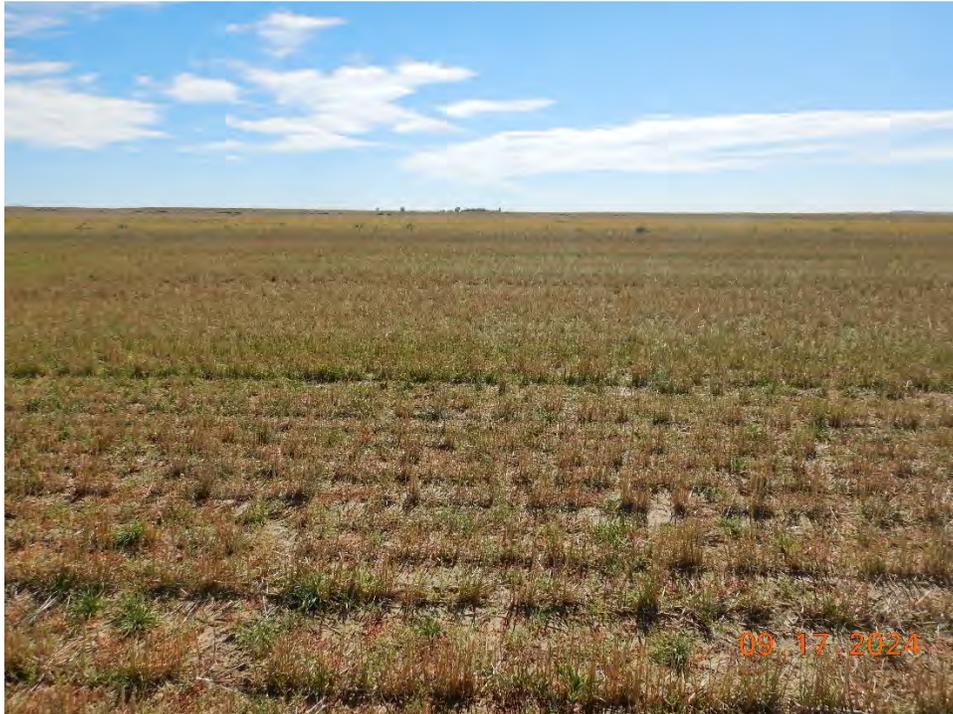
Near WET02 – Facing Upslope (E)

Remarks: Area is located in an actively cultivated agriculture field.
 Location lacked wetland indicators for vegetation, soil and hydrology; non-wetland.

Remarks:
 No soil pit was dug for this point based on lack of hydrophytic vegetation and wetland hydrology

Remarks:
 Area is located in an actively cultivated agriculture field. No hydrology indicators were found onsite.

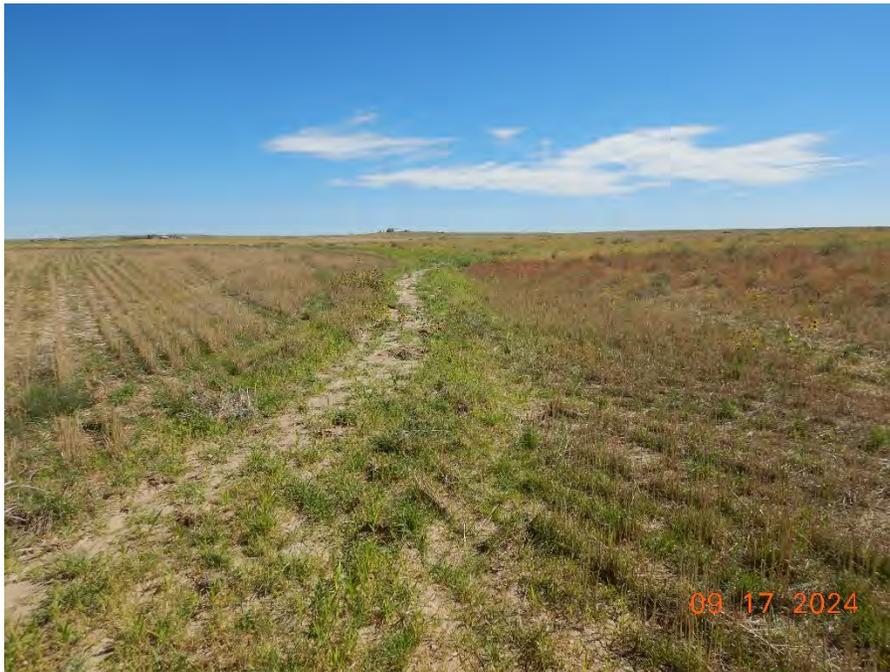
WET03 – Facing Upslope (NE)

Remarks: Area is located in an actively cultivated agriculture field.
 Location lacked wetland indicators for vegetation and soil; non-wetland.

Remarks:
 No hydric soil indicators present during assessment; Compacted clay layer at 15".

Remarks:
 Drift deposits found just down-slope of the natural drainage route.

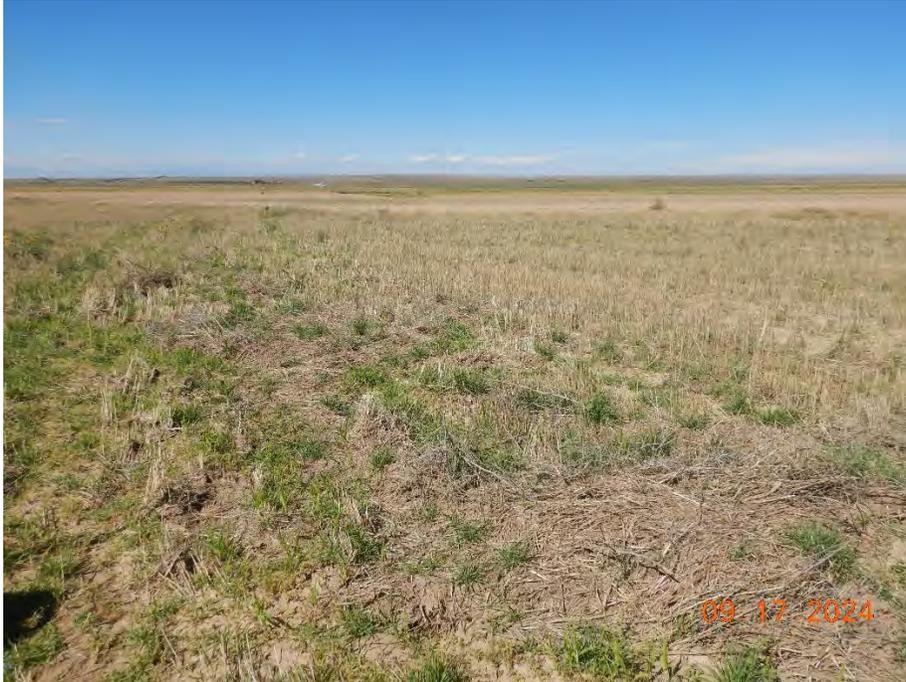
Near W04 – Facing Downslope (SW)

Remarks: Area is located in an actively cultivated agriculture field.
Location lacked wetland indicators for vegetation and hydrology; non-wetland.

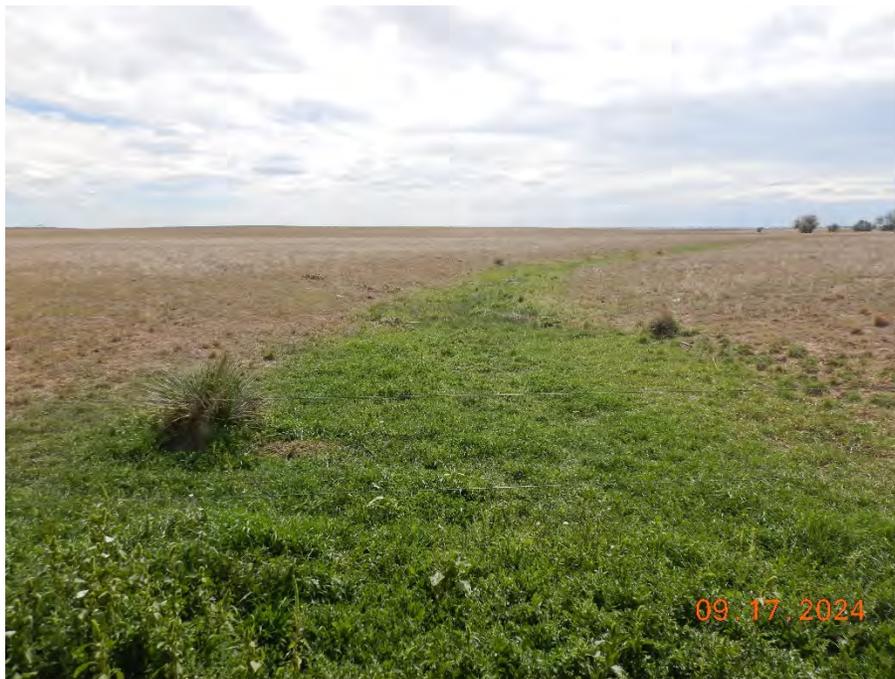
WET05 – Facing Downslope (S)

Profile Description: (Describe to the depth needed to document the indicator or confirm the absence of indicators.)								
Depth (inches)	Matrix		Redox Features				Texture	Remarks
	Color (moist)	%	Color (moist)	%	Type ¹	Loc ²		
0-6	10YR 3/2	100					Loam	
6-14	10YR 3/2	100					Clay

Restrictive Layer (if observed): Type: <u>Compacted Clay layer</u> Depth (inches): <u>15"</u>	Hydric Soil Present? Yes <input type="checkbox"/> No <input checked="" type="checkbox"/>
--	---

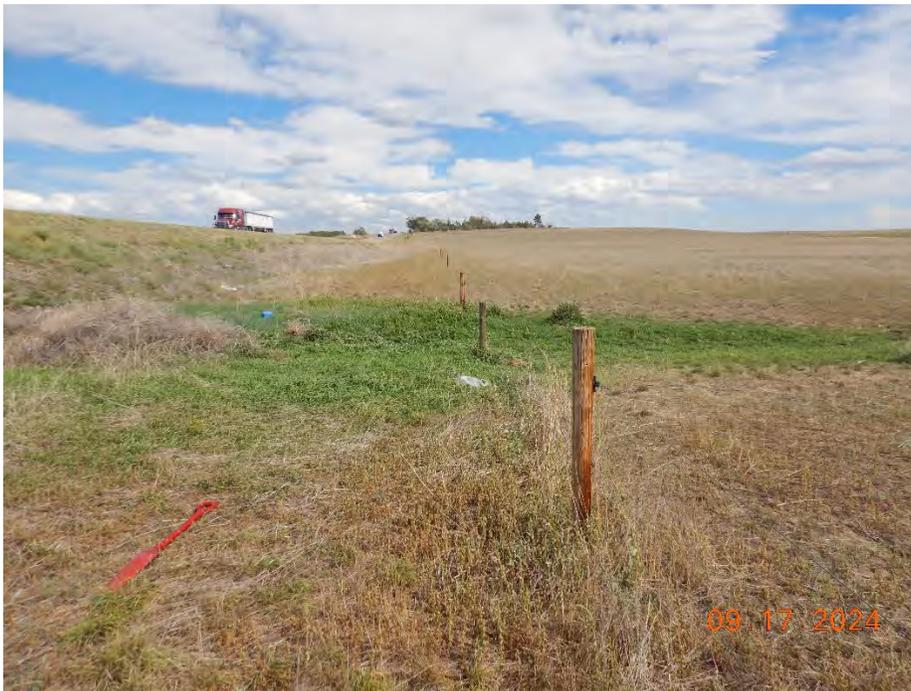
WET06 – Facing Upslope (E)

Profile Description: (Describe to the depth needed to document the indicator or confirm the absence of indicators.)								
Depth (inches)	Matrix		Redox Features				Texture	Remarks
	Color (moist)	%	Color (moist)	%	Type ¹	Loc ²		
0-6	10YR 3/2	100					Loam	
6-9	10YR 3/2	100					Clay

Restrictive Layer (if observed): Type: <u>Compacted Clay layer</u> Depth (inches): <u>9"</u>	Hydric Soil Present? Yes <input type="checkbox"/> No <input checked="" type="checkbox"/>
---	---
