Wellhead Closure Checklist						
COGCC Rule 911.a.(4) Environmental Site Closure Assessment Field Form						
Additional attachments (optional):		Pit Closure		Tank Battery Closure		Flowline Closure
Site Name & COGCC Facility Number: Lucci B #1-20		Date: 02/05/24				Remediation Project #: 29696
Associated Wells: 05-123-25938		Age of Site: Years				Number of Photos Attached: 6
Location: (GPS coordinates of wellhead or southeastern most wellhead for multiple)					40.428584 / -104.503234	
General Condition of Site: (General observations regarding housekeeping, corrosion, waste management, etc.)						
Good condition.						
USCS Soil Type: SM				Estimated Depth to Groundwater: Approx. 15-25'		
Hydrocarbon Impacted Soils / Spills: (Note estimated size and if impact appears to be surficial or extends to an unknown depth)						
None observed.						
Salt Crusted Soils or Impacted Vegetation: (Note estimated size and if impact appears to be surficial or extends to an unknown depth)

Lucci B #1-20  
API # 05-123-25938  
Remediation # 29696

Closure Assessment

February 2024

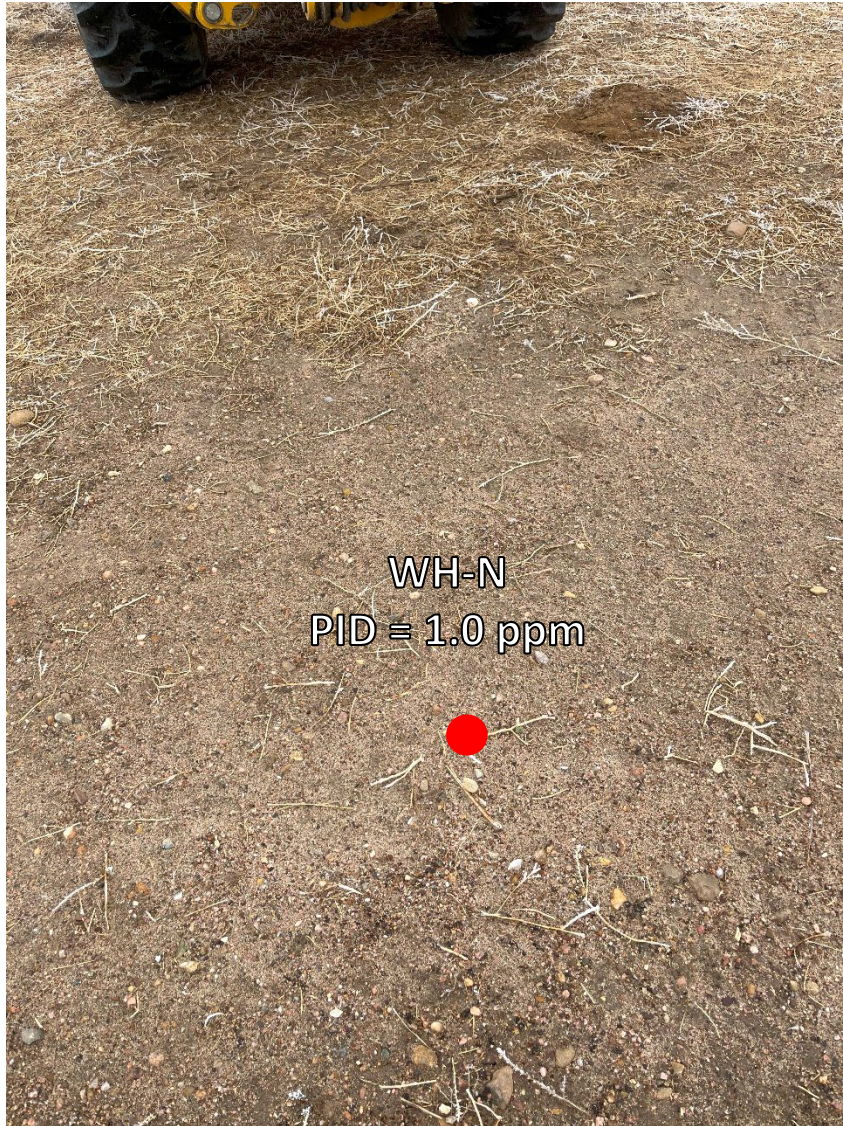
## Wellhead Surface – 02/05/24

Looking north

Site in good condition – no petroleum hydrocarbon staining or odor  
Observed on surface around wellhead

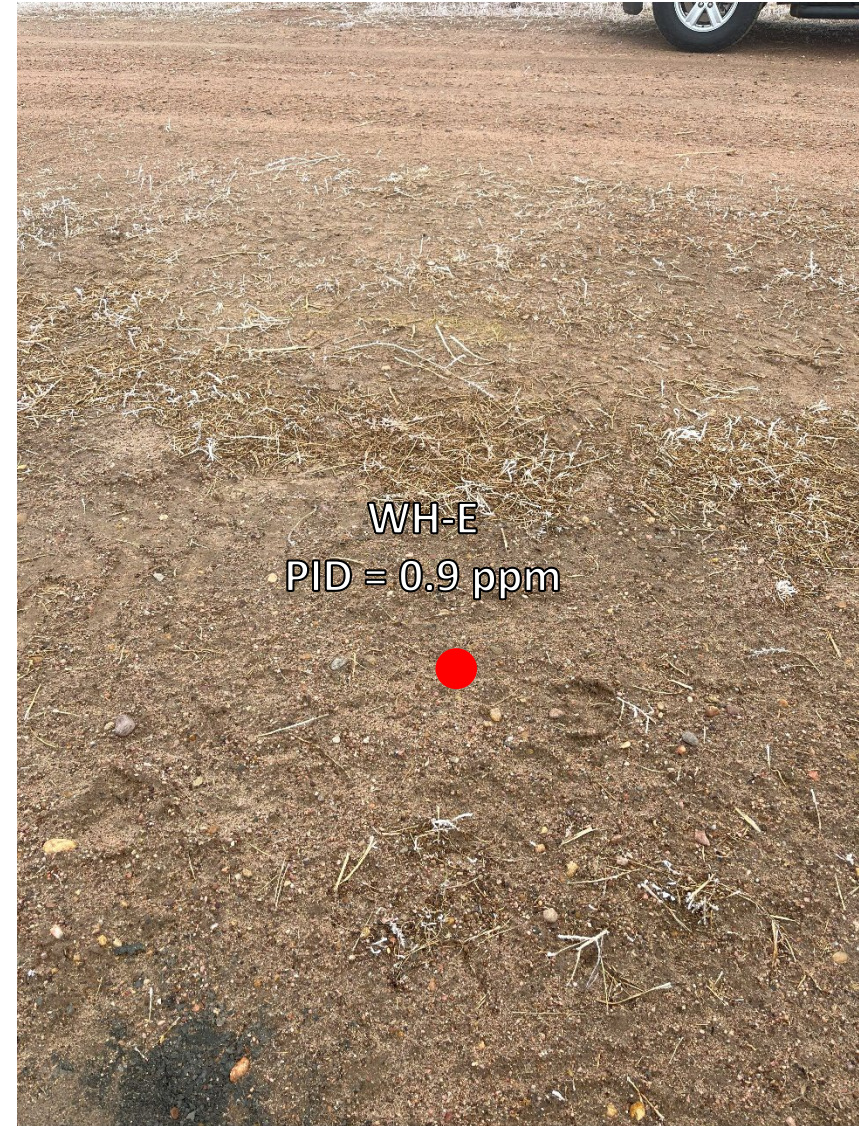
Looking east

Site in good condition – no petroleum hydrocarbon staining or odor  
Observed on surface around wellhead

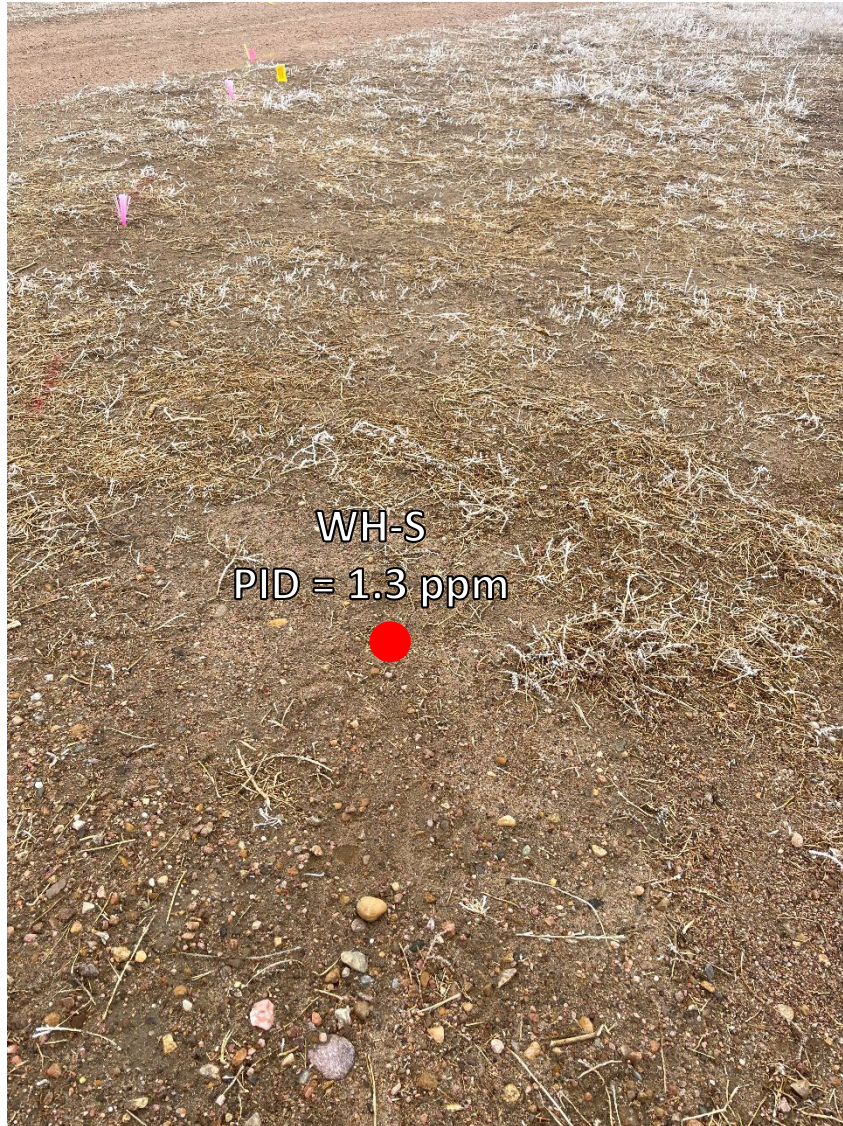
## Wellhead Surface – 02/06/24

Looking south

Site in good condition – no petroleum hydrocarbon staining or odor  
Observed on surface around wellhead
