## **Facility Closure Investigation and Environmental Summary**

Arens G26-19 Wellhead

ECMC Remediation Project #34770

Weld County, Colorado

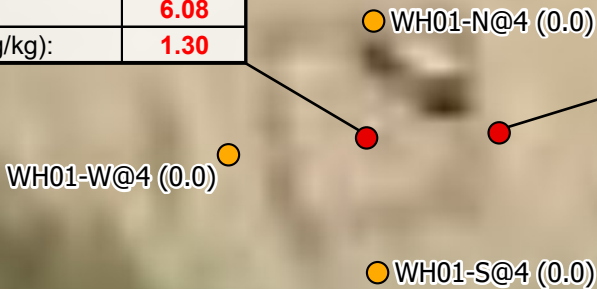
2

WH01@6	
5/17/2024	
pH:	8.49
SAR:	6.08
Arsenic (mg/kg):	1.30

FLR01@4	
5/17/2024	
pH:	8.42
SAR:	8.11
Arsenic (mg/kg):	2.72
Lead (mg/kg):	19.1

**ARENS G26-19 WELLHEAD**  
**SOIL SAMPLE AND FIELD SCREENING LOCATIONS**  
 NOBLE ENERGY  
 SW 1/4 NW 1/4 SECTION 26  
 T4N R65W, 6TH PM  
 WELD COUNTY, COLORADO

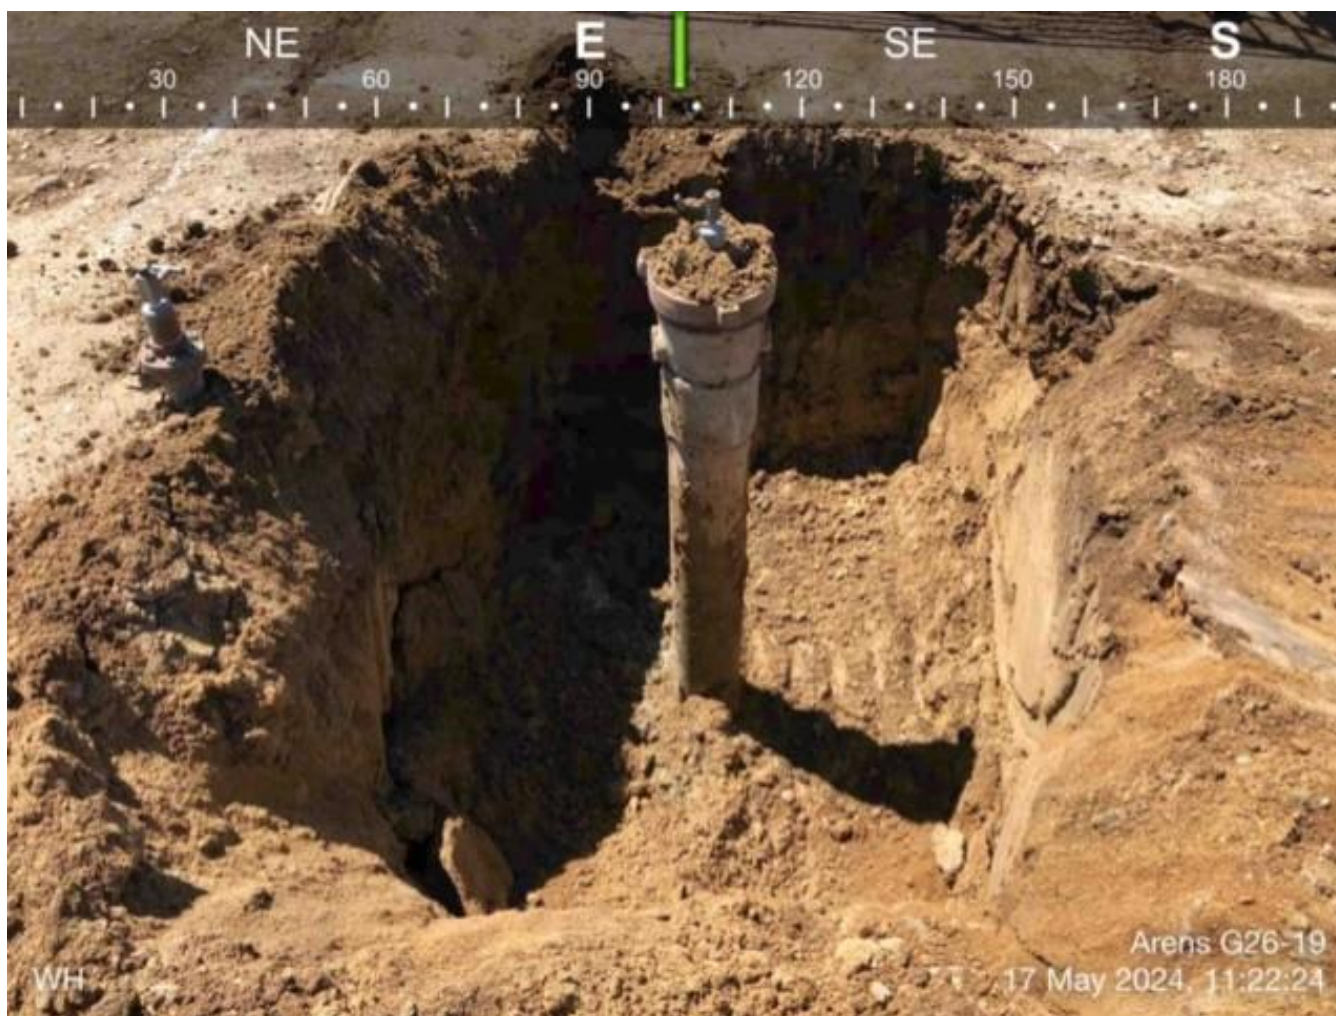
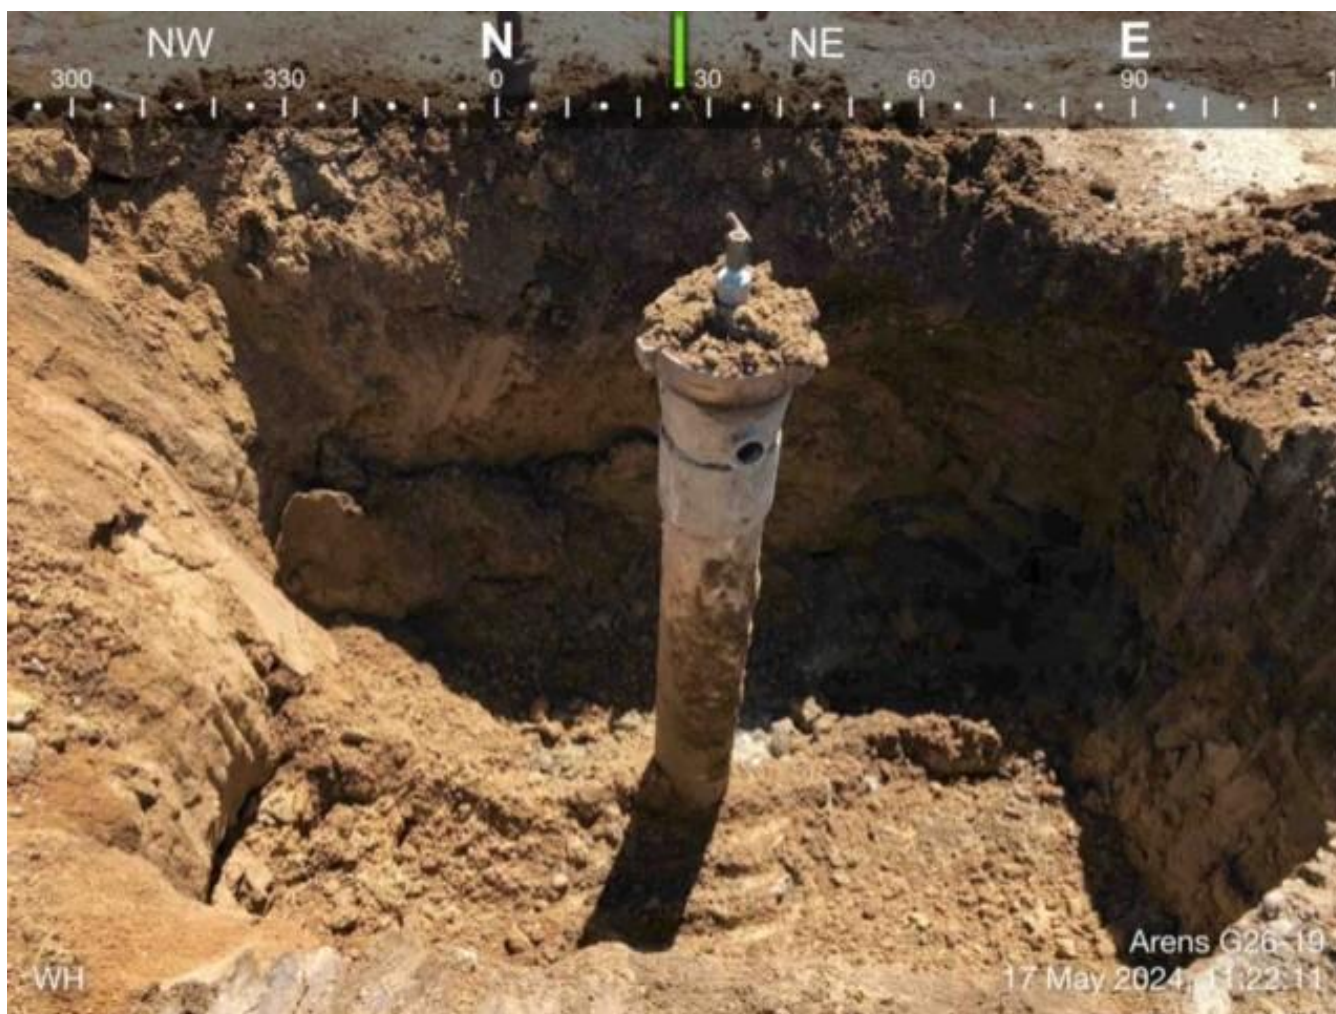
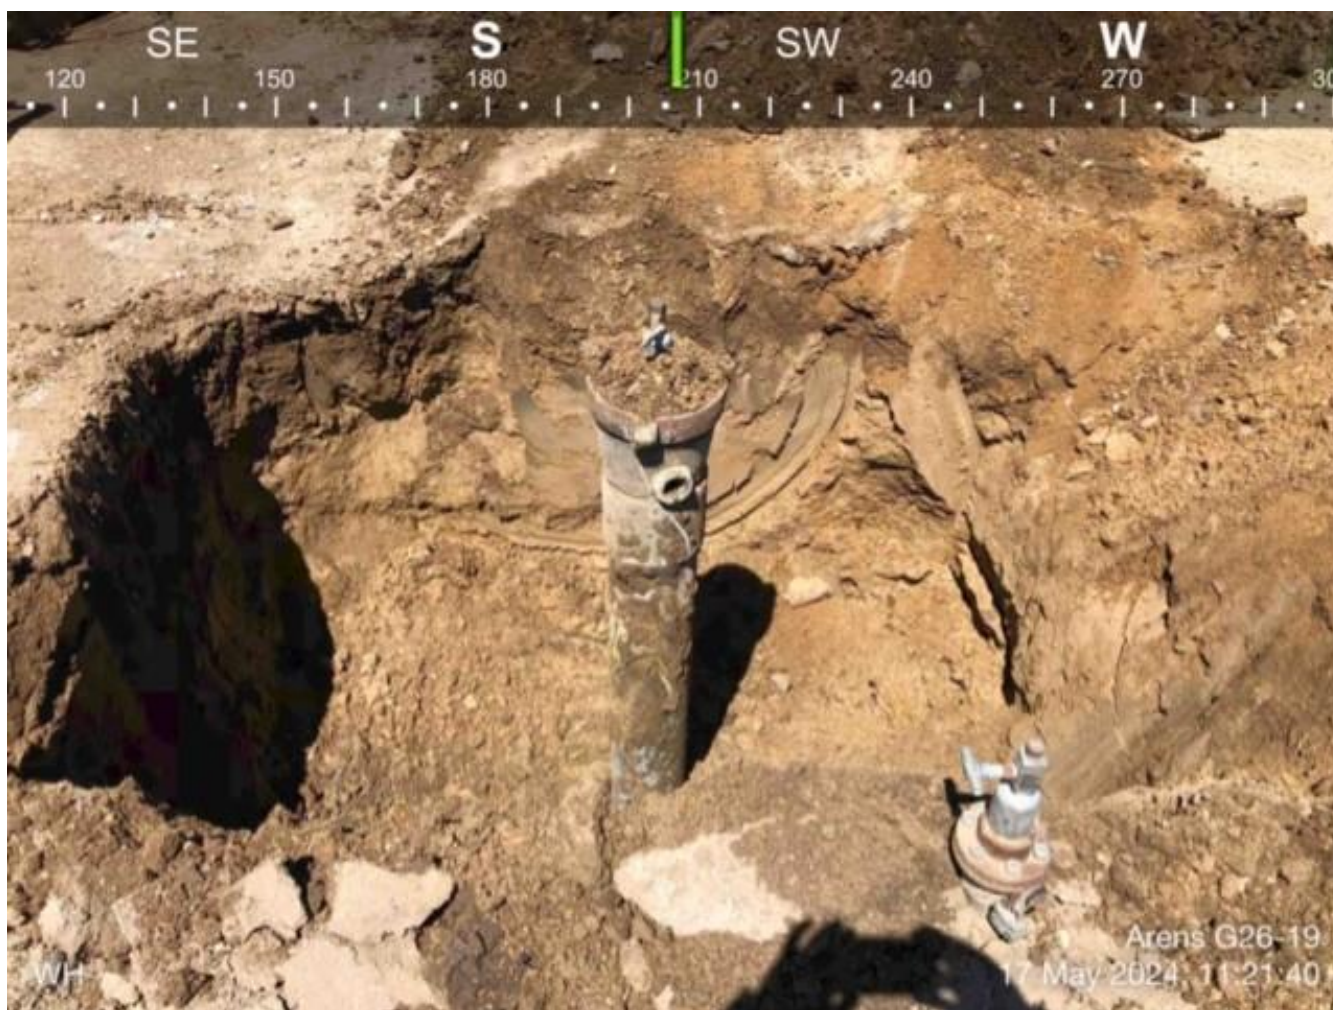
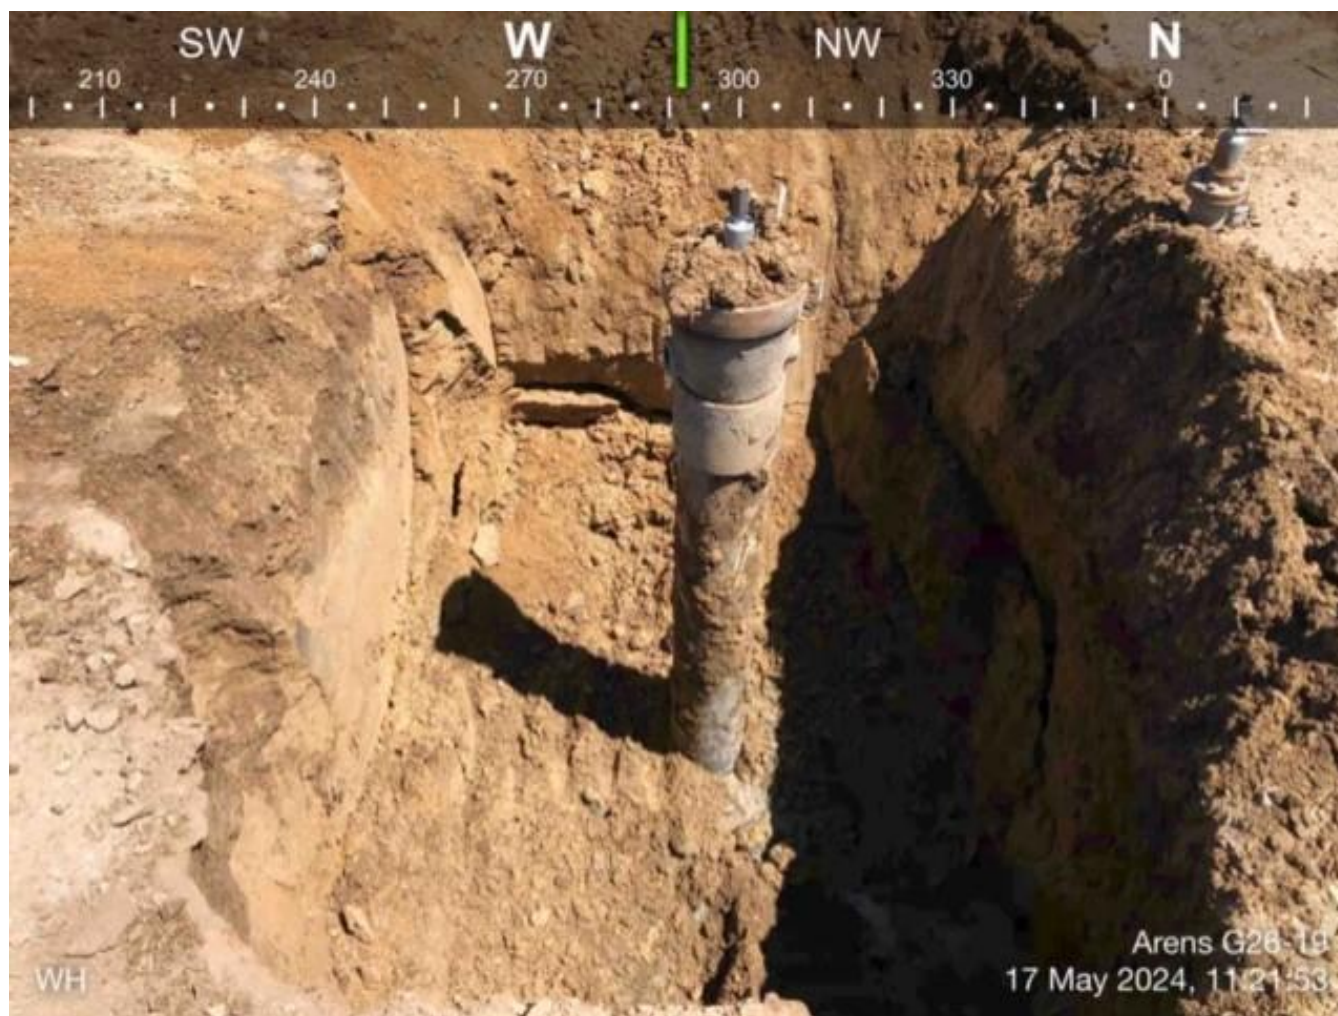
**ATTACHMENT A**  
**PHOTOGRAPHIC LOG**

None encountered or observed								
Wellhead(s)								
Well API	05-123-30608							
Age	03/12/2010- spud date							
Condition of surface around wellhead	Good							
PID Readings	0.0 ppm							
Condition of subsurface (staining present)	Staining							
PID Readings	0.0 ppm							
Sample taken? Location/Sample ID#	WH01@6, FLR01@4							
Photo Number(s)	1-4							
Other observations regarding wellheads:								
Staining observed on the north side of the wellhead; organics suspected								
Summary								
Was impacted soil identified? No <input checked="" type="checkbox"/> Yes - less than 10 cubic yards <input type="checkbox"/> Yes - more than 10 cubic yards <input type="checkbox"/>								
Total number of samples field screened: 5					Total number of samples collected: 5			
Highest PID Reading: 0.0 ppm					Total number of samples submitted to lab for analysis: 2			
If more than 10 cubic yards of impacted soil were observed:
