Wellhead Closure Checklist

COGCC Rule 911.a.(4) Environmental Site Closure Assessment Field Form

Huntsman G #13-9

Closure Assessment

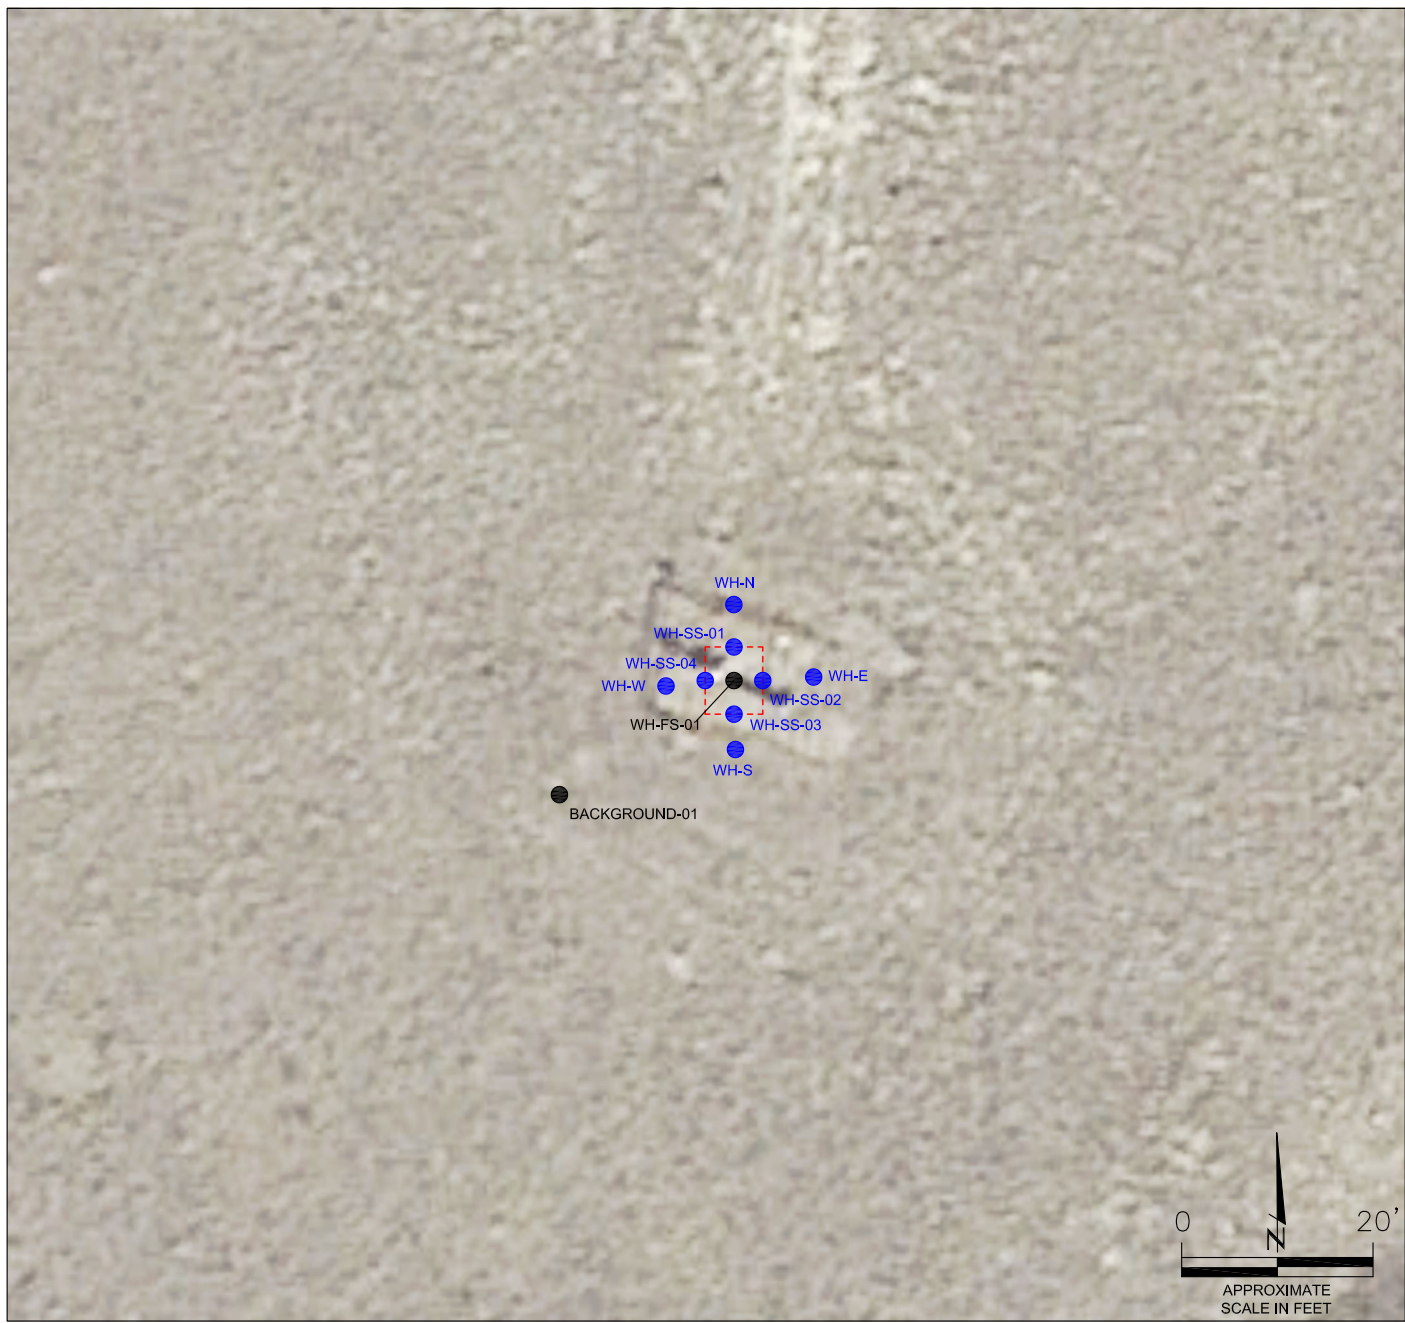
FIGURE NO.
3

- WELLHEAD ASSESSMENT BOUNDARIES
- SS-02 APPROXIMATE LOCATION OF SOIL SAMPLES FIELD SCREENED, ONLY, WITH PHOTOIONIZATION DETECTOR
- SS-02 APPROXIMATE LOCATION OF SOIL SAMPLES SUBMITTED FOR LABORATORY ANALYSIS

SAMPLE LOCATION MAP
 HUNTSMAN G #13-9
 CLOSURE ASSESSMENT
 40.310550 / -104.604642
 NE¼ SE¼ SEC.13 T4N R6SW 6PM
 WELD COUNTY, COLORADO
 API # 05-123-16321
 REMEDIATION # 31082

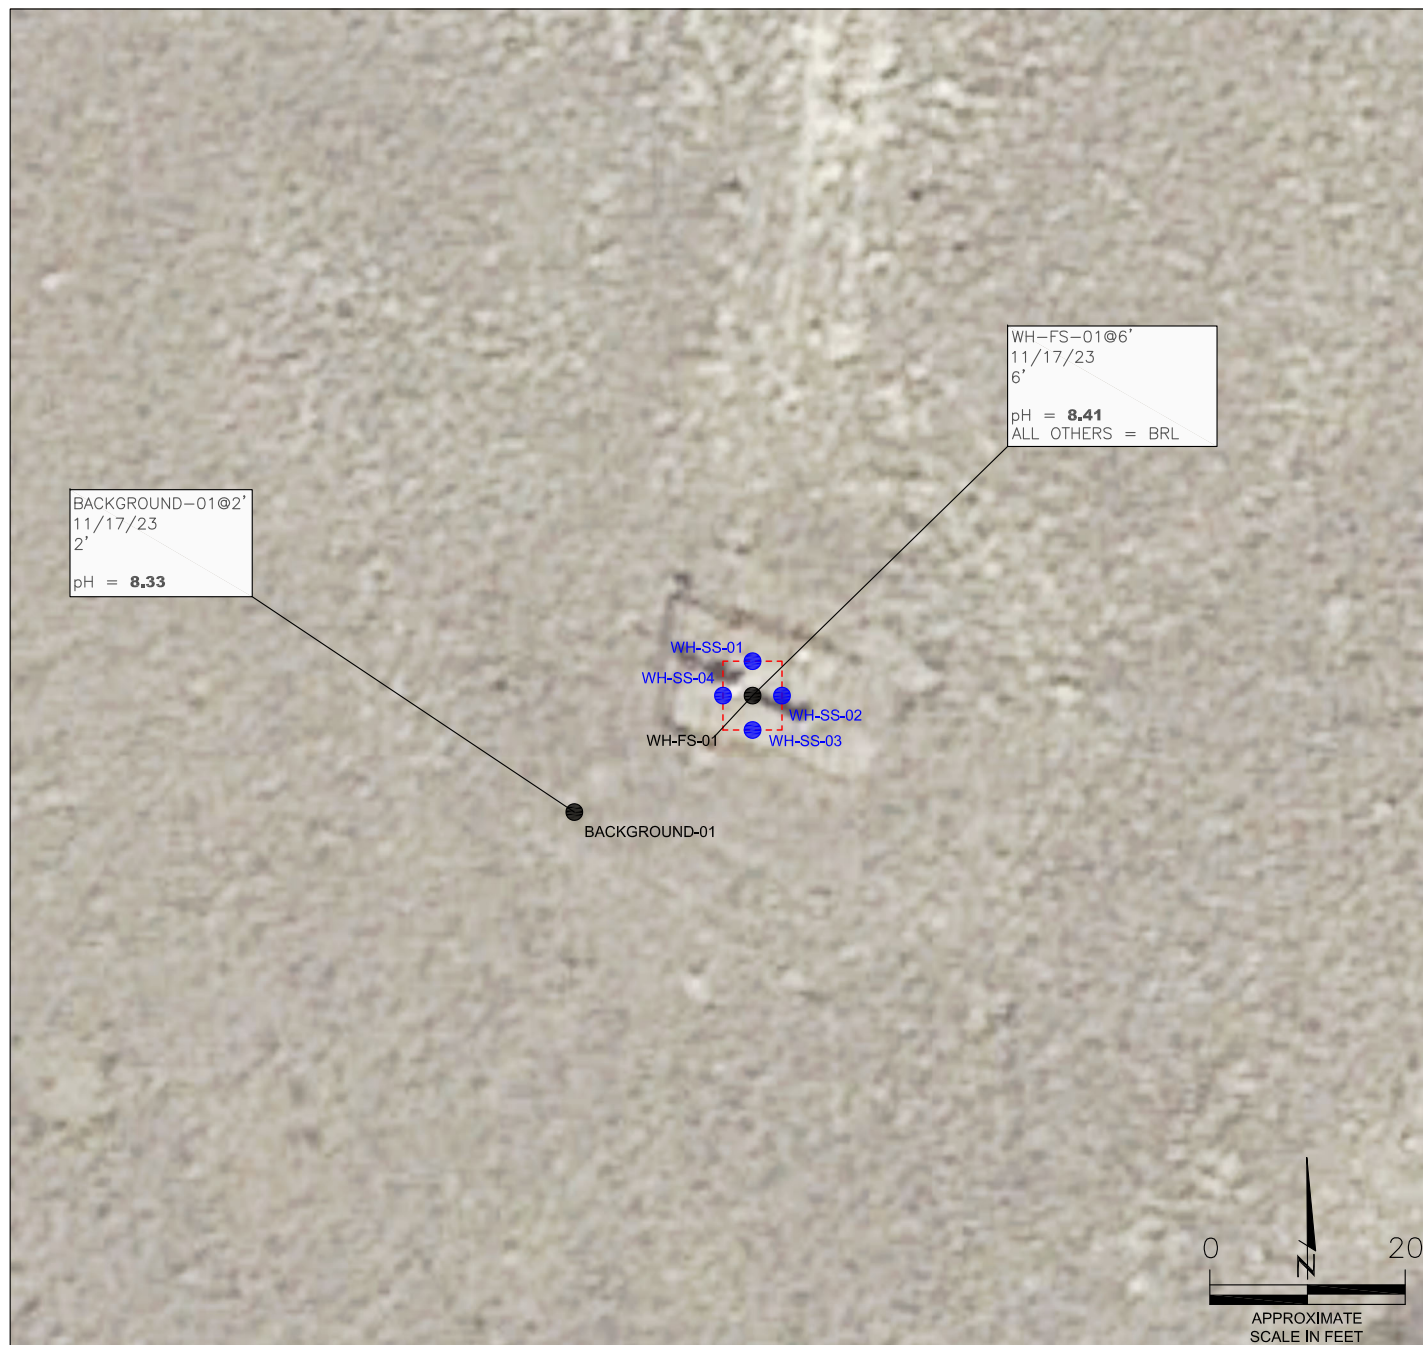
FIGURE NO.
4

NOTES:
VALUES PRESENTED IN **BOLD** EXCEED ECMC TABLE 915-1
REGULATORY LIMITS.

SOIL ANALYTICAL MAP
HUNTSMAN G #13-9
CLOSURE ASSESSMENT
40.310550 / -104.604642
NE¼ SE¼ SEC.13 T4N R65W 6PM
WELD COUNTY, COLORADO
API # 05-123-16321
REMEDIAL # 31082

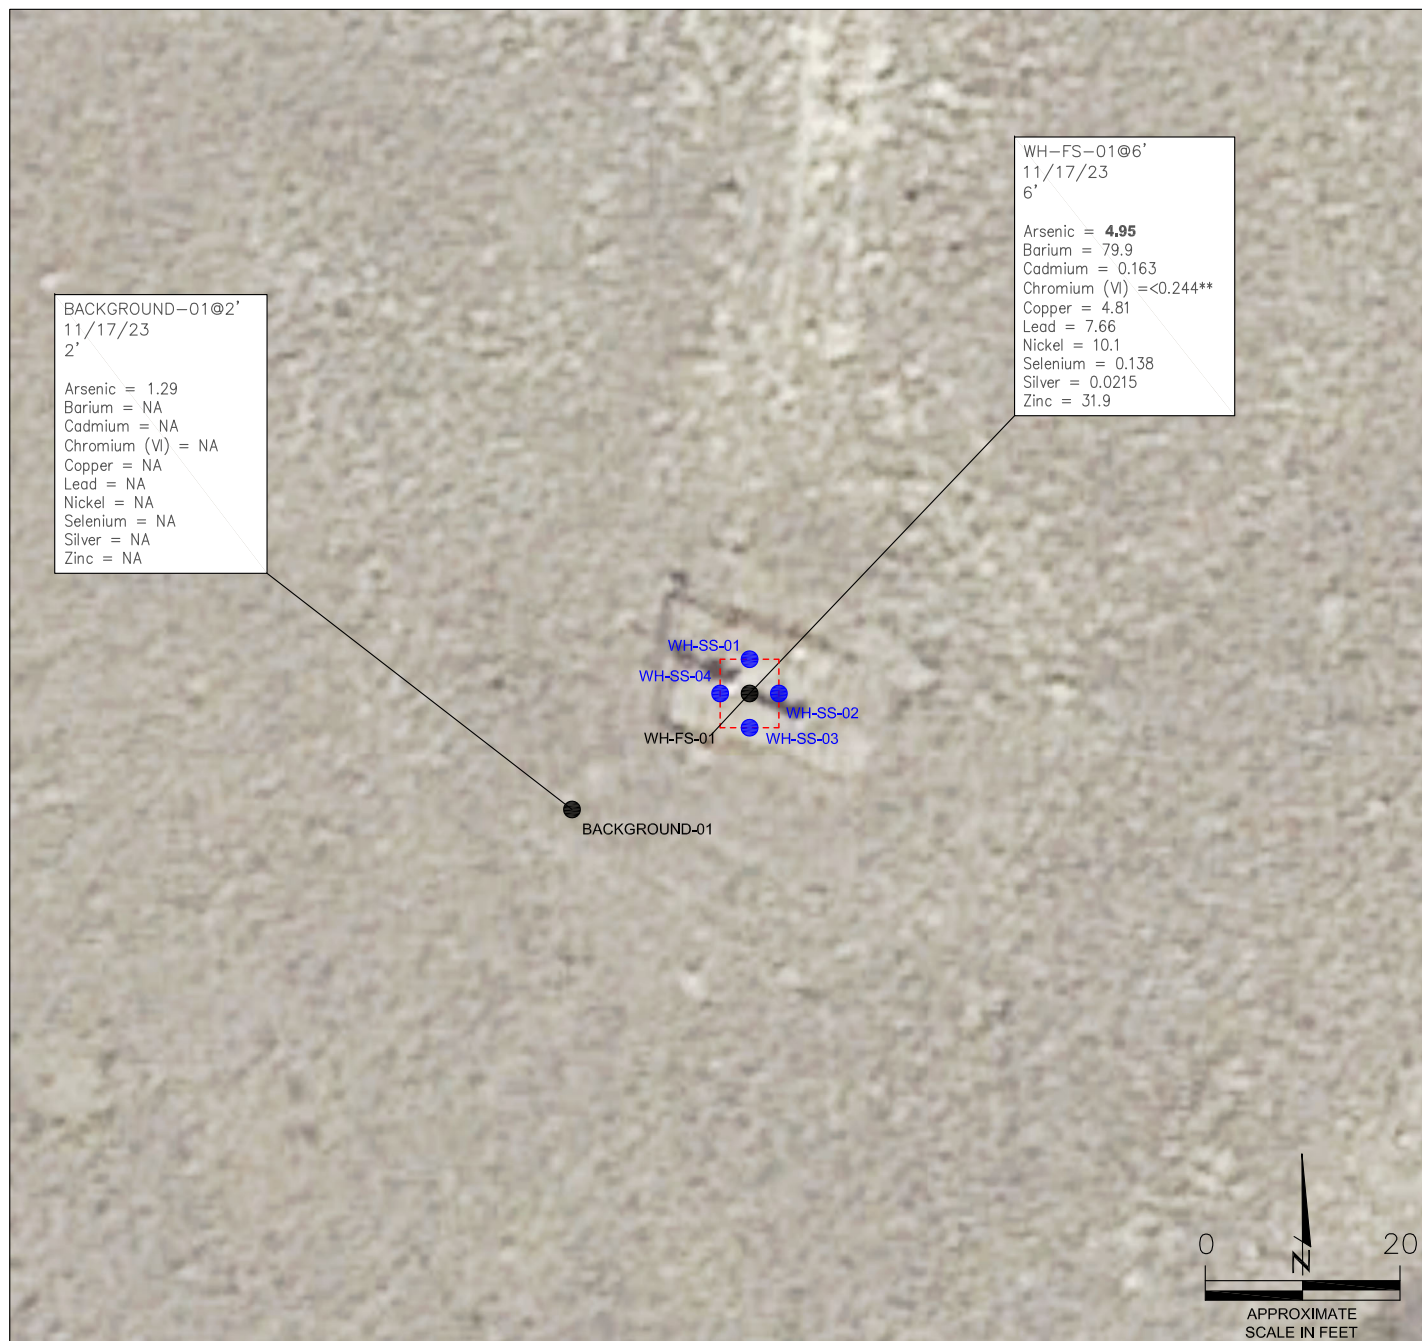
FIGURE NO.
5

ELEVATED METALS ARE NATURALLY OCCURRING IN COLORADO. LOCAL CLEAN-UP LEVELS ARE 1.25*BACKGROUND CONCENTRATIONS WHERE APPLICABLE.

VALUES PRESENTED IN **BOLD** EXCEED ECMC TABLE 915-1 REGULATORY LIMITS AND APPLICABLE LOCAL CLEAN-UP LEVELS.

METALS IN SOIL MAP
HUNTSMAN G #13-9
CLOSURE ASSESSMENT
40.310550 / -104.604642
NE¼ SE¼ SEC.13 T4N R65W 6PM
WELD COUNTY, COLORADO
API # 05-123-16321
REMEDIAION # 31082

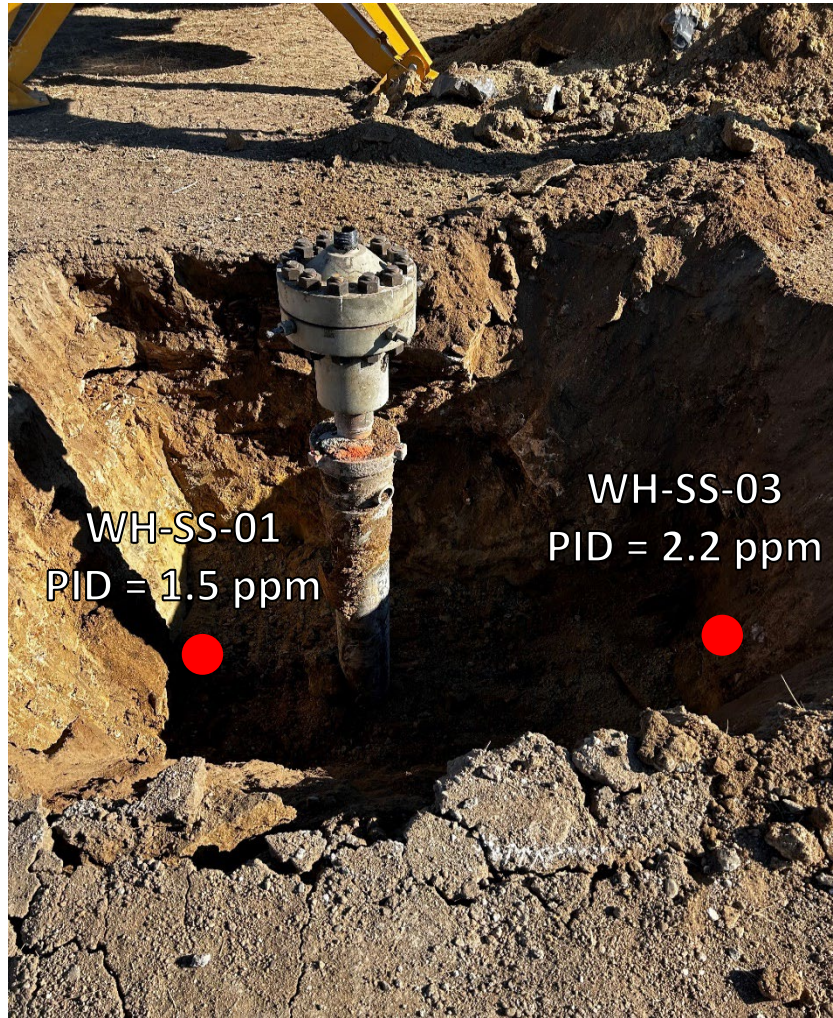
Looking east

Wellhead Excavation – 11/17/23

No petroleum hydrocarbon staining or odor observed

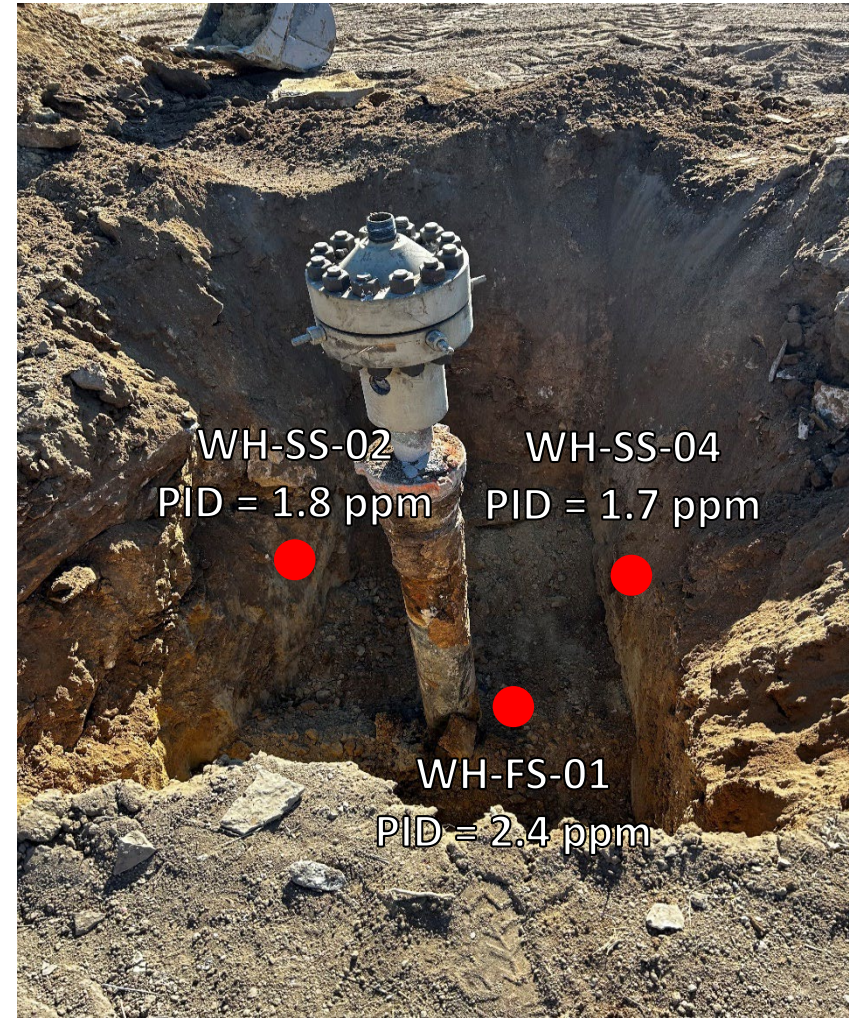
Looking south

No petroleum hydrocarbon staining or odor observed

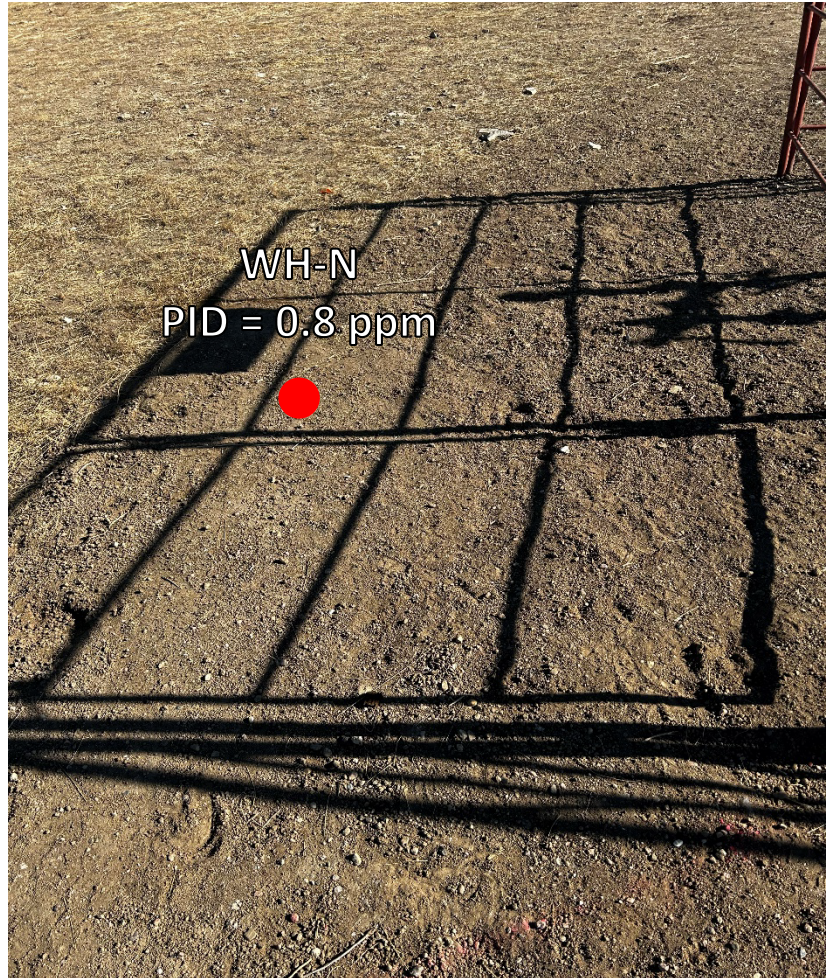
Looking east

Wellhead Surface – 11/17/23

Site in good condition – no petroleum hydrocarbon staining or odor
Observed on surface around wellhead

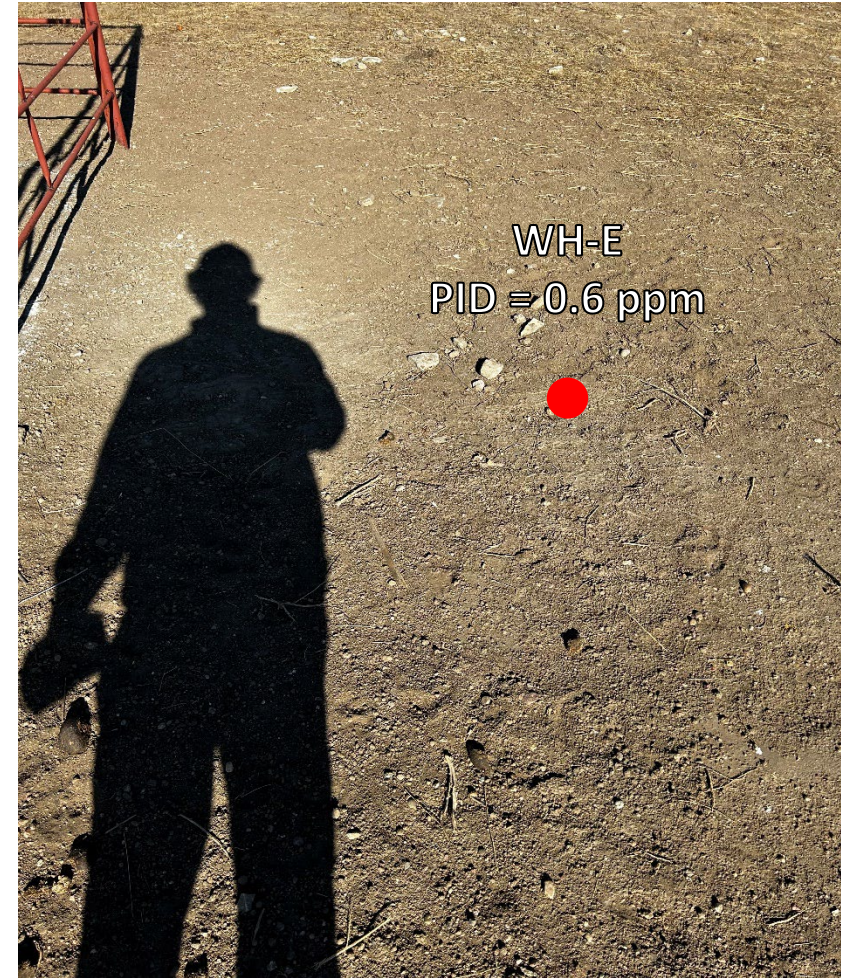
Looking north

Site in good condition – no petroleum hydrocarbon staining or odor
Observed on surface around wellhead

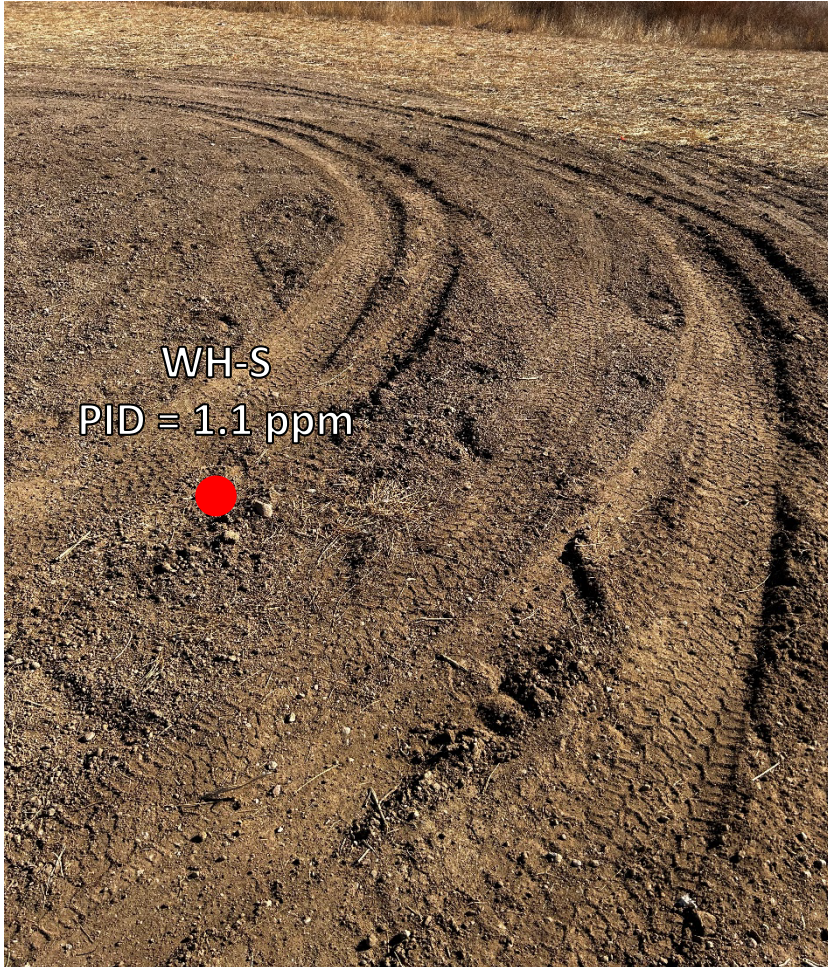
Looking east

Wellhead Surface – 11/17/23

Site in good condition – no petroleum hydrocarbon staining or odor
Observed on surface around wellhead

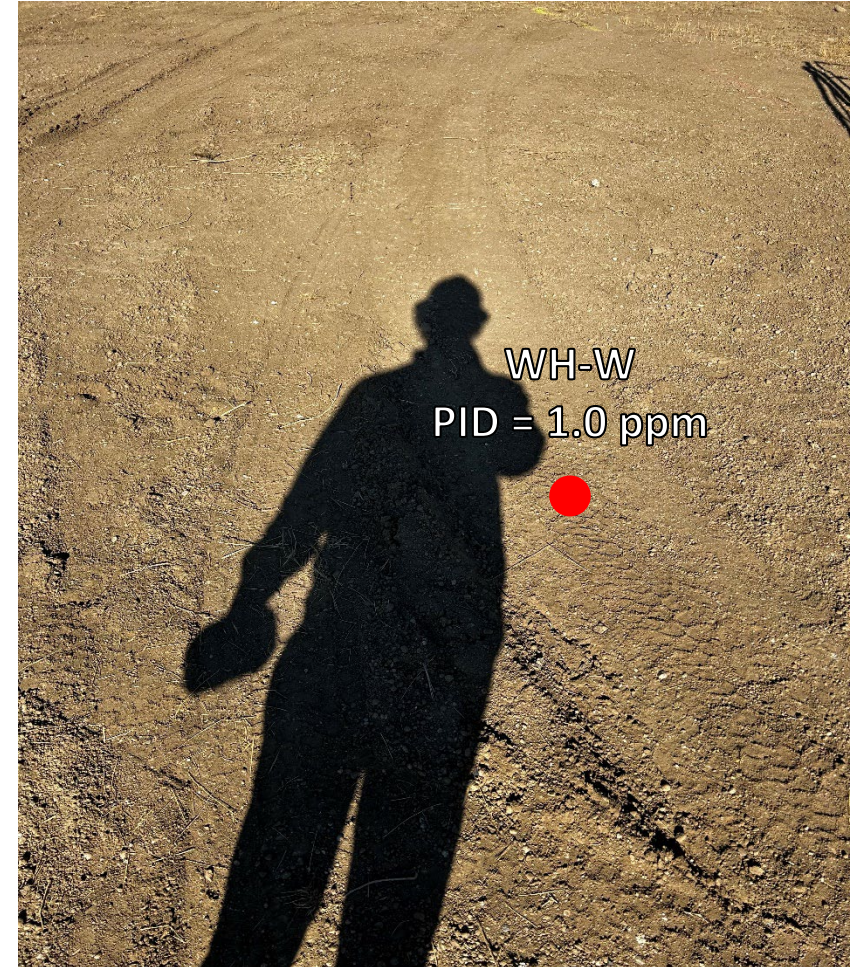
Looking north

Site in good condition – no petroleum hydrocarbon staining or odor
Observed on surface around wellhead
