Final Reclamation and Stormwater Inspection

Location ID: 320745

Well Name: COLUMBINE-STATE #1

Inspection Document #: 718600426

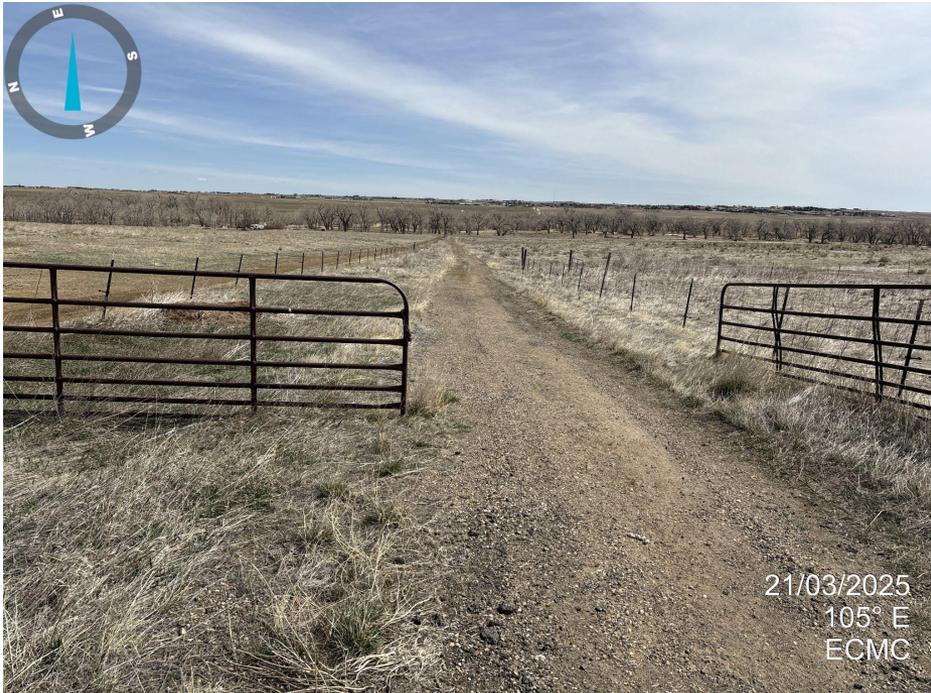
Photo 1. Looking east down the tank battery access road. This road appears to be primary access to the eastern side of property.

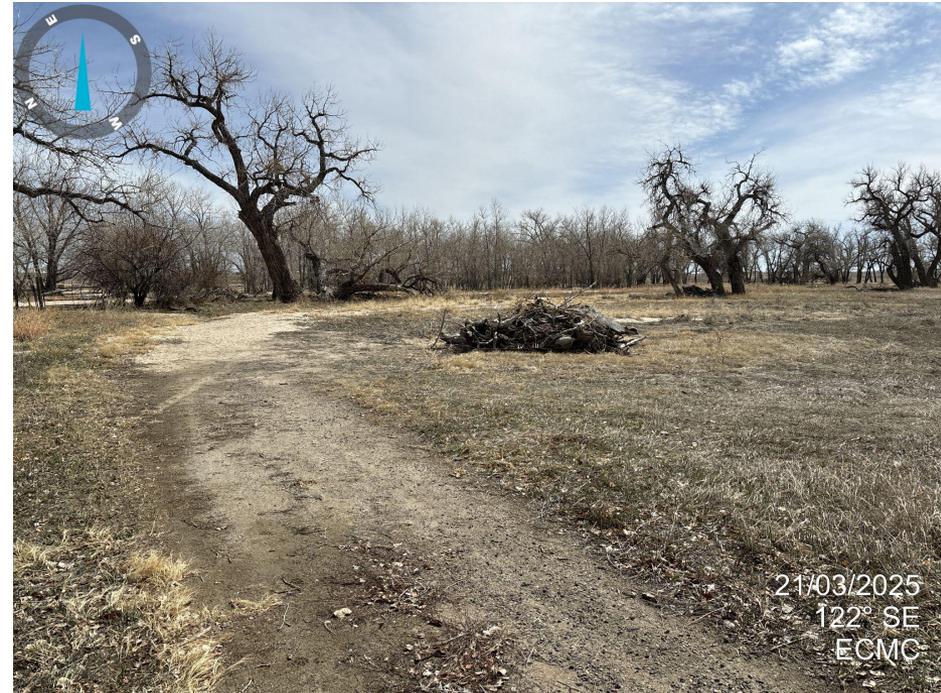
Photo 2. Looking across the former tank battery. The loop at the end of the road remains. Oil and gas equipment has been removed.

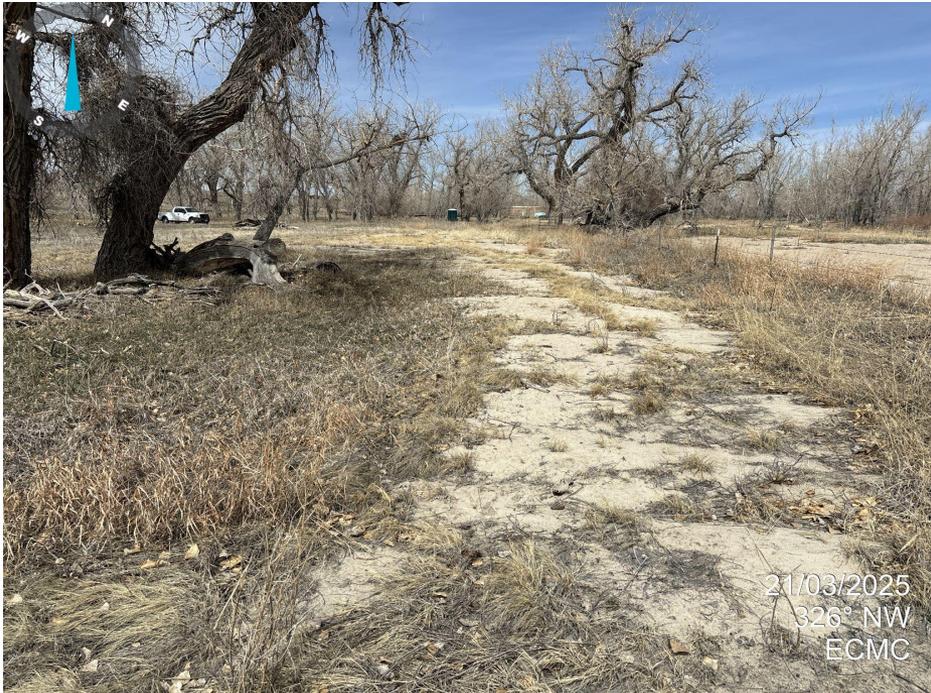
Photo 3. picture taken at east side of location looking north. Loop at the end of the road appears to be unused and has not been reclaimed.

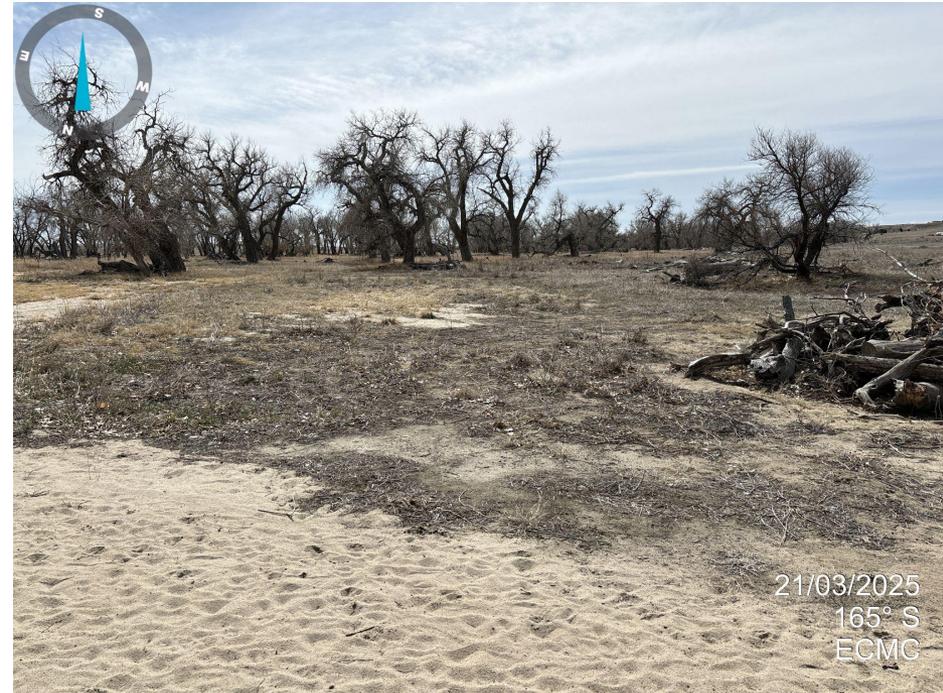
Photo 4. Looking south across former tank battery. The vegetation coverage is non uniform with large patches of bare soil. Vegetation coverage is less that the surrounding area.

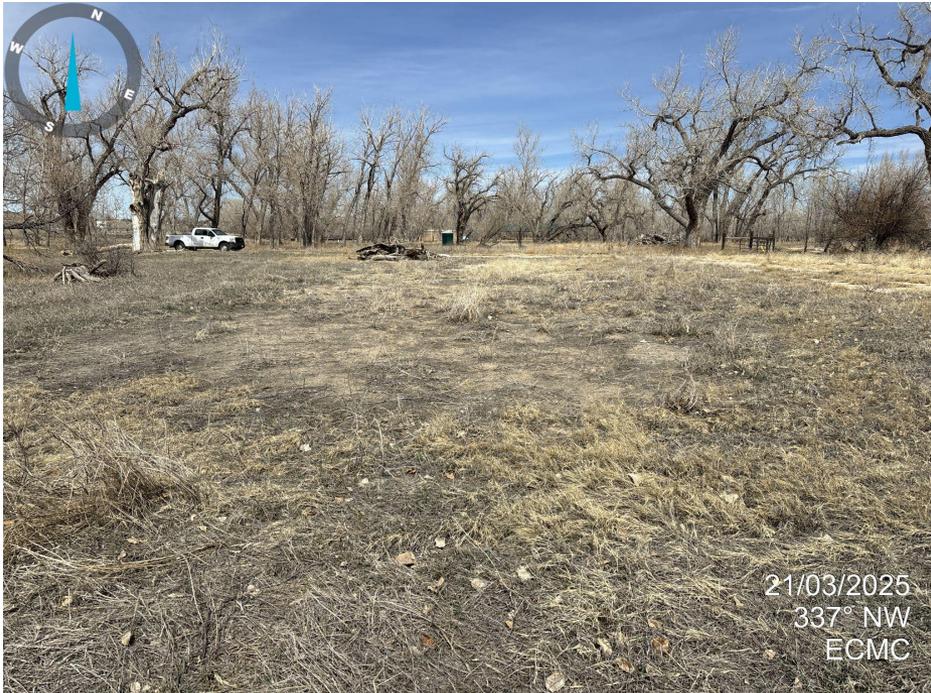
Photo 5. Looking north across the tank battery. Non uniform vegetation coverage.

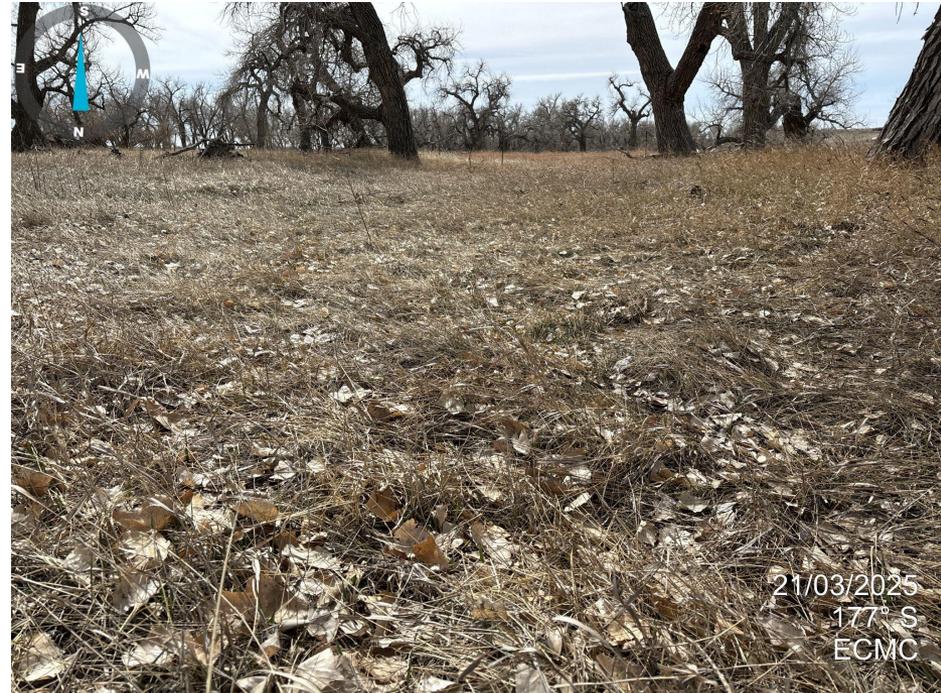
Photo 6. Reference vegetation to the south of the tank battery.

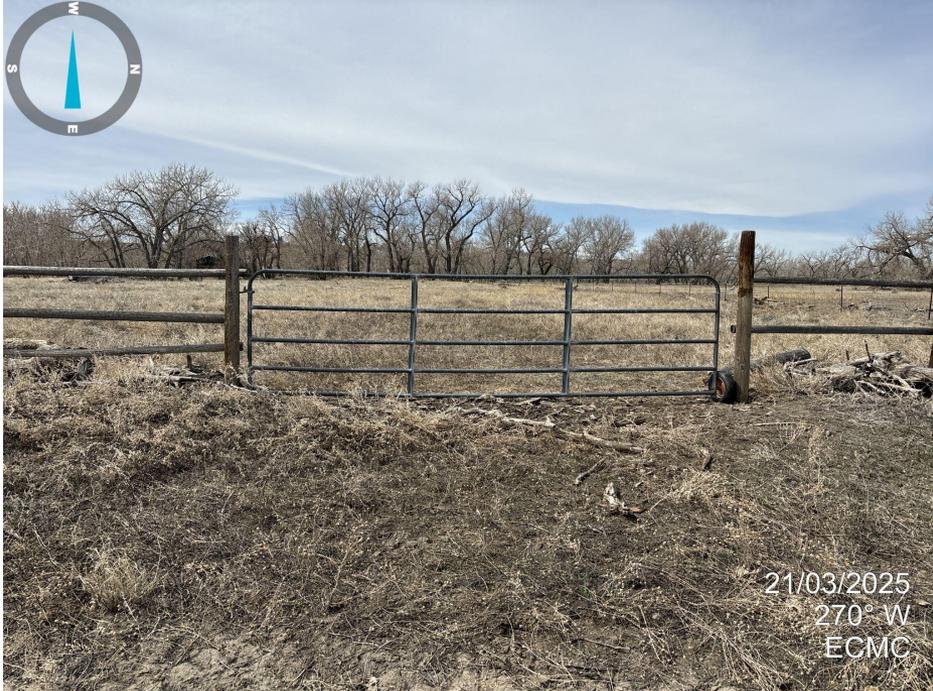
Photo 7. Well site is located approximately 1500 ft to the north of the tank battery across river. Picture taken looking west from main access road on the east side of river. Main access road appears to be used for property access.

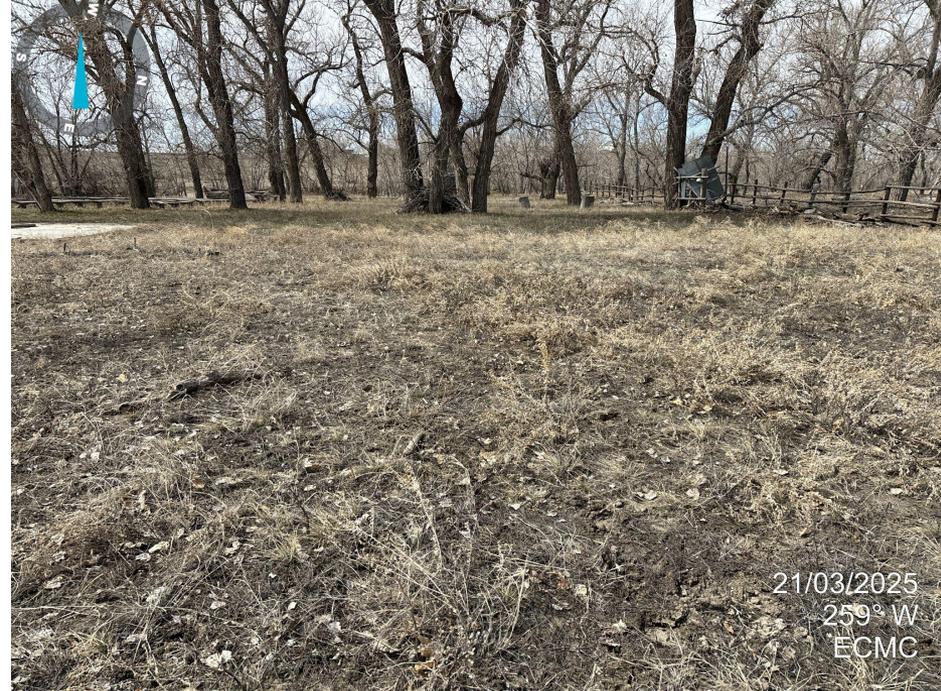
Photo 8. Looking west from wellbore. No oil and gas equipment remains. Vegetation appears to be reflective of reference area.

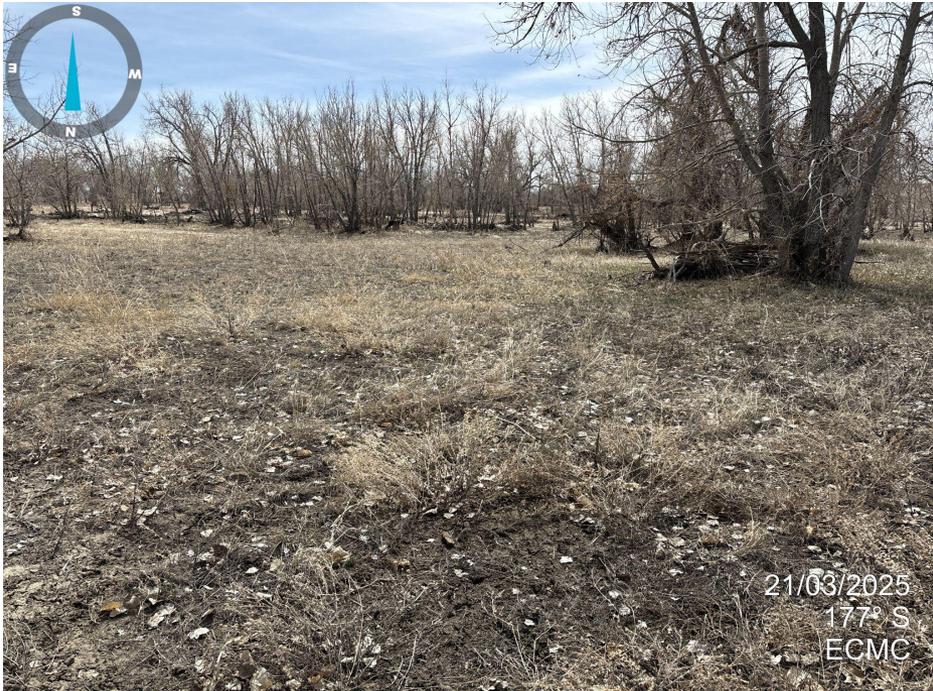
Photo 9. Looking south from wellbore. See photo 8 comments.

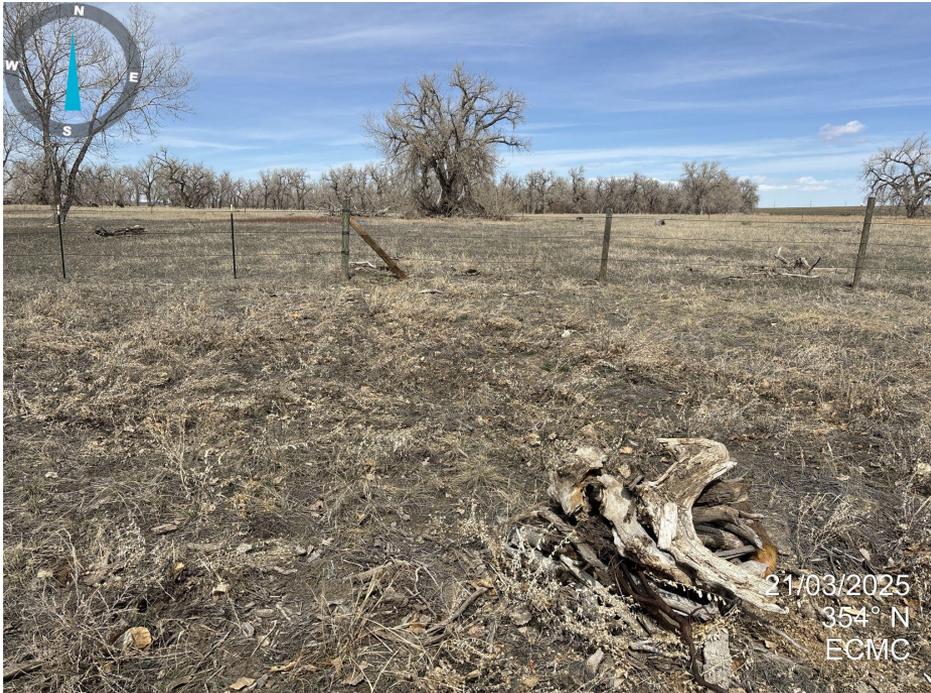
Photo 11. Looking north from wellbore. See photo 8 comments.

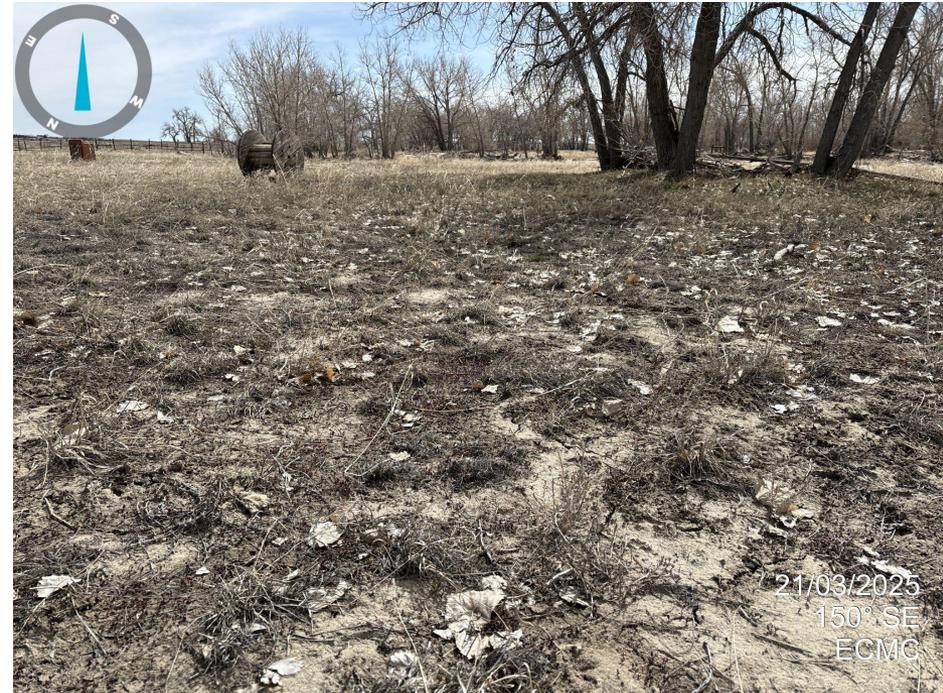
Photo 12. Reference vegetation to the south of well location.
