# Final Reclamation and Stormwater Inspection

Operator: TIMKA RESOURCES LTD - 88370

Location ID: 388515

Inspection Photos  
Location Name: Kirk A #1  
Location ID: 388515

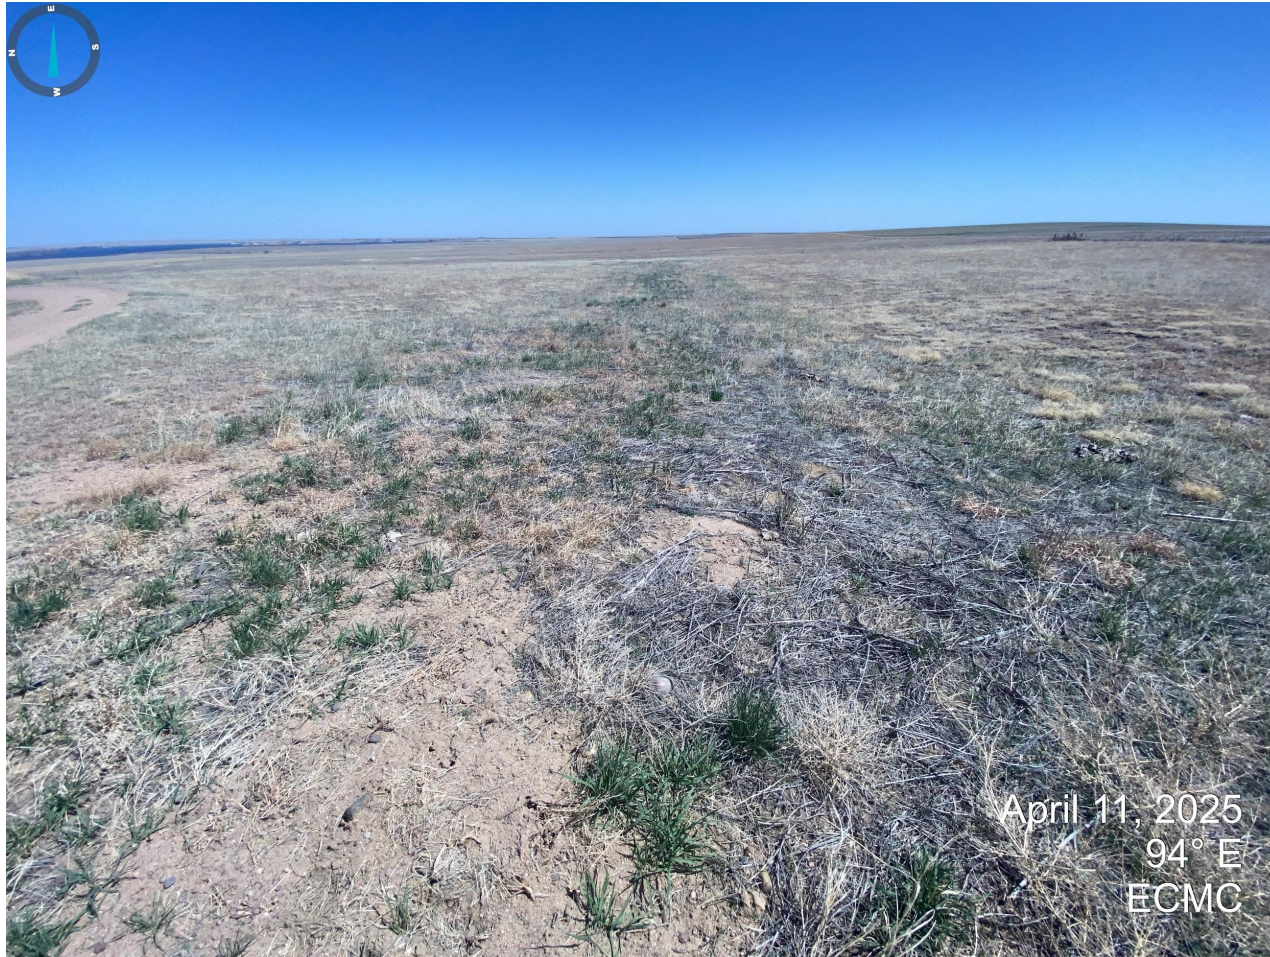
**Photo 1.** Taken along the access road, facing east towards the former location. Road base was observed throughout the former road, which does not appear reflective of the adjacent reference areas.

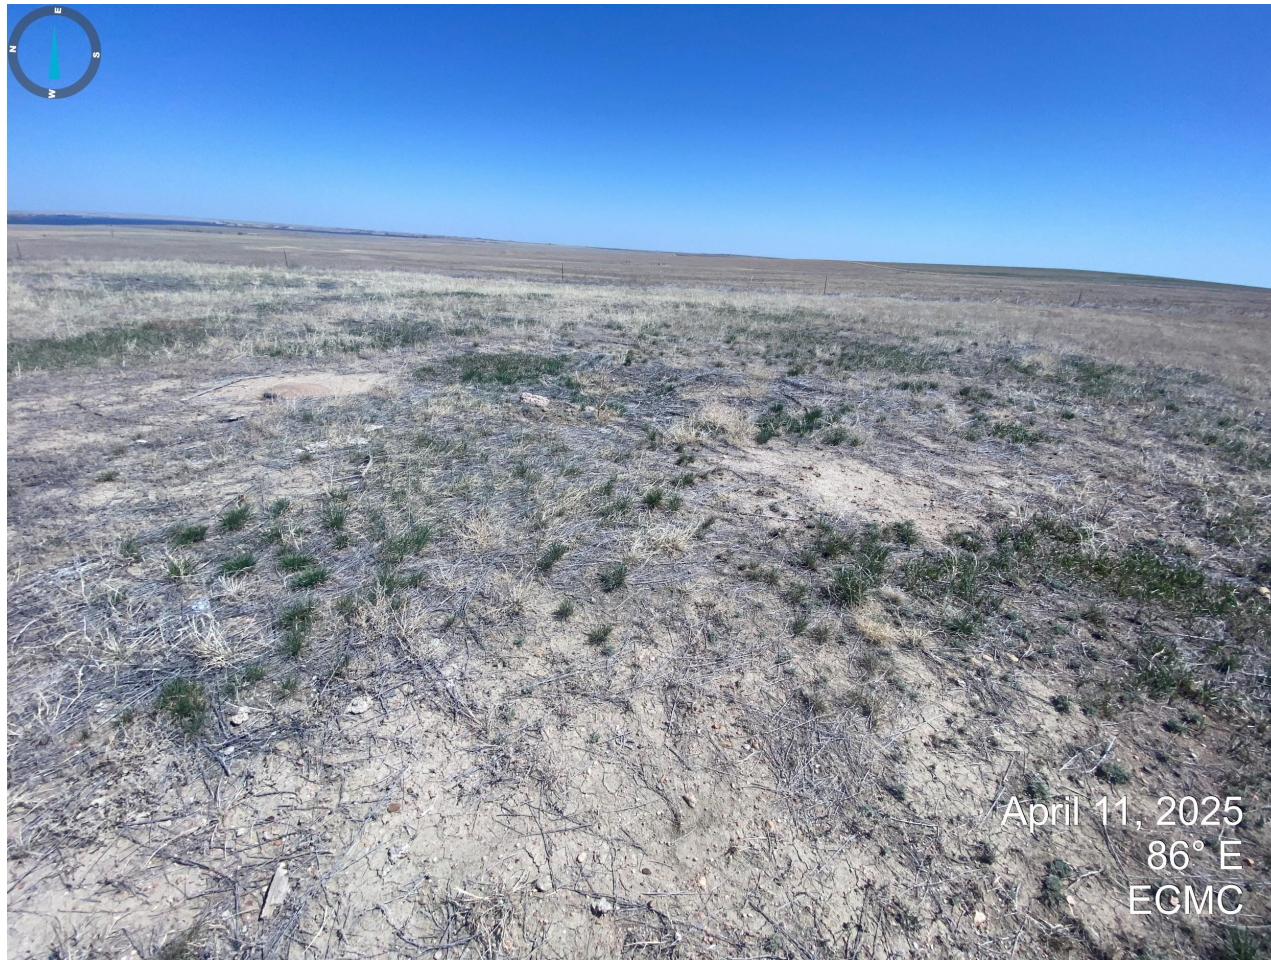
**Photo 2.** The former well location does not meet vegetative standards with evidence of non-uniform vegetation cover resulting in areas of bare soils and debris observed throughout.

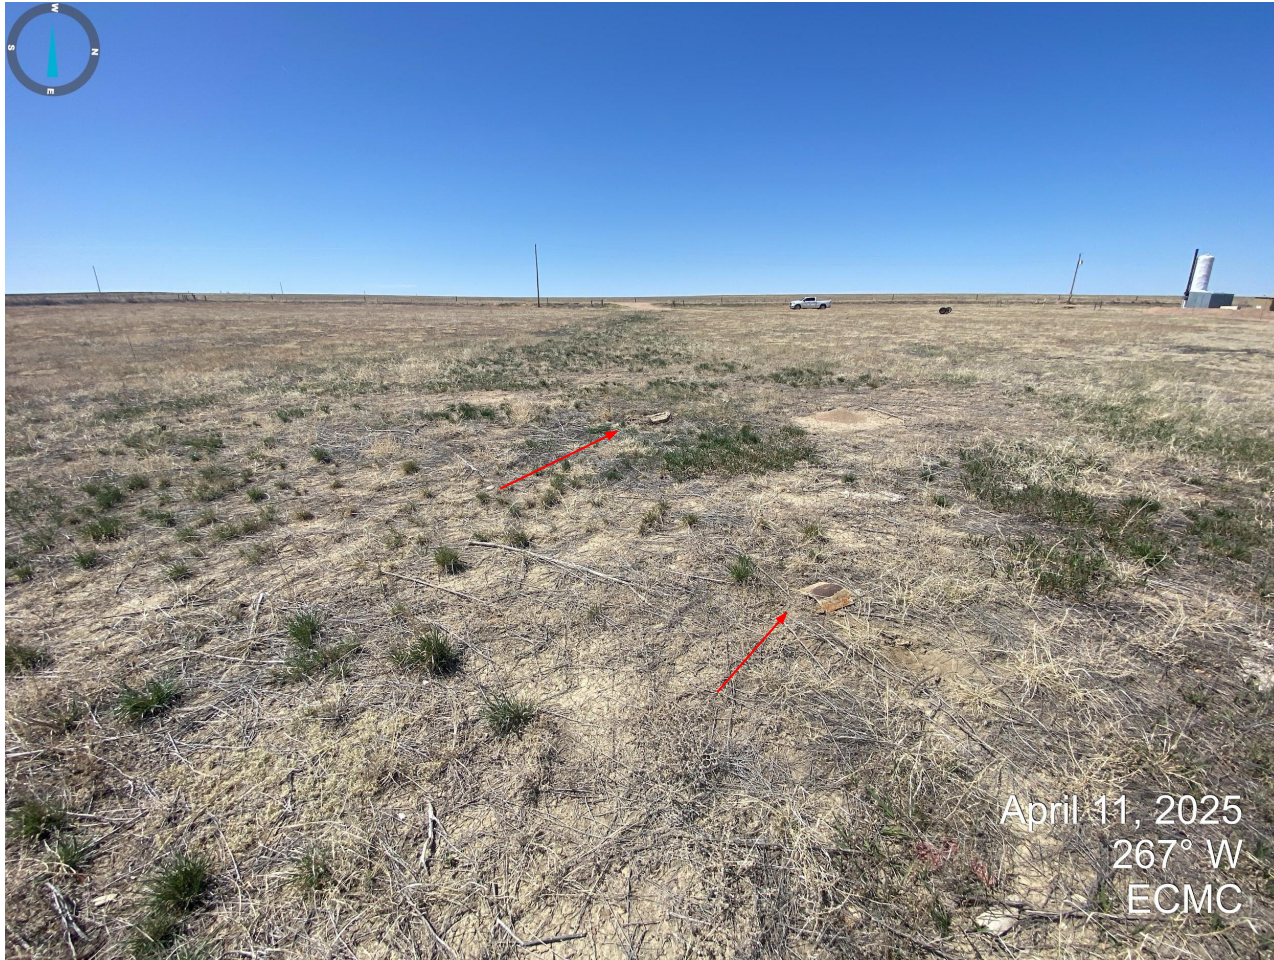
**Photo 3.** Continued from Photo 2, facing west. Debris observed throughout the former well location.
