Inspection Photos

Operator: CAERUS PICEANCE LLC #10456

Location ID: 413221

Inspection Doc: 718100420

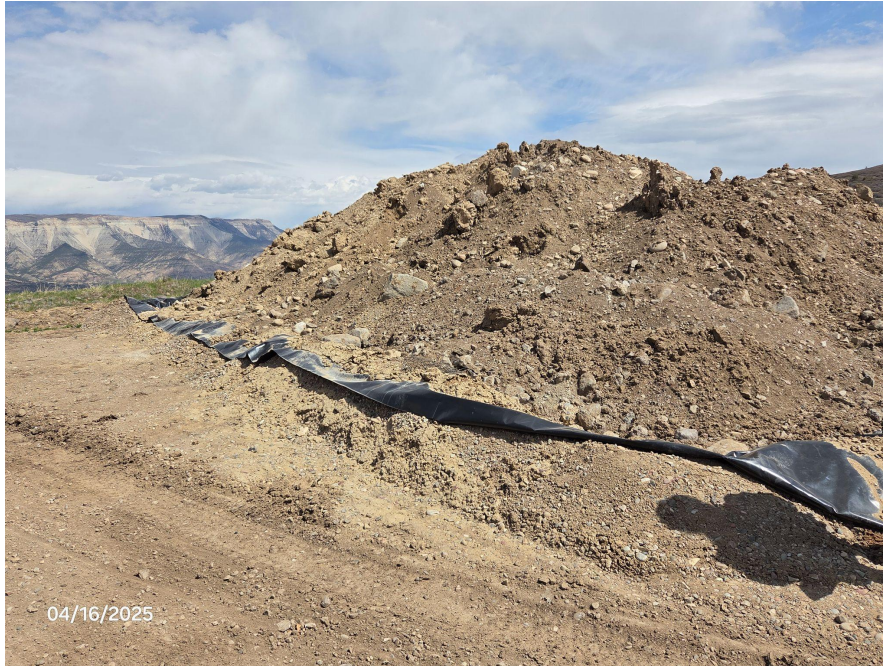
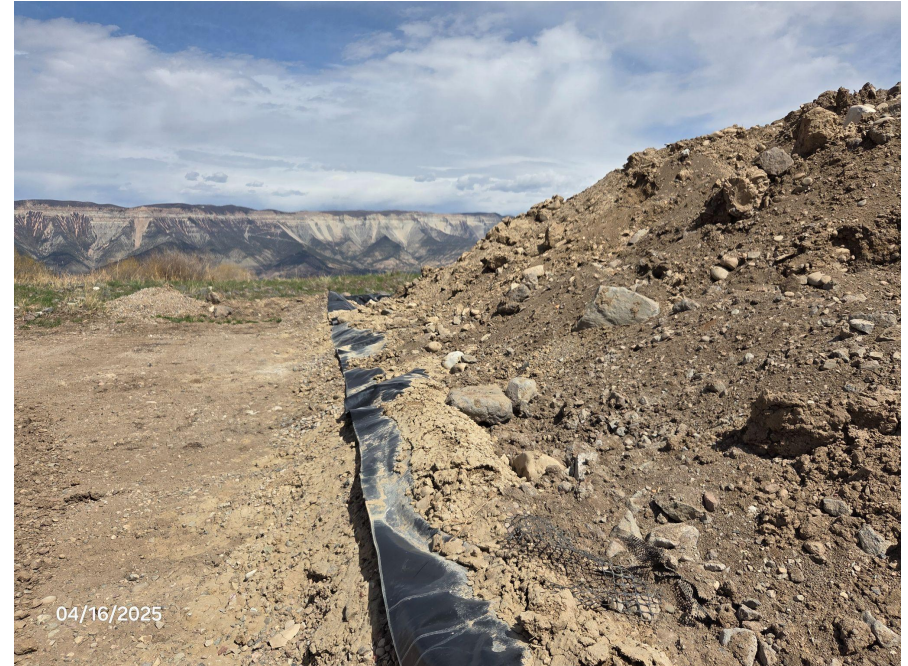
Photo 1: Photos taken from the north end of the working pad surface. Photos examples showing stockpiled material is “flowing over” beyond the liner/containment in place. Various trash/debris/rubbish also observed mixed with the stockpiled material.

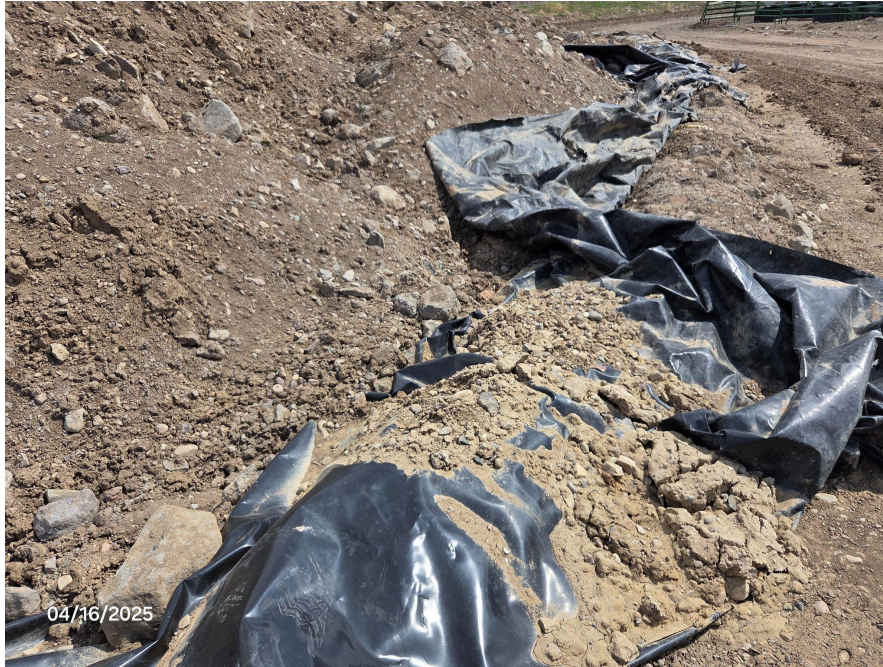
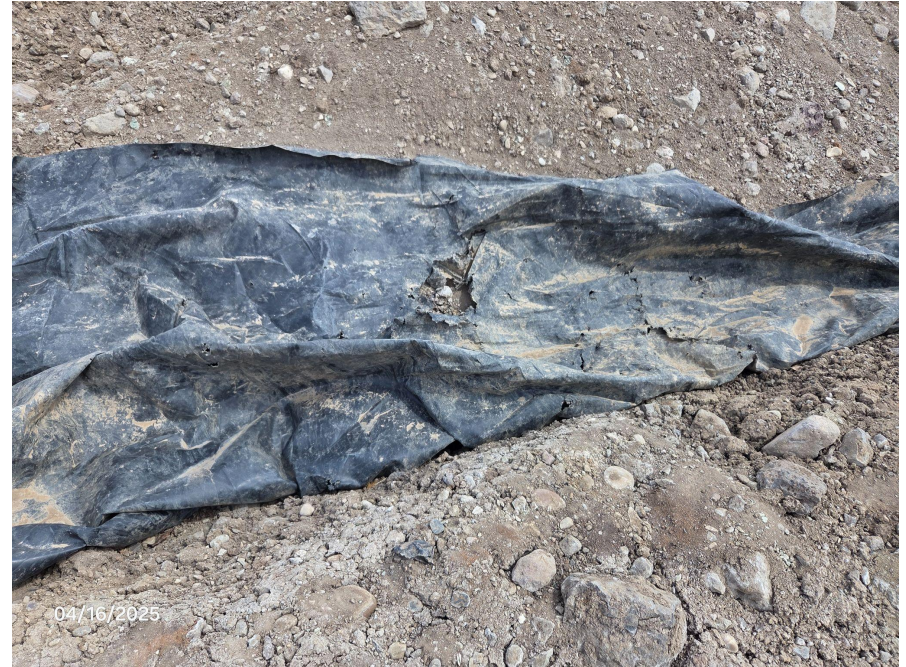
Photo 2: Continued from photo 1. Photos examples showing holes and tears exist throughout the liner placed beneath of the stockpiled materials.

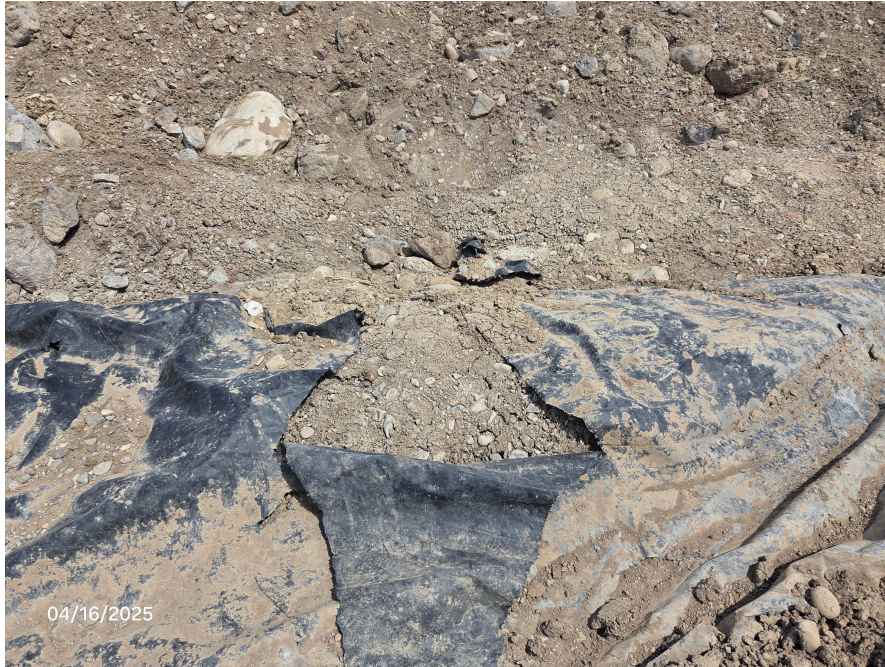
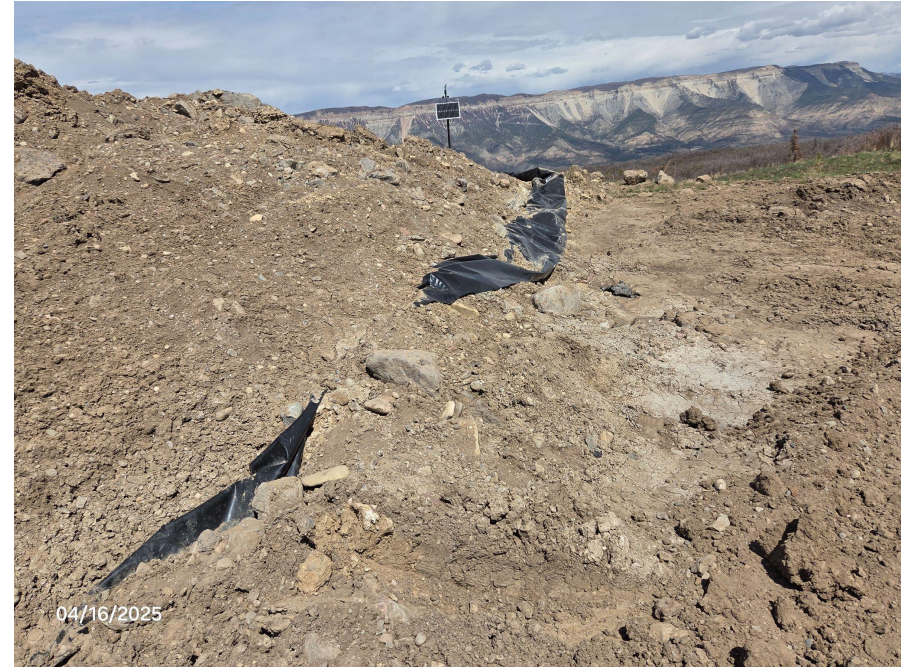
Photo 3: Continued from photo 1. Photos examples showing stockpiled material is “flowing over” beyond the liner/containment in place, and that holes and tears exist throughout the liner

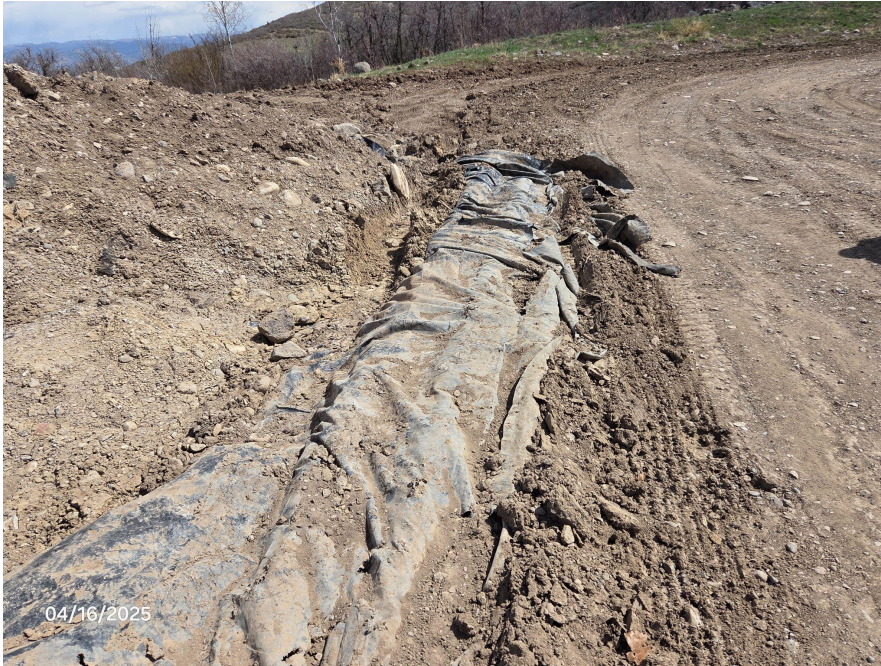
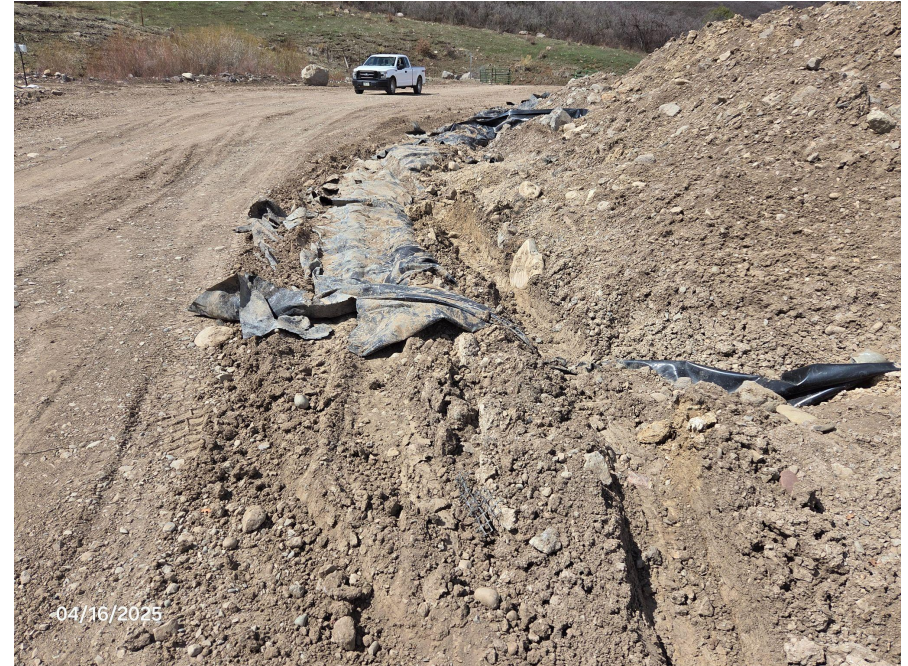
Photo 4: Continue from photo 1. Photo example showing vehicle/equipment travel over the stockpiled materials and containment measures.

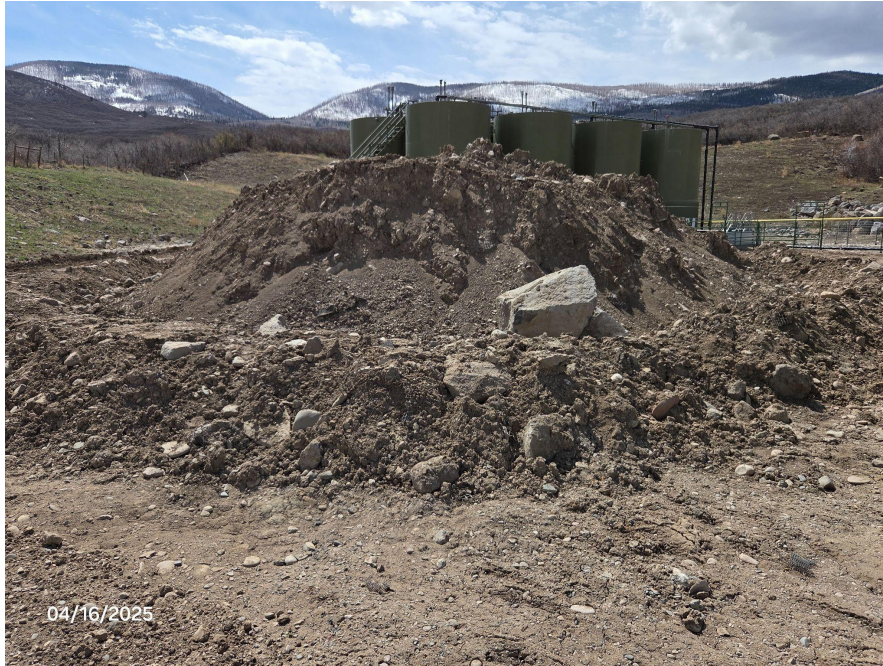
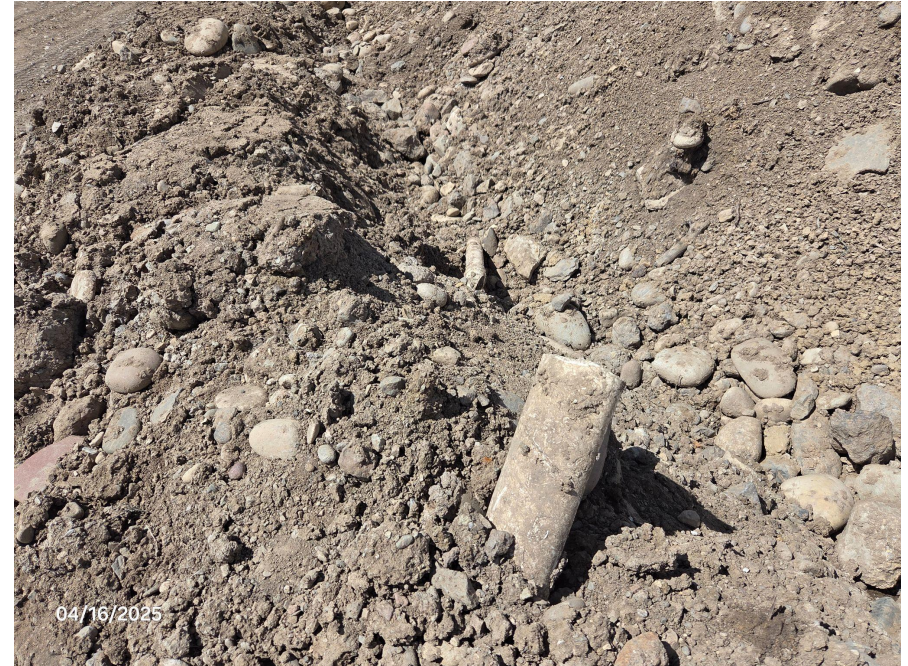
Photo 5: Photos show an additional stockpile of excavated material. No liner is evident at stockpile. Various trash/debris/rubbish also observed mixed with the stockpiled material.

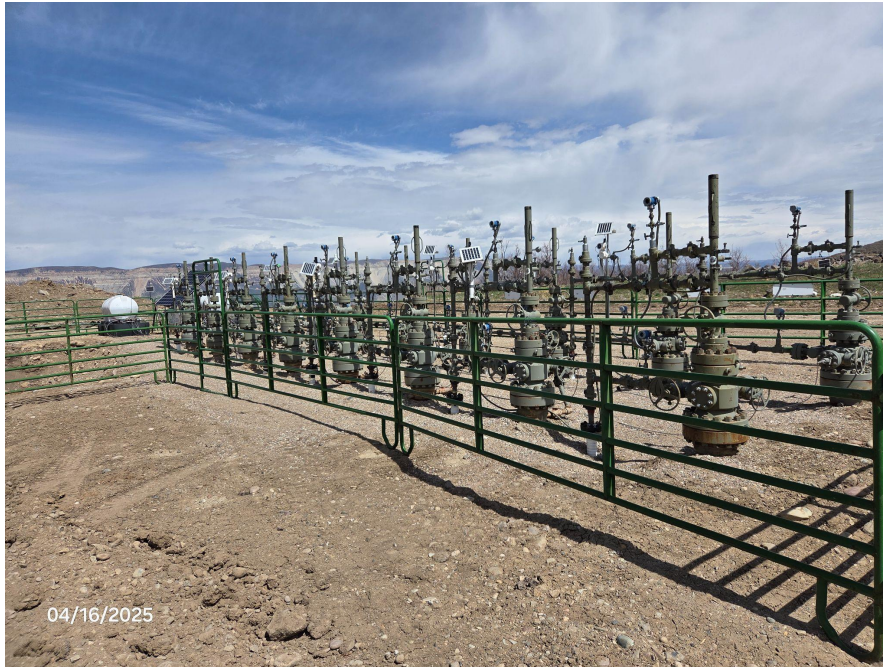
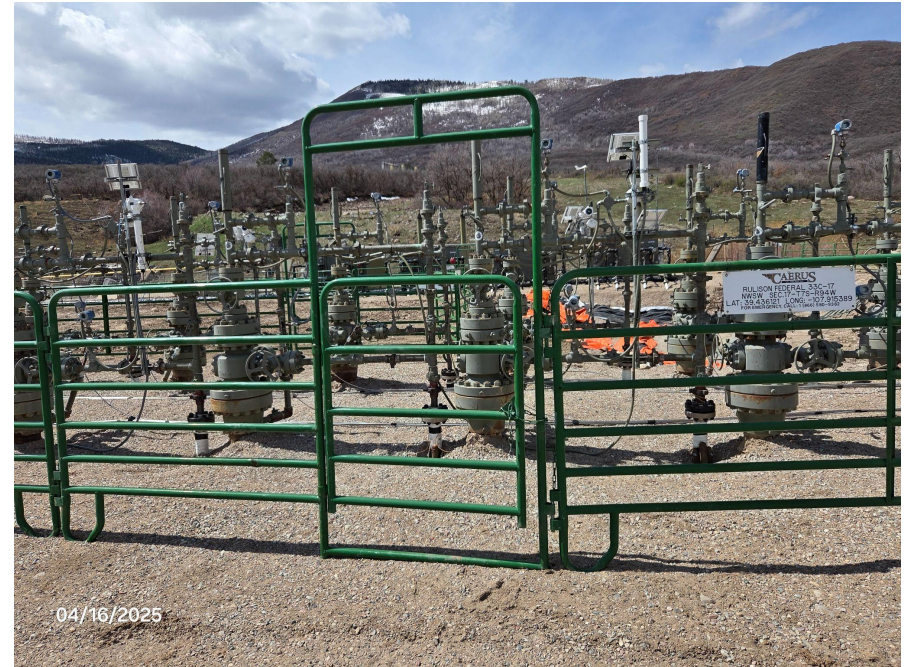
Photo 6: Photos examples showing signage missing from wells.

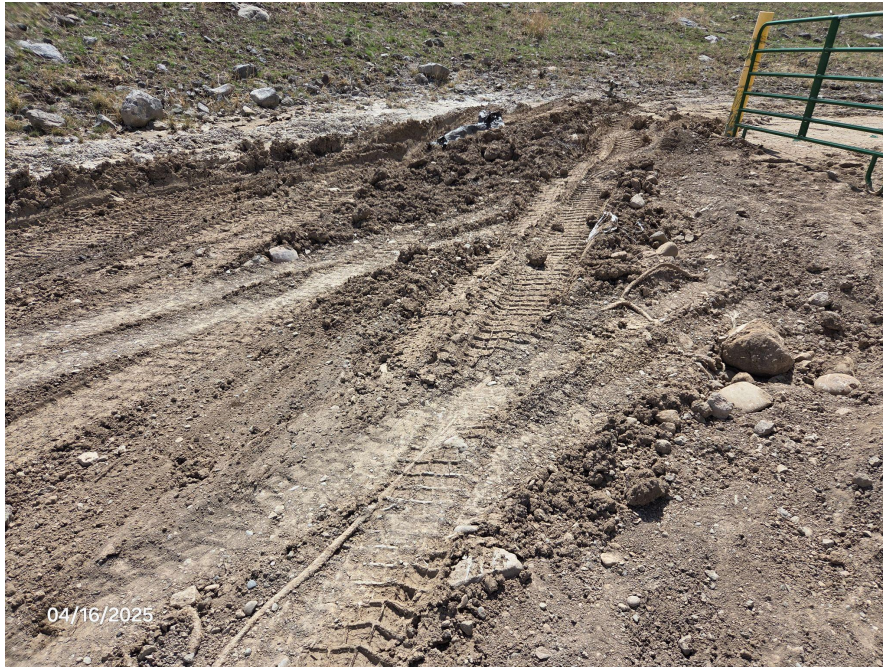
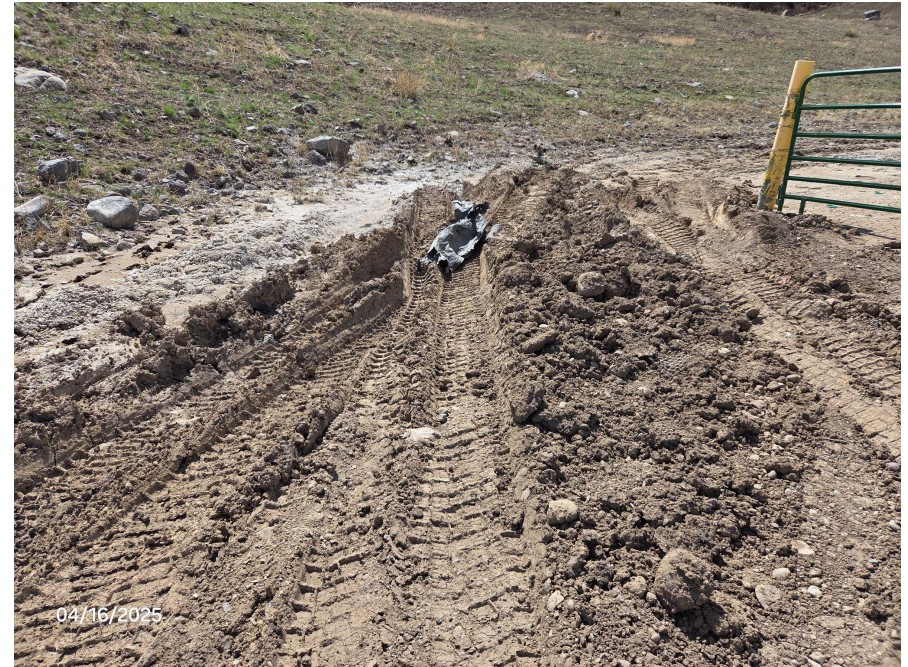
Photo 7: Photos example showing tracking/degradation observed on the working pad surface. Various trash/debris/rubbish also observed within the ruts

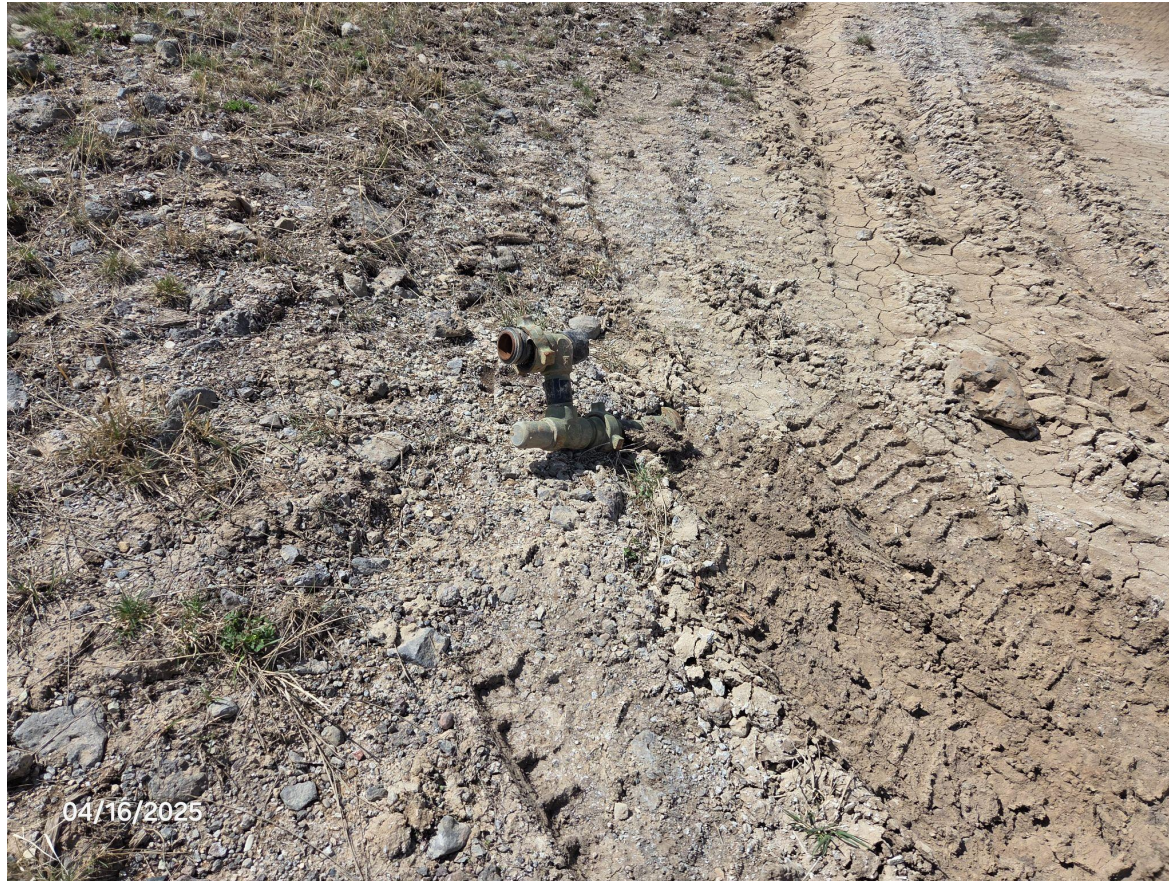
Photo 5: Unused equipment/debris observed on the south end of the Location.

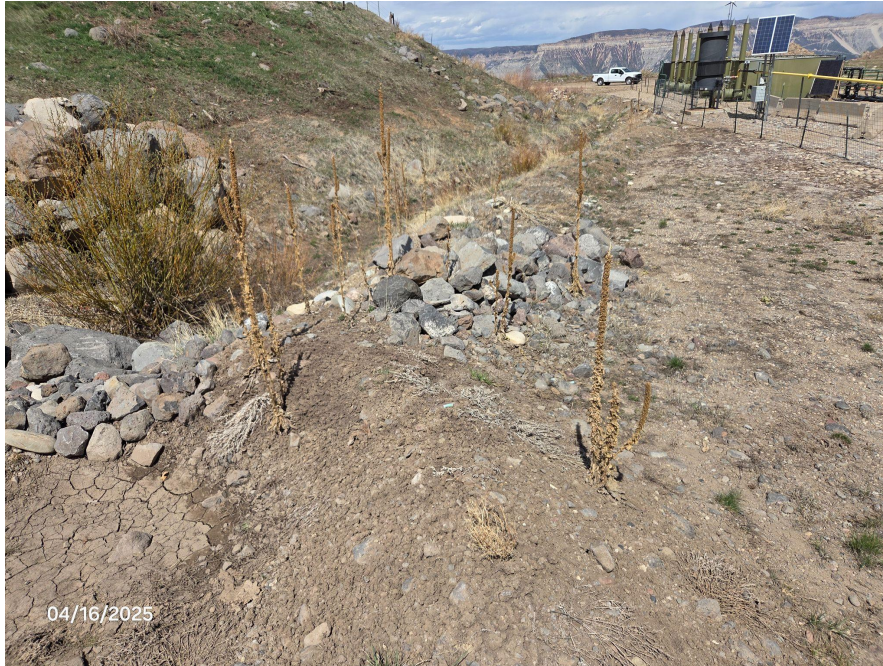
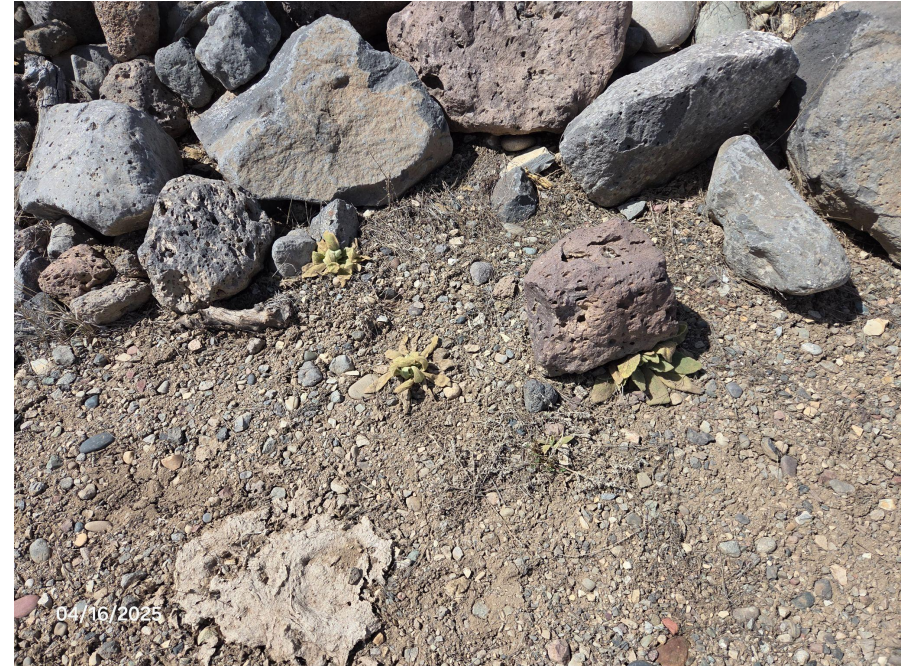
Photo 9: Photos taken from the west end of the Location. Photos examples showing weeds (Common mullein) established on the Location.
