Inspection Photos

Operator: LARAMIE ENERGY LLC #10433

Location ID: 312427

Inspection Doc: 718100476

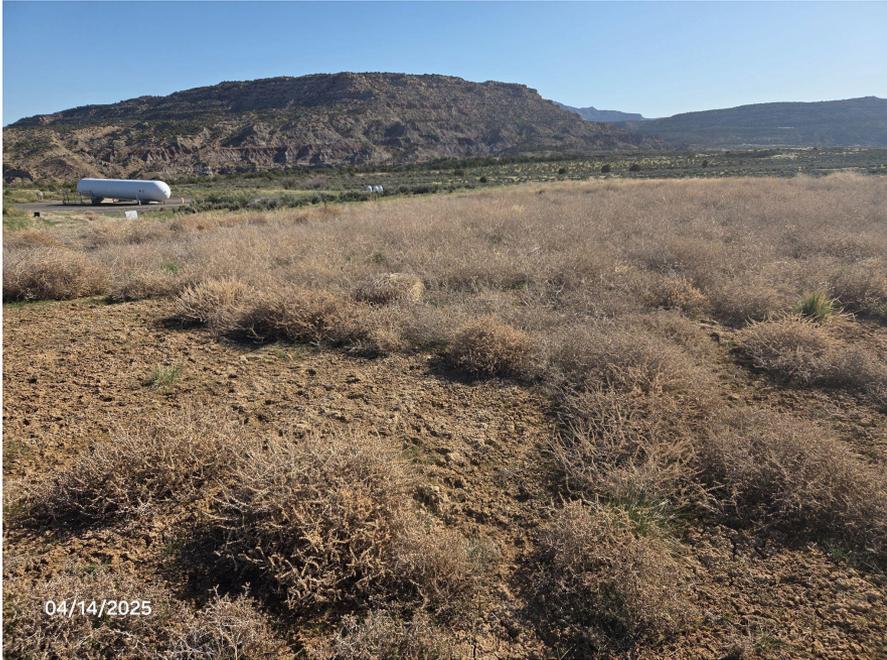
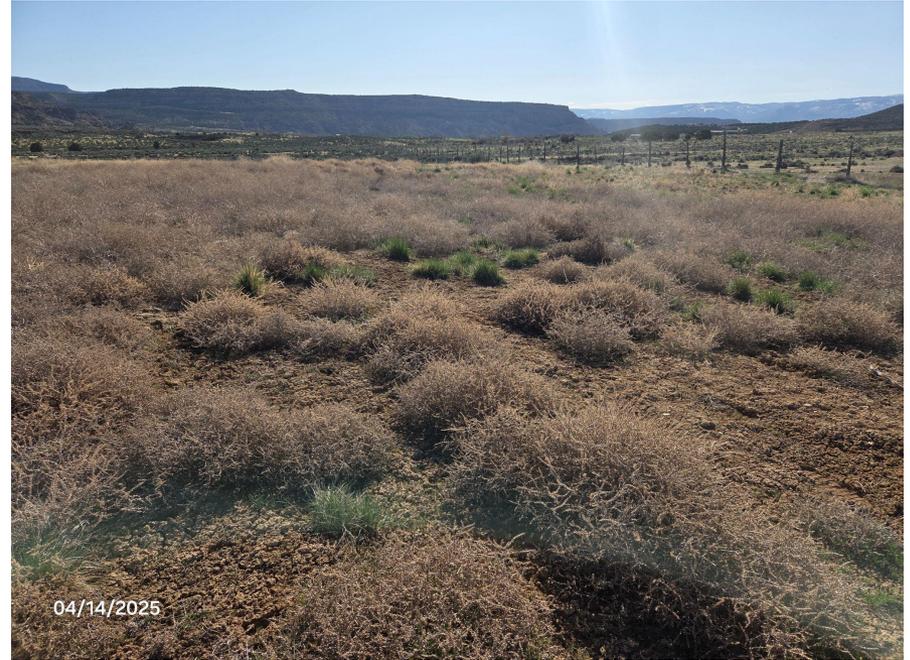
Photo 1: Photos taken from the west end of the Location, facing northeast and southeast. Photos provide an overview of the Location; vegetation on the Location is not progressing towards ECMC 1004 uniform, desirable perennial vegetative requirements; vegetation established is predominantly Undesirable Plant Species including Kochia, Russian Thistle and Redstem Filaree; perennial establishment throughout the Location is sparse.

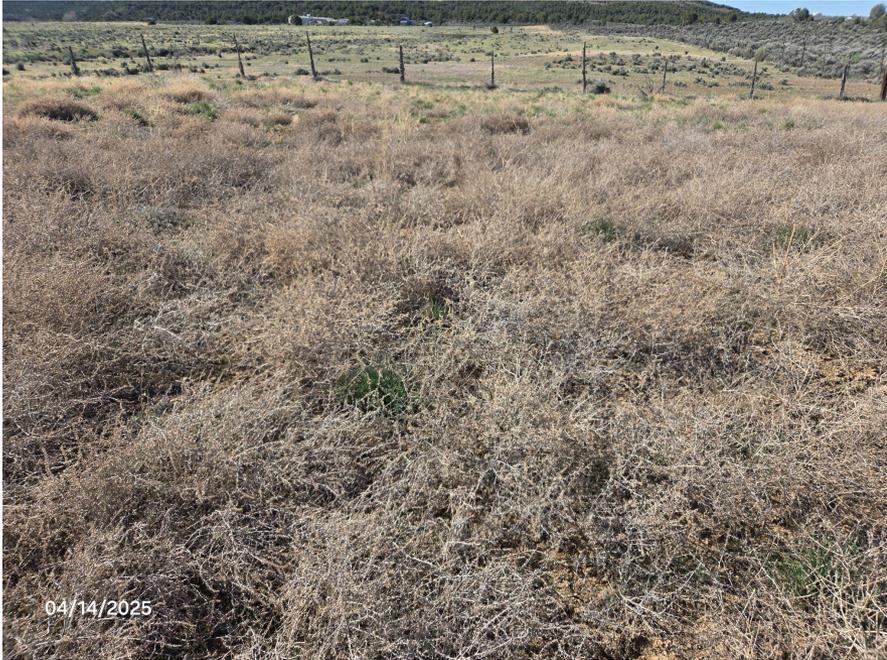
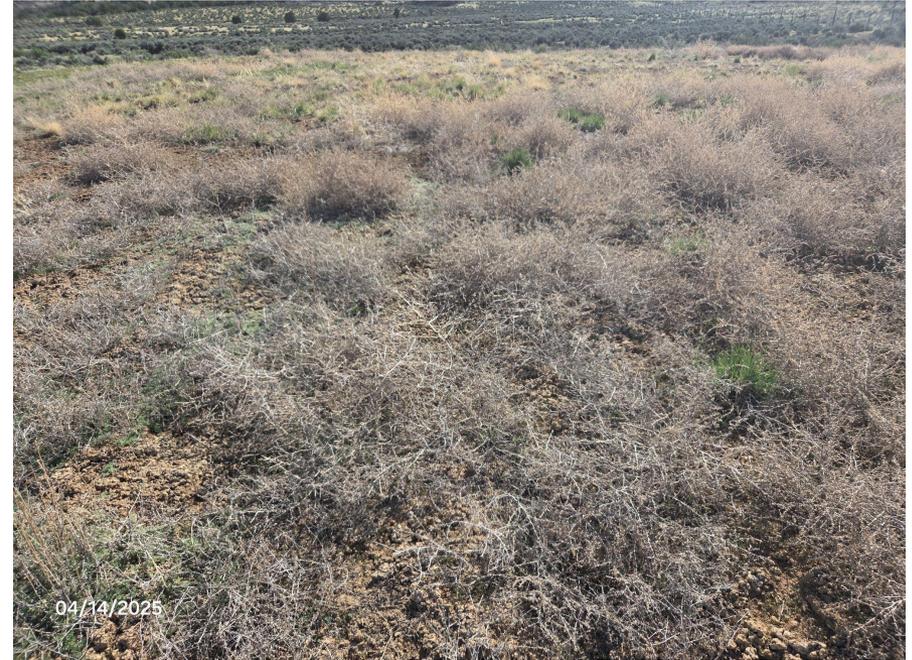
Photo 2: Continued from photo 1. Photos examples showing weed establishment (Russian thistle). Vegetation on the Location is not progressing towards ECMC 1004 uniform, desirable perennial vegetative requirements; vegetation established is predominantly Undesirable Plant Species including Kochia, Russian Thistle and Redstem Filaree; perennial establishment throughout the Location is sparse.

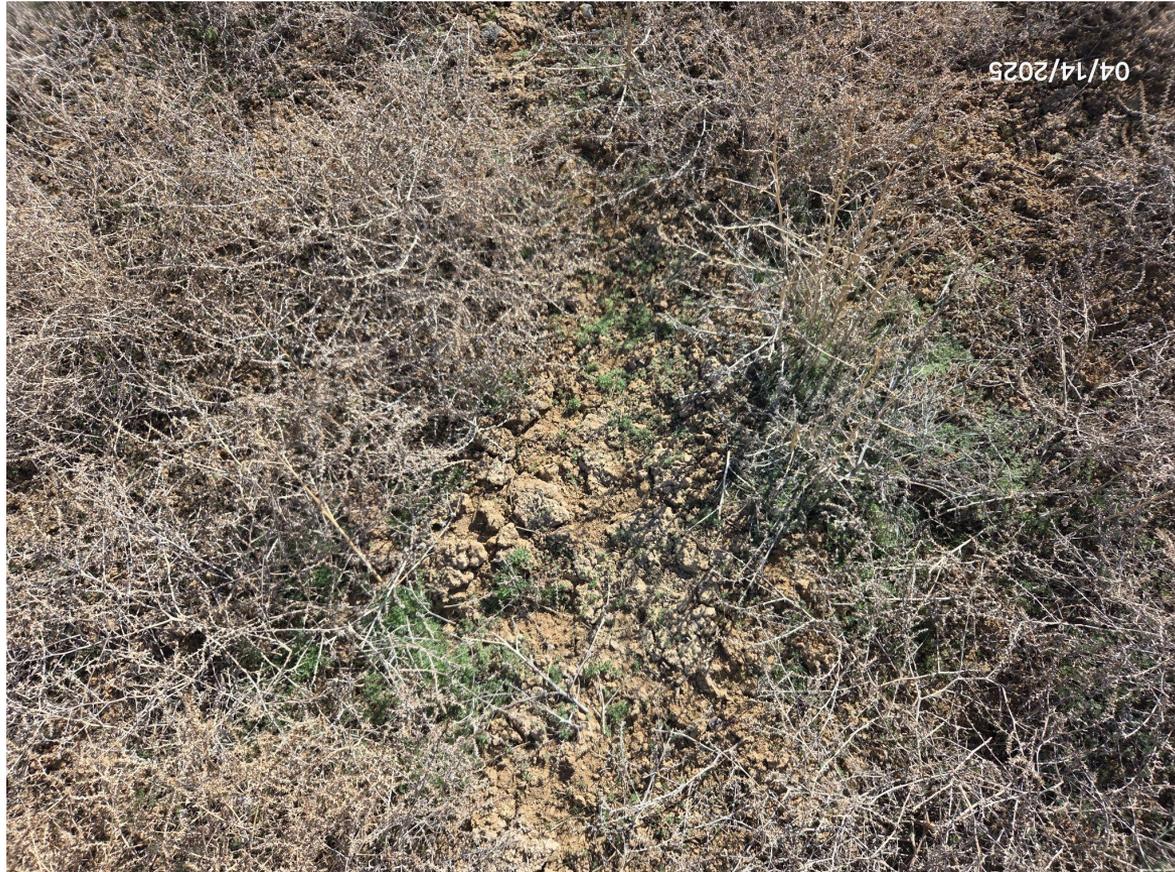
Photo 3: Continued from photo 2. Green vegetation beneath the weed debris is Kochia establishing on the Location. Perennial establishment throughout the Location is sparse.

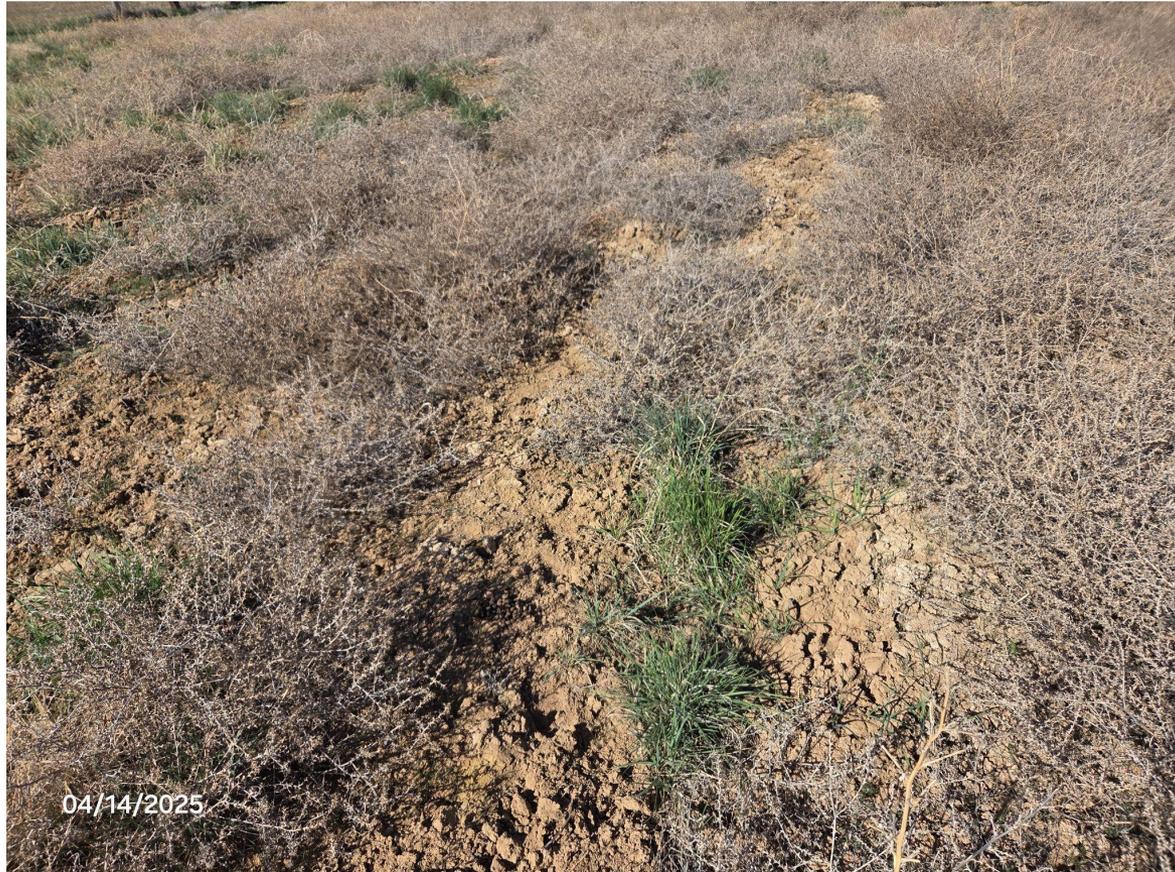
Photo 4: Photo example showing sparse perennial vegetation (green vegetation in photo).

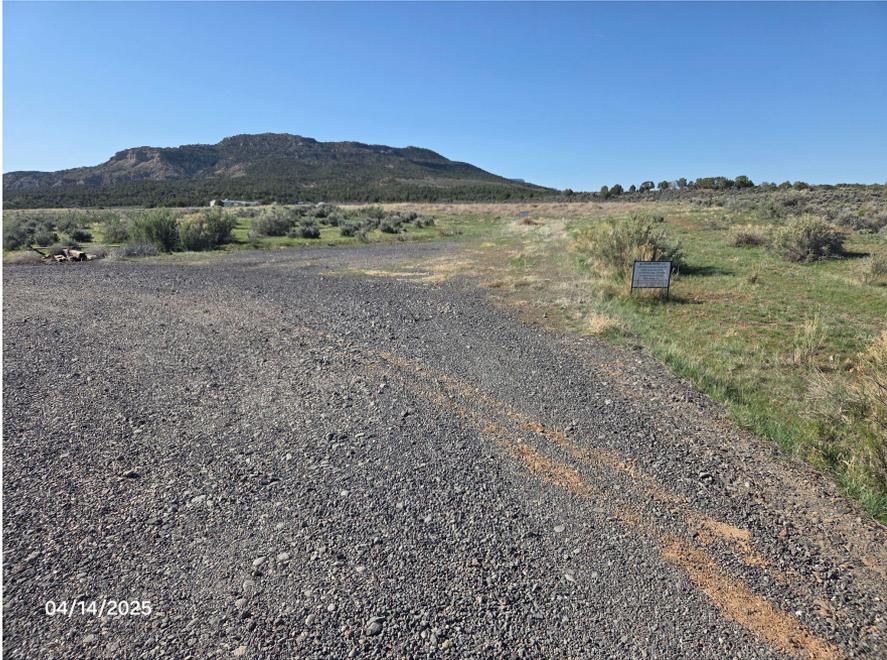
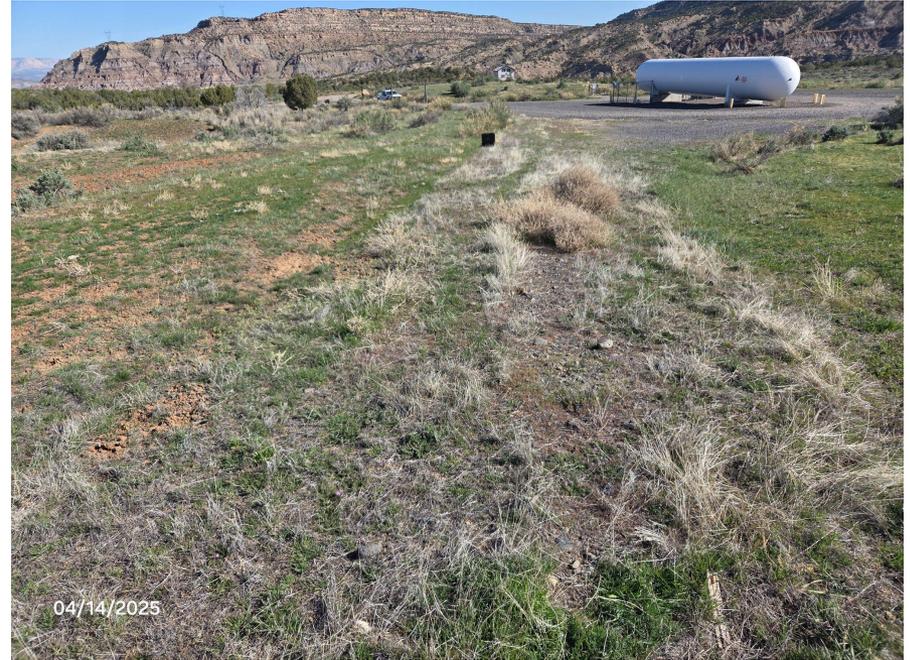
Photo 5: Photos taken from the south end of the Location. Operator has submitted a variance request to waive 1004 reclamation requirements of approximately “98 feet of access road”. Vegetation established on the access road is predominantly weeds, including cheatgrass and redstem filaree.
