# Inspection Photos

**Operator:** QB ENERGY OPERATING LLC

**Location ID:** 414880

**Inspection Doc:** 718100498

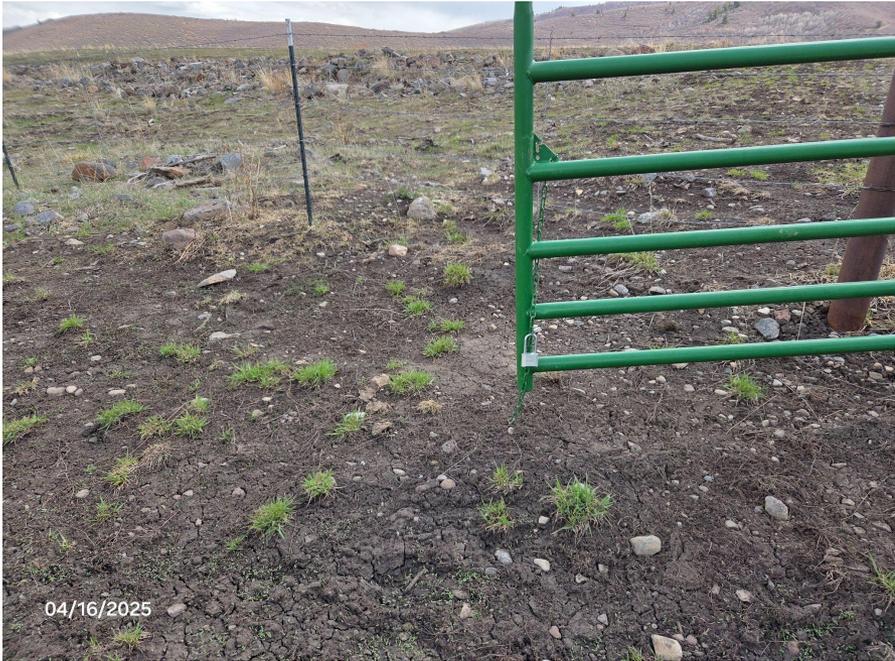
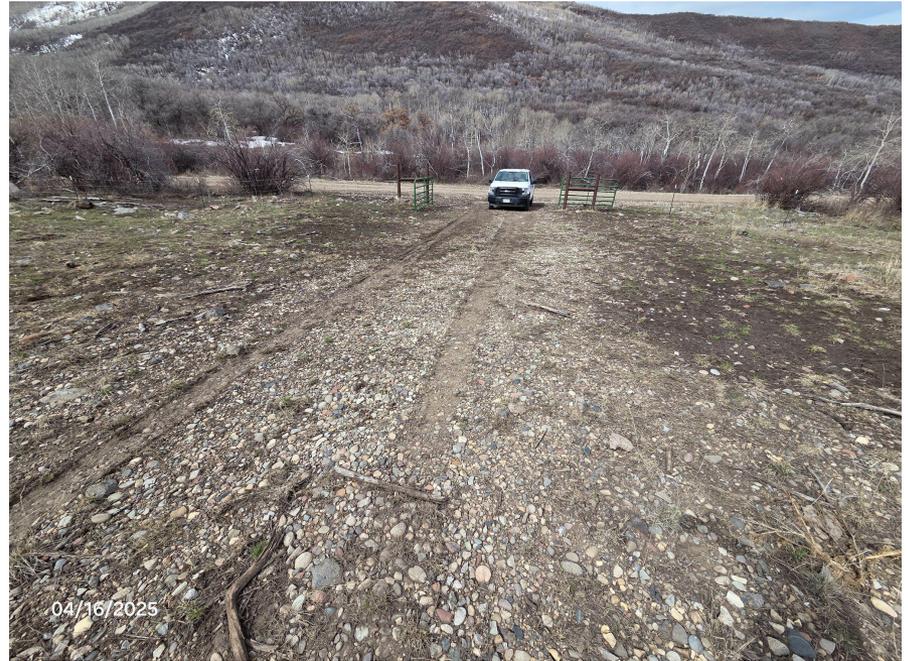
**Photo 1:** Photos taken from the Location entrance. Photos show that the Location's entrance was unlocked and open at time of inspection, and that vehicle ruts throughout the site was observed and has resulted in additional degradation to the site, and the reclamation.

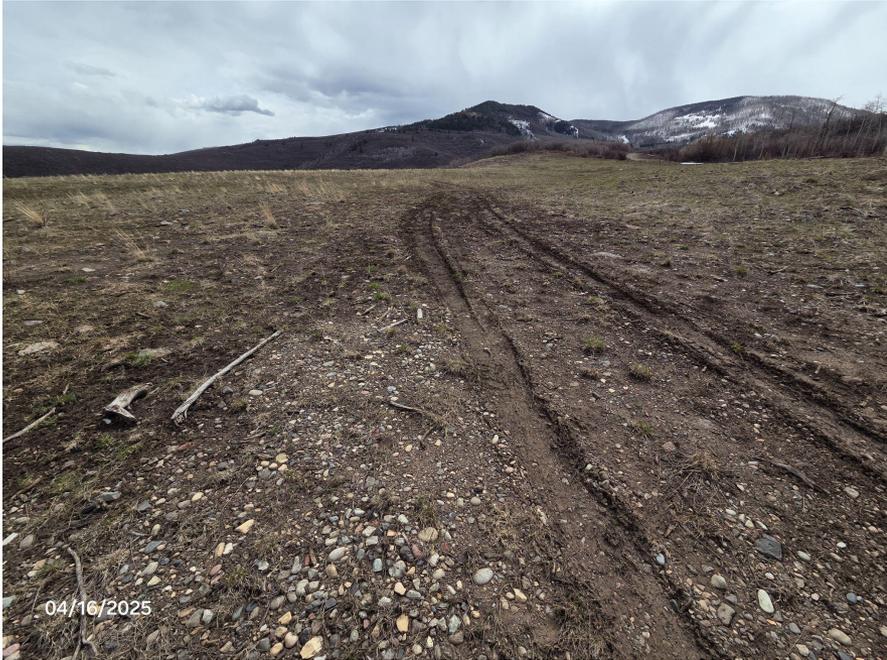
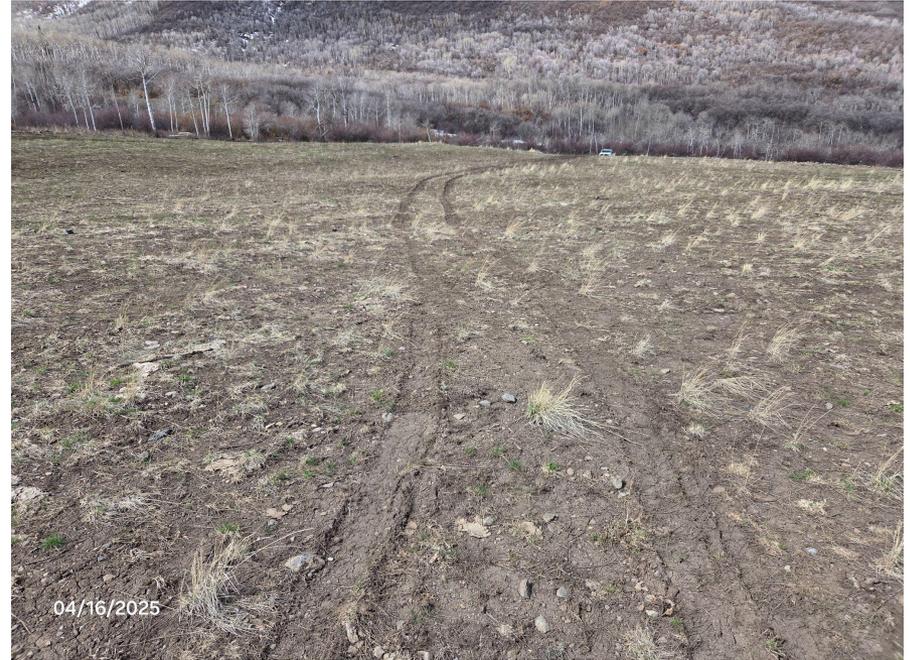
**Photo 2:** Continued from photo 1. Photos show vehicle ruts observed throughout the site, resulting in degradation to the Location and the reclamation.

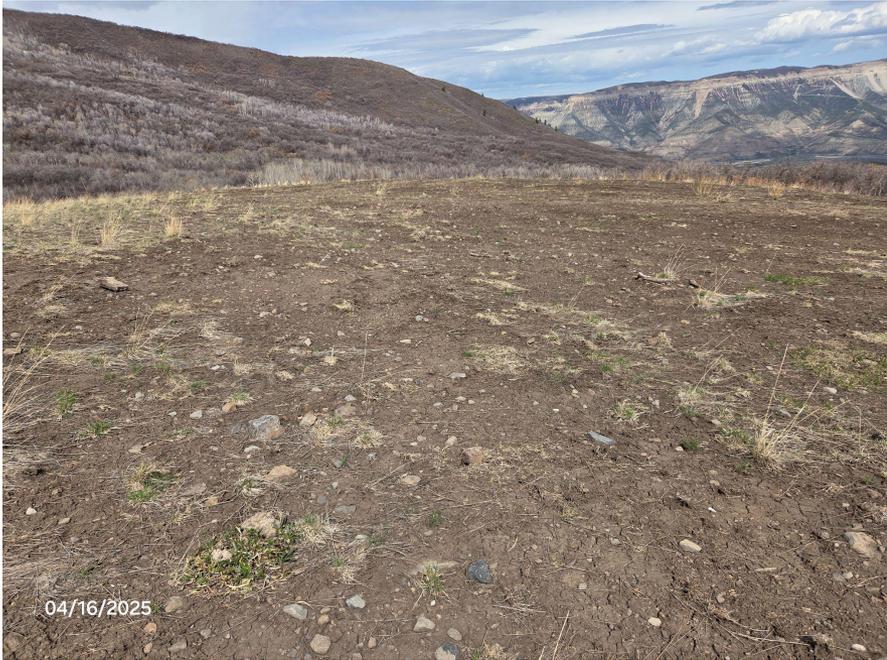
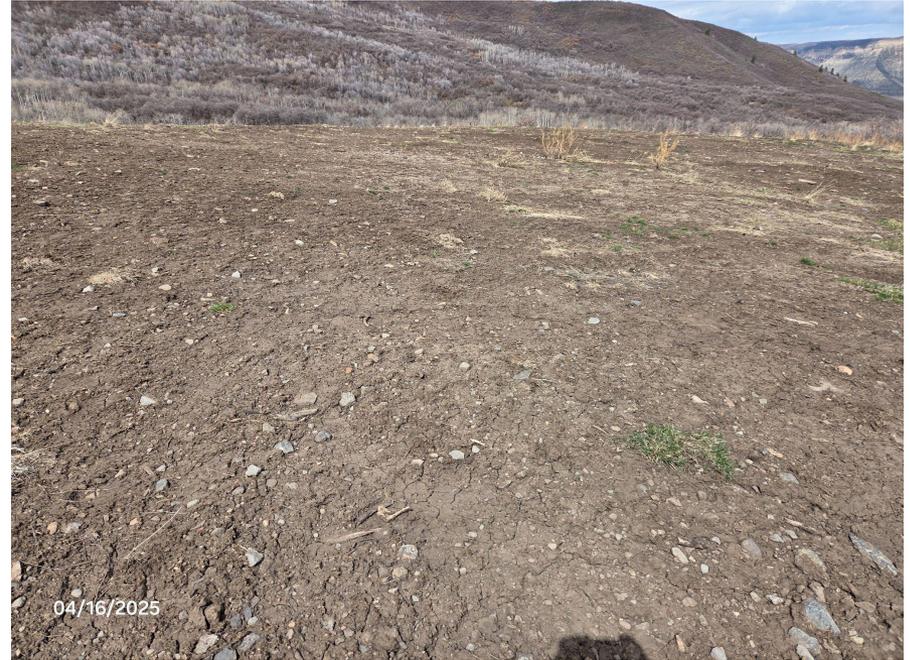
**Photo 3:** Photos taken from the northern areas of the Location. Vegetation is not progressing towards ECMC 1004 uniform, desirable perennial vegetative cover requirements.

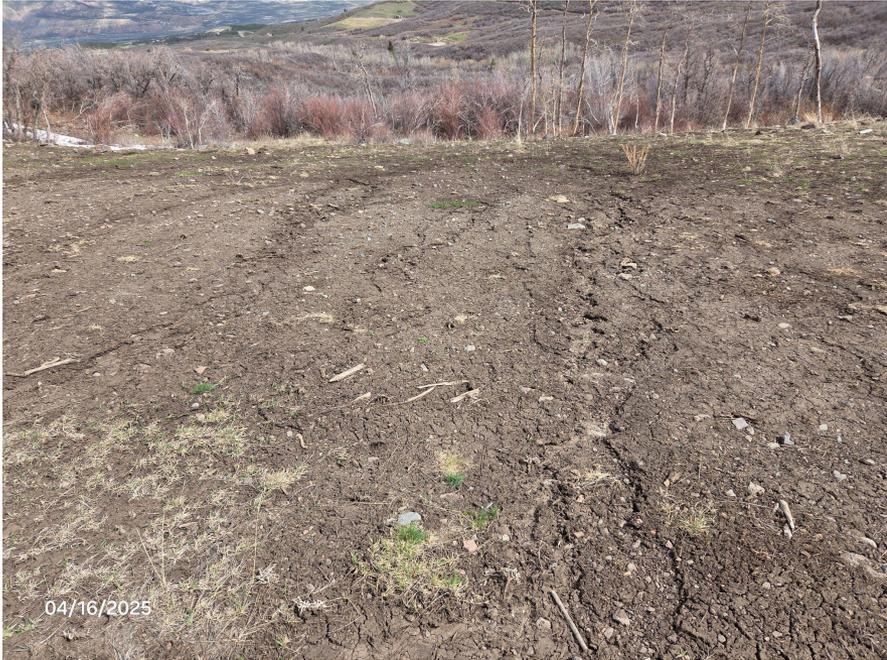
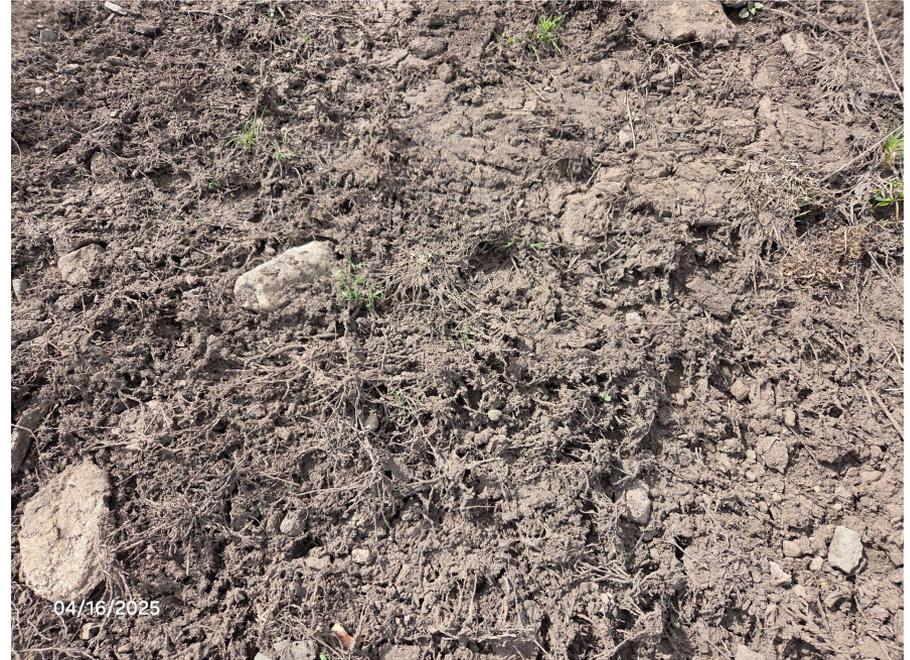
**Photo 4:** Continued from photo 3. Photos examples showing erosion degradation, and sediment transport/deposition observed on the north end of the Location.

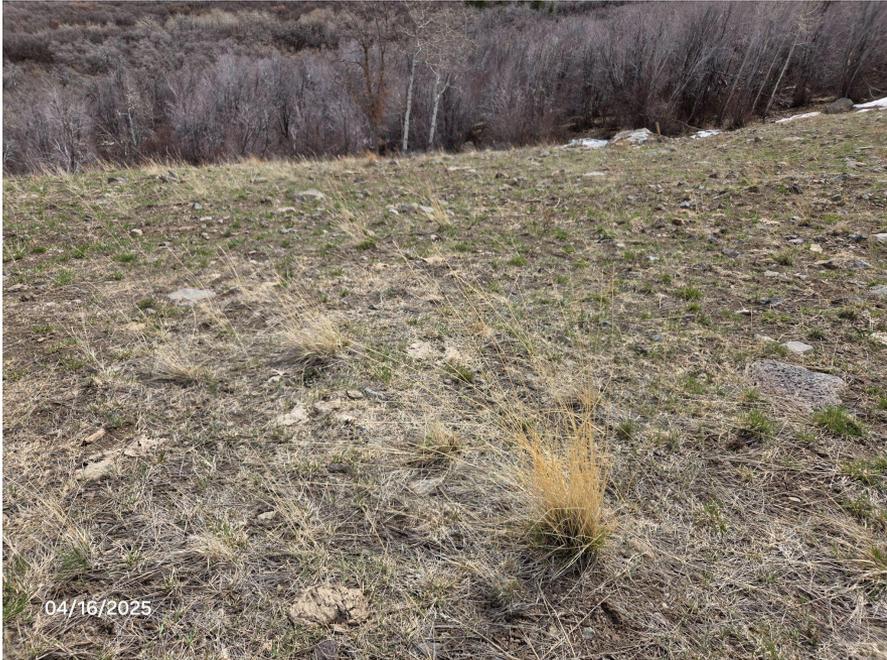
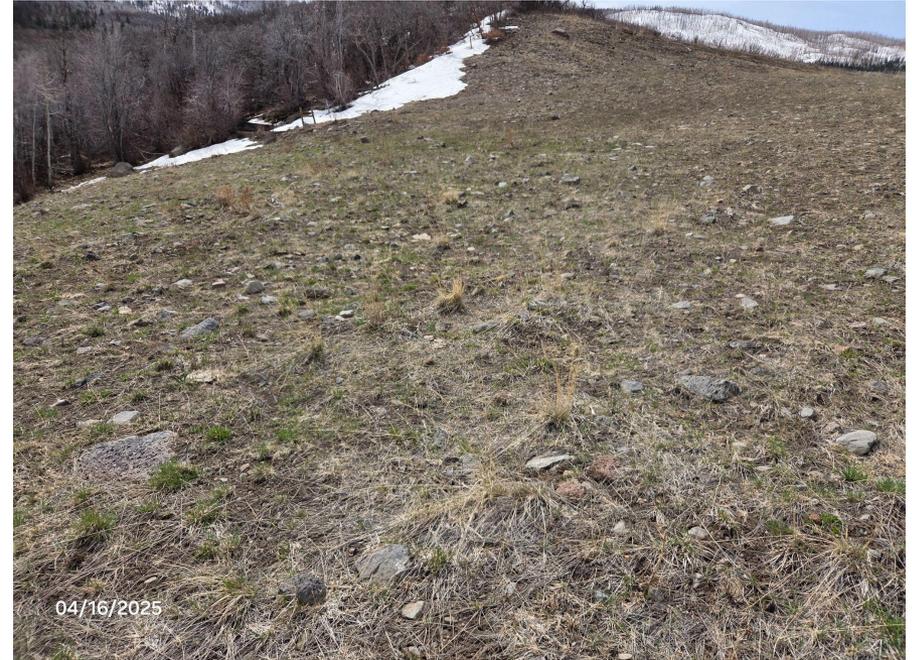
**Photo 5:** Photos taken from the eastern areas of the Location. Vegetation within these areas are progressing towards ECMC 1004 uniform, desirable perennial vegetative cover requirements.

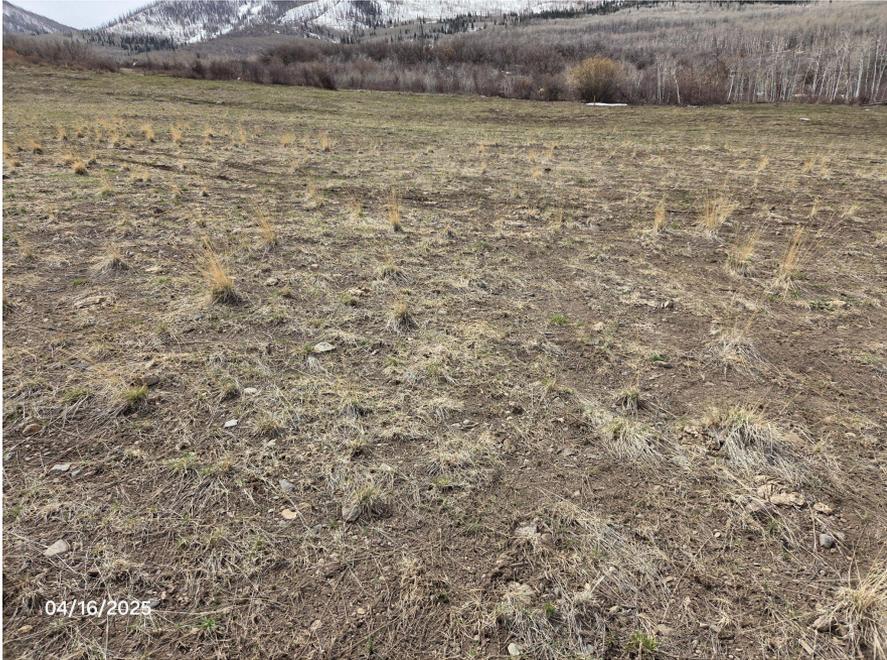
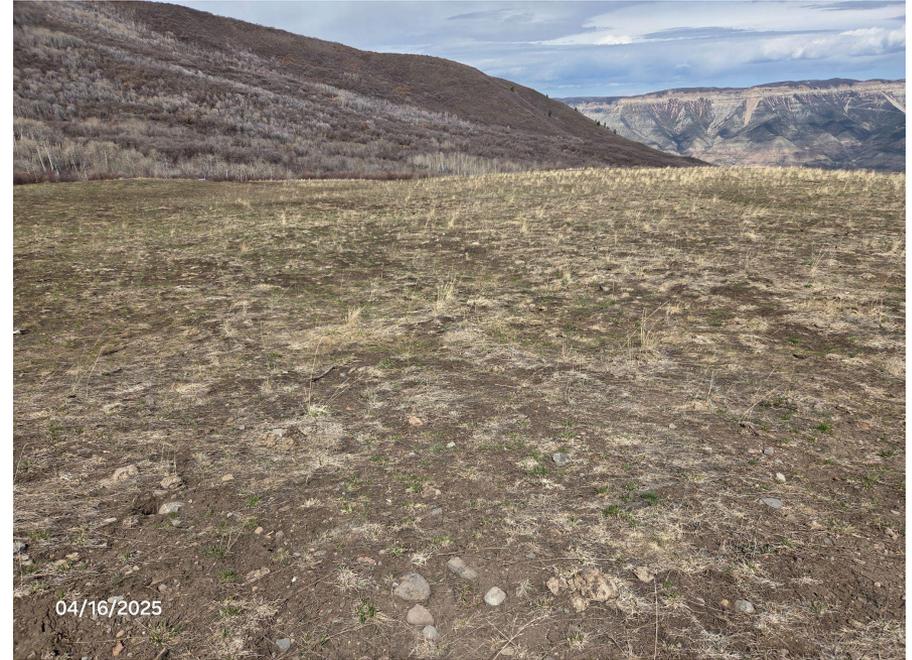
**Photo 6:** Photos taken from the southern areas of the Location. Vegetation within these areas are progressing towards ECMC 1004 uniform, desirable perennial vegetative cover requirements.

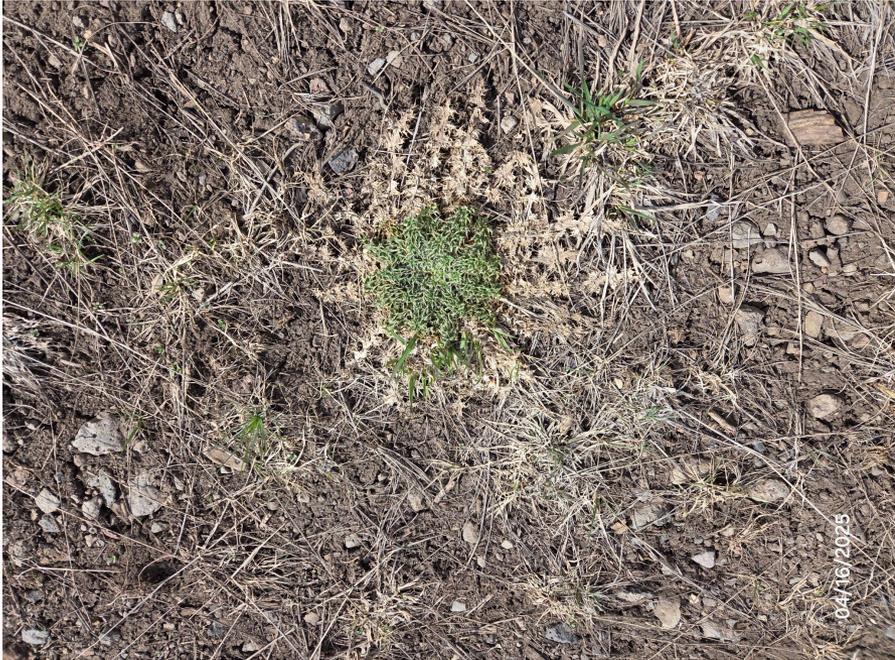
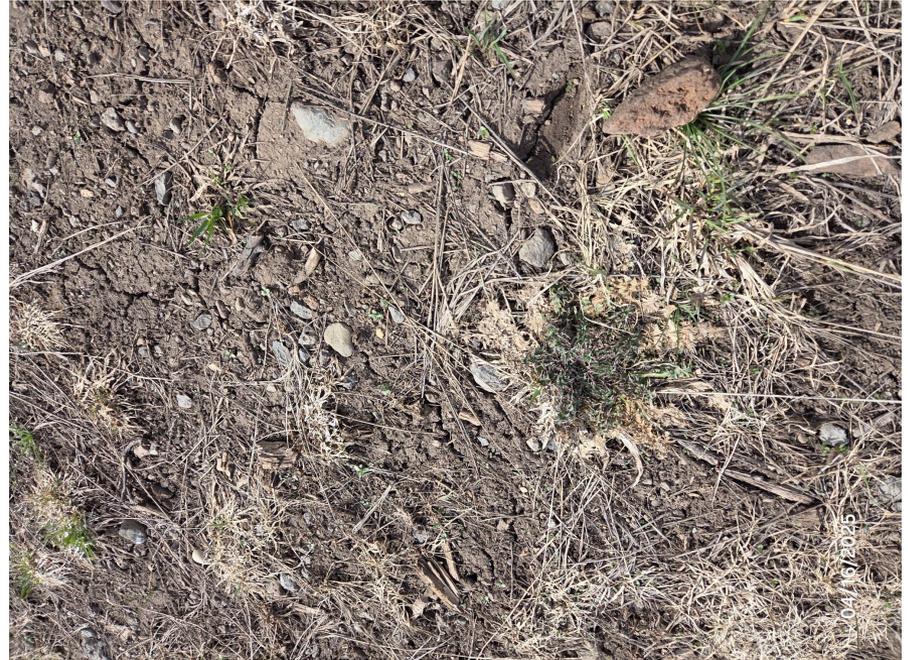
**Photo 7:** Photos examples showing weed rosettes observed on the Location.

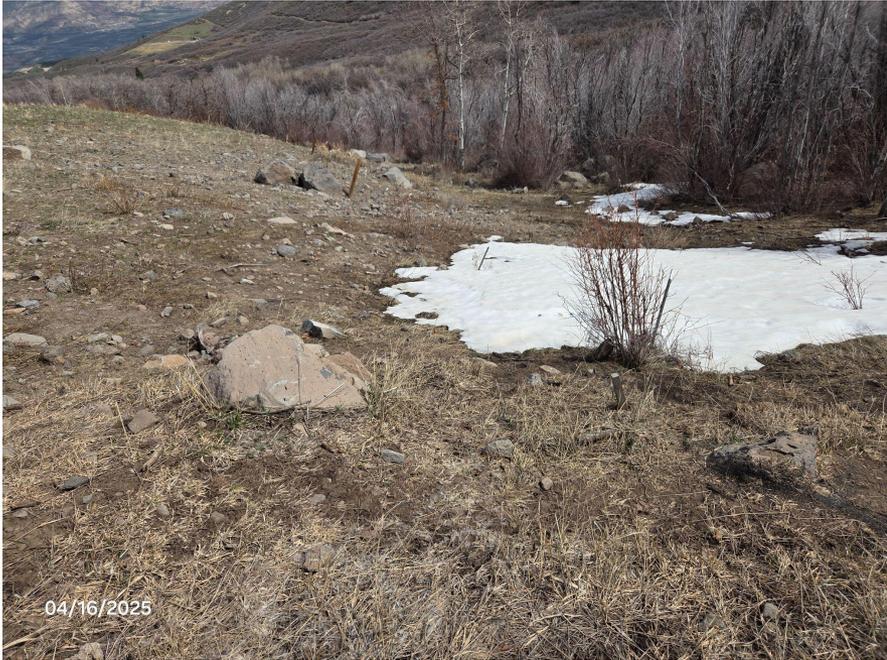
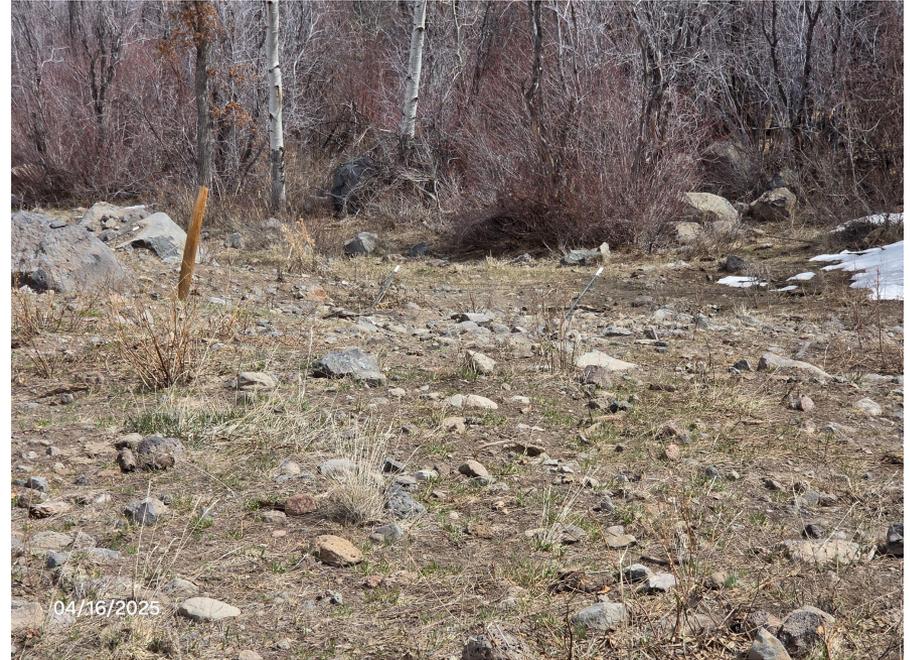
**Photo 8:** Fence along the perimeter of the Location is in disrepair.
